State Archeological Landmark Completion Report

Roof repairs at Carrington-Covert House Austin, Travis County

Antiquities Permit Number: 487

January 11, 2011

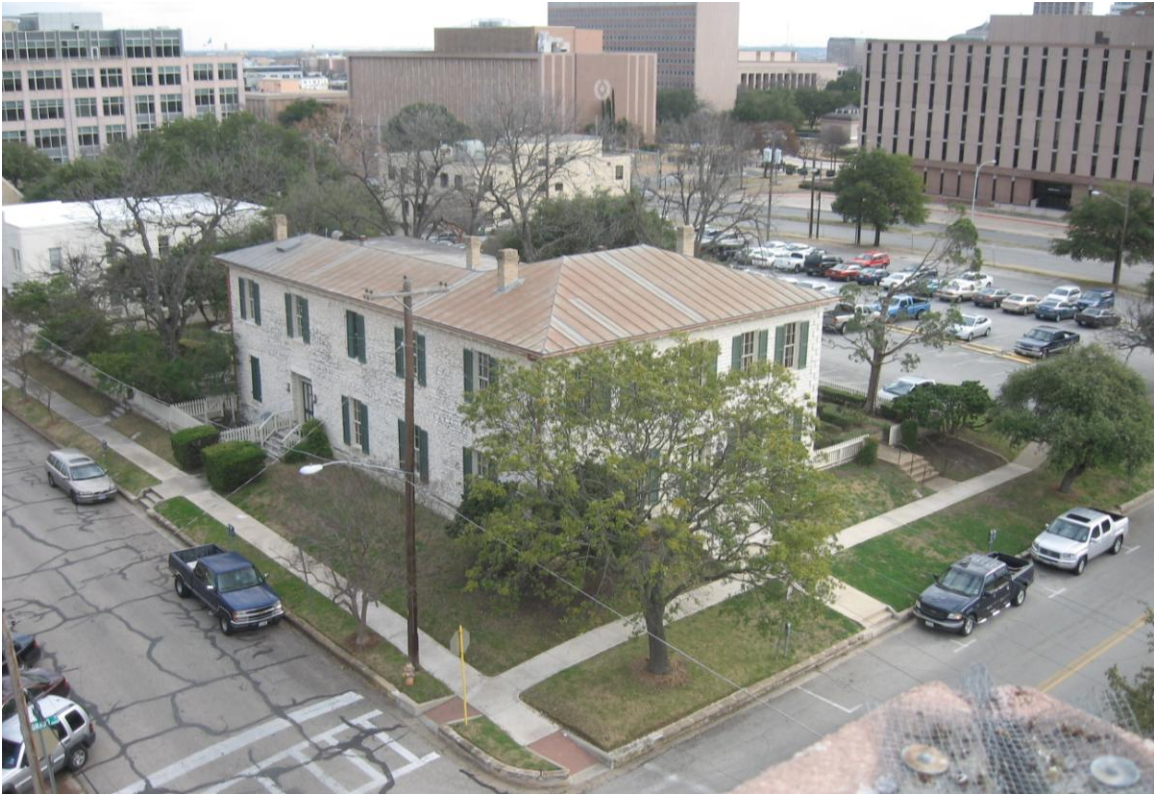
Before 1, January 27, 2010, Photo taken from top of adjacent parking garage
Overall

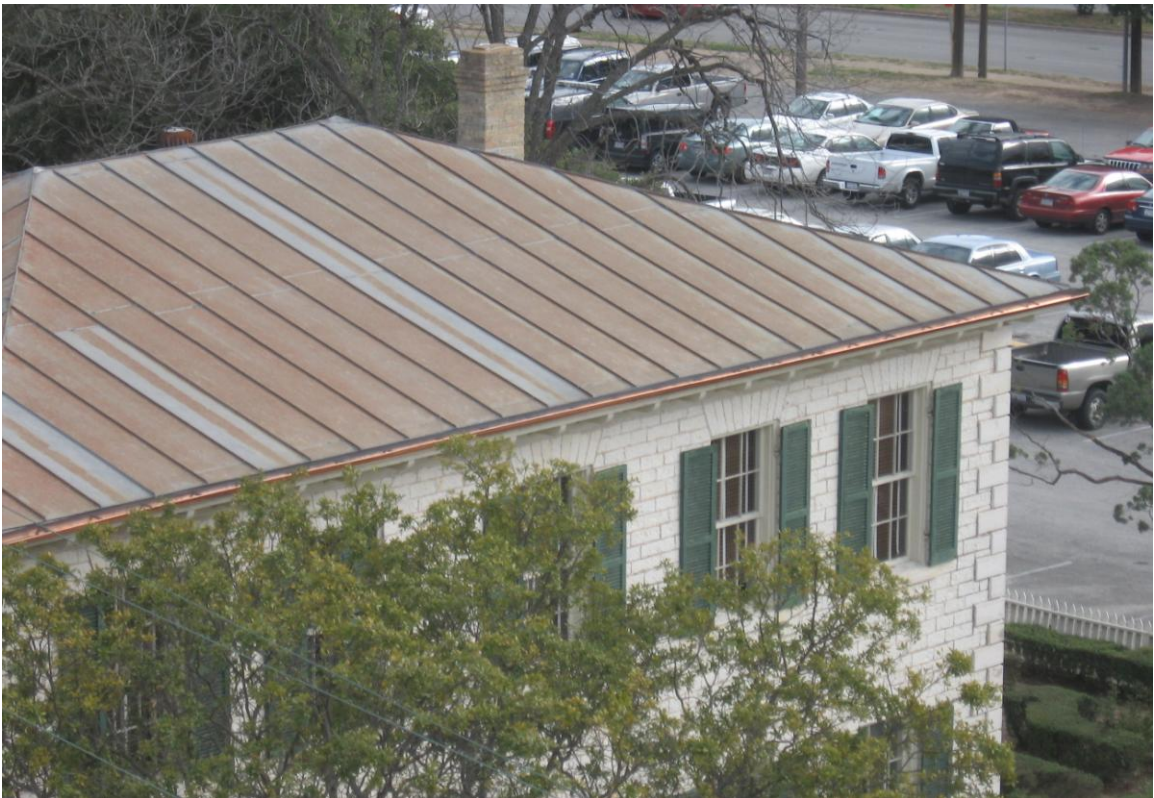
Before 2, January 27, 2010, Photo taken from top of adjacent parking garage
Southwest end

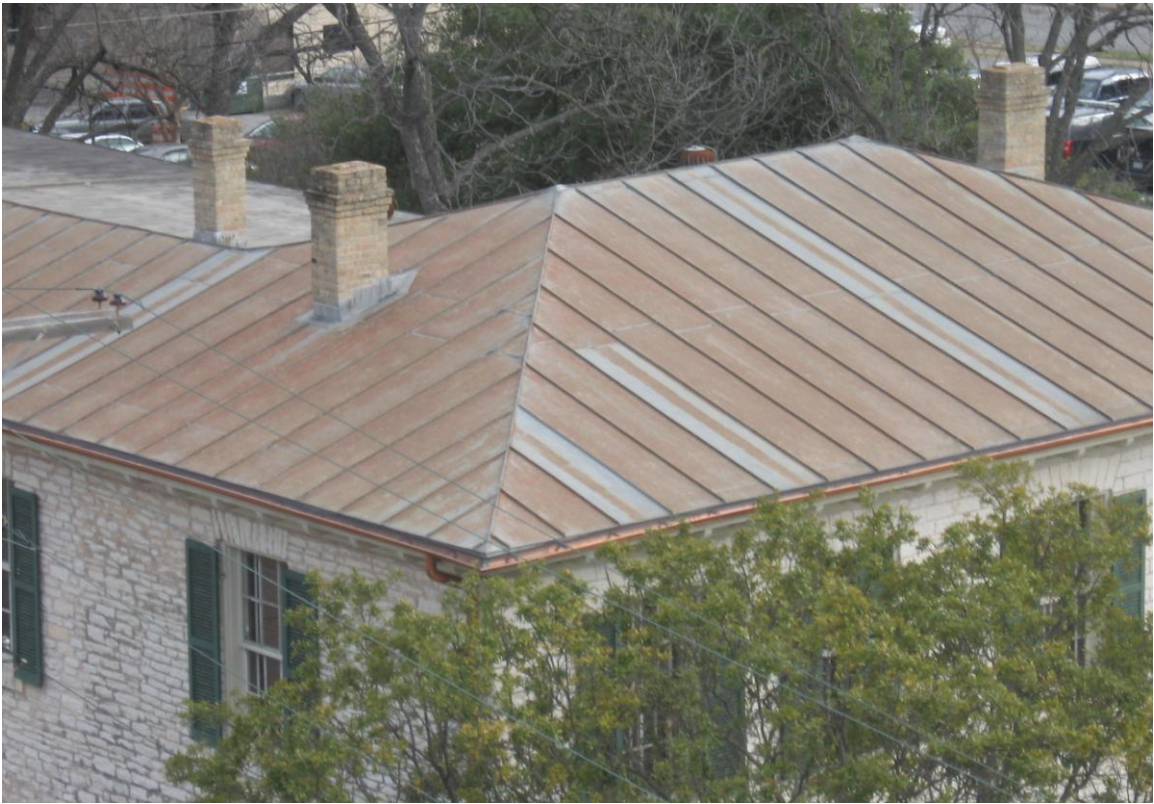
Before 3, January 27, 2010, Photo taken from top of adjacent parking garage
Northwest corner

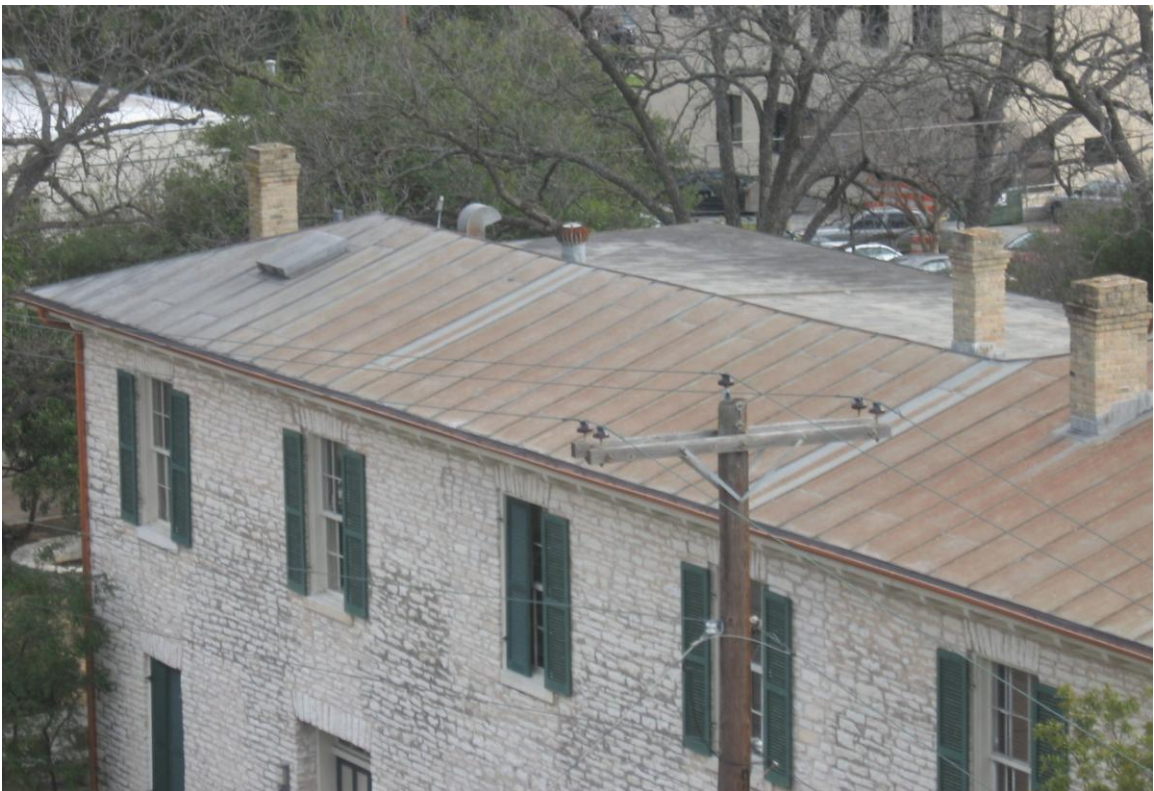
Before 4, January 27, 2010, Photo taken from top of adjacent parking garage
Northeast end

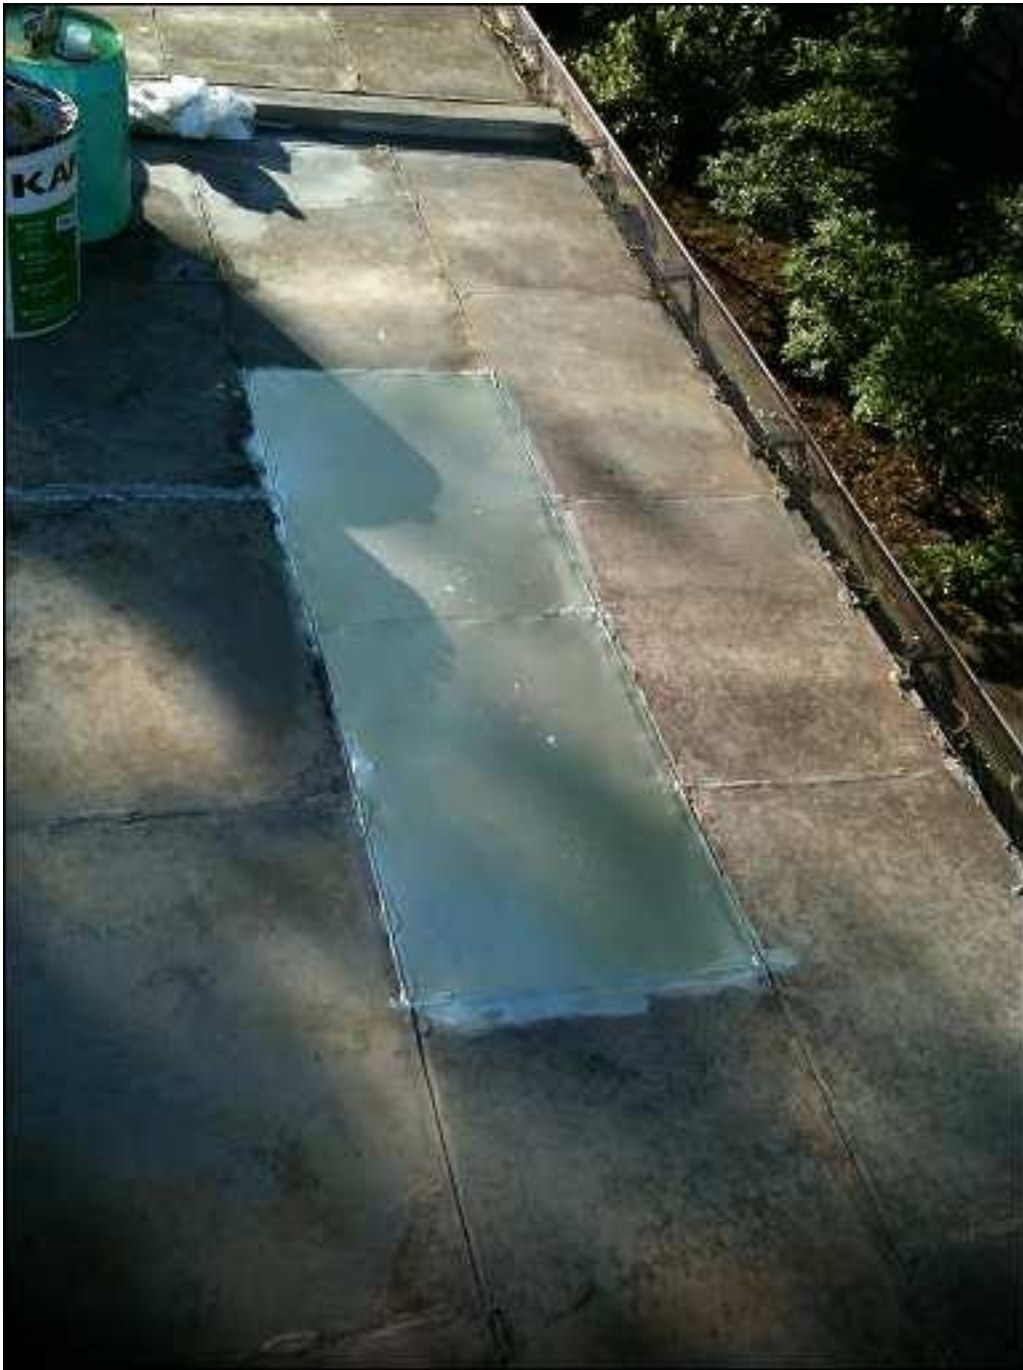
During 1, May 5, 2010
Mock-up on porch roof

A test sample was applied and the Texas Historical Commission Division of Architecture director and regional reviewer were able to review the sample.

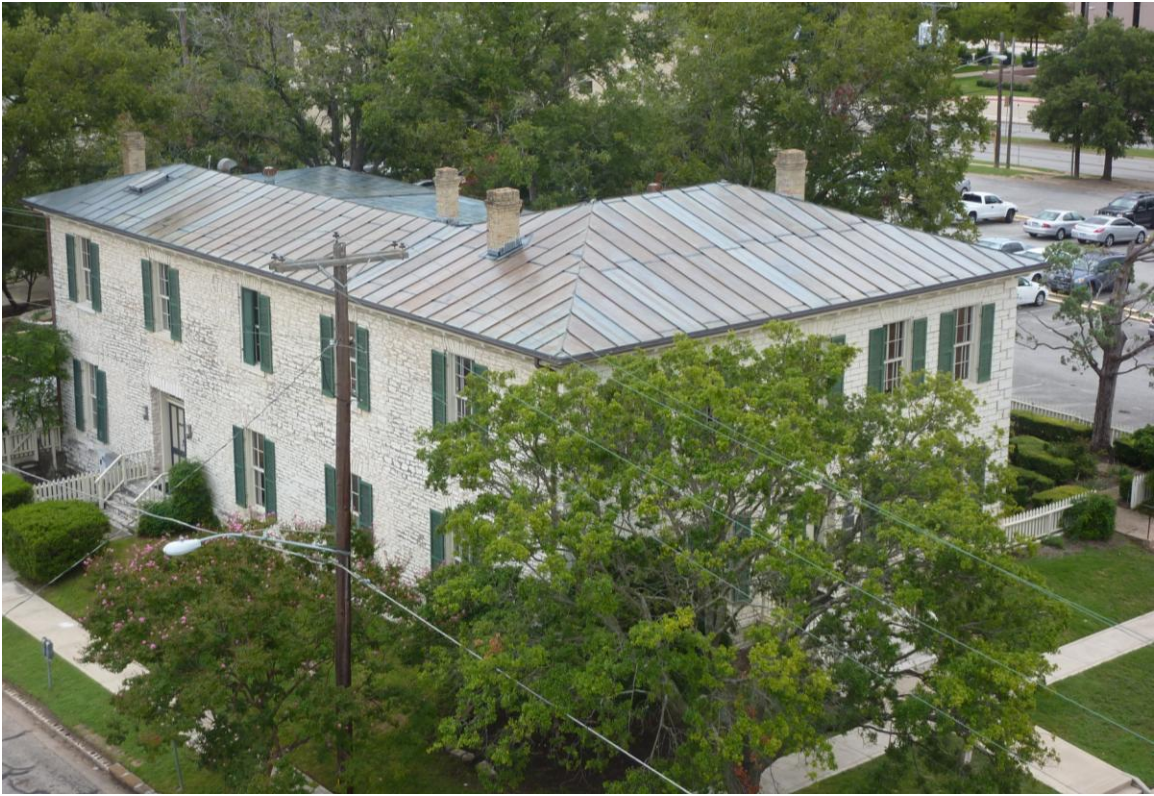
During 2, September 21, 2010, Photo taken from top of adjacent parking garage
Overall, Application of Karnack 89 Sta-Tack

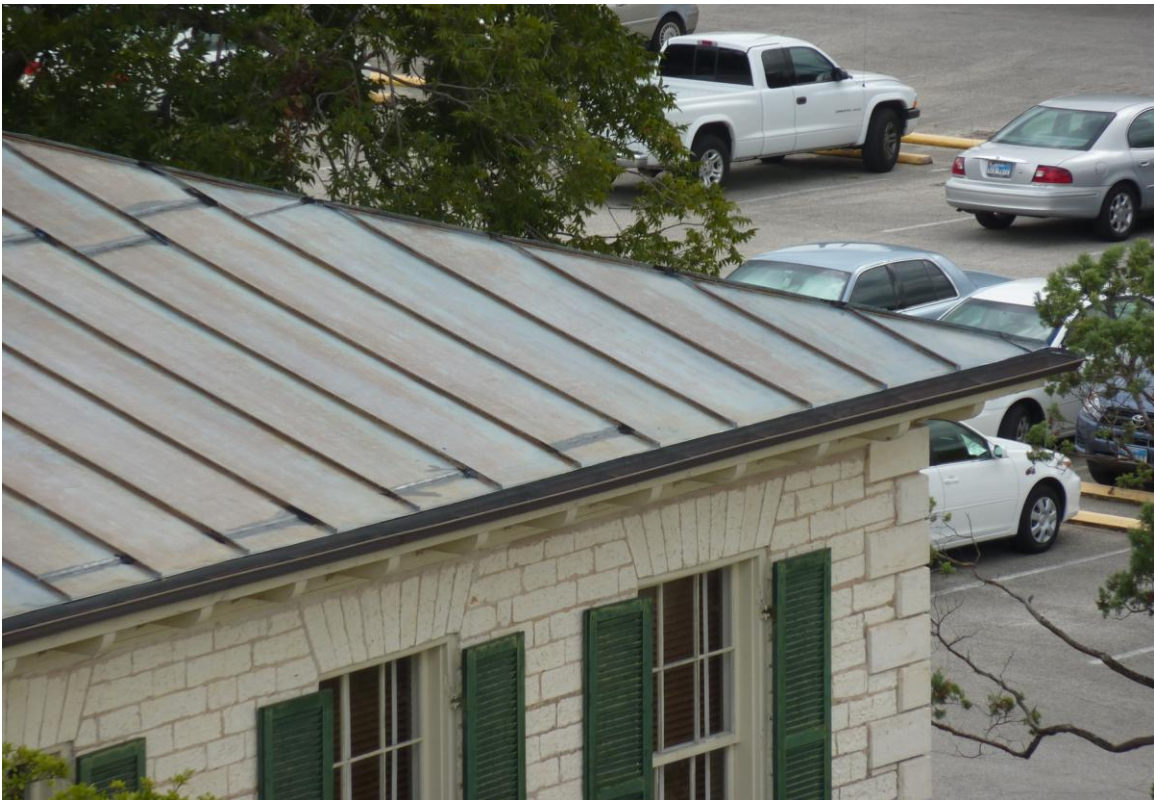
During 3, September 21, 2010, Photo taken from top of adjacent parking garage
Southwest end, Application of Karnack 89 Sta-Tack, note elastomeric sealant at joints

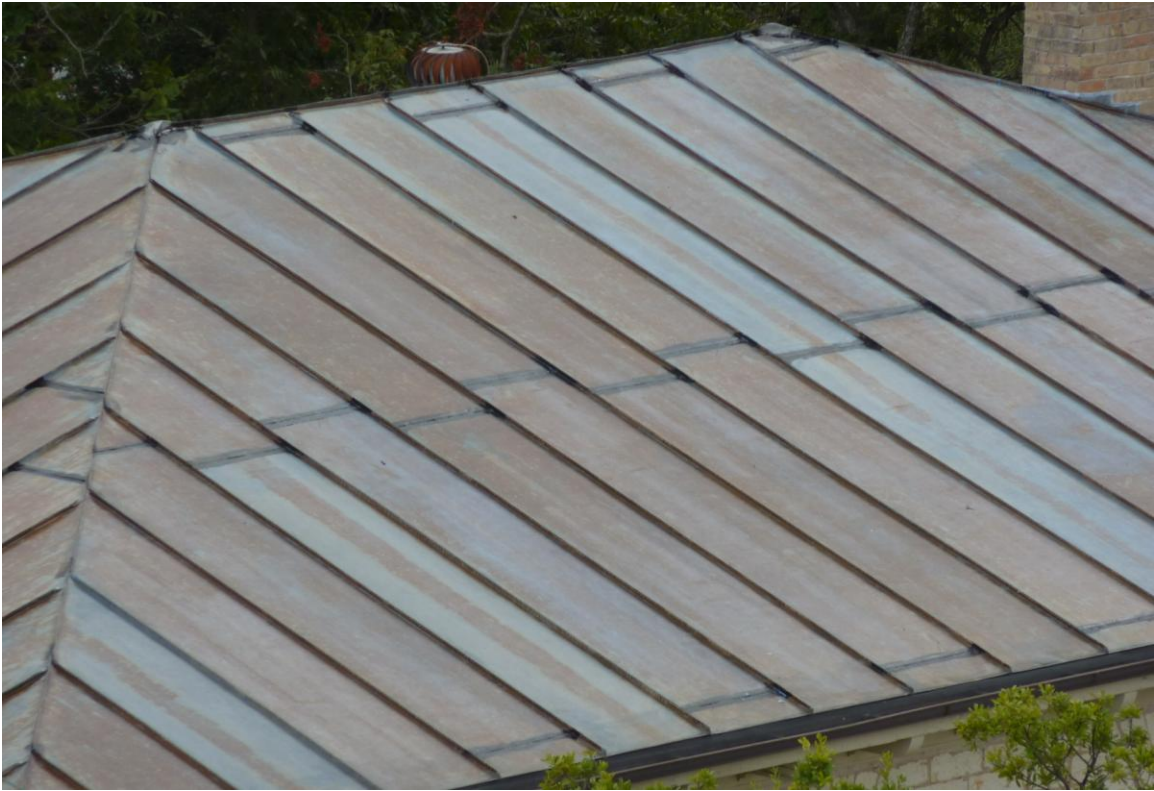
During 4, September 21, 2010, Photo taken from top of adjacent parking garage
West side, Application of Karnack 89 Sta-Tack, note elastomeric sealant at joints

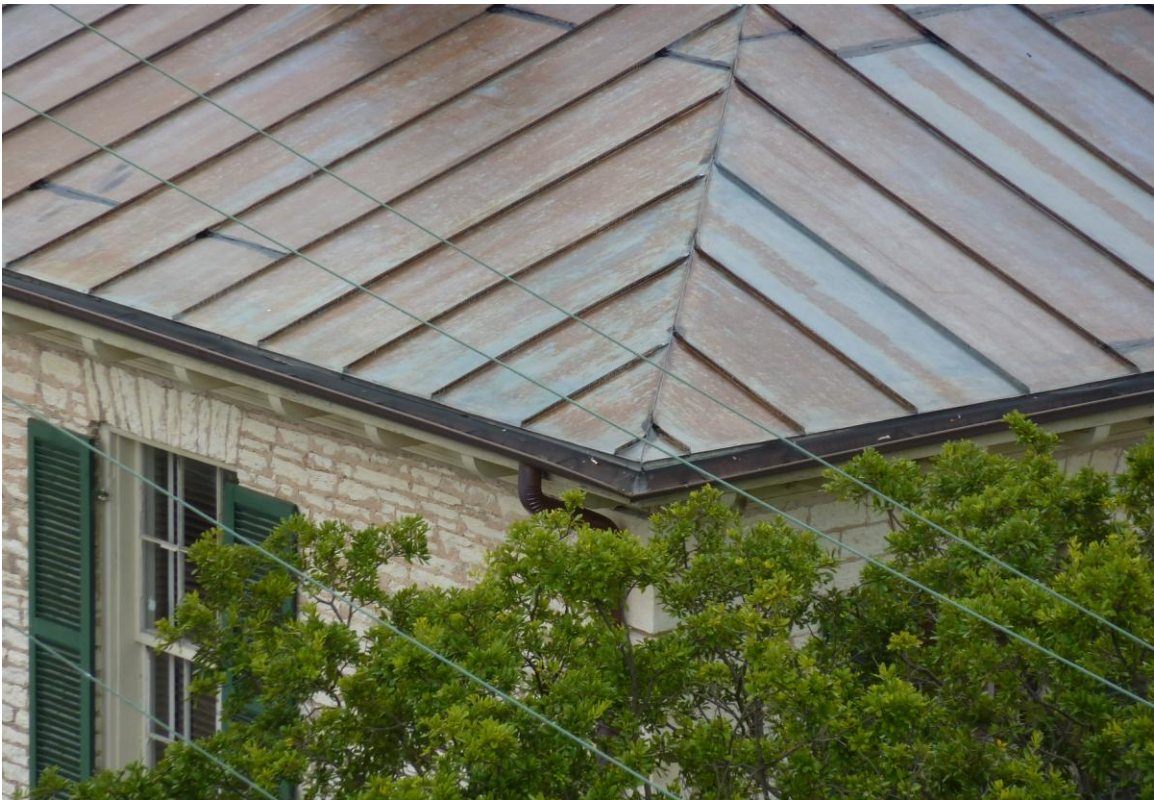
During 5, September 21, 2010, Photo taken from top of adjacent parking garage
Northwest corner, Application of Karnack 89 Sta-Tack, note elastomeric sealant at joints

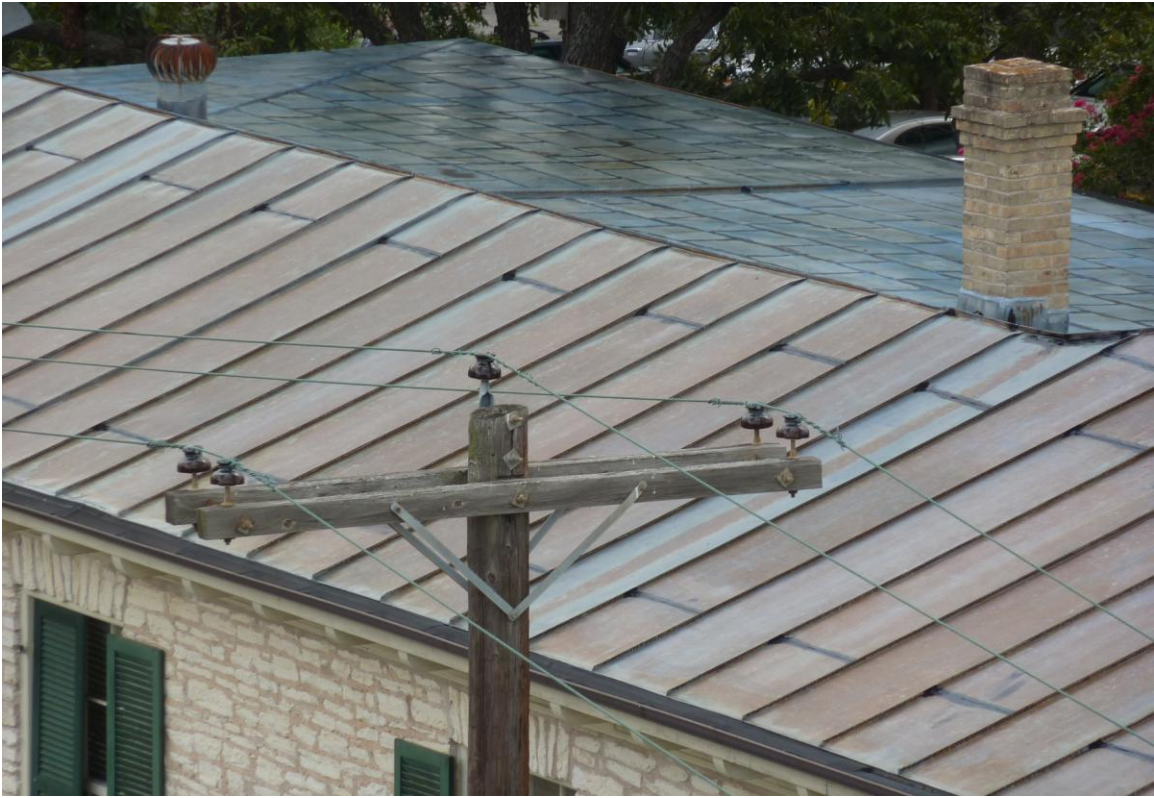
During 6, September 21, 2010, Photo taken from top of adjacent parking garage
North side, Application of Karnack 89 Sta-Tack, note elastomeric sealant at joints

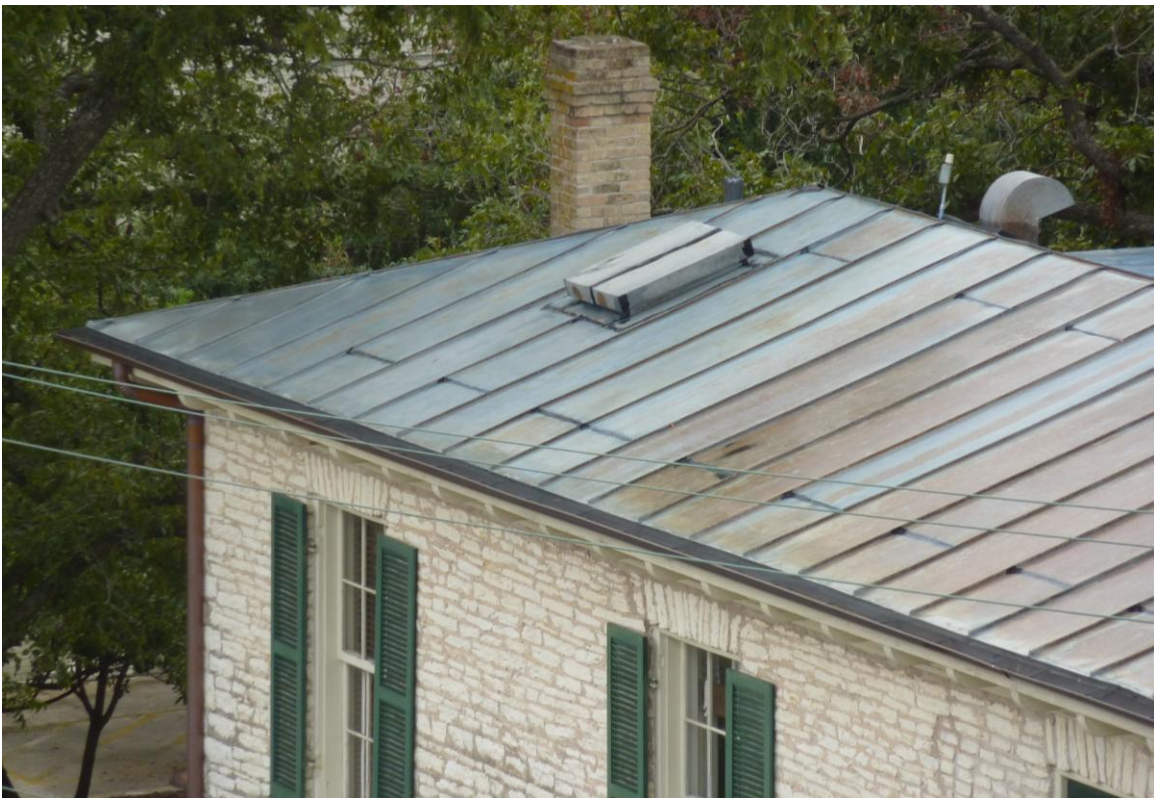
During 7, September 21, 2010, Photo taken from top of adjacent parking garage
Southeast end, Application of Karnack 89 Sta-Tack, note elastomeric sealant at joints

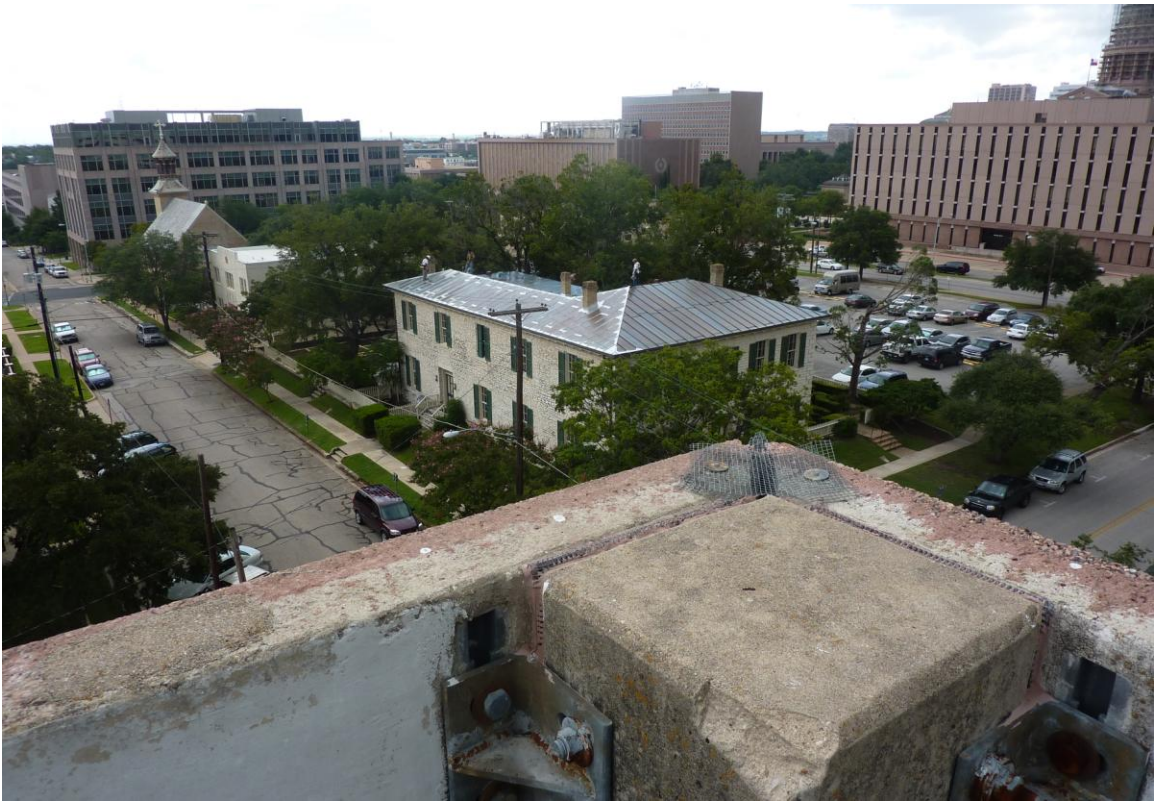
During 8, September 22, 2010, Photo taken from top of adjacent parking garage
Overall, Application of Karnack 298 Alum-R

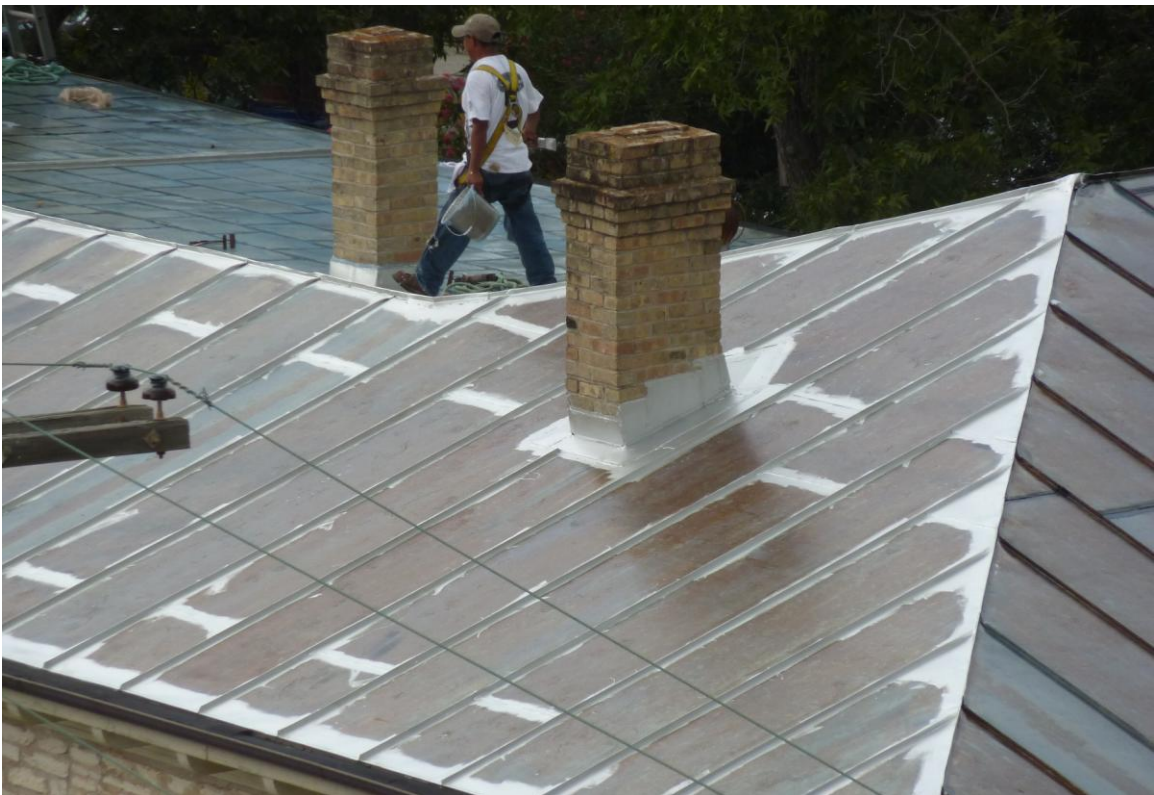
During 9, September 22, 2010, Photo taken from top of adjacent parking garage
Northwest corner, Application of Karnack 298 Alum-R, note edges and joints done first

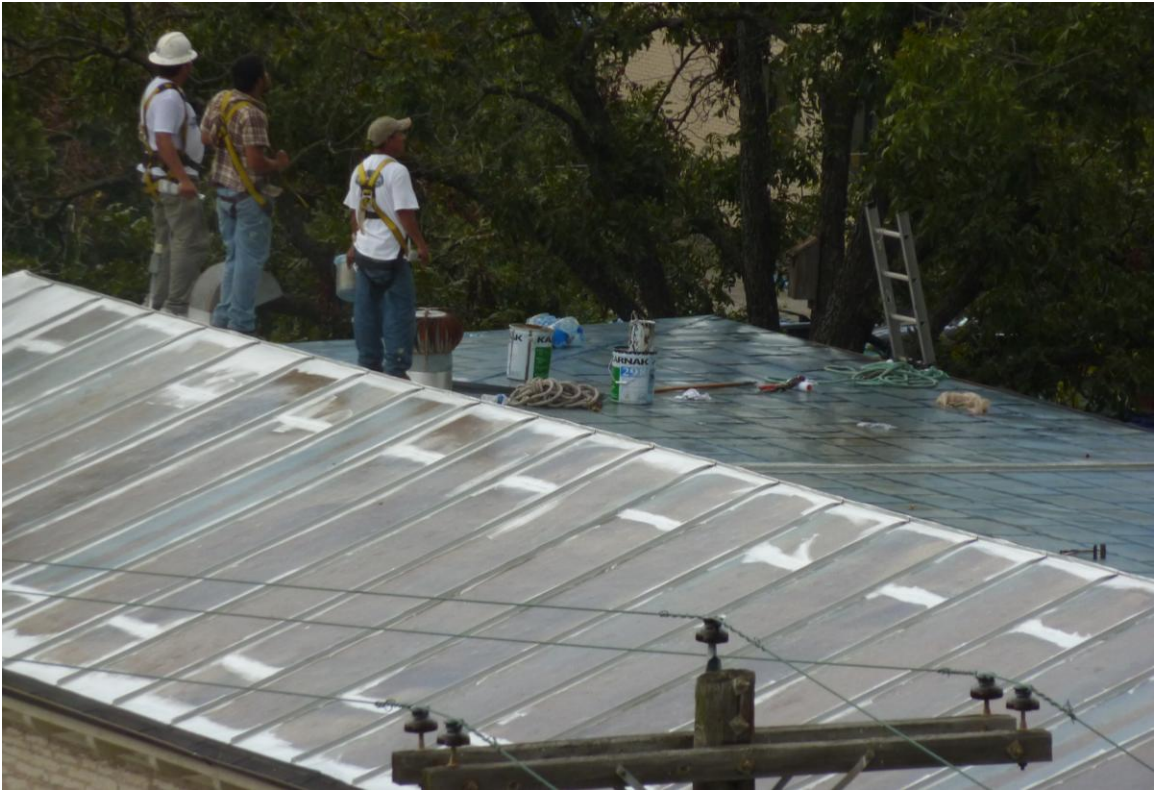
During 10, September 22, 2010, Photo taken from top of adjacent parking garage
North side, Application of Karnack 298 Alum-R

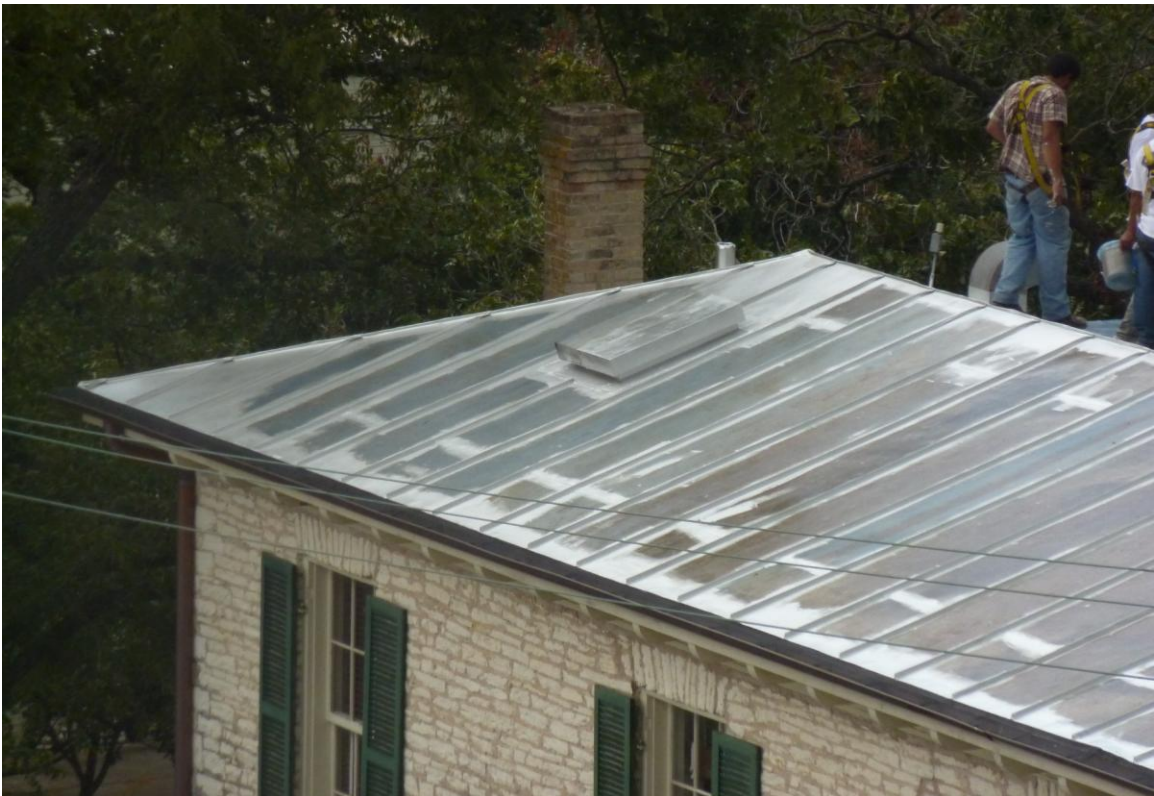
During 11, September 22, 2010, Photo taken from top of adjacent parking garage
Northeast end, Application of Karnack 298 Alum-R

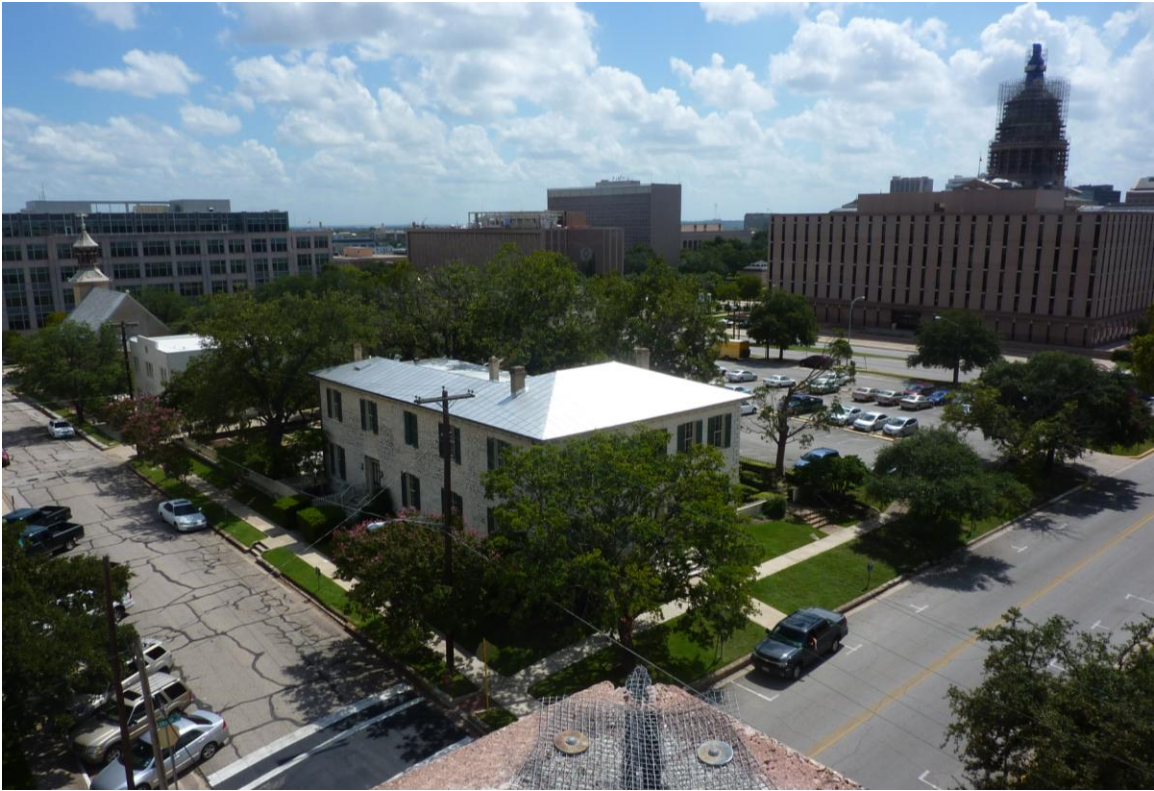
After 1, September 23, 2010, Photo taken from top of adjacent parking garage
Overall

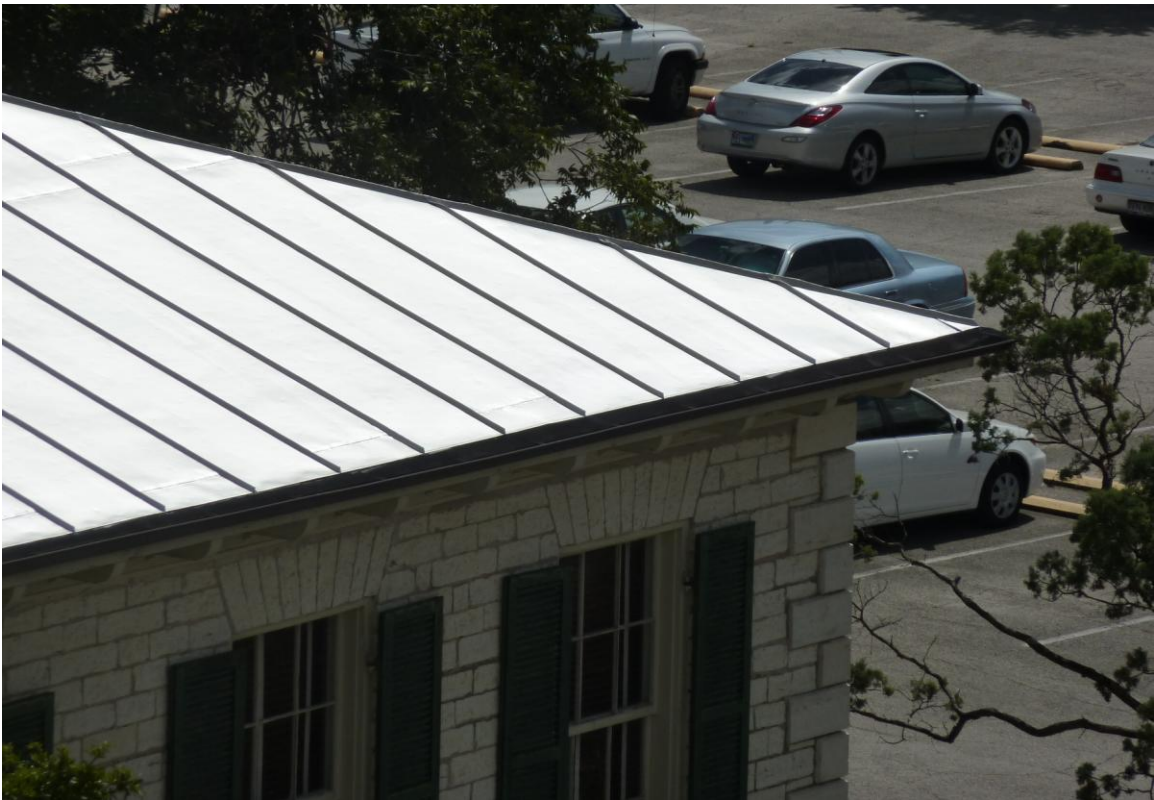
After 2, September 23, 2010, Photo taken from top of adjacent parking garage
Southwest corner

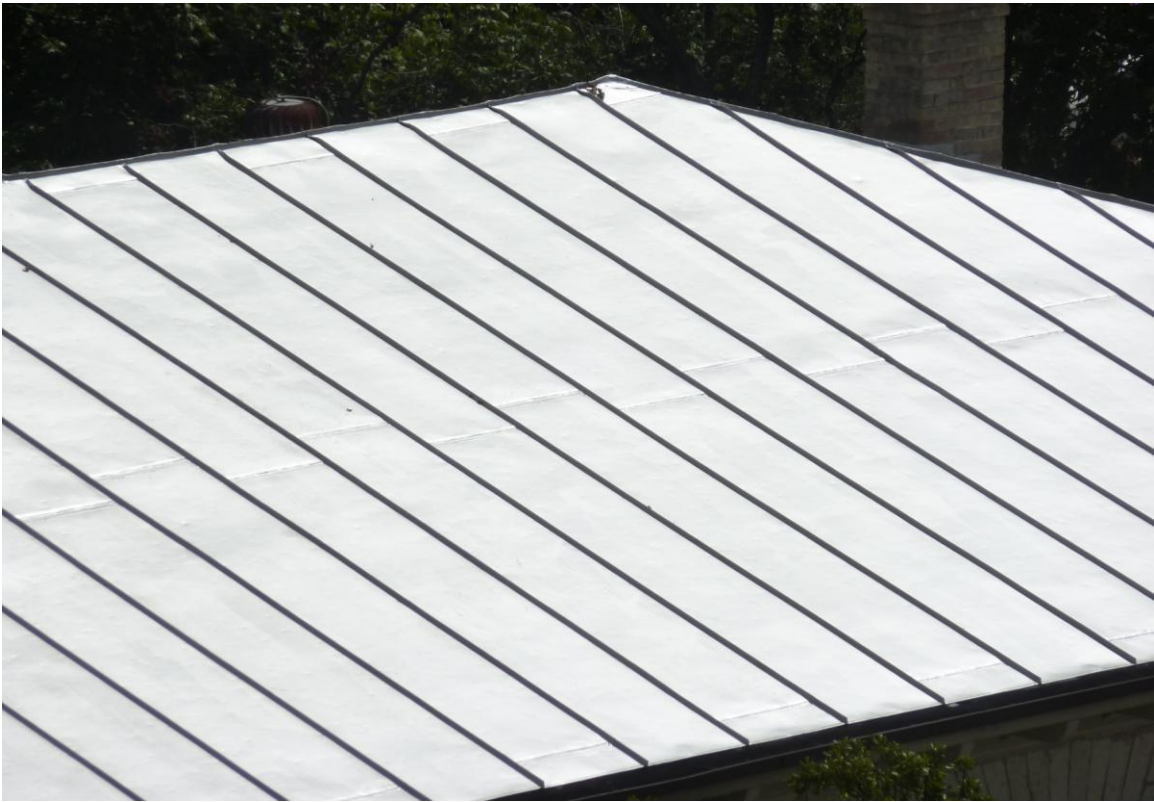
After 3, September 23, 2010, Photo taken from top of adjacent parking garage
West side

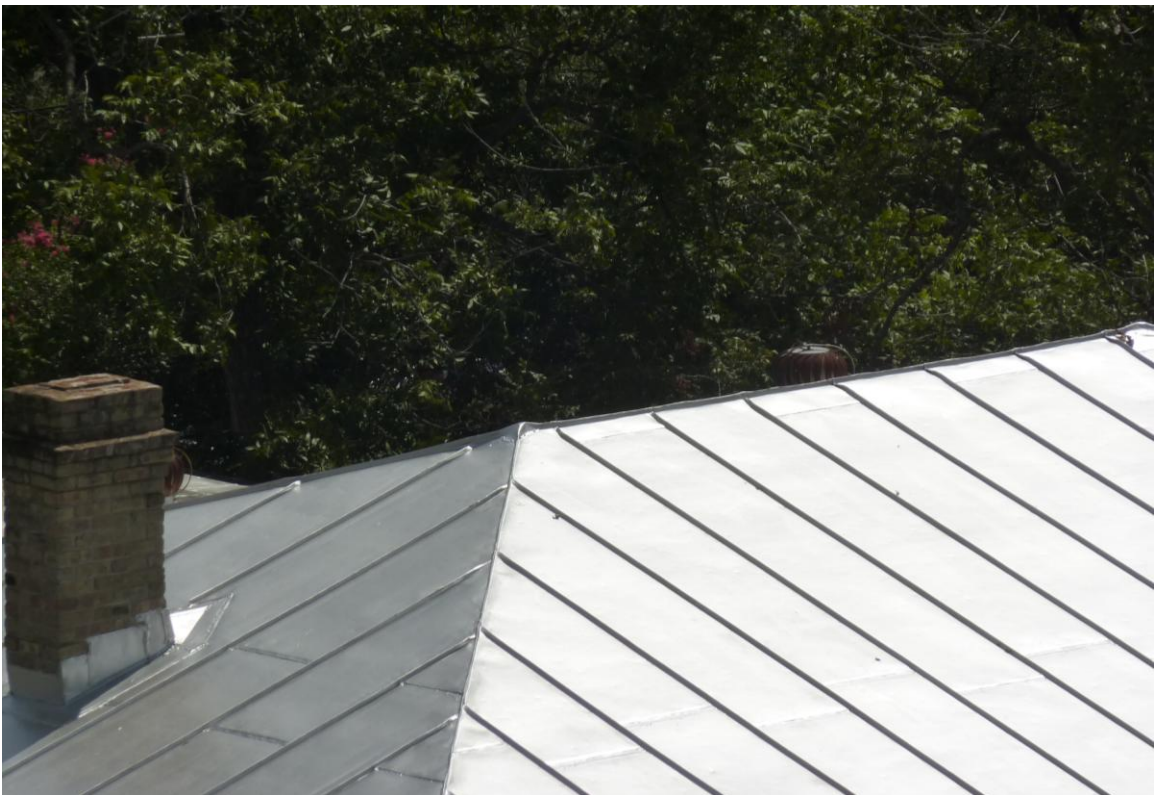
After 4, September 23, 2010, Photo taken from top of adjacent parking garage
Northwest ridge

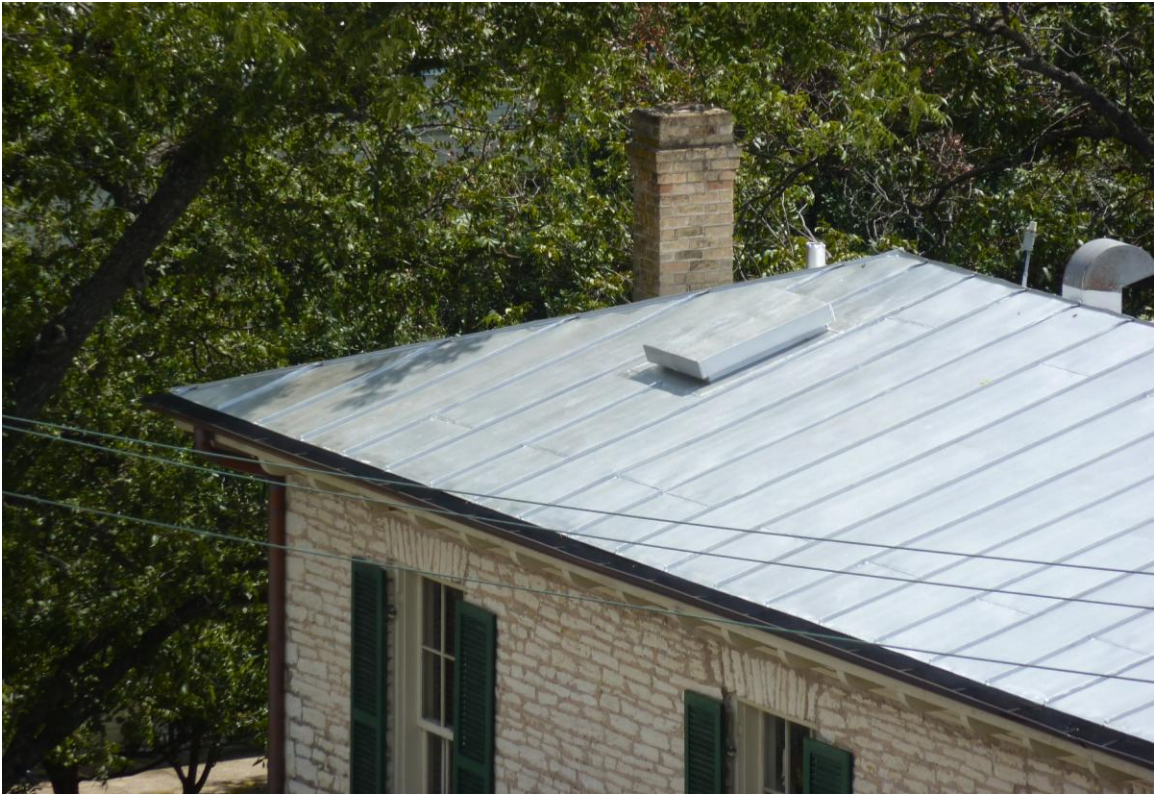
After 5, September 23, 2010, Photo taken from top of adjacent parking garage
Northeast end
