THE
TEXAS
TEN

PRESERVING THE STATE'S
HISTORIC OUTDOOR SCULPTURE

FINAL REPORT

Texas Historical Commission
Conservation Treatment
for Ten Historic
Outdoor Sculptures

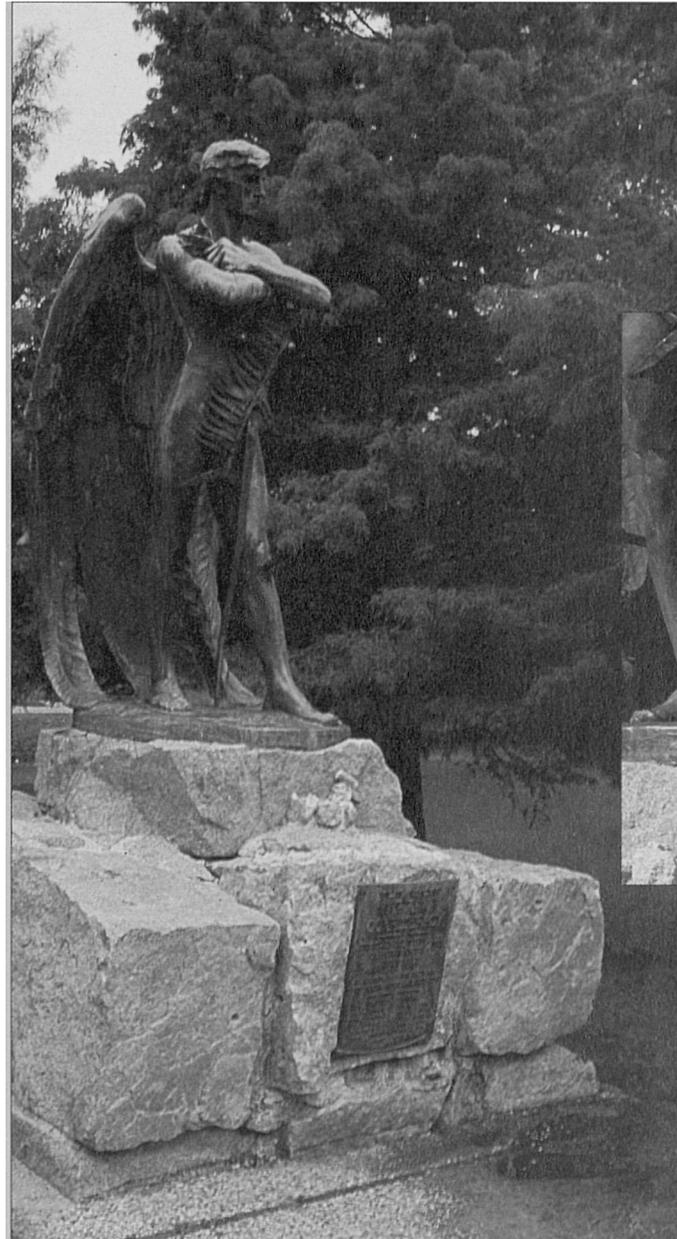
Tile bronze sculpture and granite base were structurally sound, with a few minor exceptions. Loss of bronze, indicating thinned metal from casting flaws, was observed at approximately eight holes on the back sides of the wings. At least two cracks in the bronze also appeared to be the result of thin walled casting. A circular hole in the bronze base resulted in loss of the letter 'n' in "Washington." The sword,

positioned with the tip down, was bent backward (toward the figure) and in the process suffered a crack at the bend and dislocation of the tab at the tip of the sword from its shallow anchoring hole in the base. Pitting was not severe, although somewhat more extensive on horizontal surfaces that retained water.

Corrosion of bronze surfaces was overall and extensive as indicated by the visually disfiguring green and black oxidation products typical of copper sulfide and sulfate corrosion resulting from extended outdoor exposure. Upper regions showed evidence of corrosion. Lower regions were rubbed to a polished surface due to accessibility to the public. Some of the lower regions were also affected by repeated spray from the adjacent pond fountain.

Joint material was missing from beneath the bronze base in a number of places, allowing daylight to show through beneath the sculpture. The front of the granite pedestal and the mortar-like joint material between the granite blocks were generally stained green due to corrosion product runoff.

*Shown right:
bronze sculpture and granite base,
before treatment*

Repairs to the bronze sculpture were conducted prior to patination. The sword was straightened but the small tab beneath the sword snapped off immediately during the first gentle move of the

sword. When aligned as fully as possible, the sword was secured by welding a small mound immediately behind the sword tip. The crack was closed by the realignment of the sword and the crack was bonded with epoxy and painted appropriately.

Treatment of the bronze continued with application of patina. The patinated and repaired bronze surfaces were rinsed with clear running water to remove excess chemicals and were allowed to air dry. A triple layer of protective Incralac lacquer was applied and lacquer coatings were coated with a final protective coating of paste wax, applied by hand and buffed to a uniform but fairly low sheen.

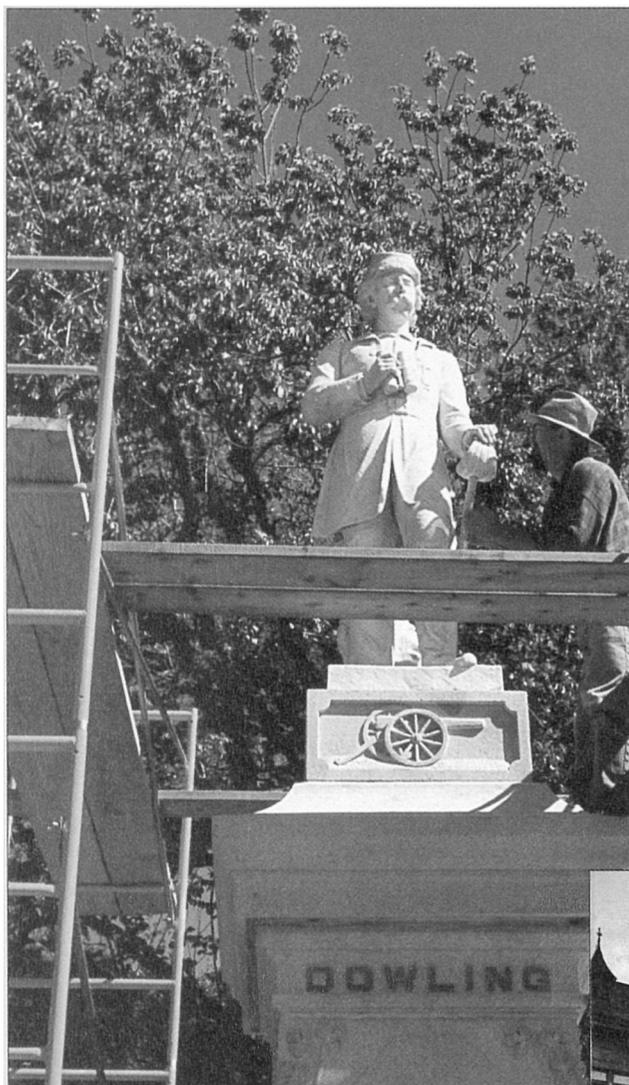
particularly on protruding areas such as Dowling's head, where much of the fine sculptural detail was lost. Surface cracks showed in the marble, and a number of sculptural elements were damaged, vandalized or missing. For example, the broken brim of the Confederate cap and a portion of the left thumb were missing, and Dowling's left foot was broken into approximately seven pieces. Some damages were extensively repaired in the past. For example, the left hand had been broken at the wrist and repaired using an iron pin and a cement-like material; the iron pin had then corroded inside the marble, releasing reddish stains. The monument was moved on at least two occasions, resulting in a number of chips on the pedestal and base, especially along the stone interface edges.

The original saber, and later wooden substitute swords, were stolen repeatedly (a 1958 Houston Post article is entitled, "Dowling's 5th Sword Missing)." A small fragment of the original saber tip remains on the base platform. There were concrete patches on the sides of the marble platform just below the figure, and the tip of the substitute sword was secured with a small mound of concrete. Concrete was also used for patching some of the losses in the marble.

The stone surfaces were soiled with grime. The marble statue was covered with black and green biological growth, particularly on those surfaces not exposed to the direct sunlight. There were red-brown stains in many spots on the marble and the granite pedestal. The cause of the reddish staining was not readily apparent, but could be the result of contamination with metallic impurities during storage when the monument was disassembled and moved in the past.

*Shown above:
monument during treatment*

All concrete patches and repairs were removed mechanically from the sculpture using hand tools, such as scalpels and chisels. A polyester resin-type repair at the base behind Dowling's left foot was in good condition and was therefore left unchanged.

The loose fragments of the marble were treated in the same way as the rest of the sculpture, matched, assembled and reattached, based on the existing drawings by Frank Teich, old photographs of the monument and visible evidence indicating the proper arrangement of the pieces. Special pins, epoxies and fillings were used to repair and reattach these fragments.

The missing sword was replaced with an artificial stone replica, based on the artist's sketch,

photographs of related Confederate swords and old photographs of the monument. The model of the sword was made of auto filler Bondo. The tip of the replica of the sword was matched with the remains of the original sword tip at the base, the hilt was positioned under the palm of Dowling's left hand, and the side of the scabbard was secured to the original protrusion on Dowling's left calf using an aluminum pin. If needed, the mold used to create the replacement sword can be reused to produce additional replacements in the future.

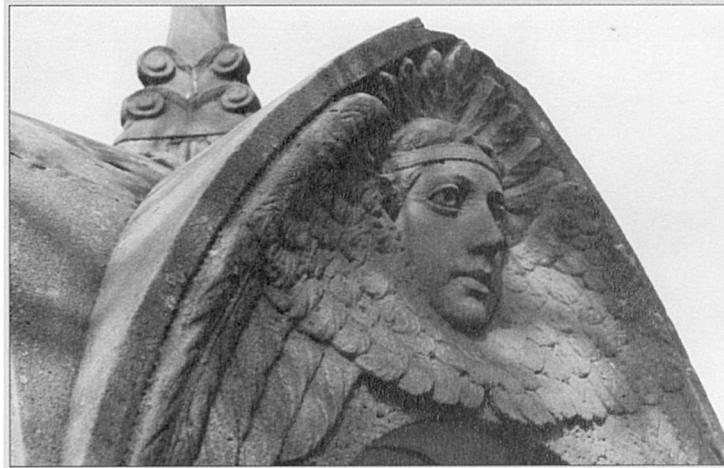
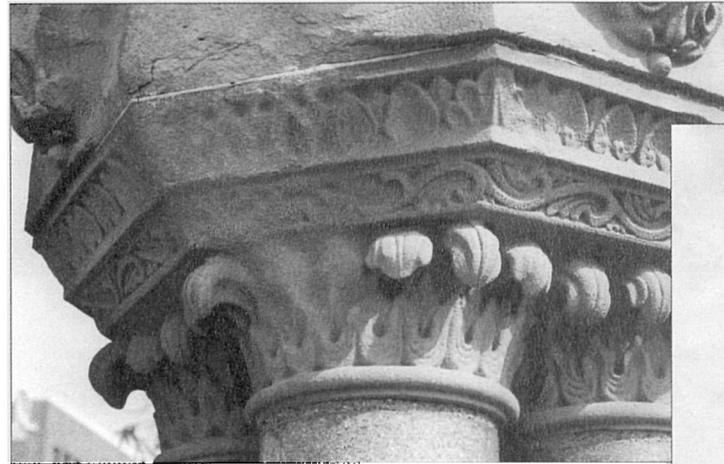
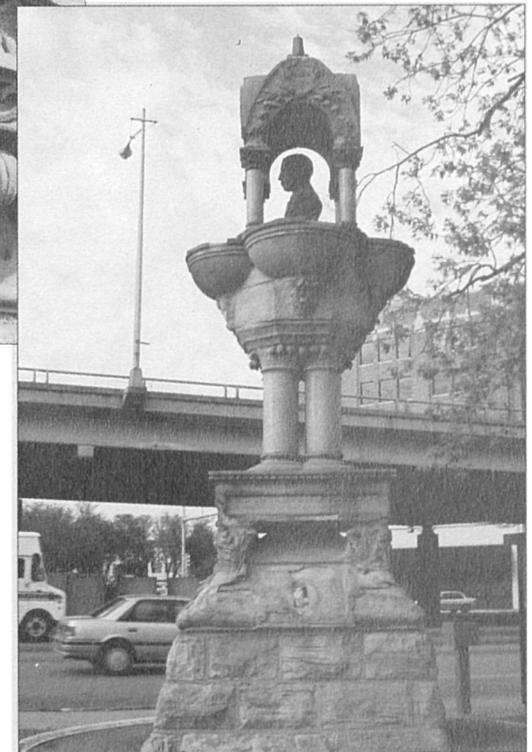
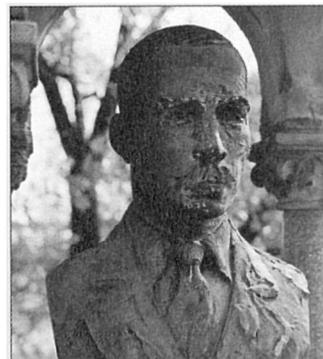
Extensive losses occurred to the surface of the sandstone, with partial or complete loss of many decorative elements. The exposed sandstone was significantly weathered, and black sulfide crusts formed in protected areas. At least one somewhat misguided restoration was attempted. Concrete was applied which is now cracked and falling away from the deteriorated sandstone. Exposed portions of damaged pipe protruding from the left and right sides of the base are non-functioning remains of the monument's original design as a fountain, and water stains were evident below the plumbing. The granite columns appeared in fair condition, and the bronze bust, although exhibiting uneven surface oxidation and accretions, did not seem seriously deteriorated.

*All photos shown right:
before treatment*

All loose parts of the monument were disassembled and secured aside. After testing the stone in inconspicuous areas for approximately six weeks, the powdering surface of the stone was consolidated before further treatment, using ProSoCo, Inc. Stone Strengthener OH. Loose pieces of the original monument were treated in a similar way. Loose and excess concrete was removed from joints in the lower part of the monument. It was unsafe for the construction of the object to remove damaged pointing concrete from the upper parts of the monument. This should be carried out later, when the object is being disassembled for the relocation. Concrete patches applied during prior treatments were also thoroughly removed.

At this point sandstone could be safely cleaned using potable water under low pressure and soft natural bristle brushes. Thick layers of dirt, accretion and metallic staining were not removable with pure water only; therefore, hydrofluoric acid was used with excellent results. All polished granite elements were carefully protected during this procedure to avoid severe damage. They were coated with hot bees wax by brushing and then wrapped in plastic foil.

Following the cleaning, desalination and reinforcement, loose elements secured aside at the beginning of the treatment were reinstalled using epoxy resin. The elements were properly set in place based on the existing old photographs of the monument and visible evidence indicating the proper arrangement of the pieces. Filling of losses in stone and reconstruction of the decorative elements were carried out based on available historic documentation and remaining fragments. The tone and texture of the fillings match the original. Reconstructions of the existing gargoyles and other decorations were made using a mold and artificial stone. Repointing was carried out using white portland cement and pure sand in a 1:8 ratio combined with black pigment. "A"

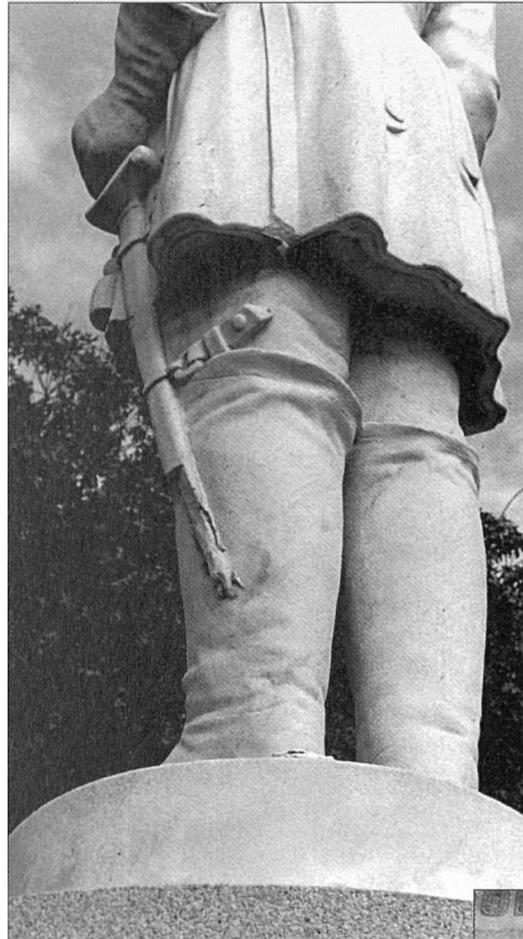
Shown above: loss to the sword scabbard, before treatment

4. Old, inappropriate fills were removed mechanically. Losses were filled or cast in place. Many of the smaller losses were modeled in place, then finished mechanically after hardening. The two sword scabbards and the hat brim were cast using plaster waste molds, the positive initially modeled in water clay. A

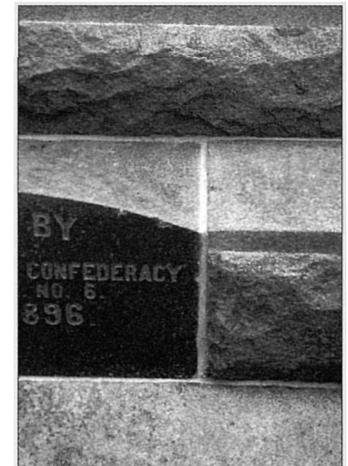
Near right: before treatment

Far right: after treatment to repoint the joints

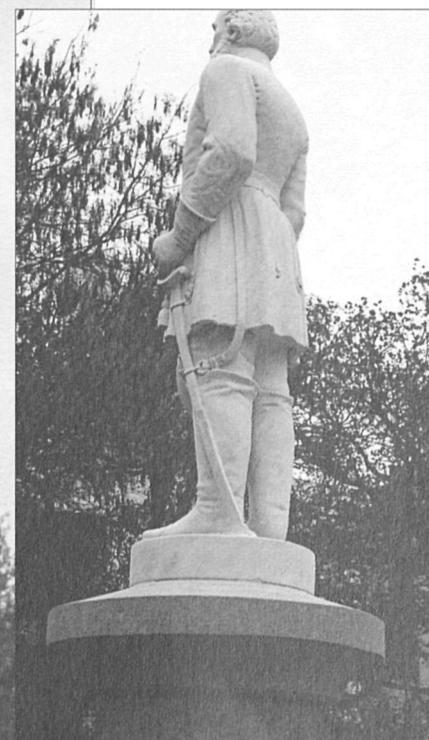
*Far right: after treatment,
missing scabbard replaced*

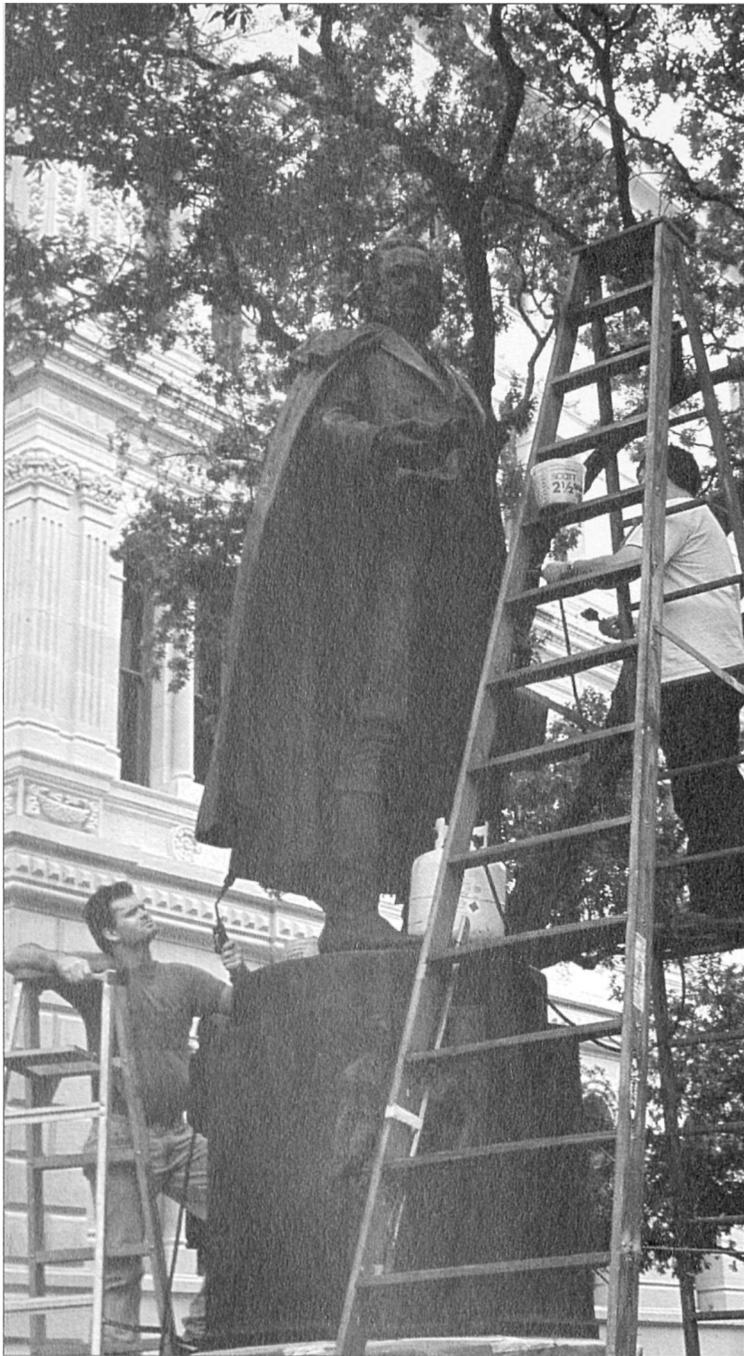
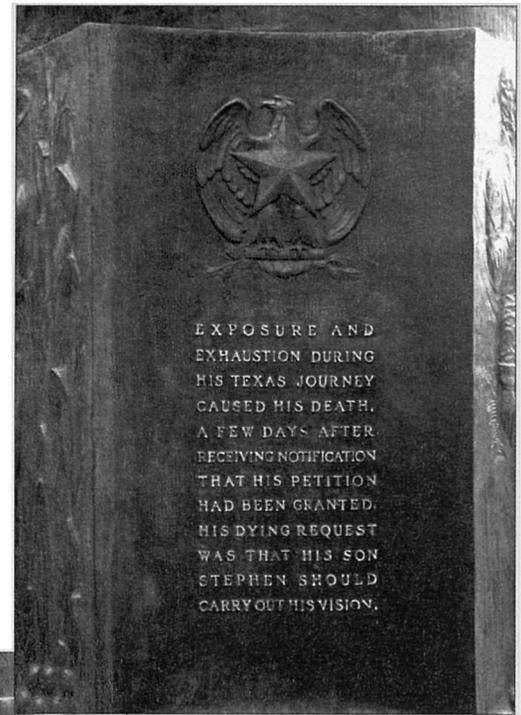
*Left and above:
bronze bas-relief panel,
comparisons of before and
after treatments*

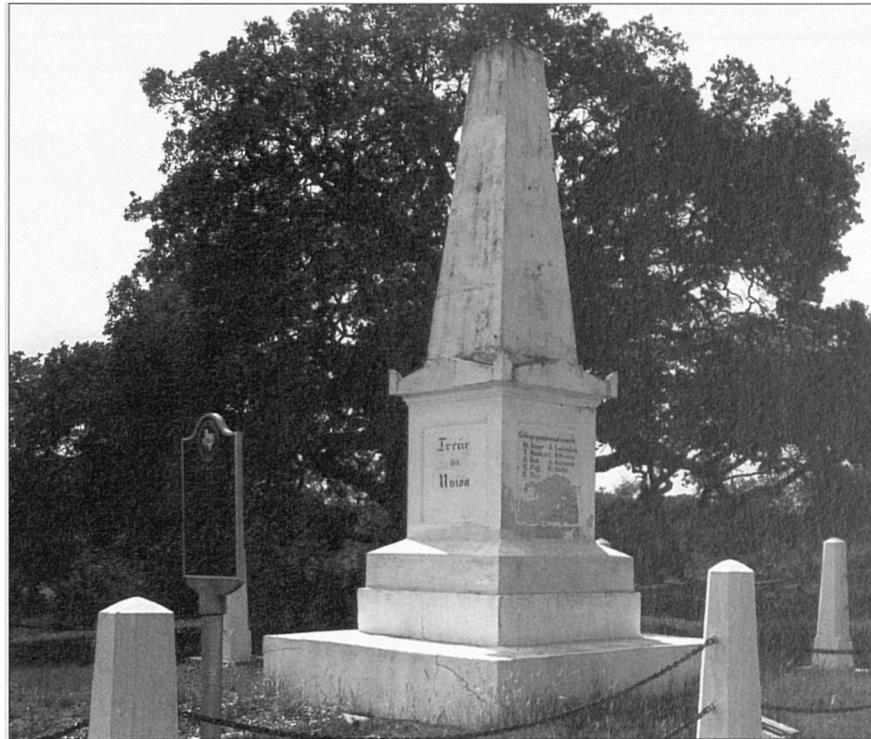
Shown above right: before treatment

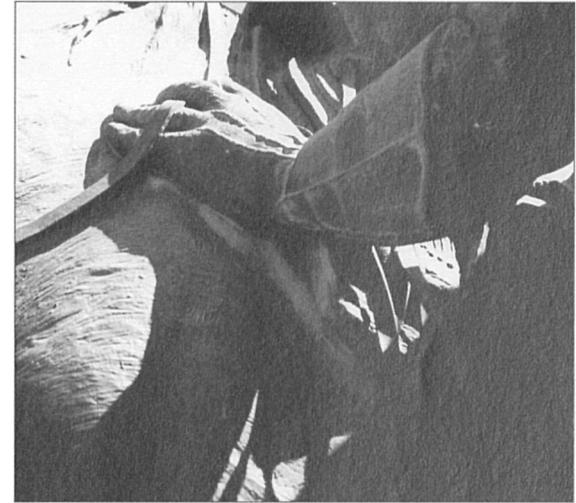
Above, top: staining and corrosion of the bronze, before treatment

Chemical repatination of the bronze was undertaken to return the bronze to a uniform appearance. Surfaces were examined and no evidence of unaltered, pristine patina was identified. Instead, the existing shades of brown, remaining evident on the sculpture but mixed with green and black colored products of corrosion, were reproduced. The resulting tone of brown is uniform and evenly applied.

The bronze sculpture was thoroughly washed following chemical repatination to remove chemical residue. Surfaces were air dried. Clear Inralac lacquer was applied by brush in one coat, followed by two spray coats. Clear paste wax was applied over the lacquer for additional protection 'k
