TEXAS DEPARTMENT OF TRANSPORTATION

Historical Studies Report No. 2009-01

A Field Guide to Irrigation in the Lower Rio Grande Valley

The Creation of a Magic Valley
Irrigation in the Lower Rio Grande Valley

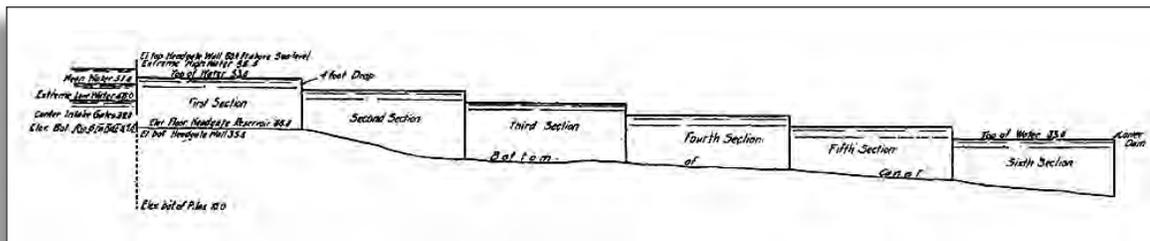
Figure 23: Plan of locks on the San Benito Land & Water Company irrigation system (1907).
Source: San Benito Land & Water Company, *San Benito in the Lower Rio Grande Valley*, 1910

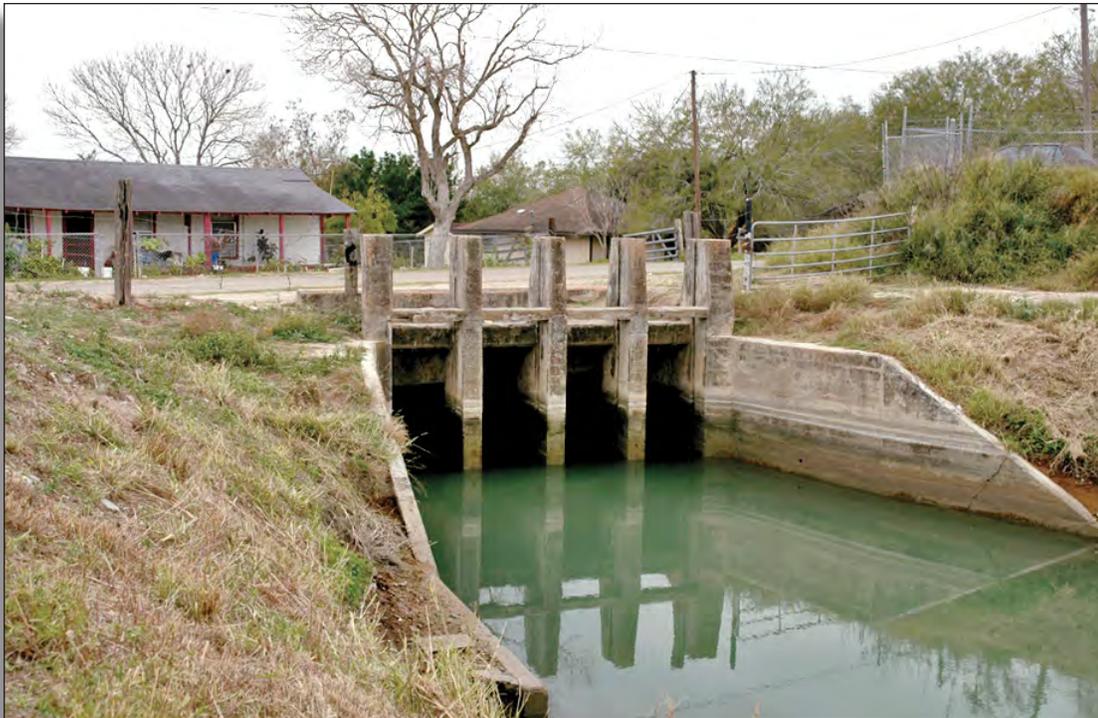
Figure 67: Headworks at beginning of Edinburg Main Canal, Hidalgo County Irrigation District No. 1.

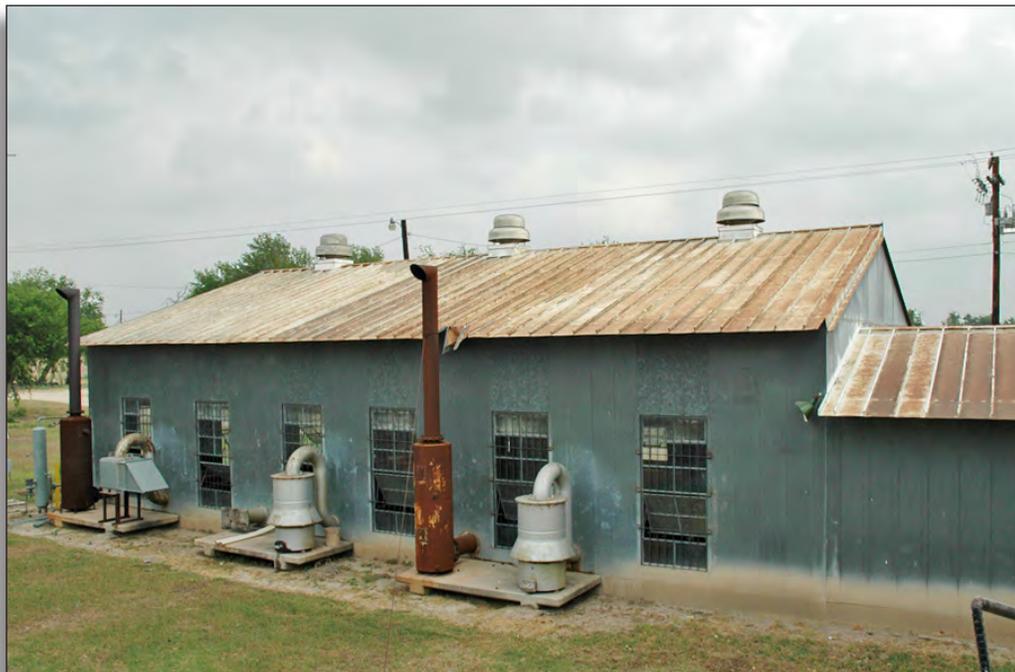
Figure 70: First lift pump station, United Irrigation District.

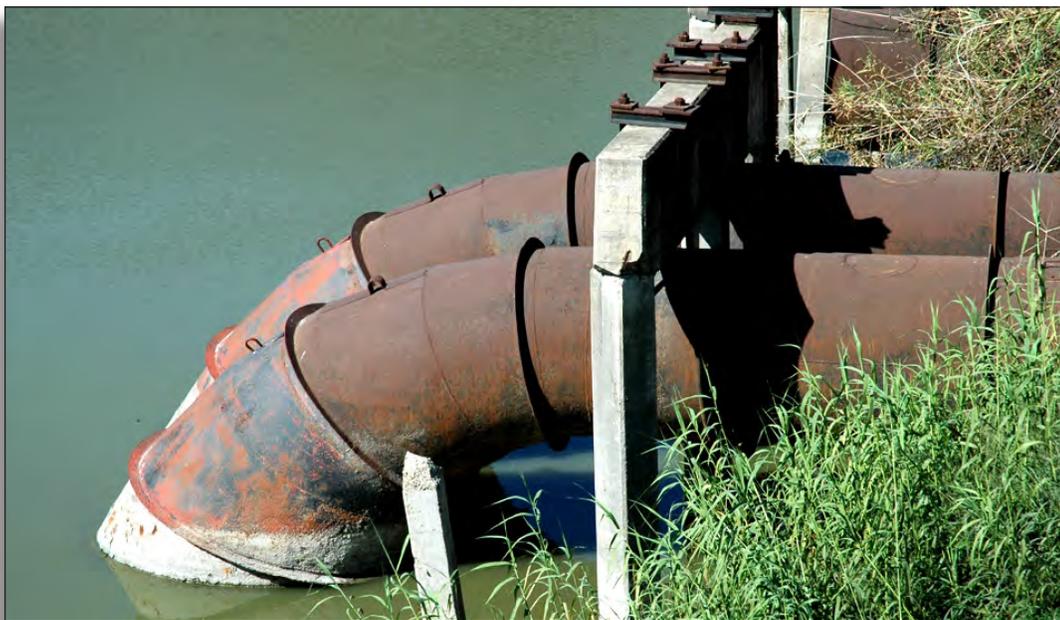
Figure 75: Inlet pipes to first lift pumphouse, Hidalgo County Irrigation District No. 1.

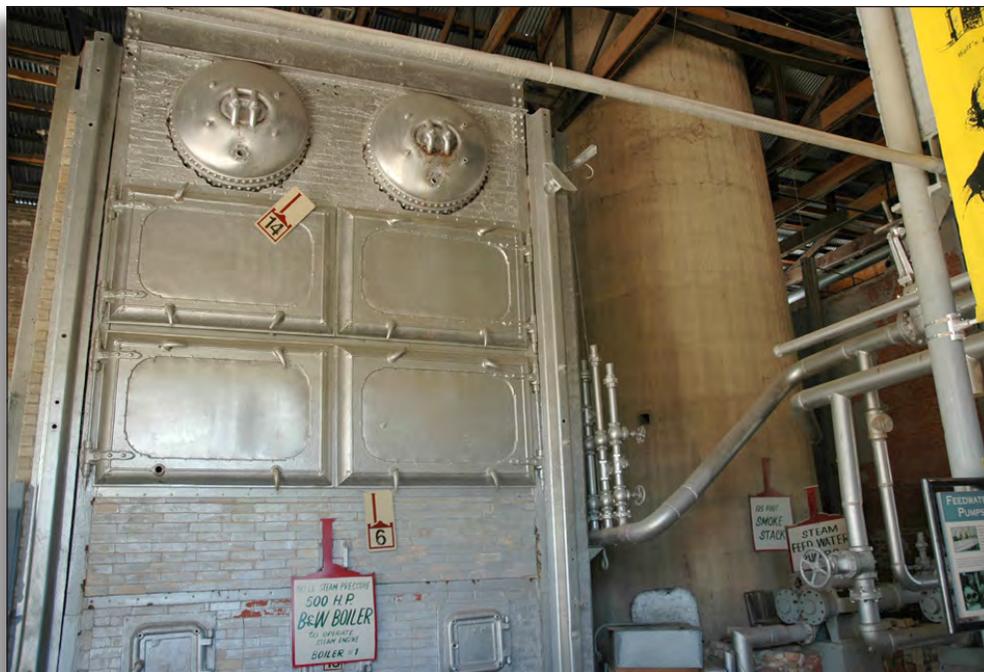
Figure 76: Interior view of boiler room, Old Hidalgo First Lift Pumphouse.

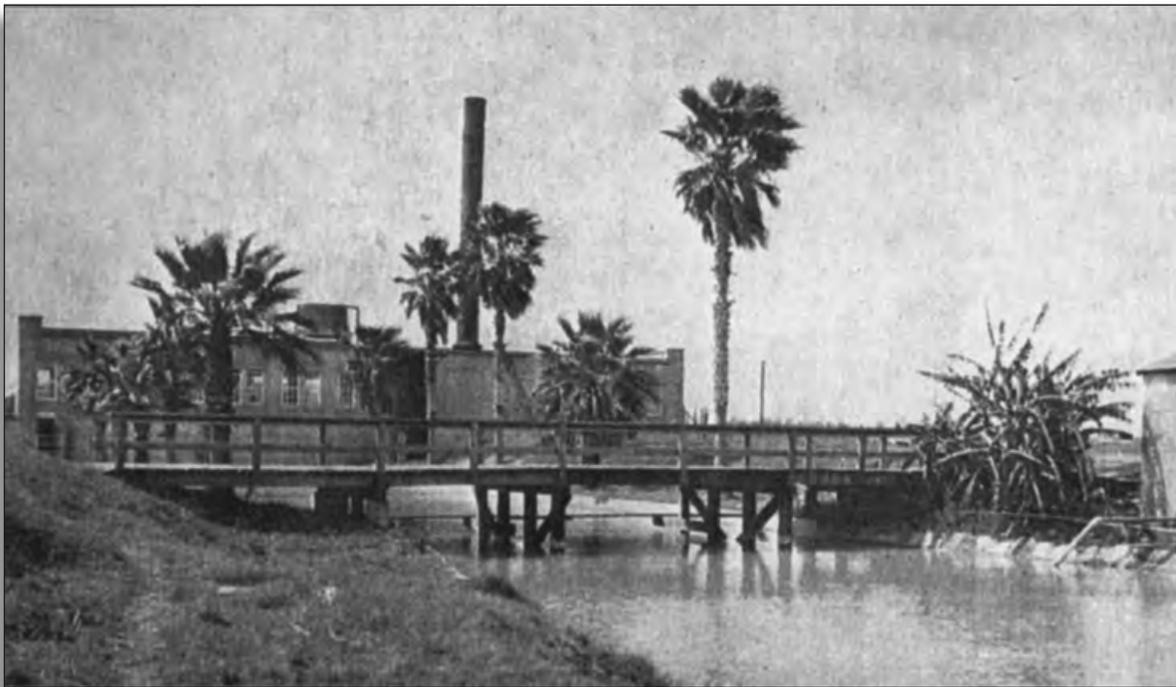
Figure 83: This early second lift pump, built of redwood, provided both irrigation and drinking water for Weslaco.
Source: Gerhardt and Tamez, *Images of America: Weslaco*

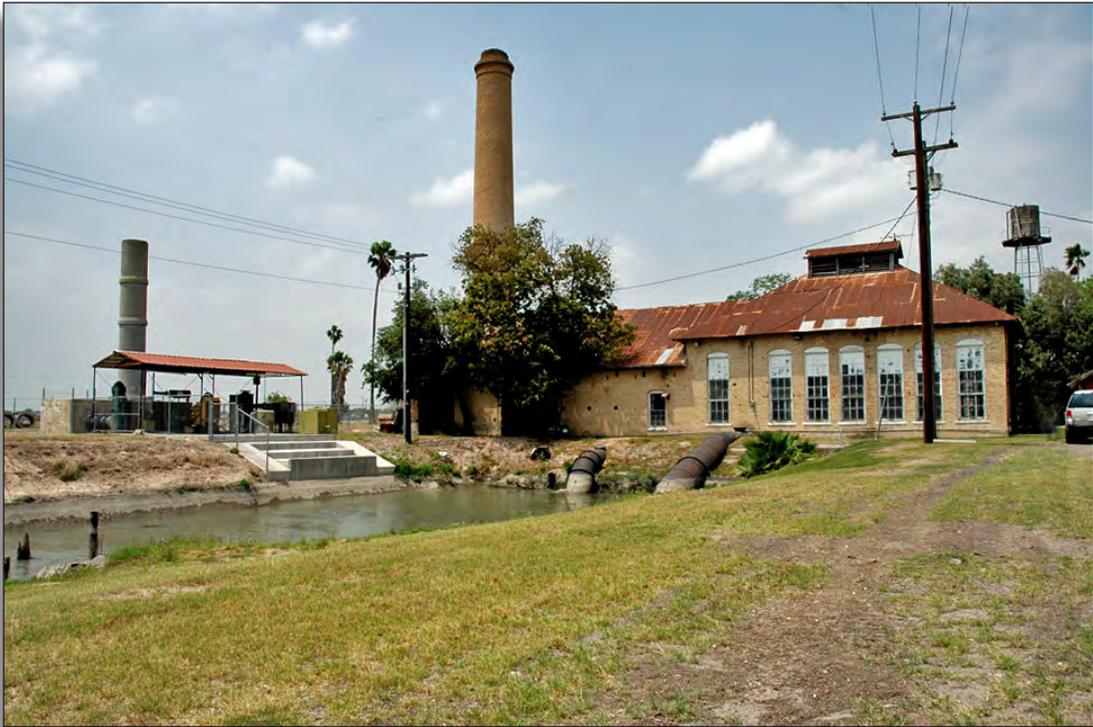
Figure 86: New third lift pumping plant (1989), on left, and old third lift pumping plant (1921), on right, United Irrigation District.

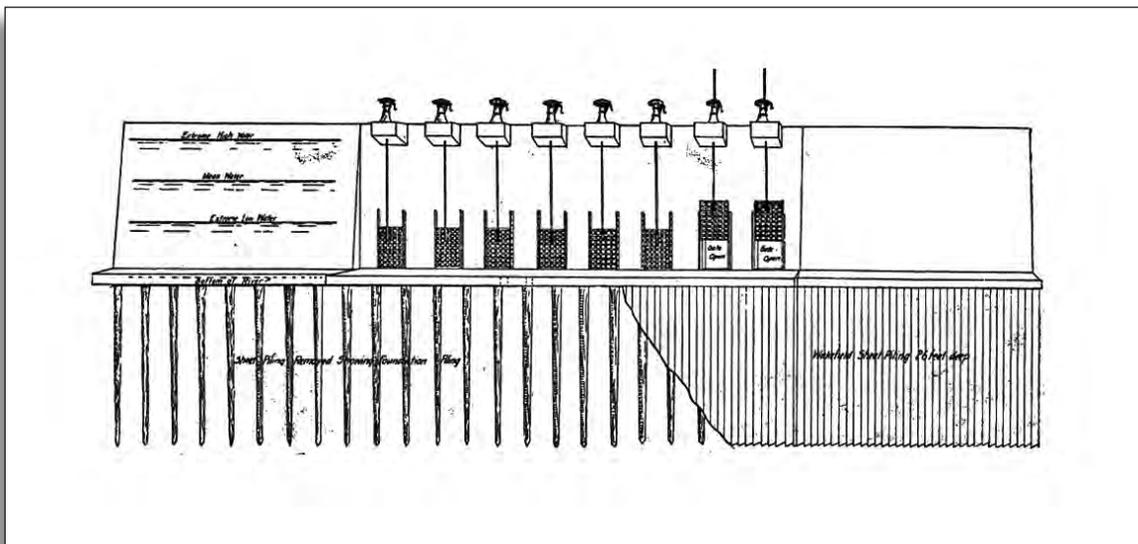
Figure 89: Diagram of head gates, San Benito Land and Irrigation Company, c.1905
(Cameron County Irrigation District No. 2.).

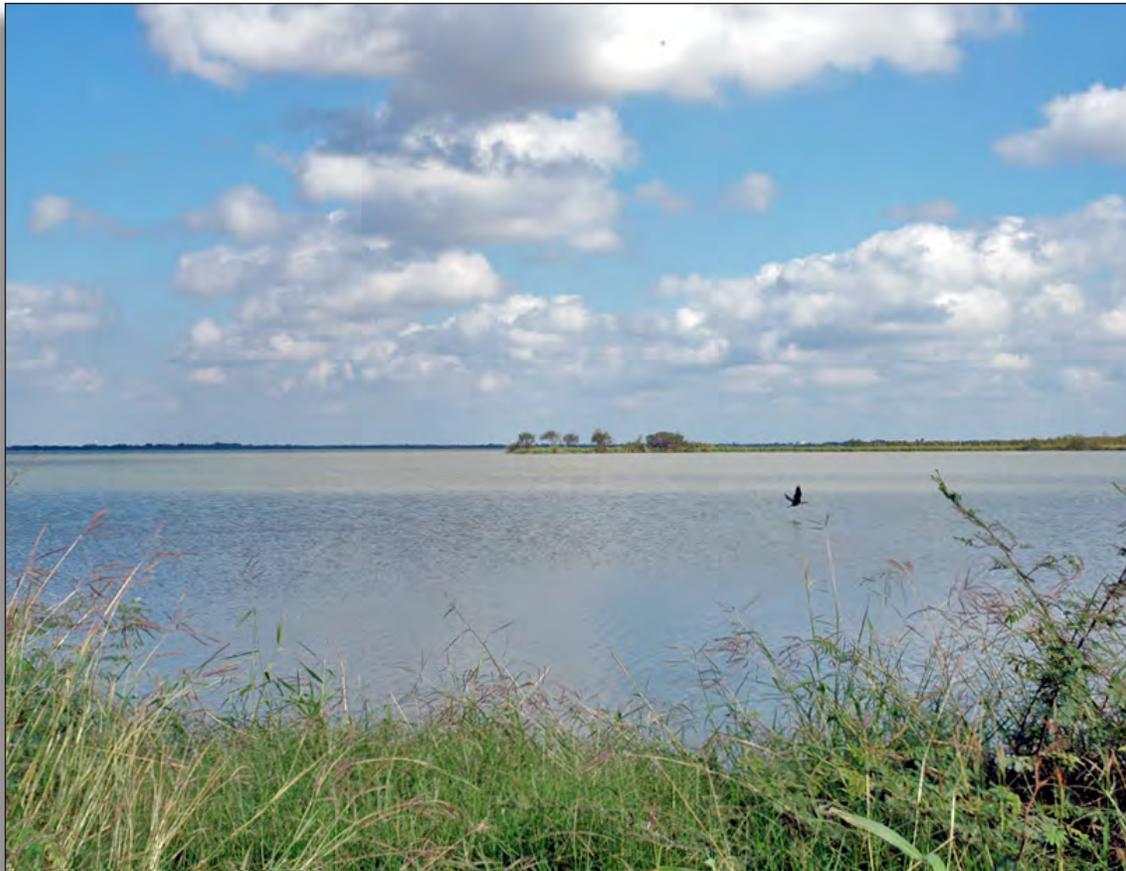
Figure 96: View across settling basin, Cameron County Irrigation District No. 6.

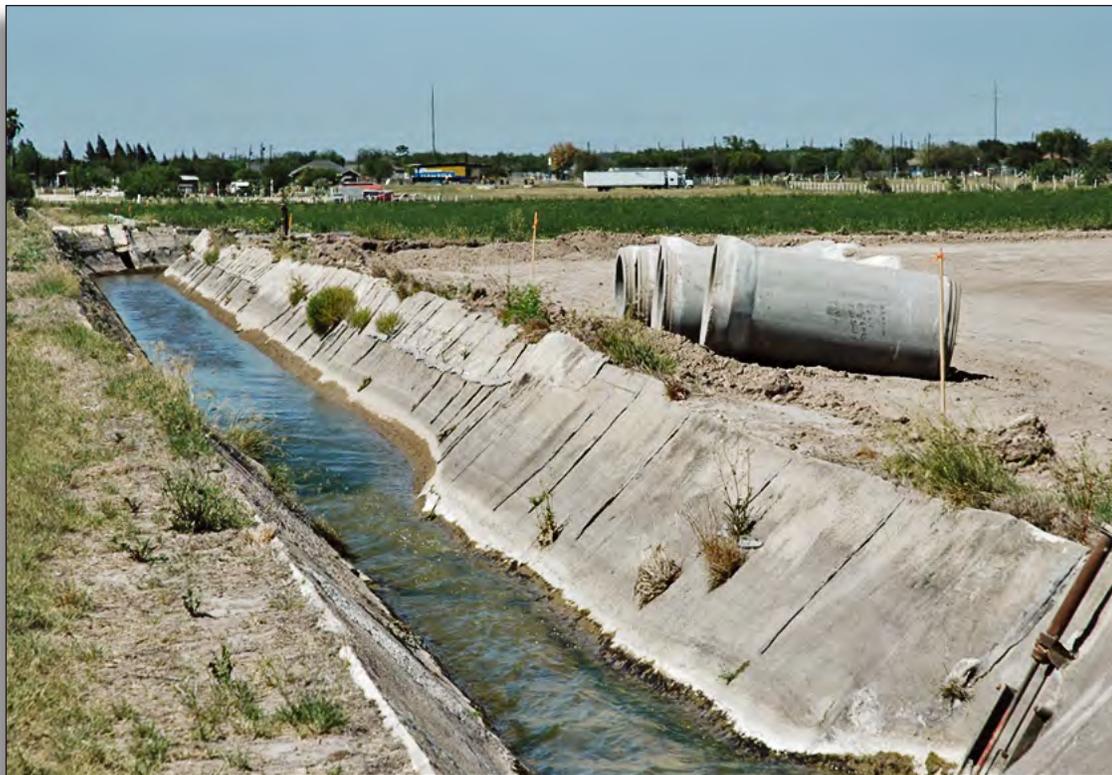
Figure 116: Lateral being placed in underground pipeline along Troser Road, United Irrigation District.

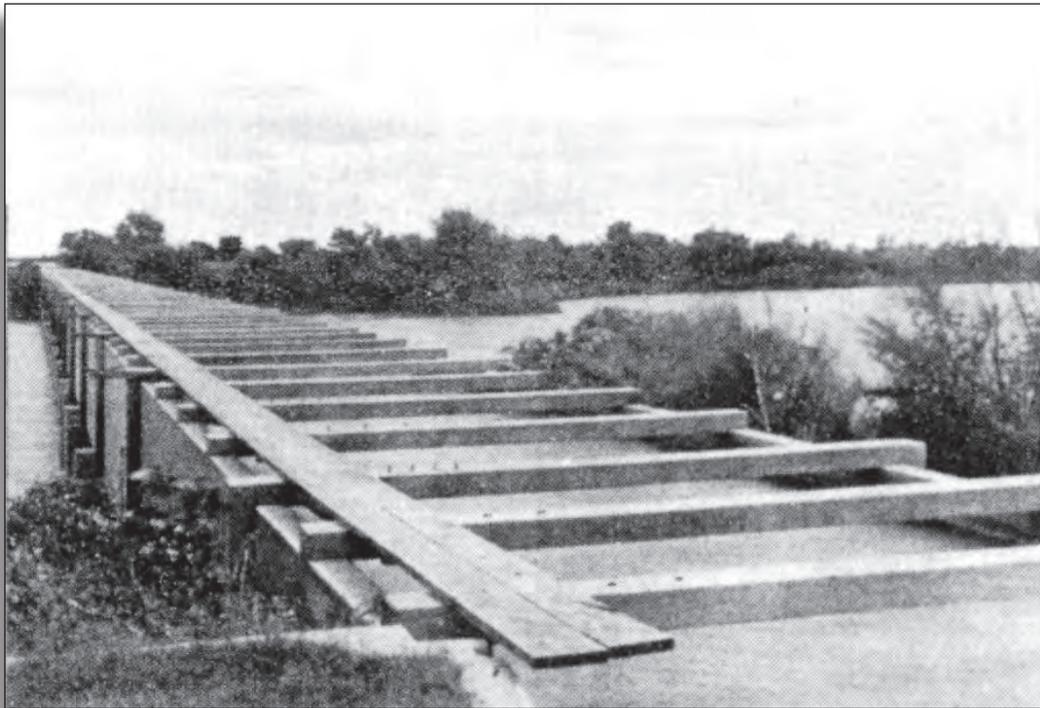
Figure 125: Wooden flume across resaca (c.1920s)
Source: Watson, *The Lower Rio Grande Valley of Texas and Its Builders*

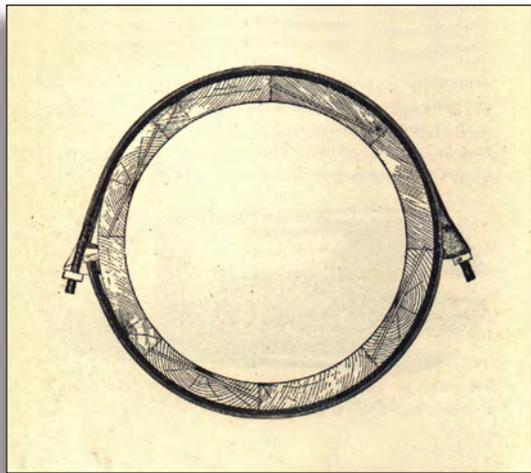
Figure 134: Cross section, 19th century stave pipe.
Source: Wilcox, *Irrigation Farming*

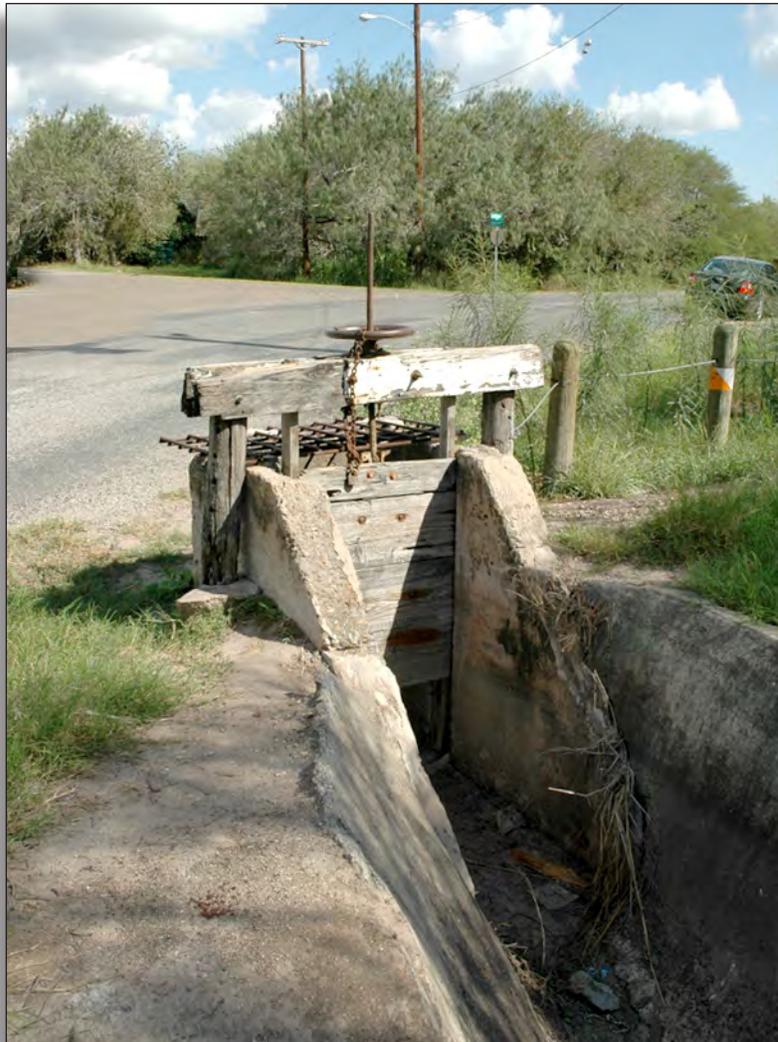
Figure 149: Head gate on Stub Canal, Cameron County Irrigation District No. 6.

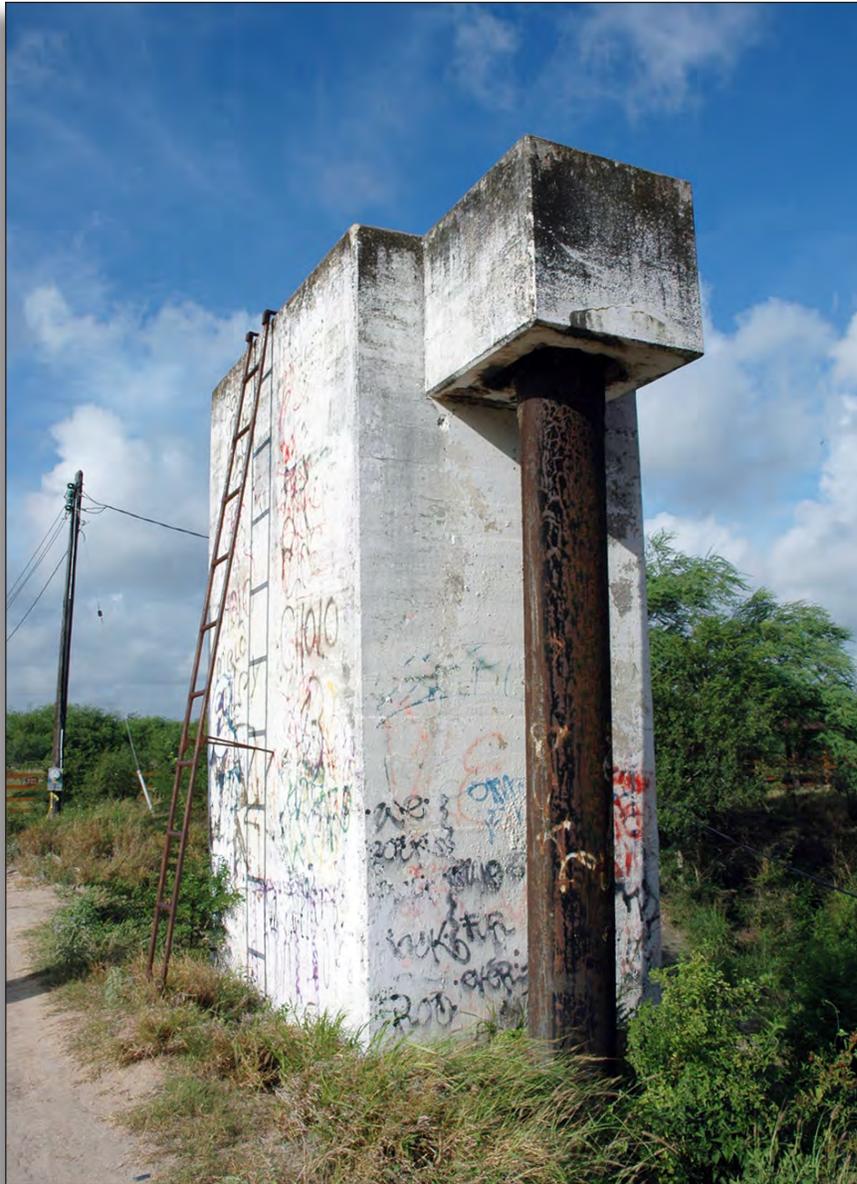
Figure 175: Surge chamber (1948) near Pump No. 3, Santa Cruz Irrigation District No. 15.

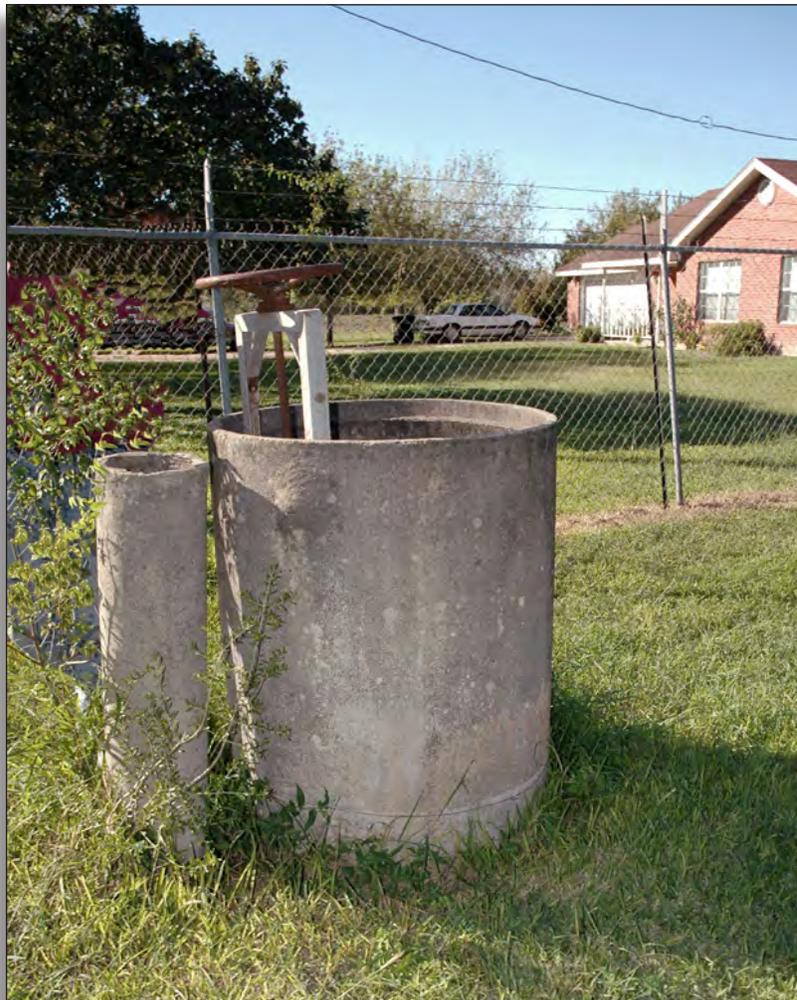
Figure 180: Vent pipe (left) adjacent to diversion stand (right), late 1930s, Cameron County Irrigation District No. 6.

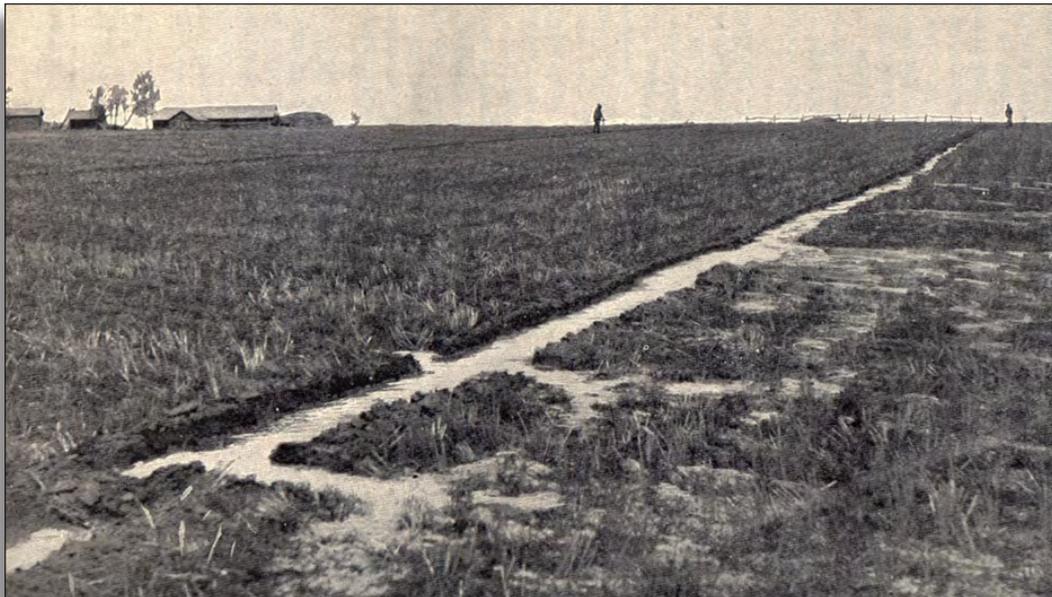
Figure 181: An early example of flood irrigation.
Source: Israelsen, *Irrigation Principles and Practices*

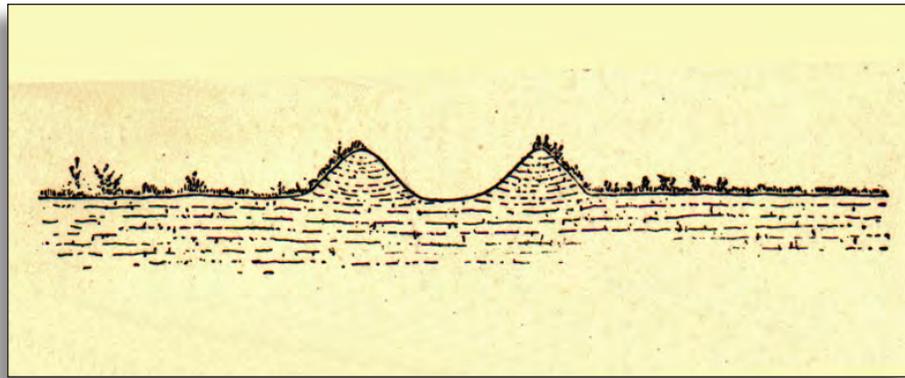
Figure 183: Cross section drawing of an early earthen sub-lateral canal (1902).
Source: Newell, *Irrigation in the United States*

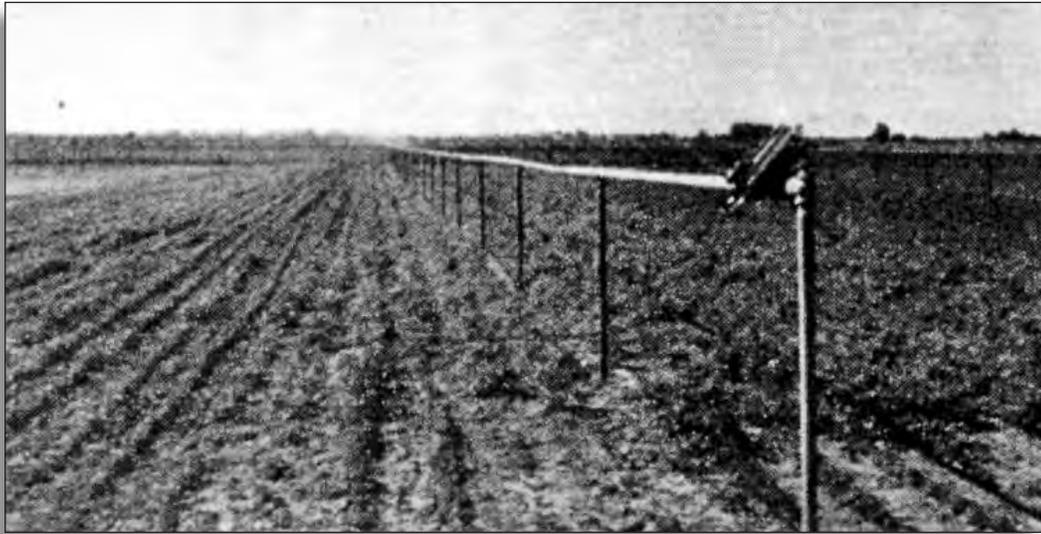
Figure 198: Overhead spray pipes (c.1930).
Source: Watson: *The Lower Rio Grande Valley of Texas and Its Builders*

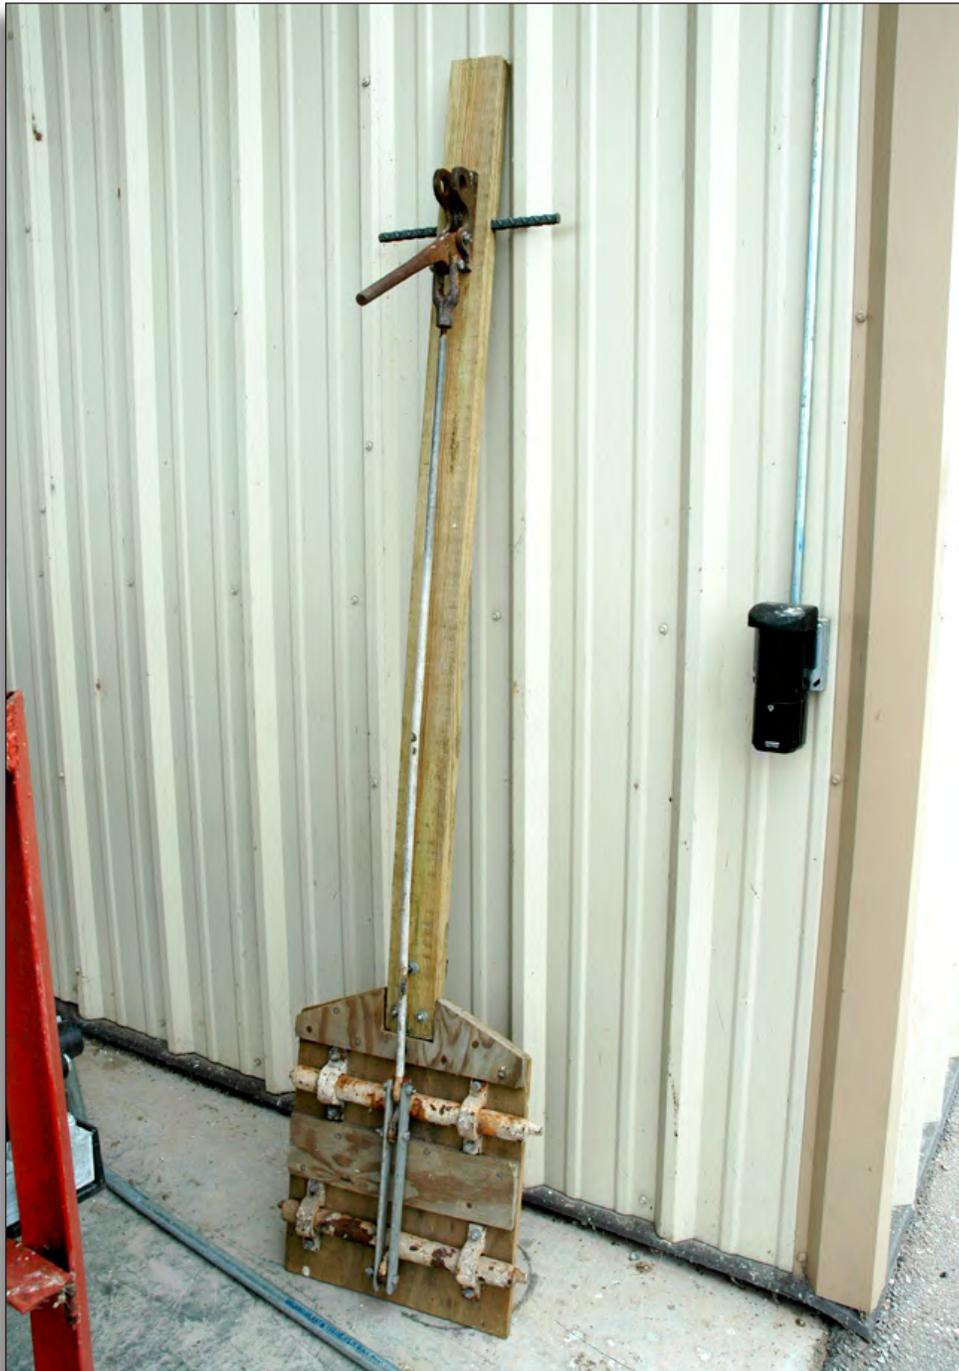
Figure 202: Wooden turn-out gate (rot gate), constructed by Cameron County Irrigation District No. 2 in 2007.

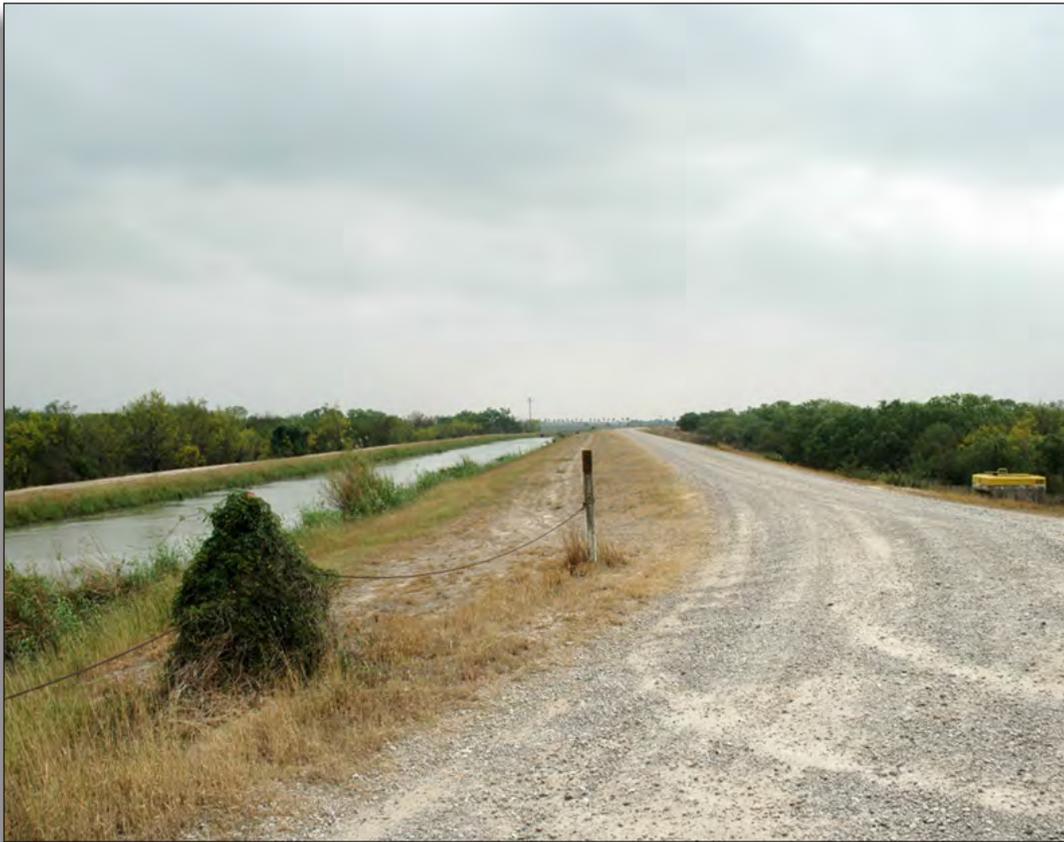
Figure 214: Road atop levee at floodgate, United Irrigation District.

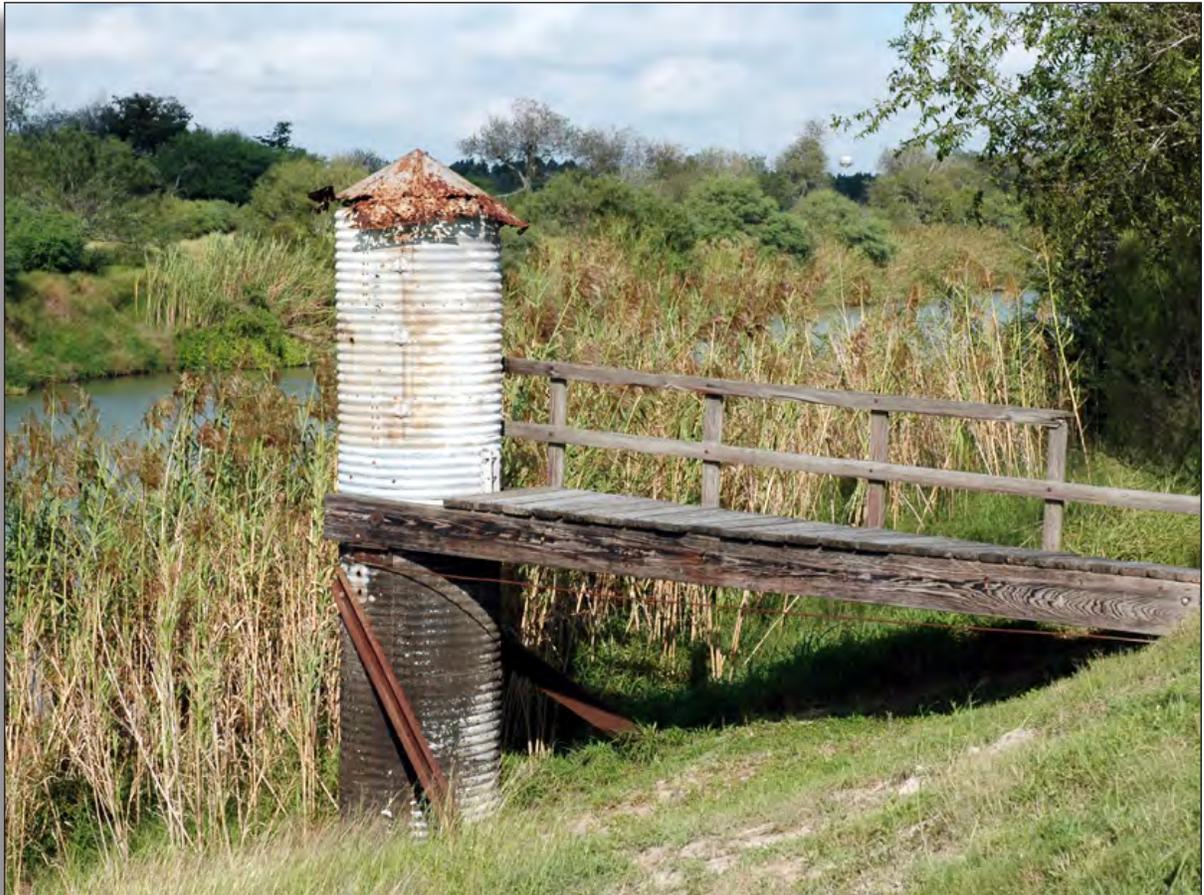
Figure 246: Gauging station, International Boundary & Water Commission, first lift pump house, Cameron County Irrigation District No. 6.

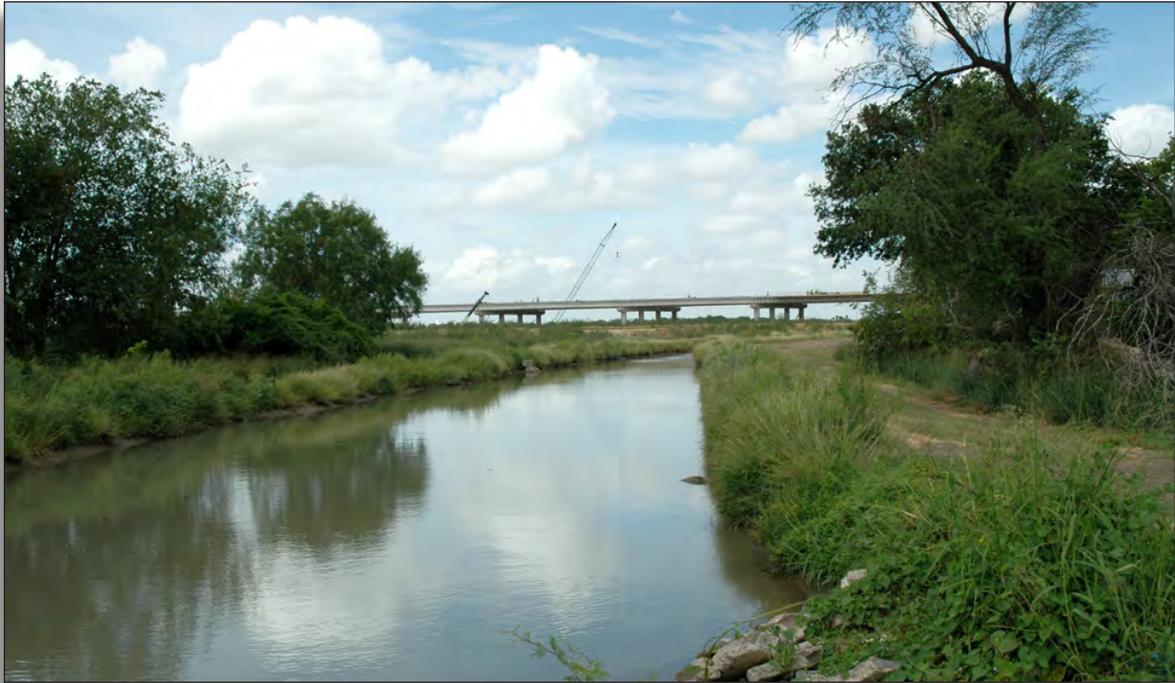
Figure 277: New alignment (1974) of the main canal for Hidalgo County Irrigation District No. 19.

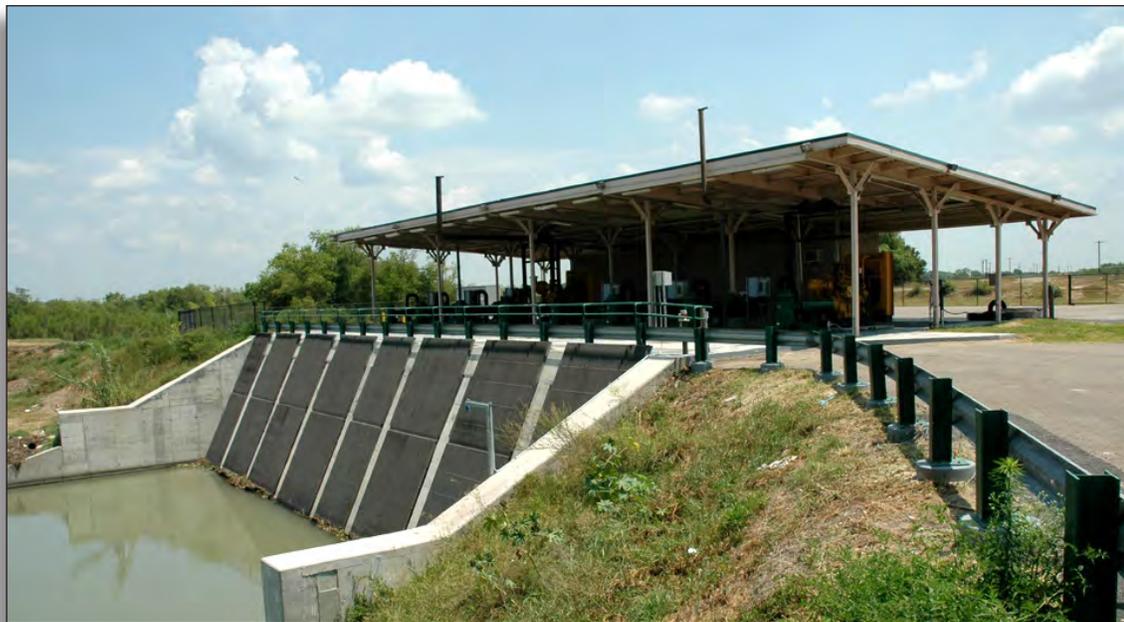
Figure 279: The modern pumping plant (2005) at Los Indios is located north of the old pumping plant and required a realignment of the main canal.

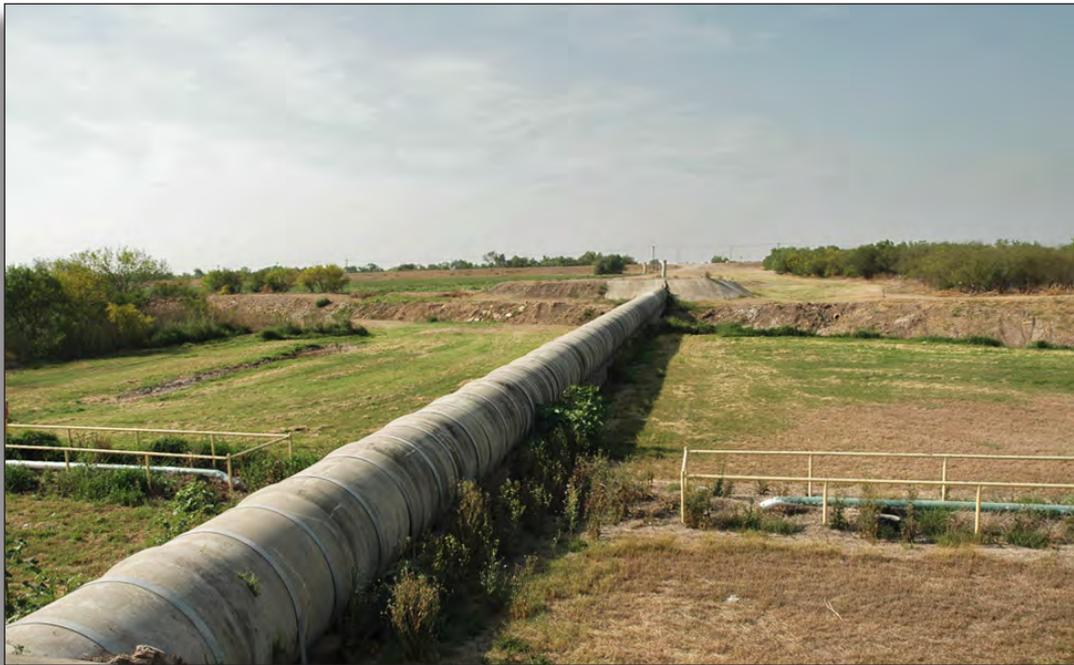
Figure 286: The design of the main canal has been altered by replacement of canal with underground pipeline and installation of a 72" pipe flume (1984) that crosses the main floodway channel, Hidalgo County Irrigation District No. 3.

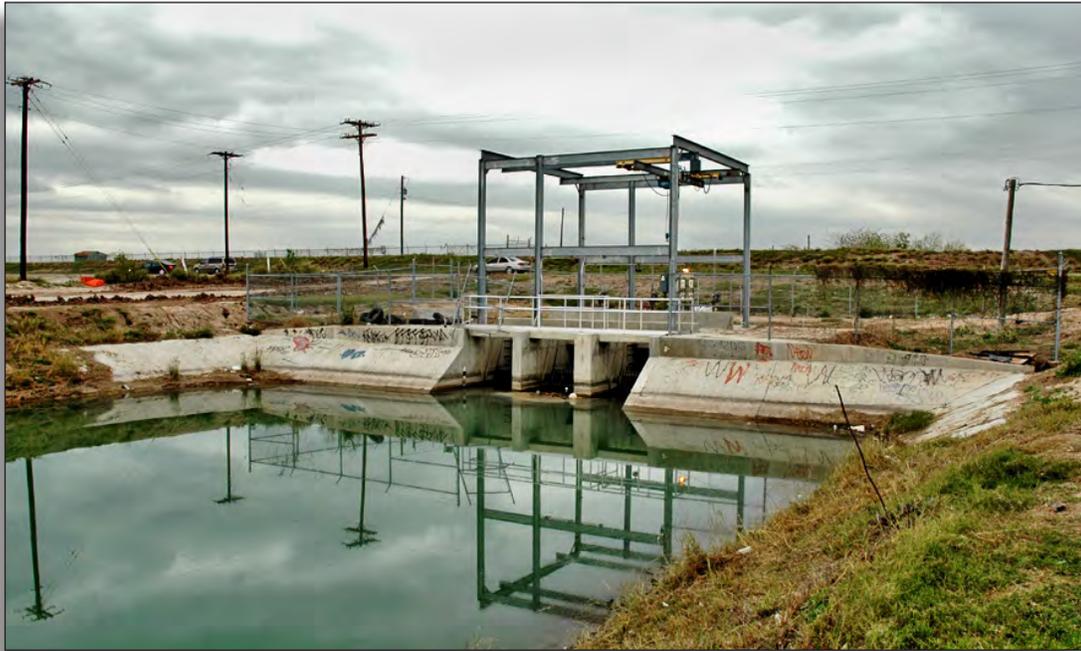
Figure 287: Design of the first check gate on Edinburg Main Canal is a state-of-the-art example of modern irrigation technology that impacts the overall design, Hidalgo County Irrigation District No. 1.

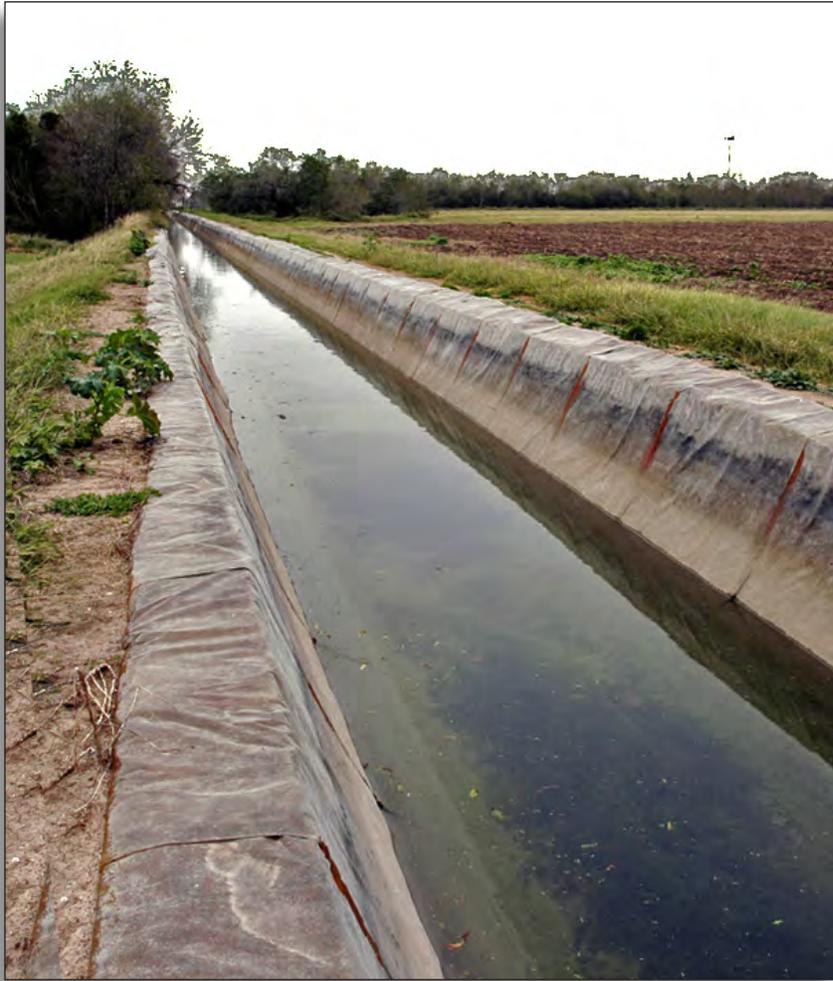
Figure 289: Modern geomembrane lining material of this lateral canal did not exist during the historic period, Hidalgo County Irrigation District No. 1.

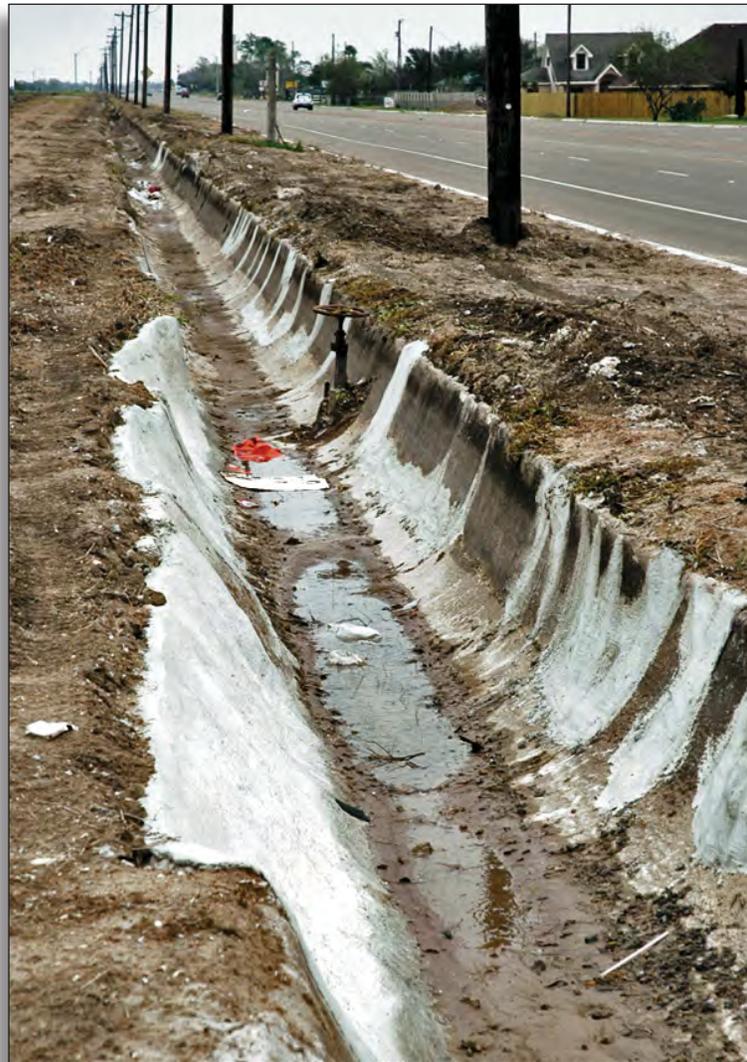
Figure 296: Modern repairs to this concrete lateral have impacted integrity of workmanship, Hidalgo County Irrigation District No. 1.

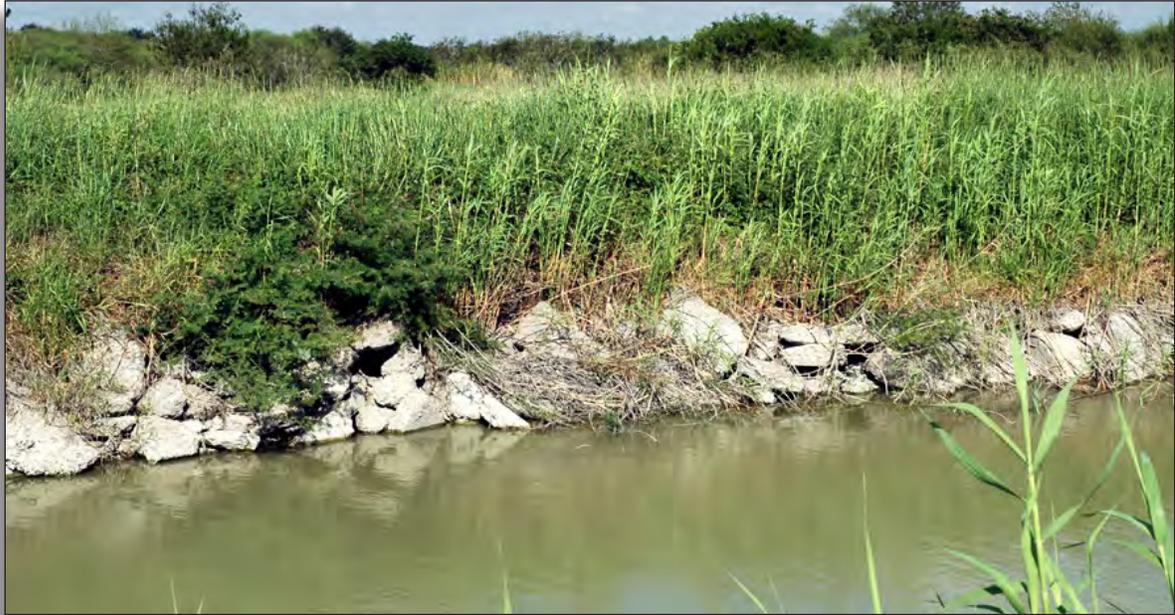
Figure 297: The lining of this earthen main canal with concrete rip-rap is a minor alteration to the integrity of workmanship, Cameron County Irrigation District No. 6.

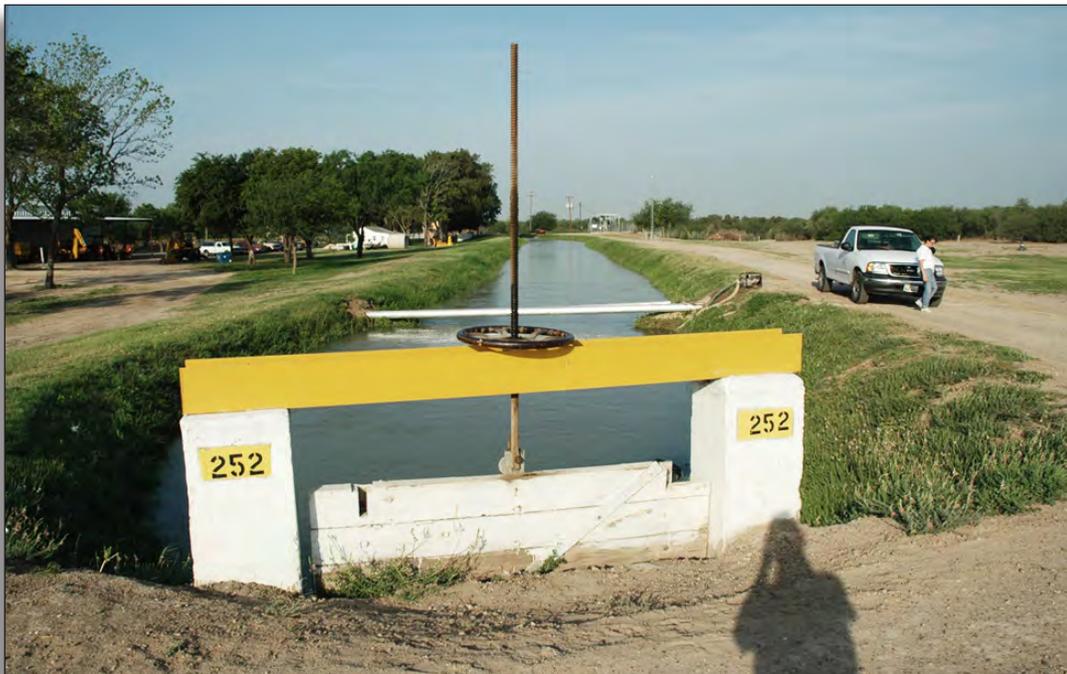
Figure 302: Workmanship is impacted by replacement of the original railroad tie crossbar with a modern steel I-beam on Check Gate No.1, Hidalgo County Irrigation District No. 3.
