TEXAS DEPARTMENT OF TRANSPORTATION

Historical Studies Report No. 2009-01

A Field Guide to Irrigation in the Lower Rio Grande Valley

The Creation of a Magic Valley
Irrigation in the Lower Rio Grande Valley

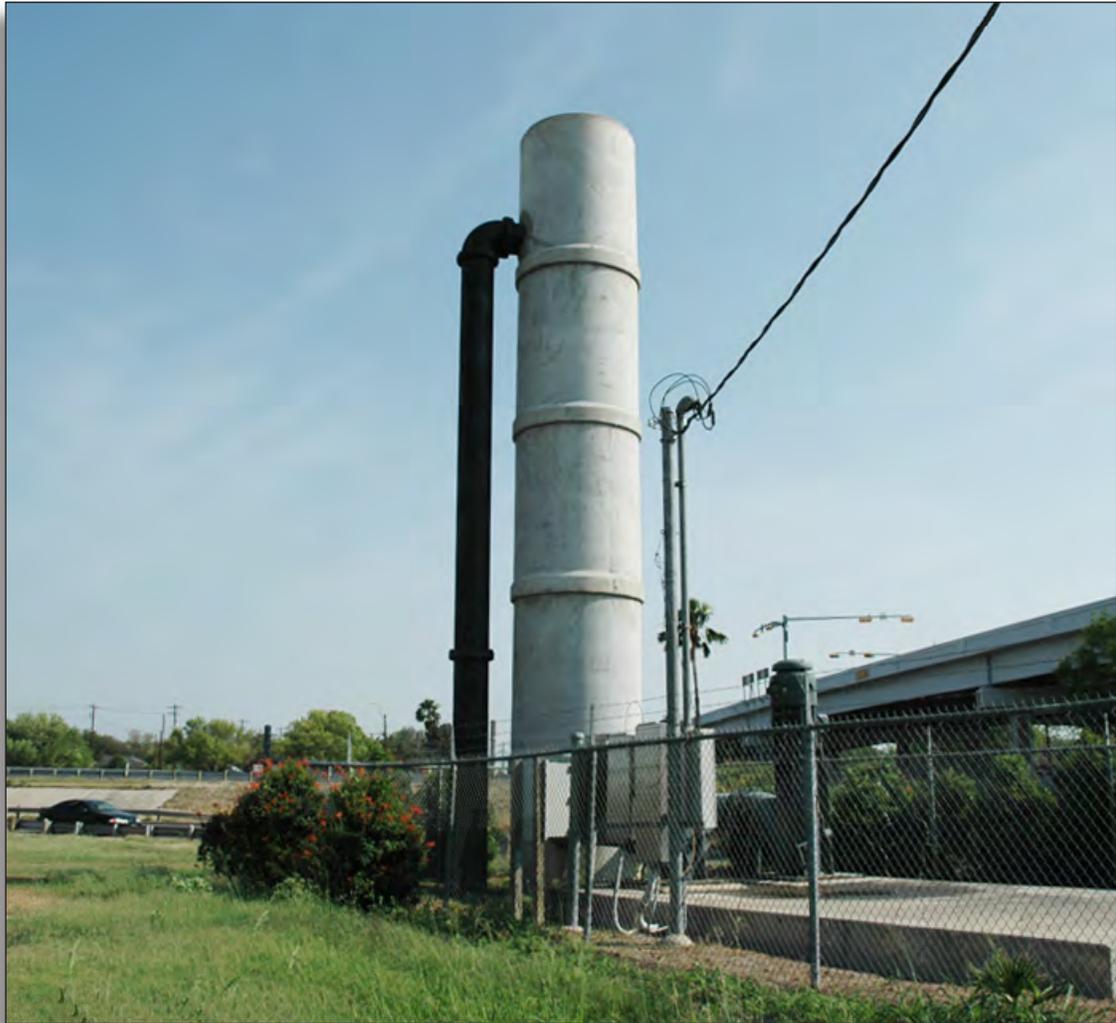
Figure 319: This second lift pumping plant lacks integrity of association because it is of modern design, it delivers water for municipal purposes and it lacks an agricultural setting, Hidalgo County Irrigation District No. 3.

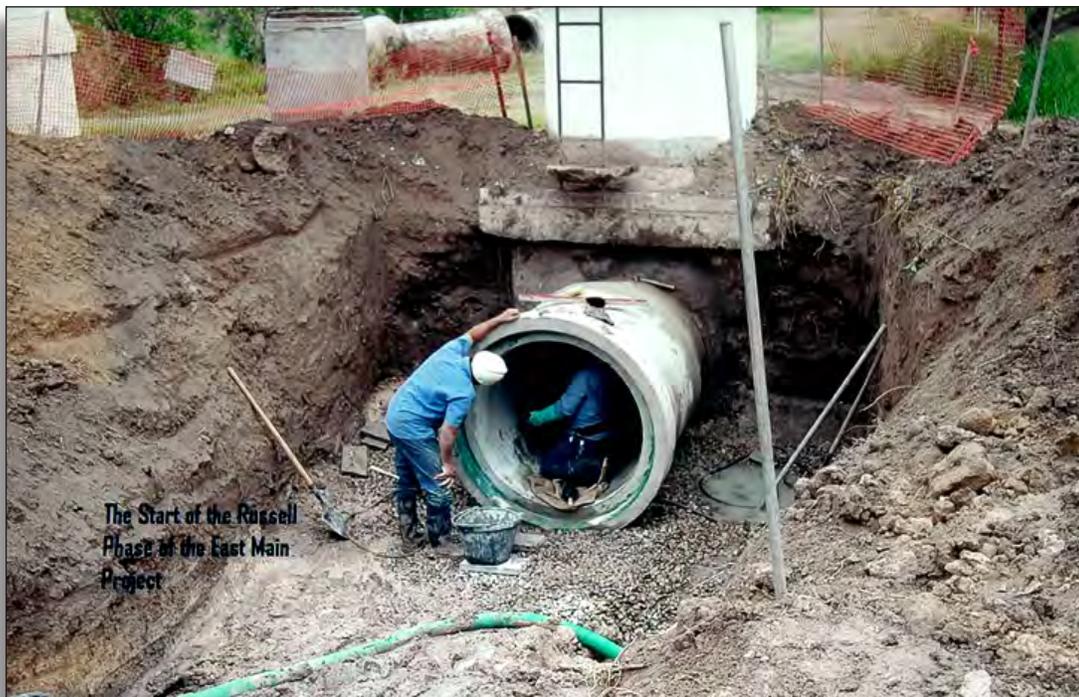
Figure 322: Installation of 48" concrete pipe with rubber gasketed joints, East Main Project (2005).
Photo collection, Hidalgo County Irrigation District No. 1

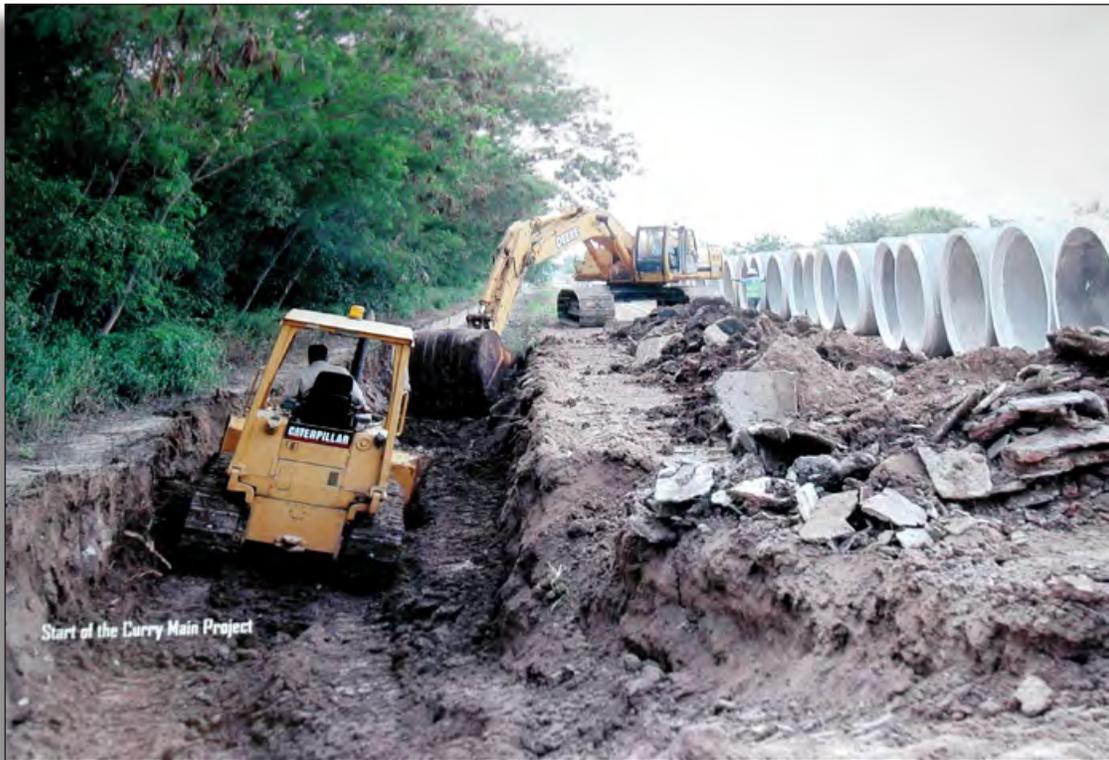
Figure 323: Initial construction on the placement of Curry Main Canal into underground pipeline (2004).
Photo collection, Hidalgo County Irrigation District No. 1
