**TEXAS HISTORICAL COMMISSION**

# **Texas Main Street**

**Design Services: Case Studies from Main  
Street Cities**

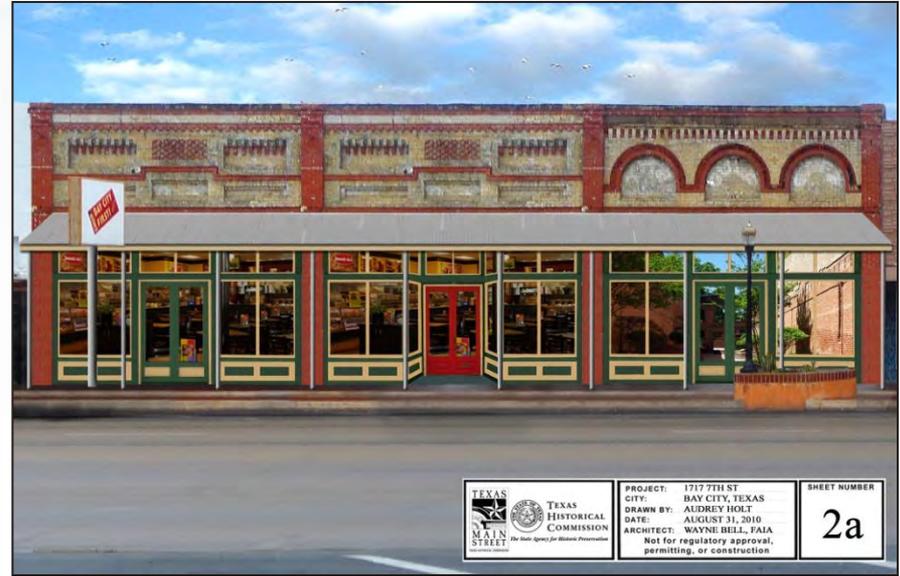
Rendering

- After removal of the slipcover on the far left, inspect the condition of brick and mortar and make repairs as necessary.
- Replace storefronts with wooden storefronts based on the historic photograph.
- Recreate pole-supported canopy seen in the historical photograph.
- Rebuild a structure in the center storefront bay, combining it with the structure on the left for the dining areas for a restaurant. Leave the right storefront bay open air for a patio area.

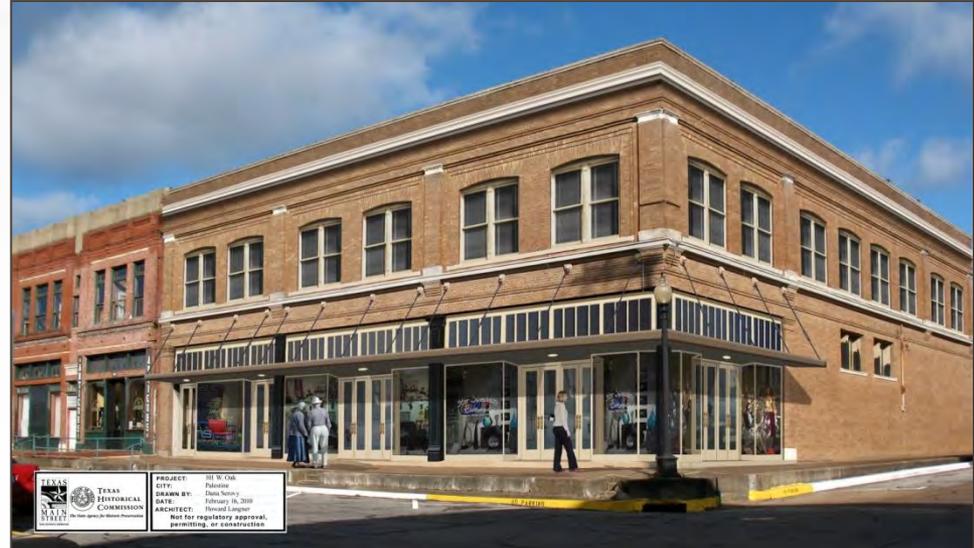
*Rendering*

- Historic wooden windows are stored in the upper floor of building. Remove the window covers, put the windows back in the window openings and repair historic windows.
- Transom windows are intact and can be seen from the interior. Remove plywood covers and make any needed repairs to the transom windows.
- Remove the modern storefront and reveal cast iron columns. Rebuild wooden storefronts based on historical photographs.
- Rebuild a tie rod supported canopy.

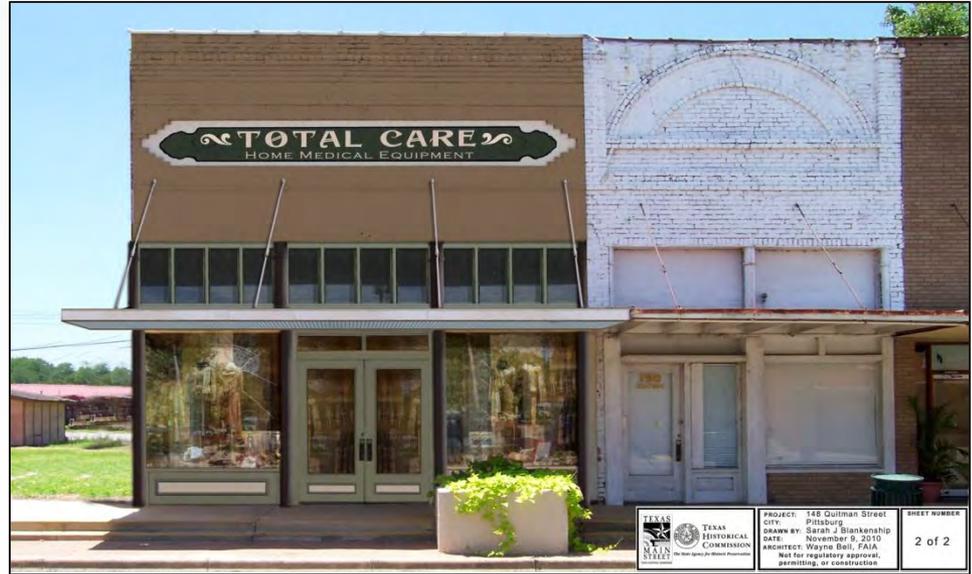
*Rendering*

- A building was demolished on the left. Prior to any cosmetic changes, inspect this party wall for structural stability and ensure its impenetrability to water.
- Cast iron columns can be seen at the top of the storefront. Remove coverings to reveal columns all the way down to the ground.
- Recreate a historically appropriate wooden storefront.
- Paint the building façade an earth tone color similar to the original brick.
- Place signage in the sign frieze area. Sample signage was rendered.

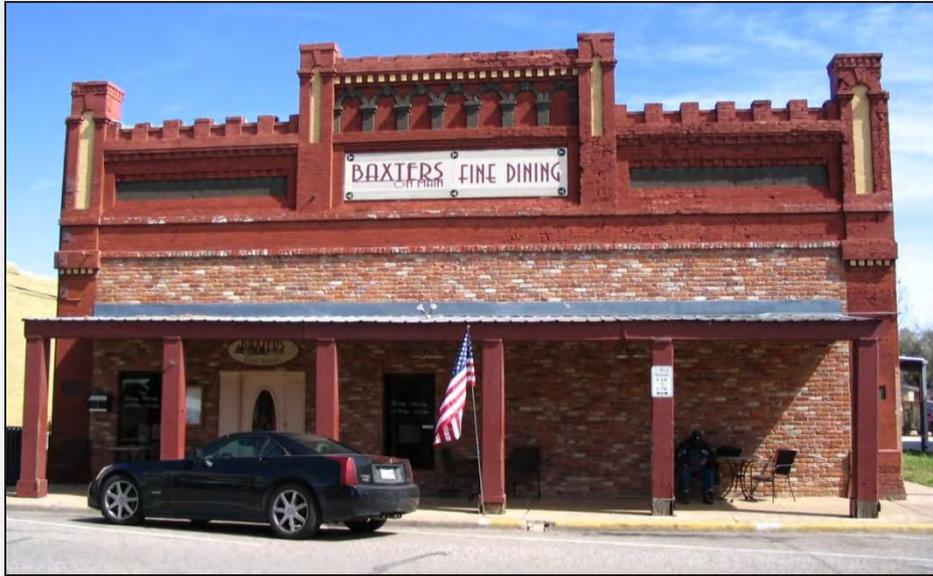
Existing Photograph

- Replace the bricked-in façade with period appropriate wooden storefront.
- Recreate the transom windows above canopy.
- Replace the existing column canopy supports with more slender poles.
- Consider signage that reinterprets the “dry goods” and “groceries” signs shown in historical photographs.

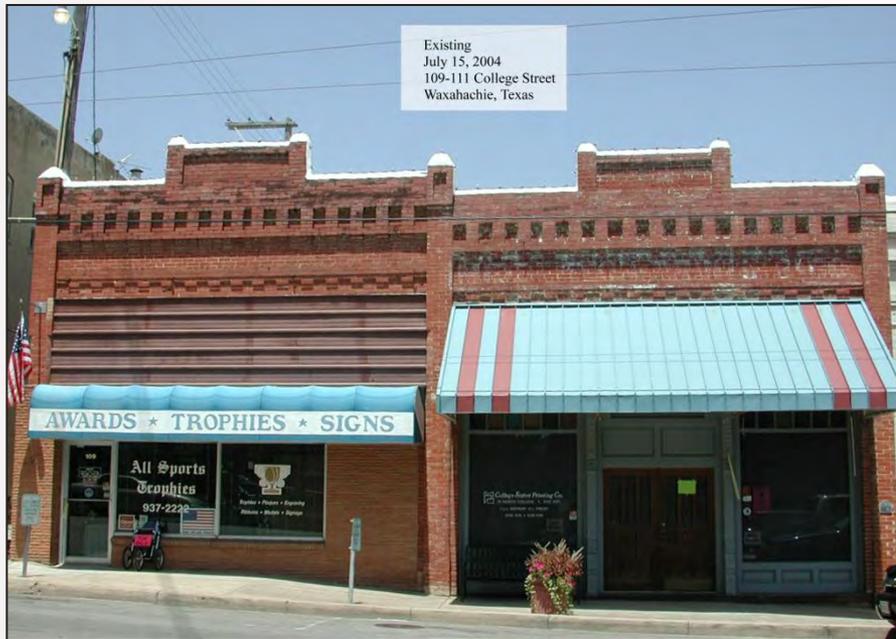
*Existing Photograph*

- Remove the slipcover over the transom windows on the left building and repair them.
- For both buildings, remove the existing awnings and replace them with ones that will showcase the stained glass transom windows.
- Rebuild the storefront on left building to be more historically appropriate. Use the storefront on the right as guidance. Differentiating the storefronts through colors is recommended.

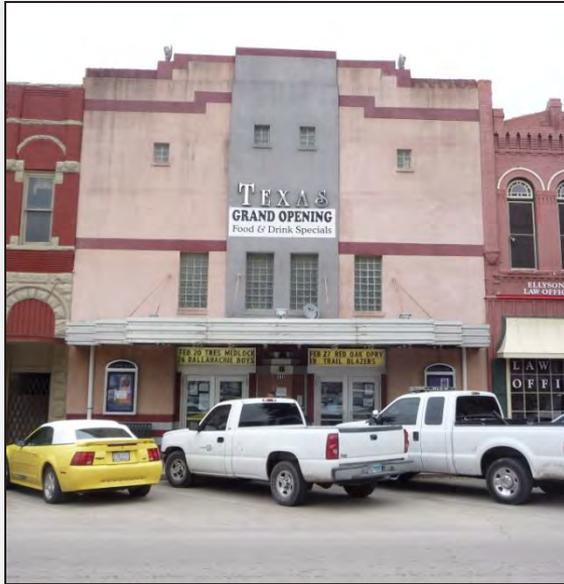
*Existing Photograph*

- A new color scheme was requested. The building's current style has Art Deco motifs. Repaint the façade to pick up on existing architectural features.
- Use colors that complement the tile on the first floor façade.
- Consider replicating the historic "Texas" sign (see Rendering 2).

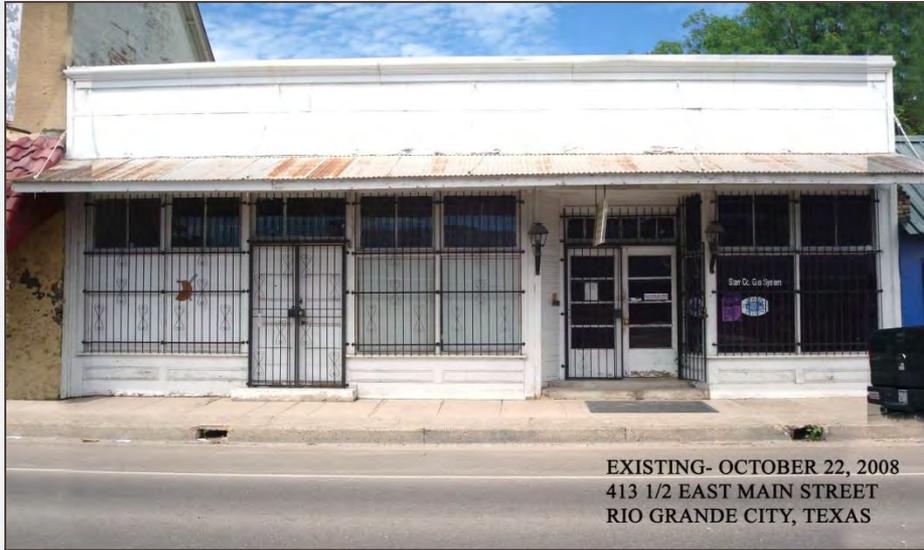
*Existing Photograph*

- Retain and repair the existing canopy.
- Remove the metal bars from the windows and doors to increase pedestrian friendliness.
- Repaint the building using a red for the pressed metal on the upper façade (to mimic brick), and use cream and brown for the wooden storefront trim.
- Add signage for “Starr County Gas Company” on the windows on either side of the main entrance.

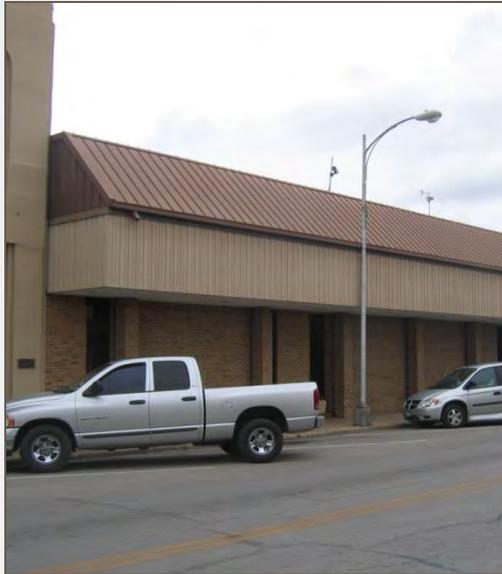
*Existing Photograph*

- Remove the brick slipcover and mansard style metal canopy.
- Following the removal of the brick slipcover, inspect the condition of the brick and mortar and make repairs as necessary, taking care to match the color and composition of existing mortar.
- Recreate the tie rod canopy, wood storefront, and transom windows using traditional proportions.

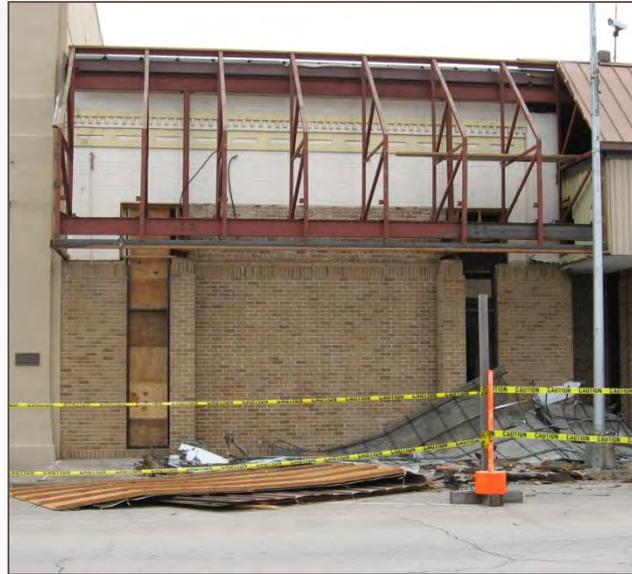
*Existing conditions under slipcover*

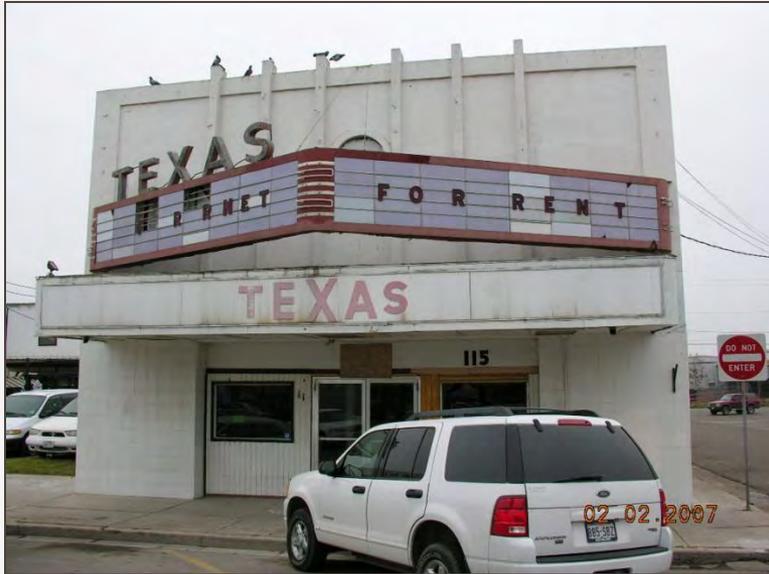
*Existing Photograph*

- Remove the upper marquee and repair the lower marquee.
- Repaint the façade, including the upper façade's decorative effects that are seen in the historic photograph.
- Restore the neon "TEXAS" letters & the strips of neon on the upper façade.
- Tile the storefront in the spirit of the Art Deco style using black and white tiles and add decorative detailing to the doors.

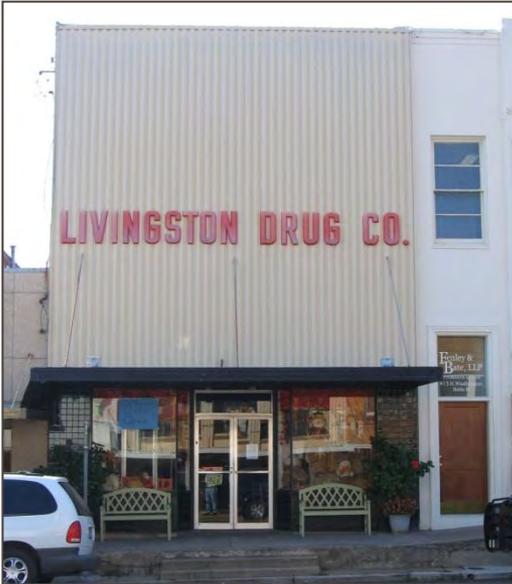
Existing Photograph

- After the removal of the metal slipcover, inspect the condition of the brick and mortar and make repairs as necessary, taking care to match color and composition of the existing mortar.
- Consider rebuilding parapet as it appears in the historical photographs.
- Return the windows to their original configuration. Replace the two right, upper windows with one-over-one sash windows.
- Consider replacing the current doors with wooden doors.

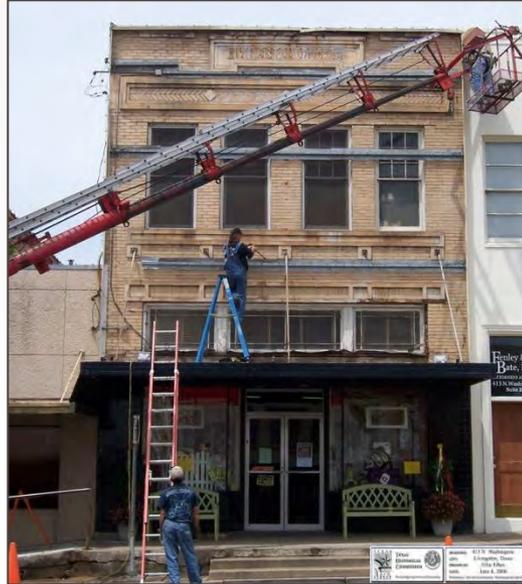
Existing conditions under slipcover

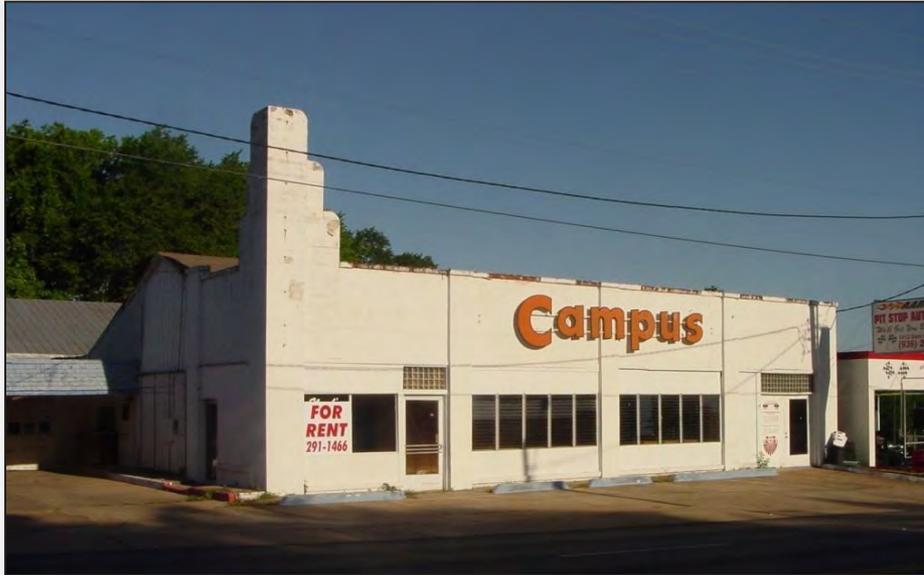
*Existing Photograph*

- Repaint the building to accent its architectural details and call attention its Art Deco styling.
- A neutral base color may be accented with two shades of blue-green and maroon.
- Exact paint color selections were chosen from the manufacturer of the owner's choice.

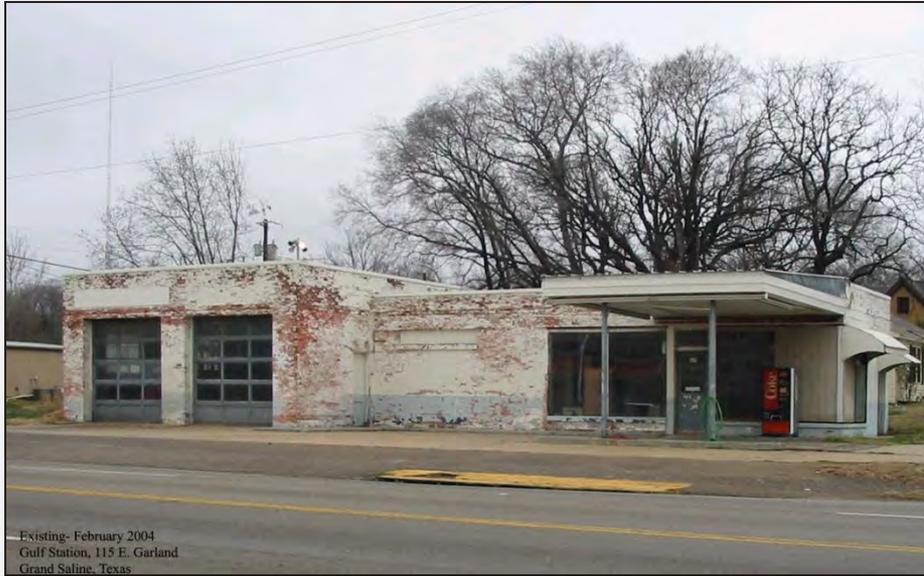
*Existing Photograph*

- Retain the original architecture of the building. Reopen the glass window on the right corner.
- Inspect condition of brick and mortar. Clean brick using gentlest means possible and make repairs as necessary, taking care to match the color and composition of existing mortar when repointing.
- Repaint the building using colors that were historically used on Gulf Stations.
- Consider placing antique gas pumps under canopy.

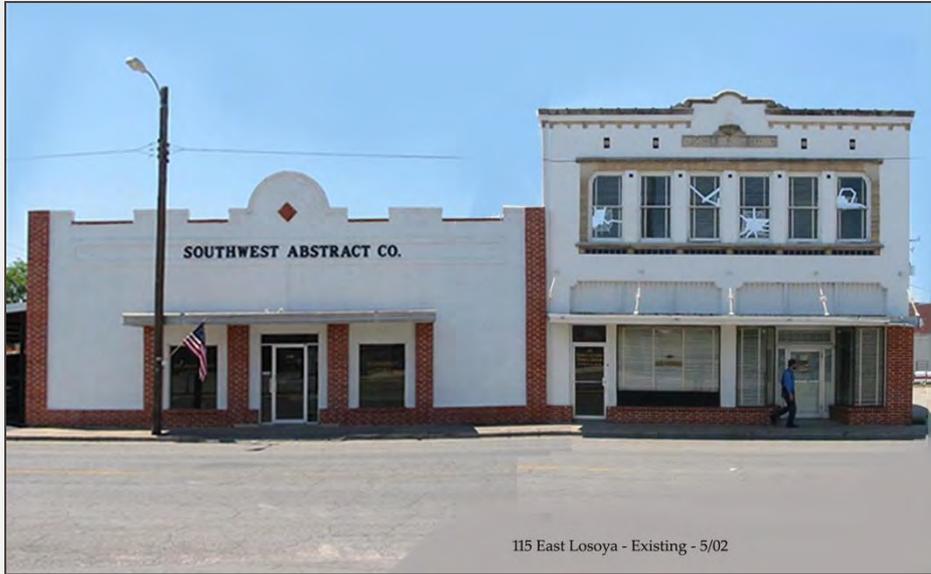
115 East Losoya - Existing - 5/02

*Existing Photograph*

- Use coordinating color schemes for each adjacent building to differentiate them from each other.
- Highlight the architectural details, such as the banding along cornice, the sign frame, and the canopies, with contrasting paint colors.
- Replace the broken windows on the second story of the right building.

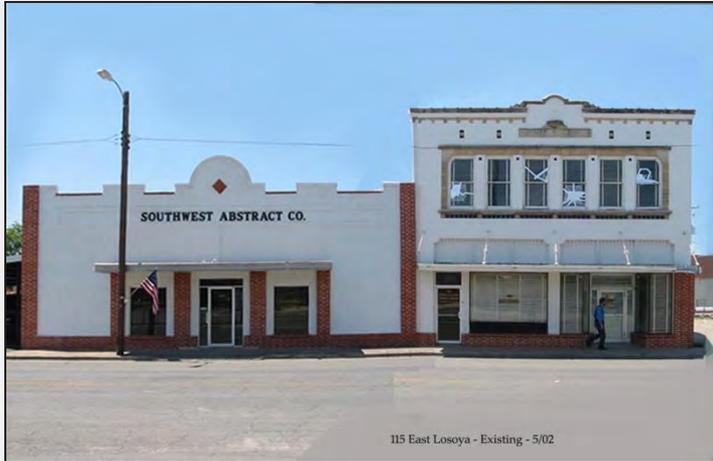
115 East Losoya - Existing - 5/02

*Existing Photograph*

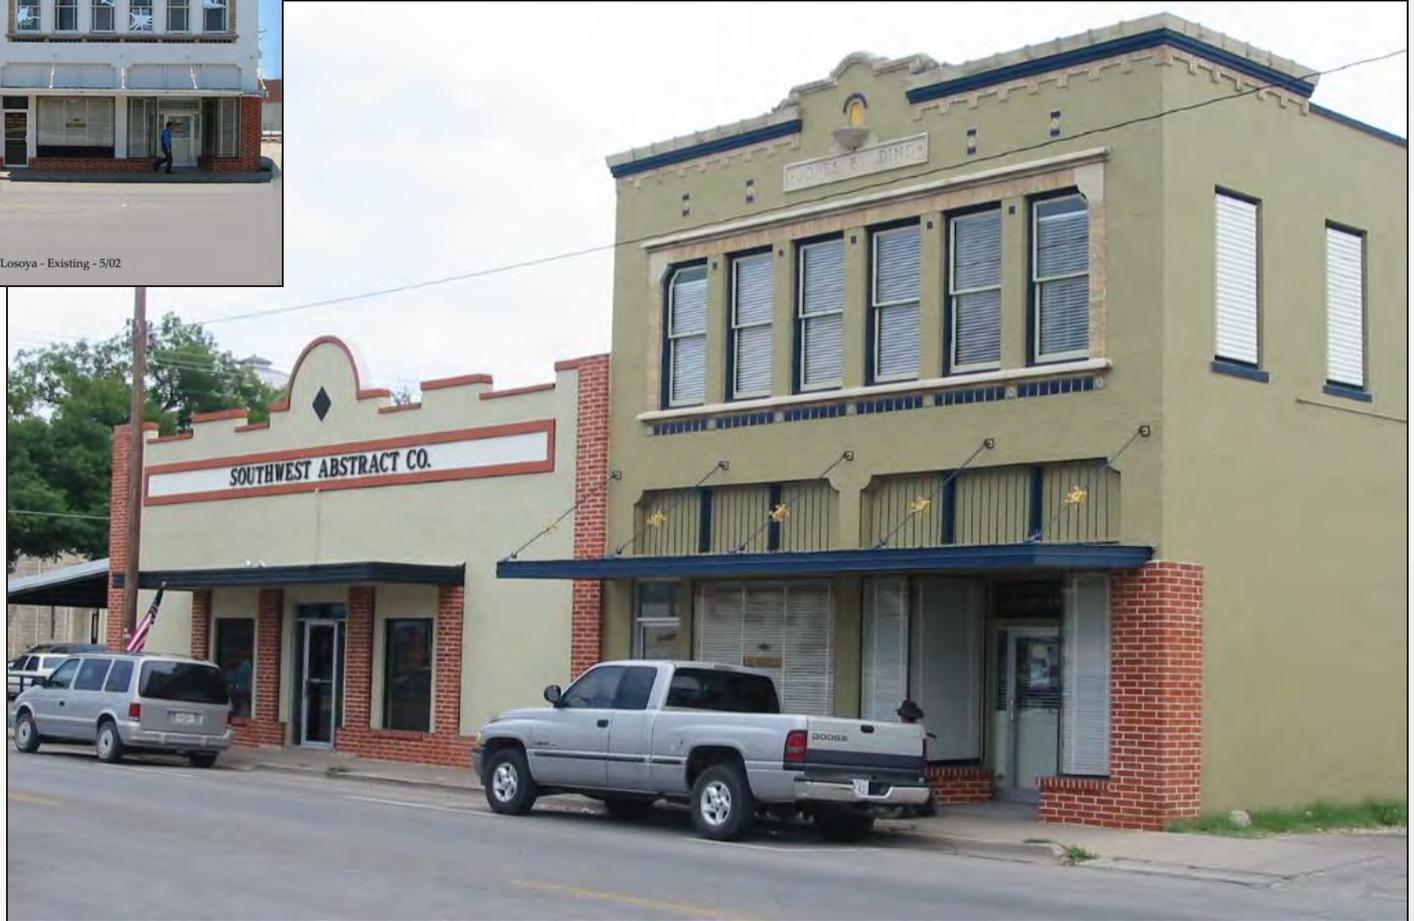
*After Photograph*

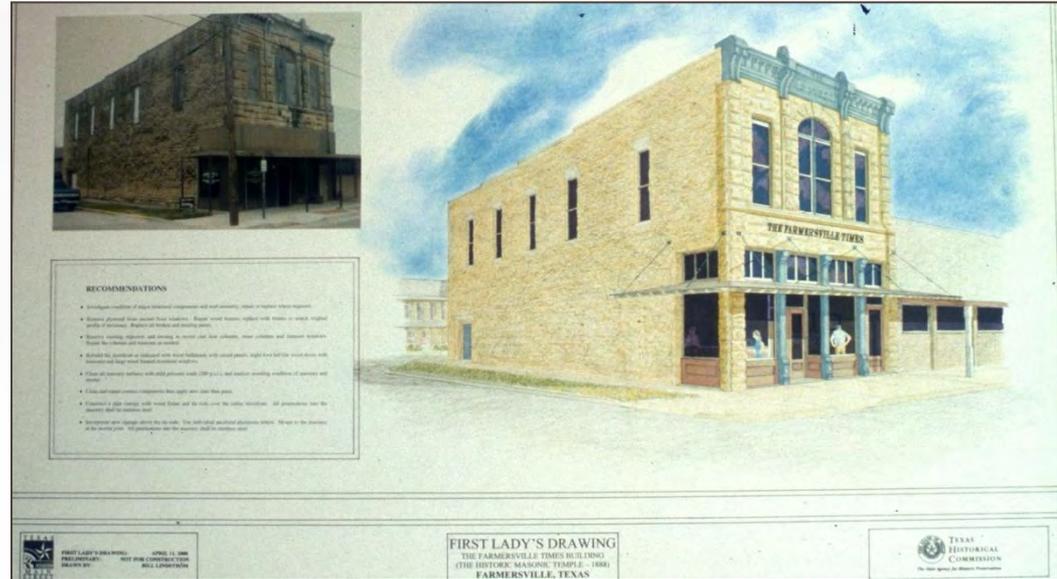
Rendering

- Remove the slipcovers over the lower portions of the façade and gently clean the stone to restore original appearance.
- Restore the transom windows and second story windows.
- Restore the storefront including columns, bulkheads and tie rod canopy.

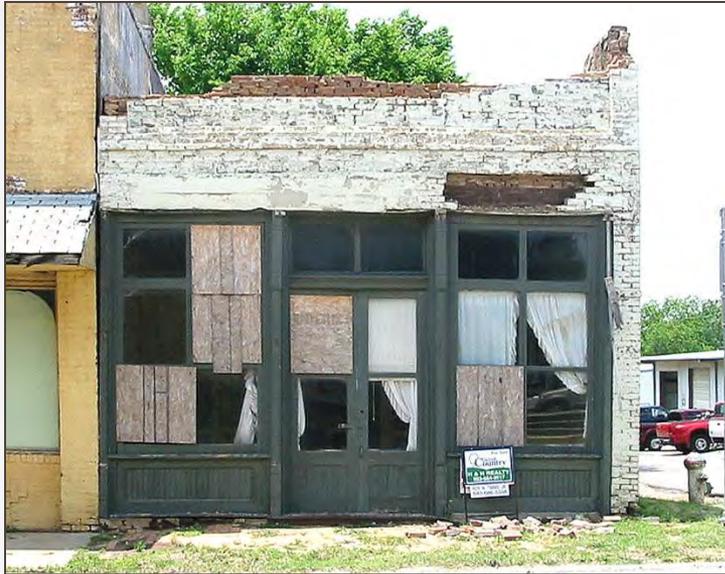
*Existing Photograph*

- Gently clean the brick to remove the white paint. Rebuild the portion of the parapet that collapsed.
- Replace the broken panes of glass in the storefront.
- Accent architectural features, such as the columns, doors and window frames, with contrasting paint colors.

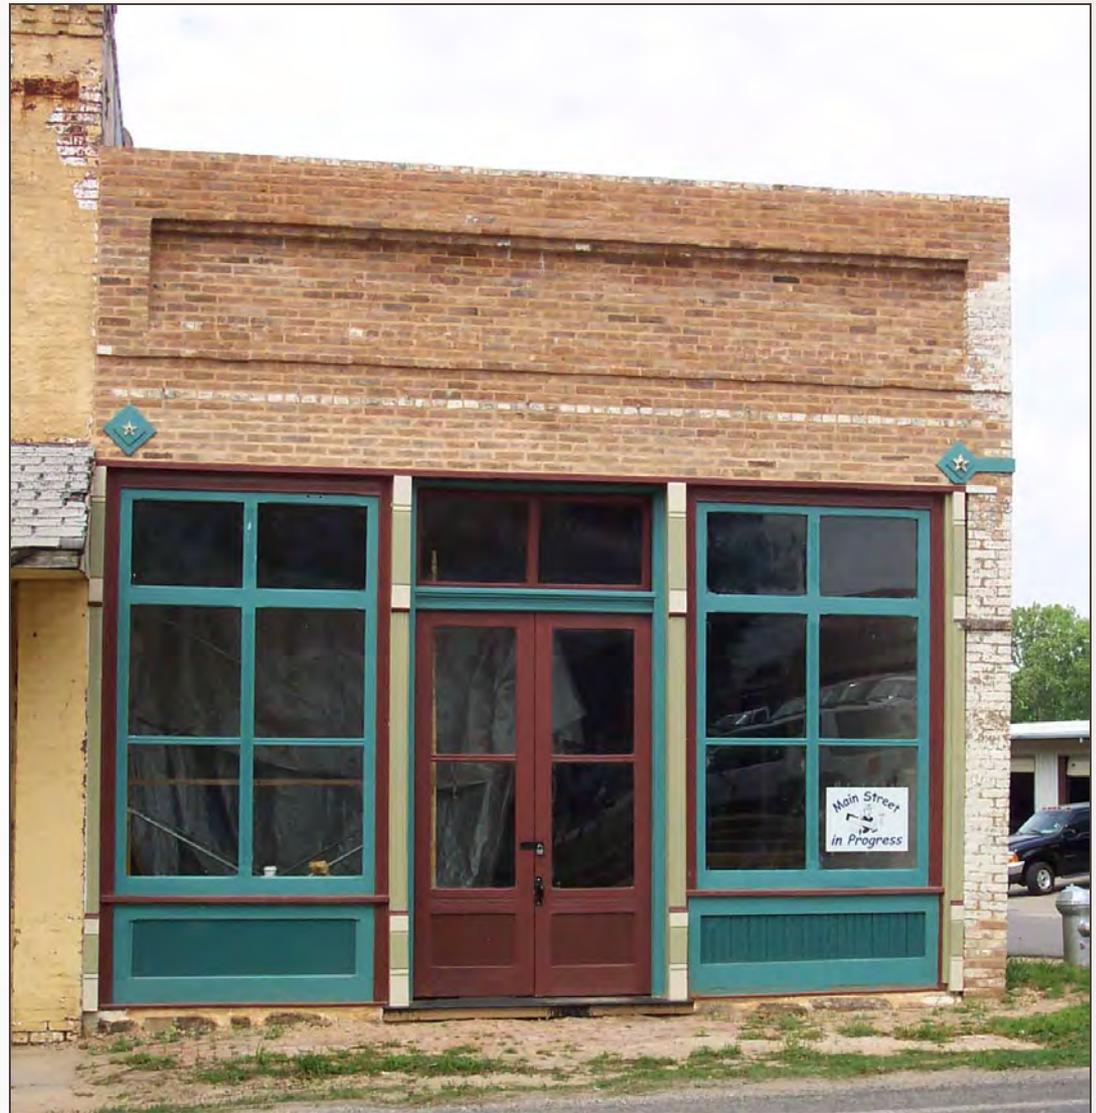
*After Photograph*

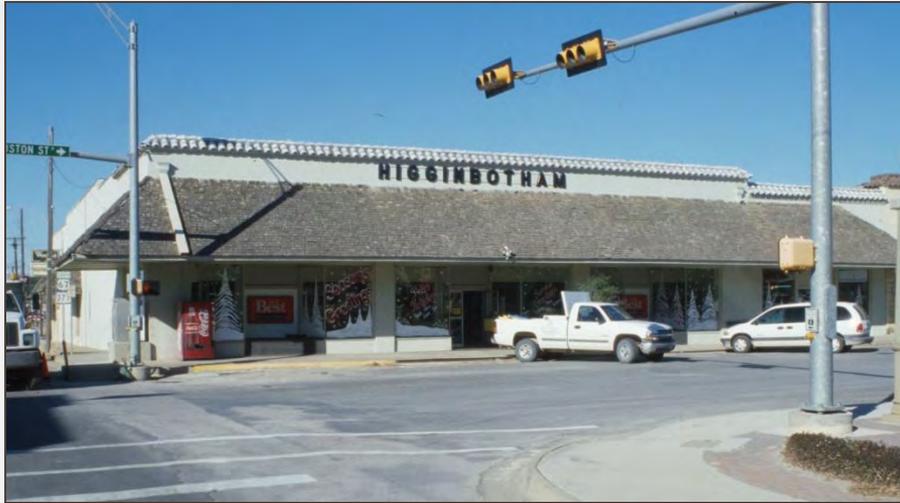
*Existing Photograph*

- Remove the shingled awning and assess condition of the façade beneath, taking care to preserve as much original architectural detail as possible.
- Repair transom windows as necessary and recreate the tie rod supported canopy.
- Repaint the building using a neutral color palette to highlight architectural details.

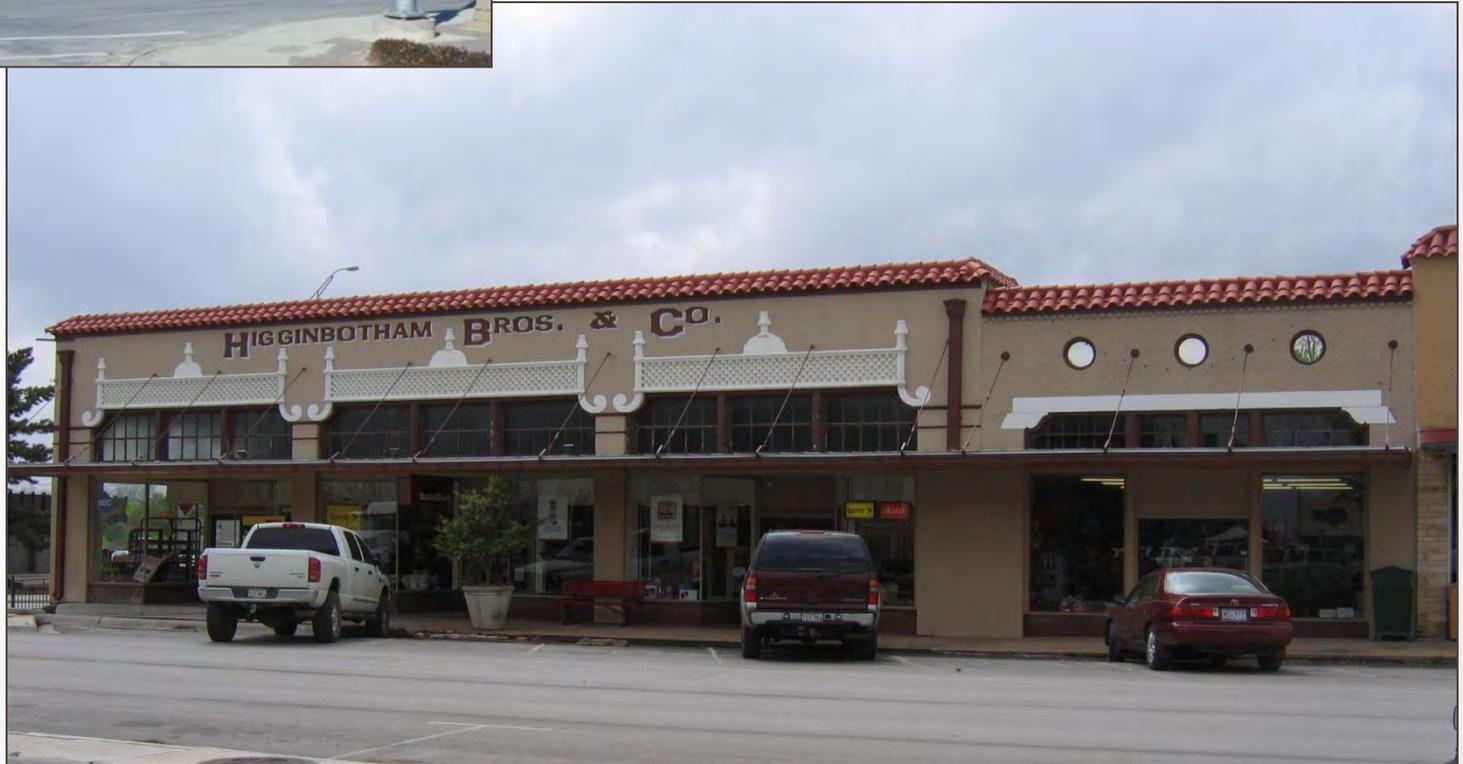
*After Photograph*

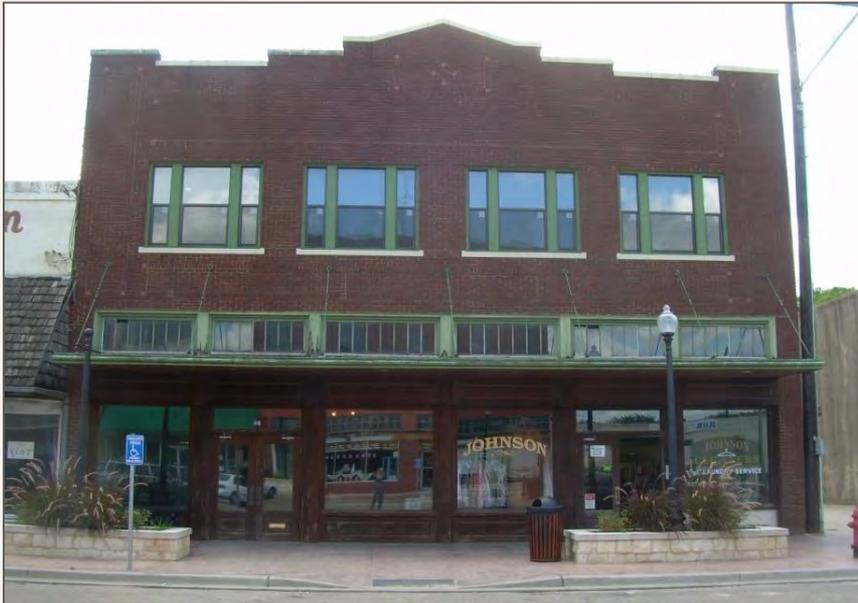
*Existing Photograph*

- Repair and repaint, rather than replace, the transom windows and wooden storefront. Maintenance issues can be resolved without considering replacing the storefront with rock, or the transom windows with vinyl windows. Simple repairs and a coat of paint are a long lasting, cost effective solution.
- Owners requested new color schemes. The color scheme ties the upper story windows with the transom windows and storefront below, highlights architectural details and coordinates with the brick.

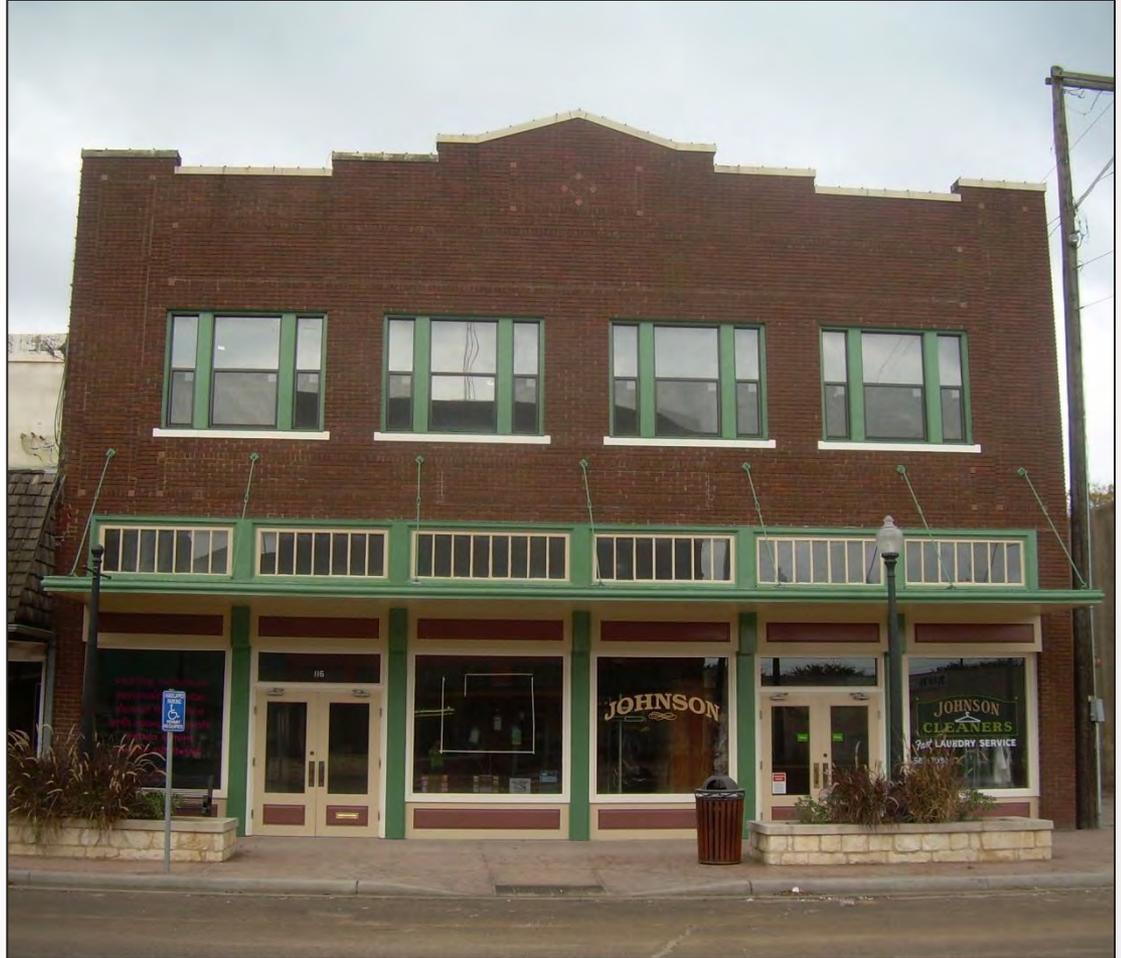
*After Photograph*

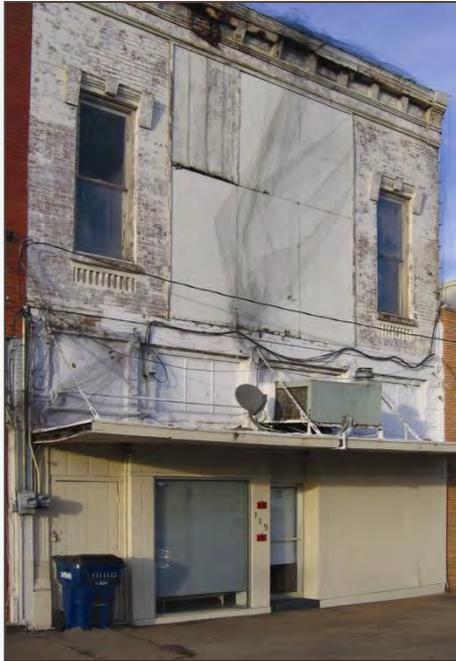
*Existing Photograph*

- Reveal, clean, repair, and repaint the cast iron elements on façade.
- Restore the transom windows and repair the existing canopy, rather than recreating the canopy seen in historical photo.
- Recreate the bay window on the second story, and the traditional storefront on the first story.

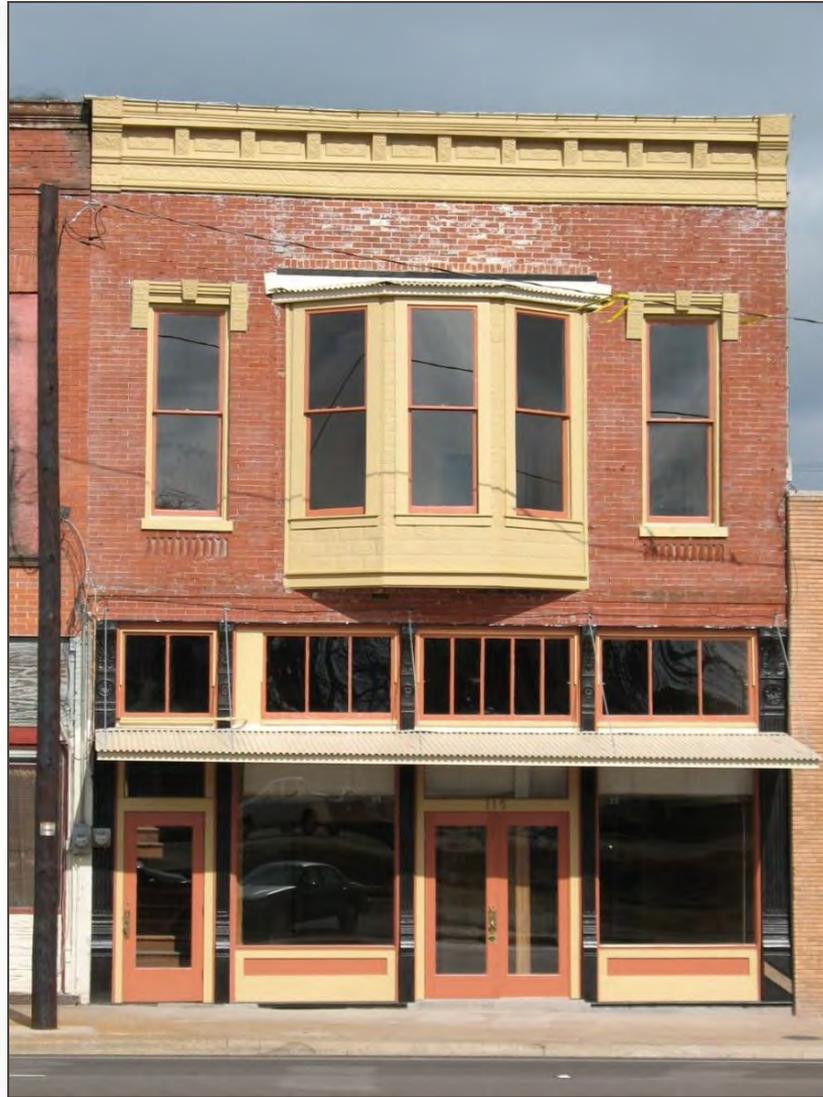
*After Photograph*

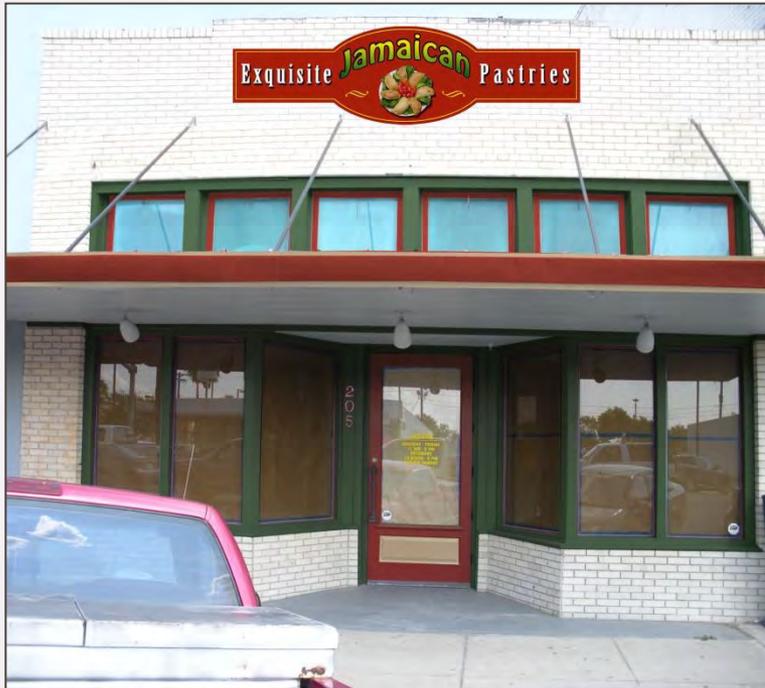
Objective: Design a sign to be in balance with overall character of property. A sign should not in any way obscure or compete with the architectural details of a historic façade.

*Rendering*
