# Executive Committee

# TEXAS HISTORICAL COMMISSION

## AGENDA EXECUTIVE COMMITTEE

**3. Brackenridge Park, Lambert Beach area, San Antonio, Bexar County**

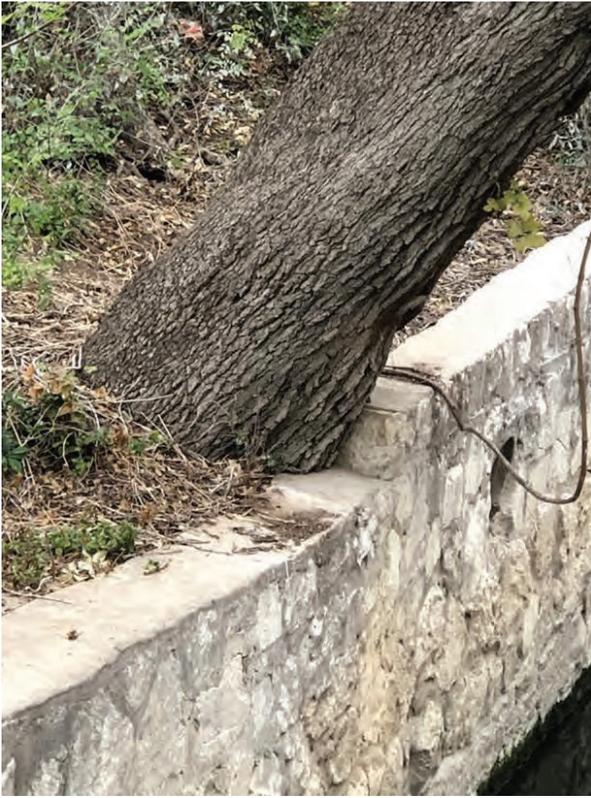
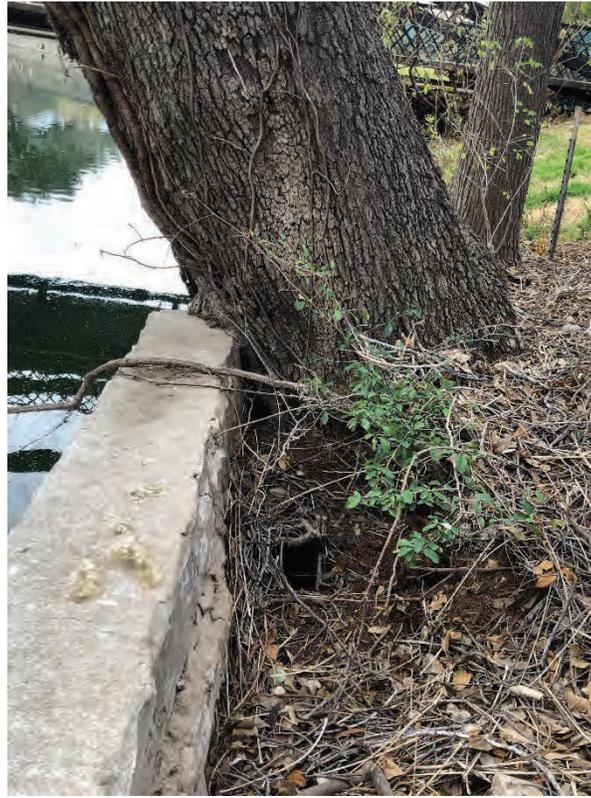
*Figures 1 & 2: Tree No. 95, 32-inch Live Oak proposed to be removed. Proximity to Cultural Resource: 0 inches.*

In removing the 48 trees, COSA is following the guidelines set forth in the Secretary of the Interior's *Standards for the Treatment of Historic Properties*. The trees are damaging, and will continue to damage, the historic stone walls and the Pump House. In order to protect and preserve their form, integrity, and materials, the trees will need to be removed. In the areas where the trees have already destroyed historic resources, reconstruction methods will be utilized. COSA's goal is to also protect the areas of significance as outlined in the *Brackenridge Park National Register Nomination*, which includes landscape architecture and entertainment and recreation. Lambert Beach is listed as a contributing resource within those areas of significance in 1915 and 1925, which include the historic stone walls. According to the nomination, Brackenridge Park never had a formal landscape plan. While there was a plan for Lambert Beach, there is no evidence that any of the existing trees were part of that plan, but rather planted from random seed dispersal. Letting the trees remain to further harm and erase the historic resources would set an unacceptable precedent for future projects.

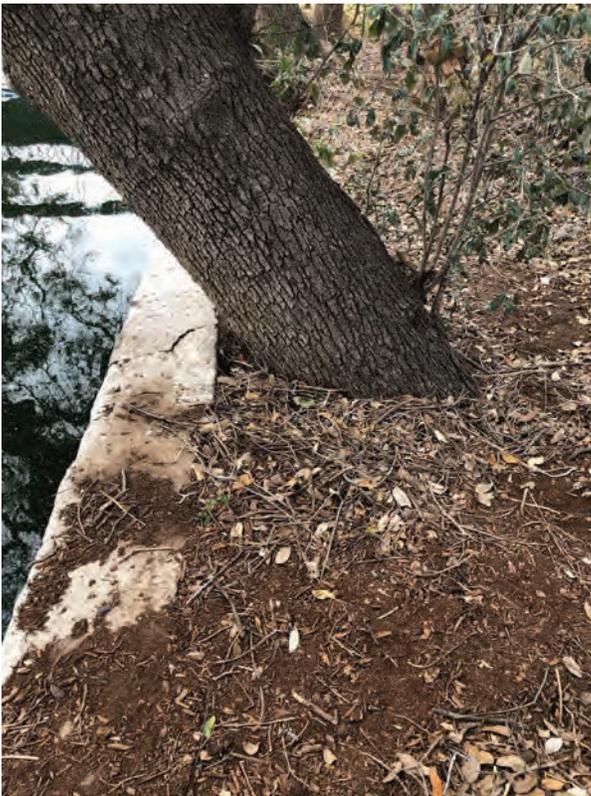
*Figure 3: Tree No. 97, 22-inch Live Oak proposed to be removed. Proximity to Cultural Resource: 3 inches*

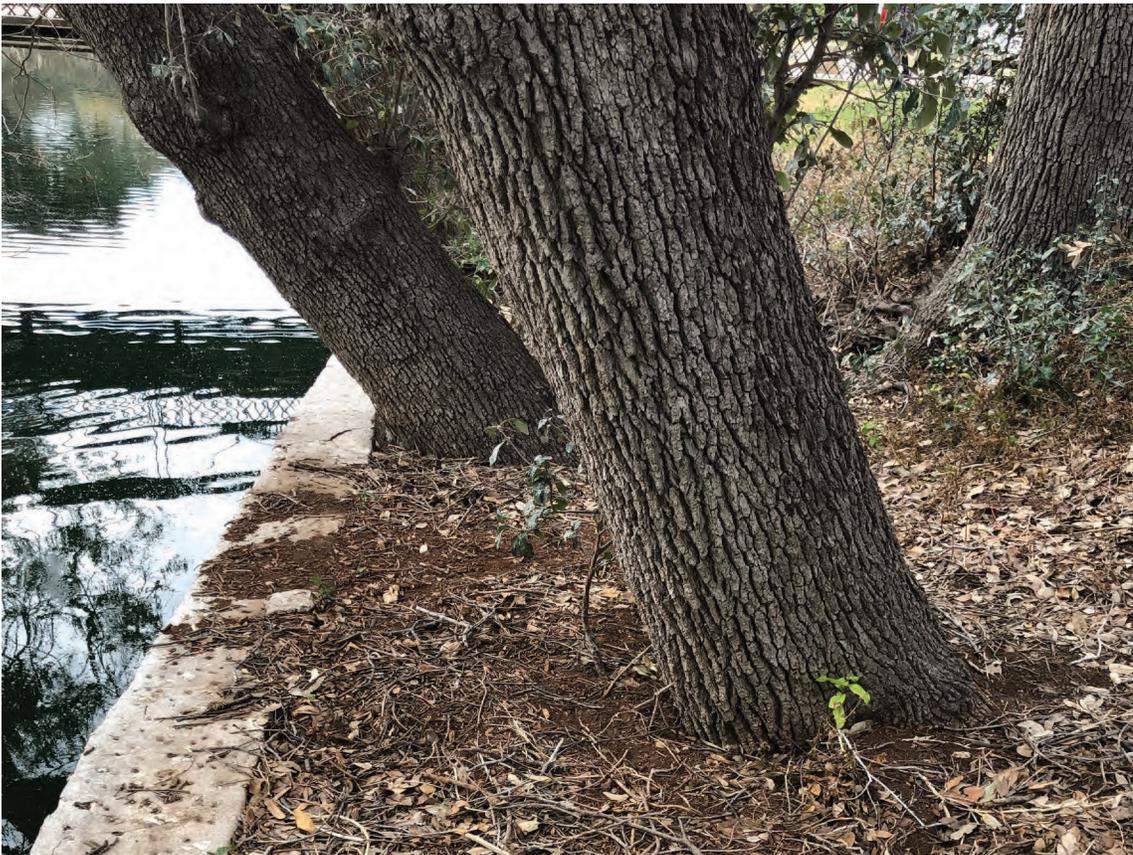
*Figure 4: Foreground - Tree 98, 18-inch Live Oak proposed to be removed. Proximity to Cultural Resource: 18 inches. Background Left – Tree No. 97 proposed to be removed, Background Right – Tree No. 96 proposed to be preserved.*

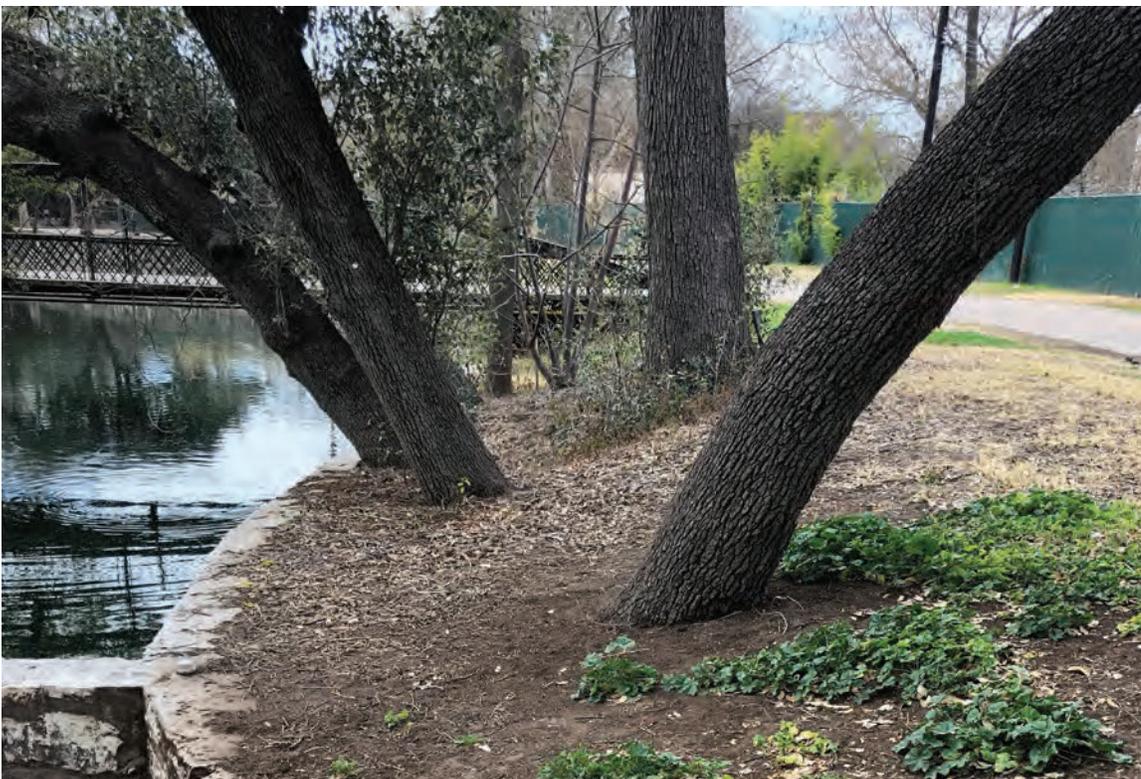
*Figure 5: Foreground – Tree No. 99, 16-inch live oak proposed to be removed. Proximity to Cultural Resource: Less than 5 feet. Background – (L to R) Tree No. 97, Tree No. 98, both proposed to be removed, Tree No. 96 proposed to be preserved.*

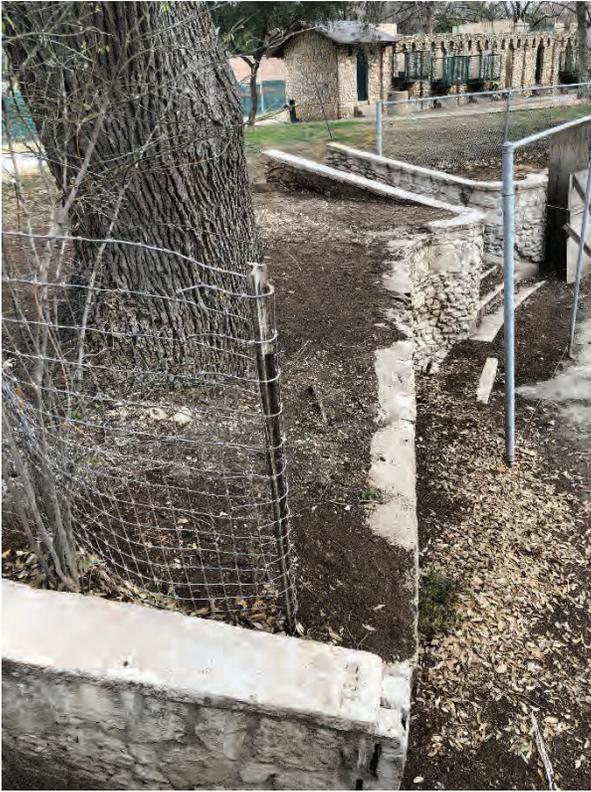
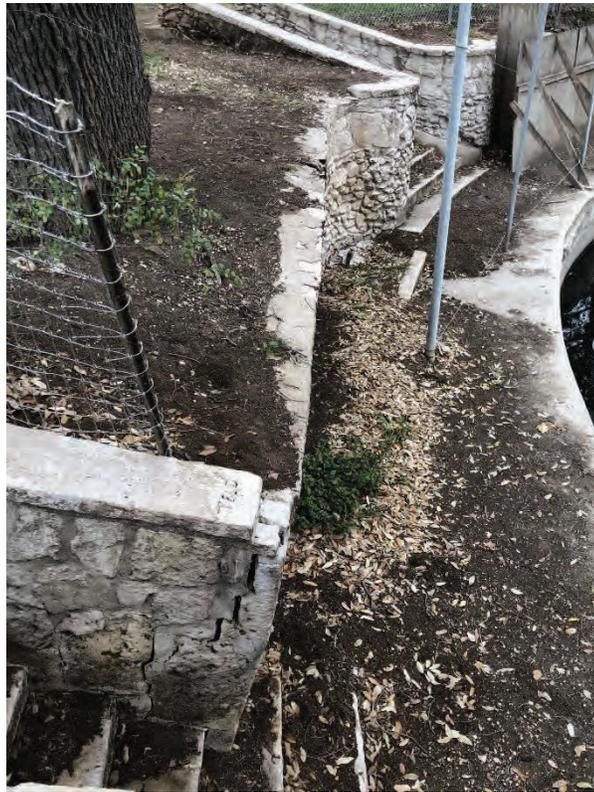
*Figures 6 and 7: Tree No. 100, 37-inch Live Oak proposed to be removed. Proximity to original position of Cultural Resource (severe lean): less than 15 inches*

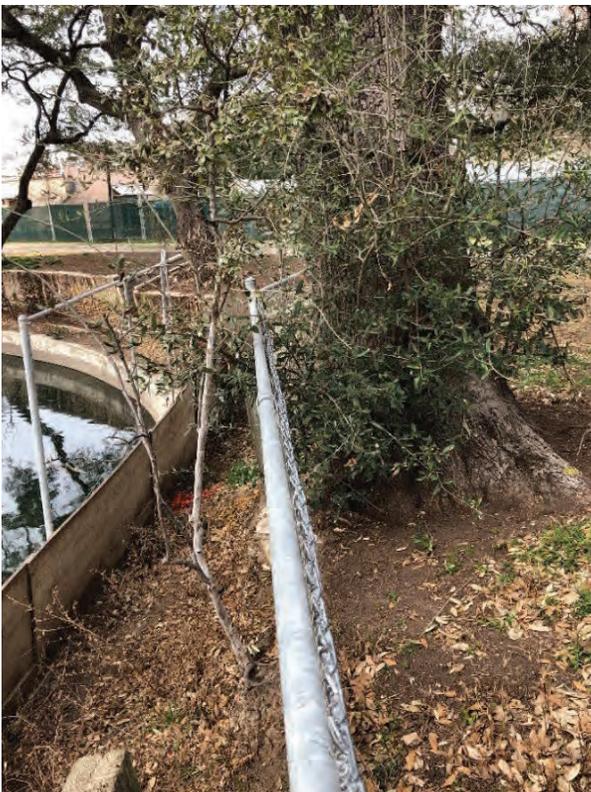
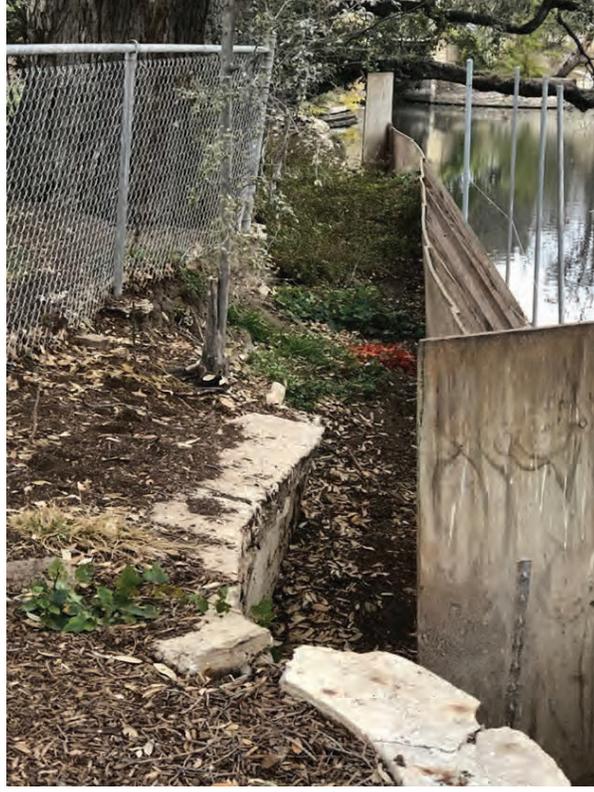
*Figures 8 and 9: Tree No. 101, 44-inch Live Oak proposed to be relocated approximately 15-20 feet further away from river than current location. Proximity to original position of Cultural Resource (demolished): less than 18 inches.*

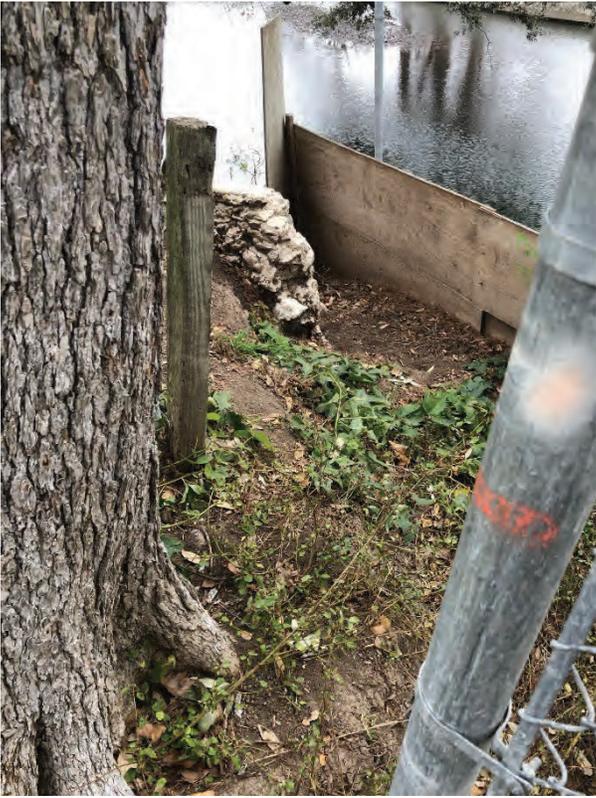
Figure 10: Tree No. 102, 18-inch Cedar Elm proposed to be removed. Proximity to original position of Cultural Resource(demolished): less than 3 feet.

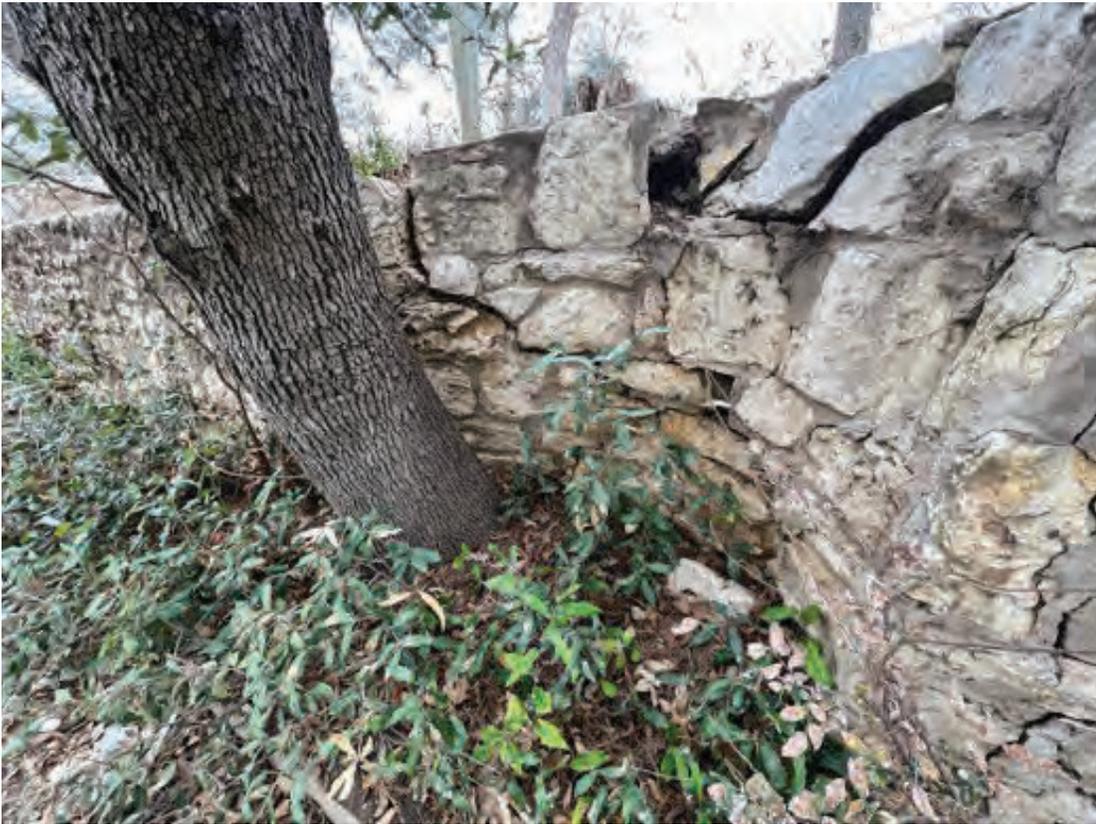
Figure 11: Tree No. 134, 16-inch Live Oak proposed to be removed. Proximity to Cultural Resource: 0 inches.

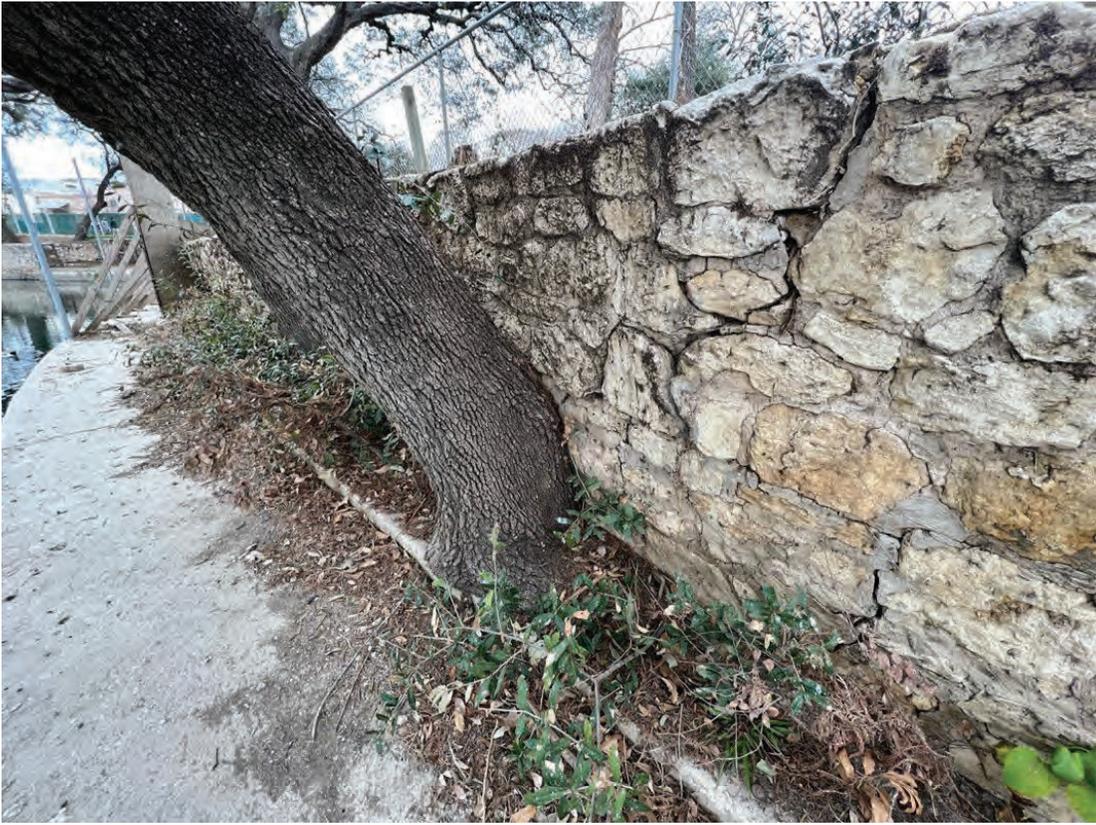
Figure 12: Tree No. 135, 15-inch Live Oak proposed to be removed. Proximity to Cultural Resource: 0 inches.

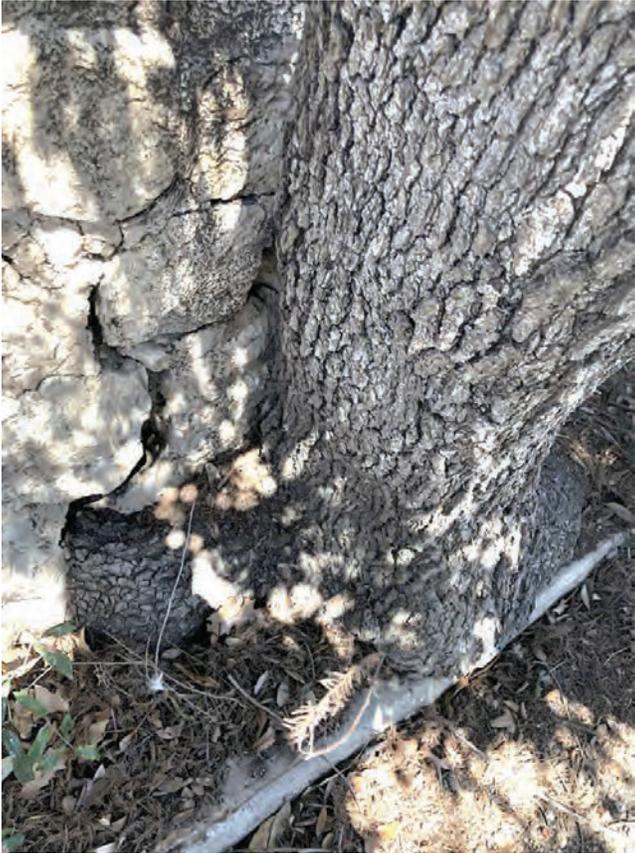
Figure 13: Tree No. 135, 15-inch Live Oak proposed to be removed. Proximity to Cultural Resource: 0 inches.

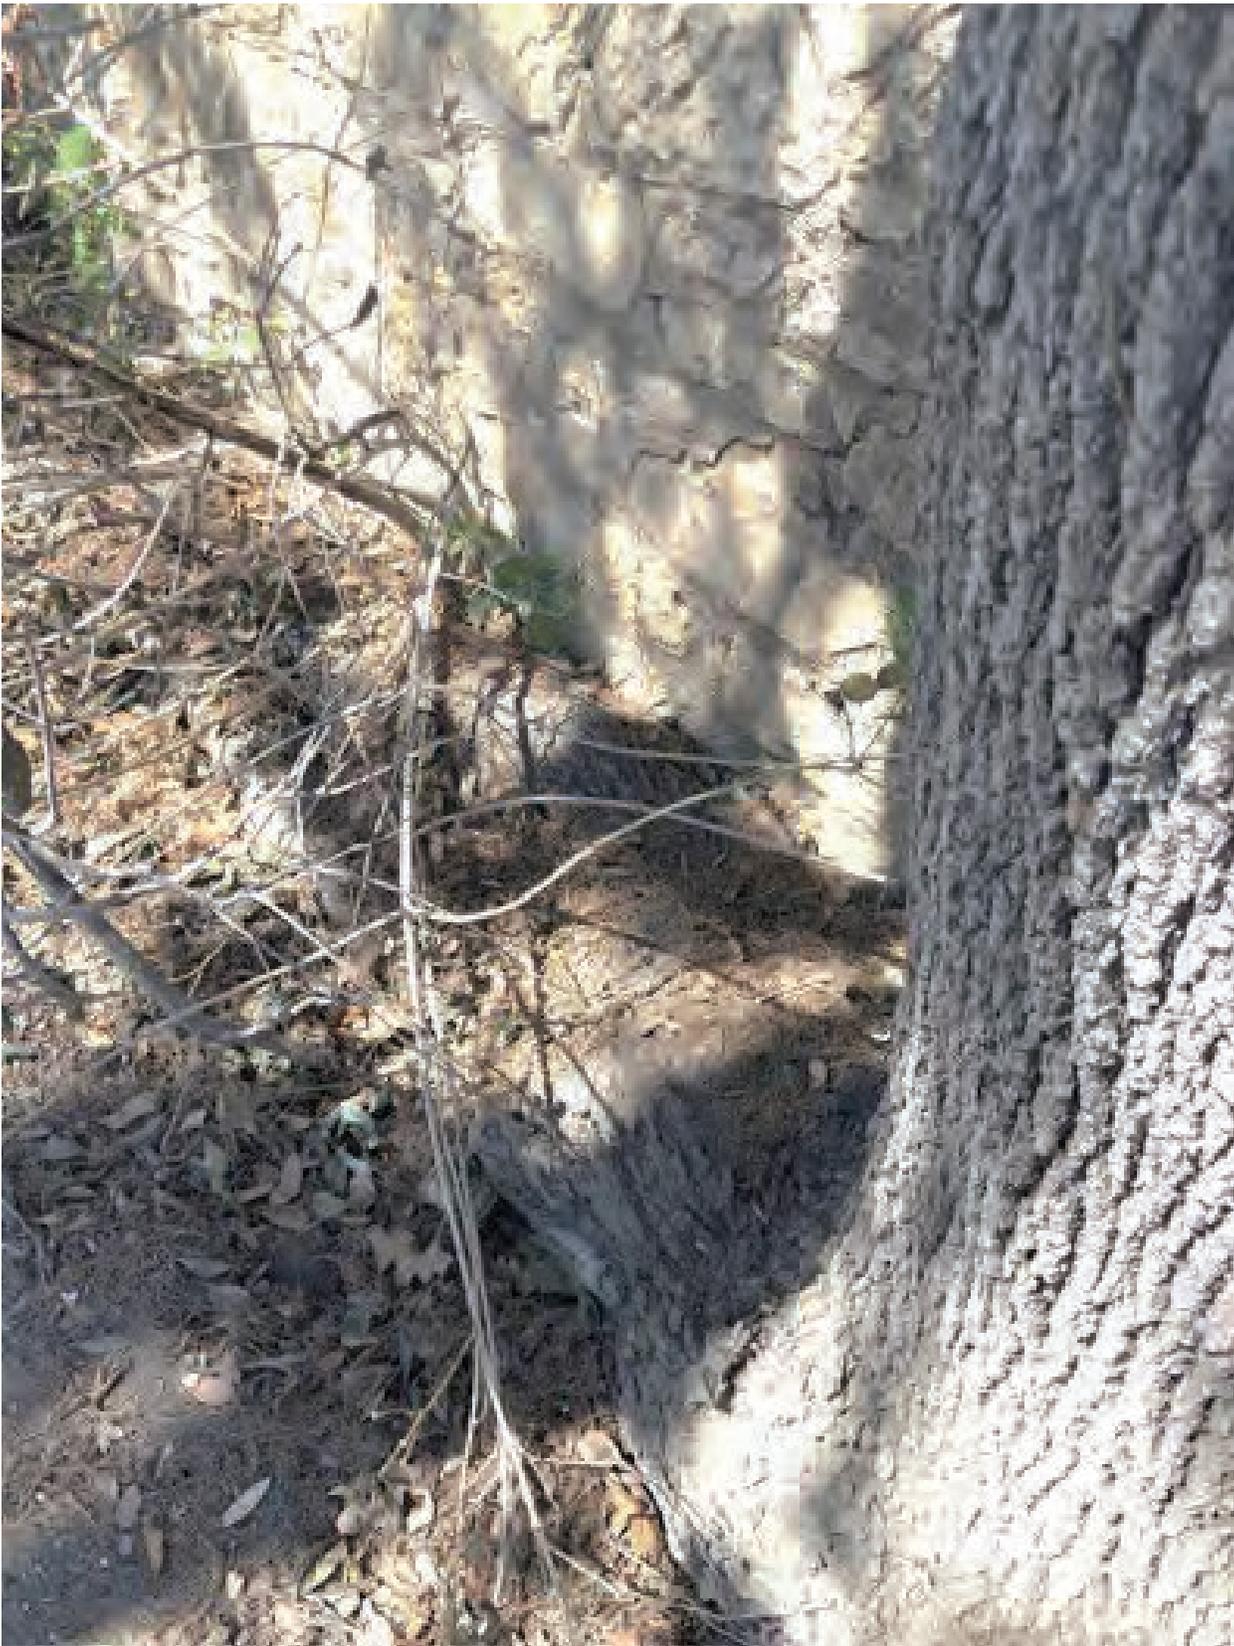
Figure 14: Tree No. 136, 20-inch Live Oak proposed to be removed. Proximity to Cultural Resource: 0 inches.

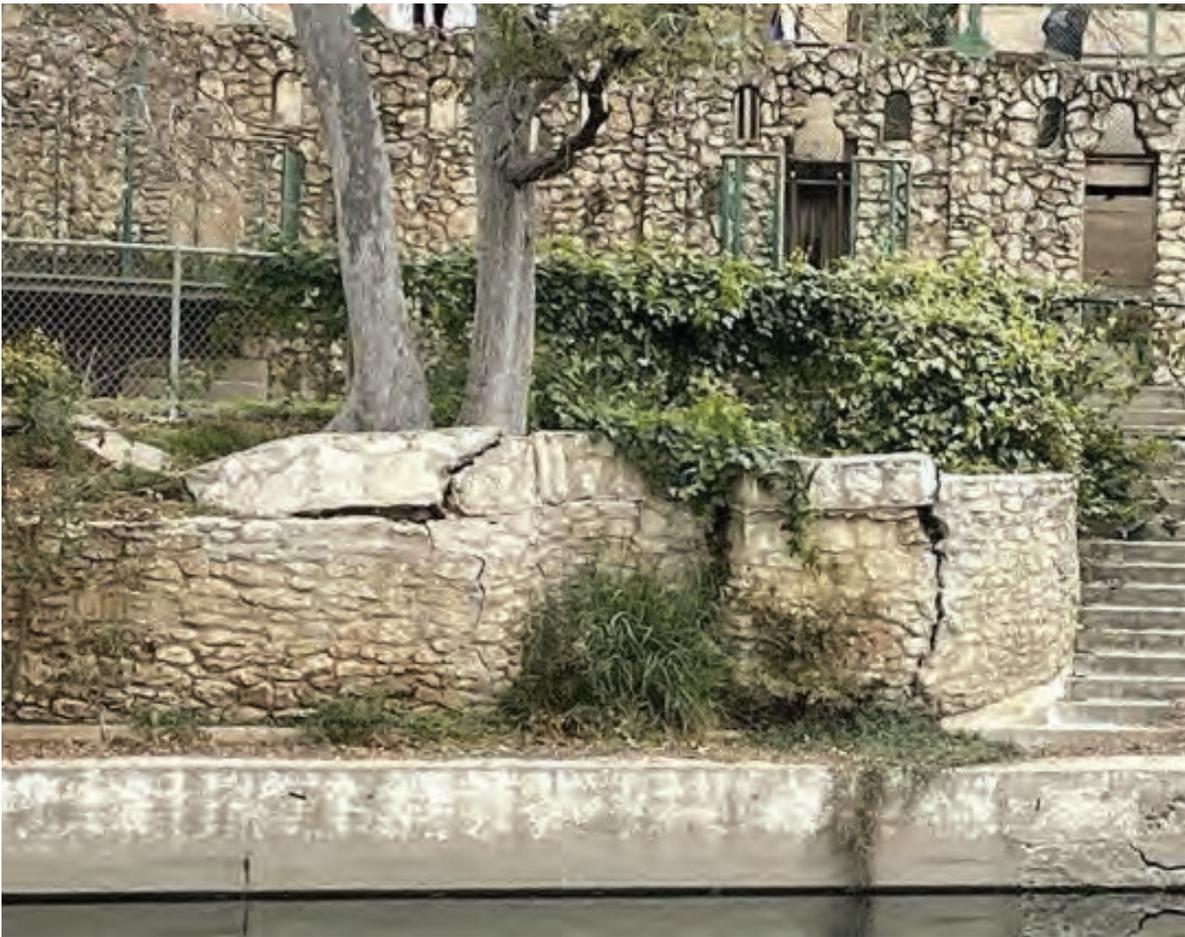
Figure 15: (L to R) Tree Nos. 137, 17-inch Cedar Elm, and 138, a 16-inch Cedar Elm, proposed to be removed. Proximity to Cultural Resource: 1-3 inches.

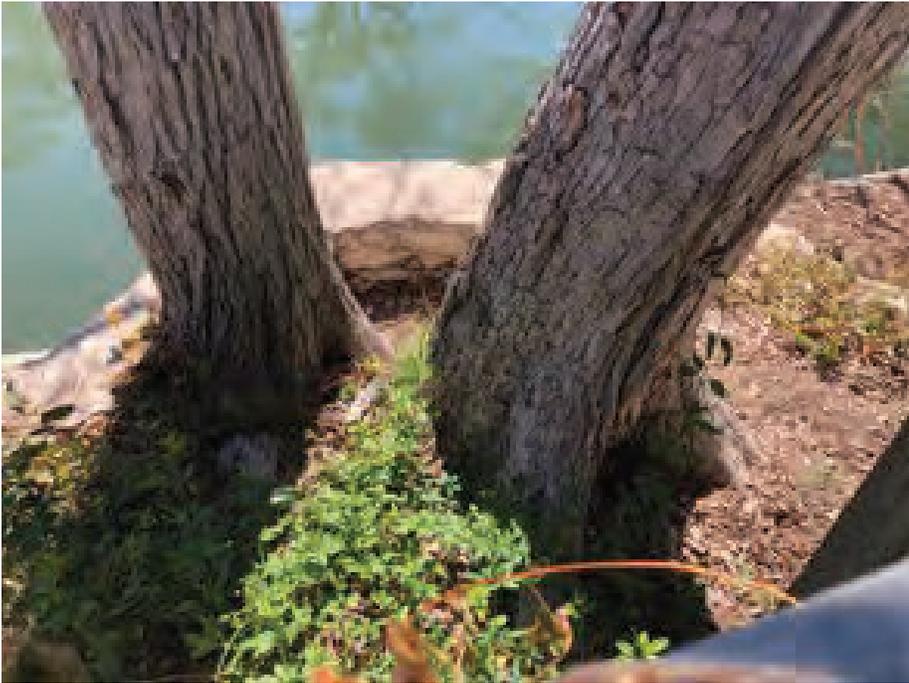
Figure 16: (L to R) Tree Nos. 138, 16-inch Cedar Elm, and 137, a 17-inch Cedar Elm, proposed to be removed. Proximity to Cultural Resource: 1-3 inches.

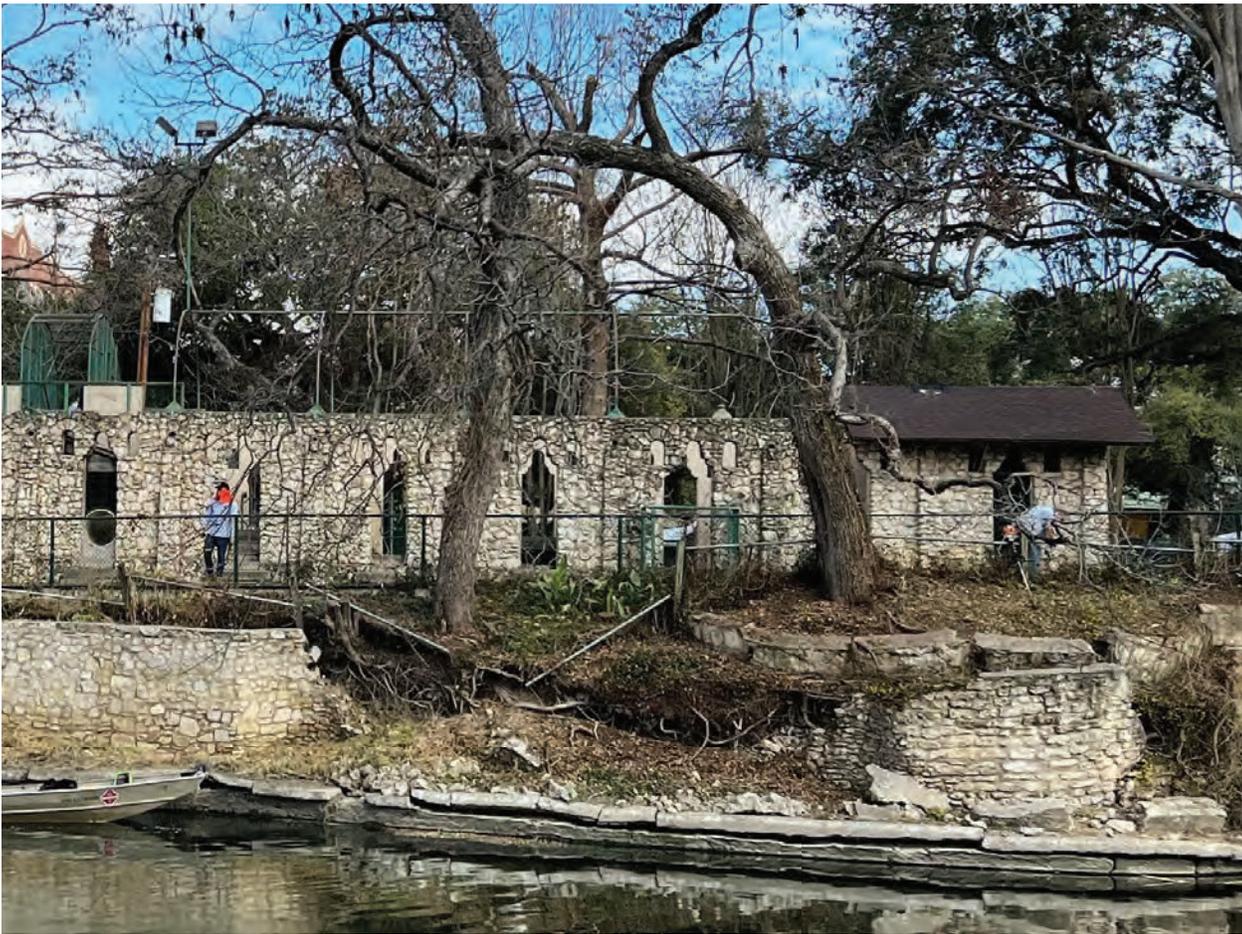
Figure 17: (L to R) Tree Nos. 139, a 26-inch Pecan, and 140, a 24-inch Pecan, proposed to be removed. Proximity to original position of cultural resource (partially demolished): less than 2 feet.

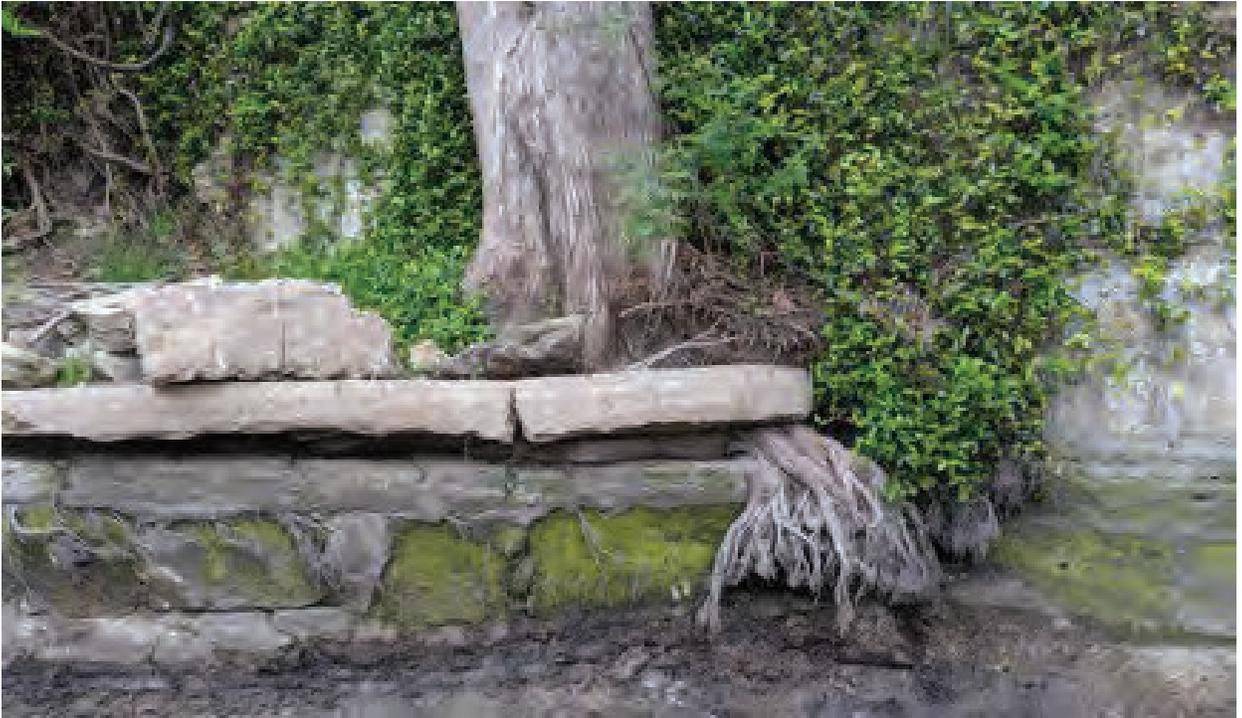
Figure 18: Tree No. 141, 27-inch Bald Cypress proposed to be removed. Proximity to Cultural Resource: 0 inches.

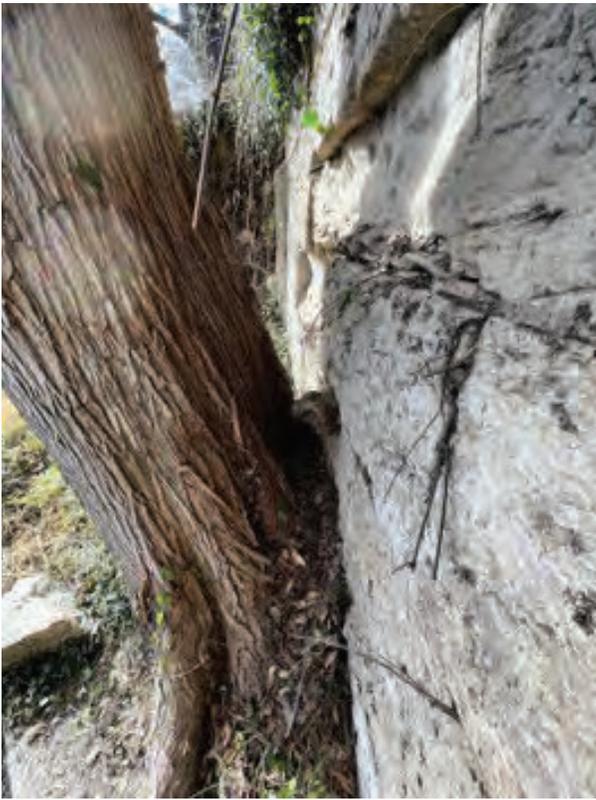
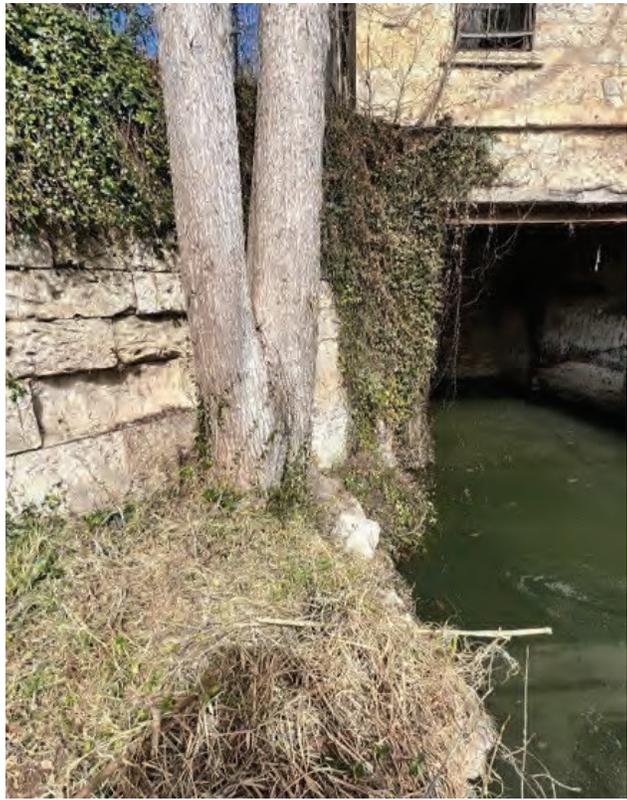
Figure 19 and 20: Tree No. 141, 27-inch Bald Cypress proposed to be removed. Proximity to Cultural Resource: 0 inches.

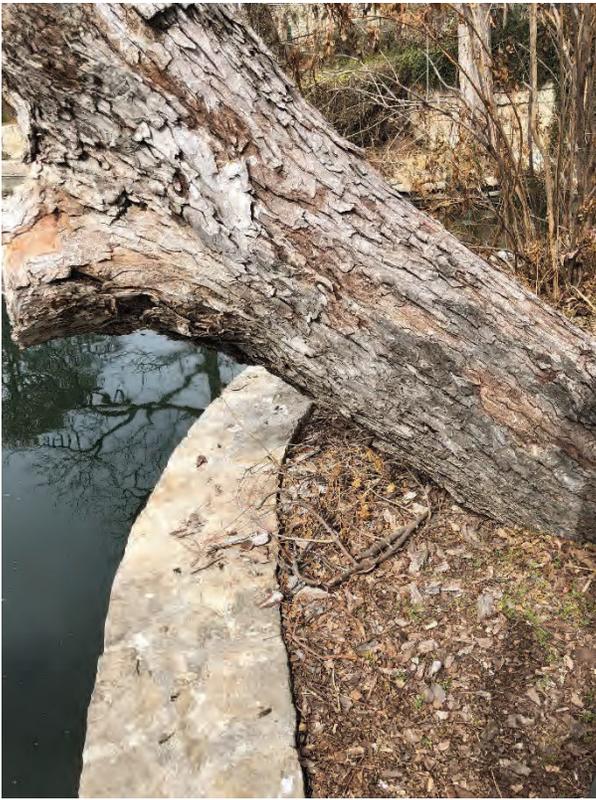
Figure 21: Tree No. 142, 20-inch Pecan proposed to be removed. Proximity to Cultural Resources: 6 inches to 5 feet

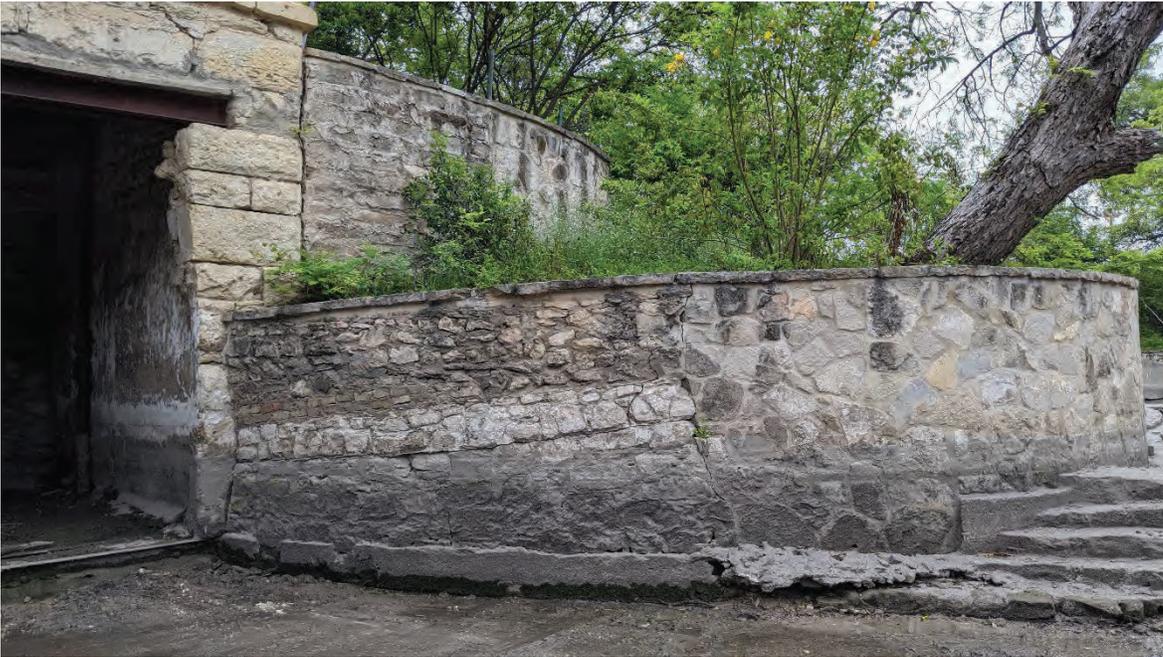
Figure 22: Tree No. 142, 20-inch Pecan proposed to be removed. Proximity to Cultural Resources: 6 inches to 5 feet

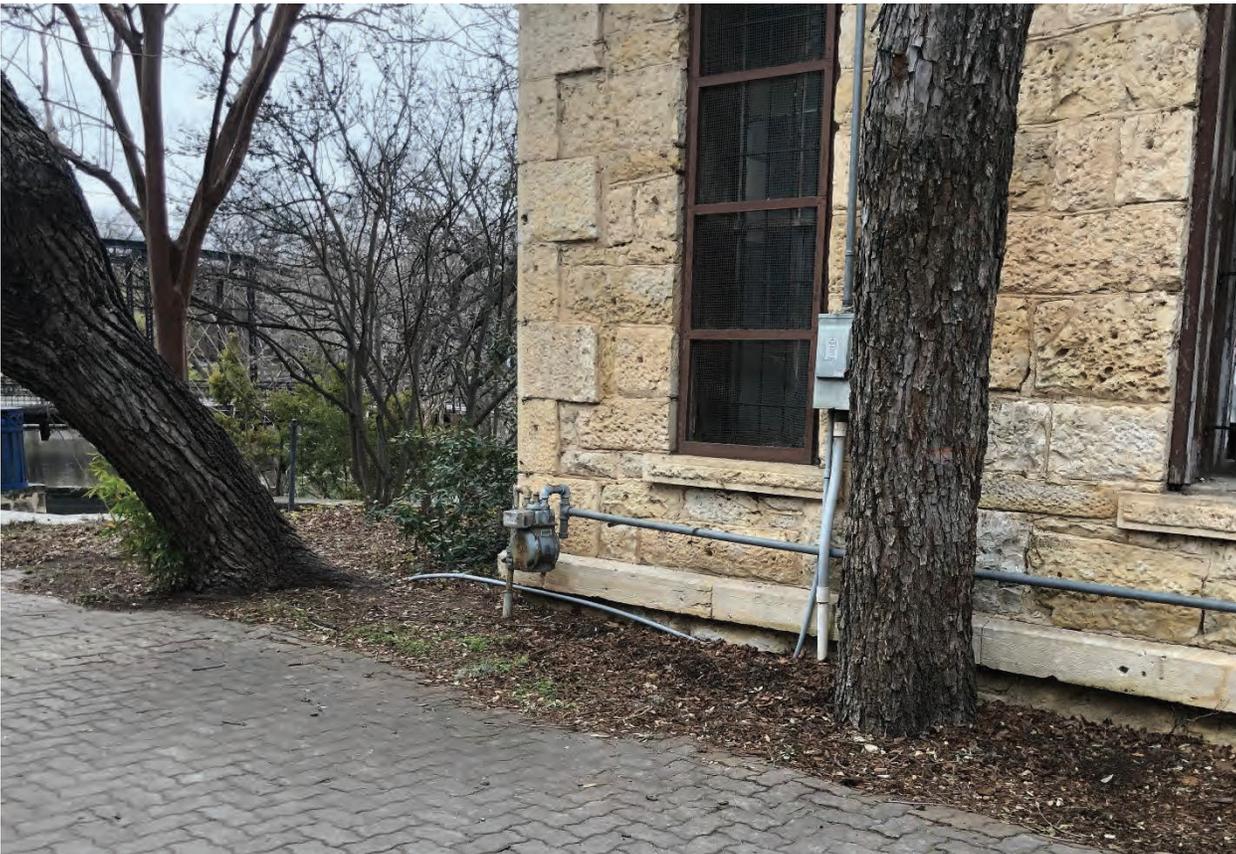
Figure 23: (L to R) Tree Nos. 108, 22-inch Black Walnut, and 107, 18-inch Black Walnut, both proposed to be removed. Proximity to Cultural Resource: 3 to less than 24 inches.

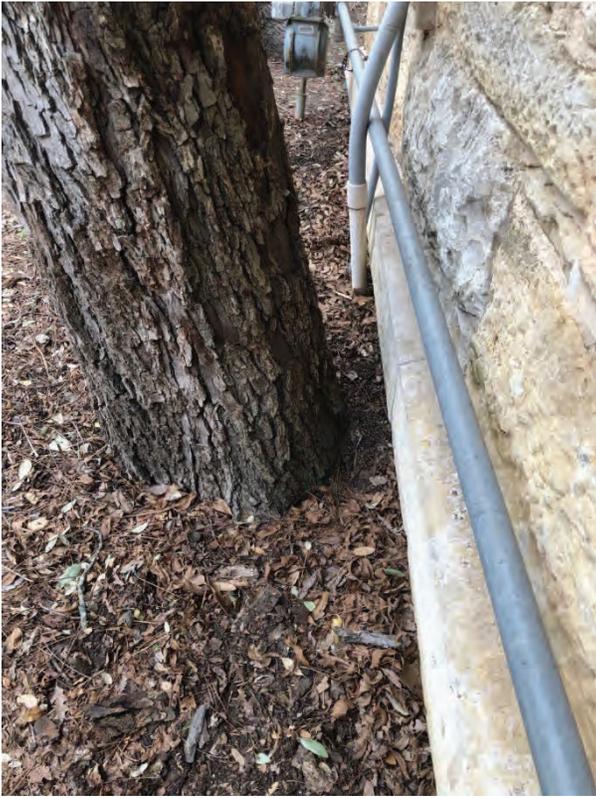
Figure 24: Tree No. 107, 18-inch Black Walnut proposed to be removed. Proximity to Cultural Resource: 3 inches.

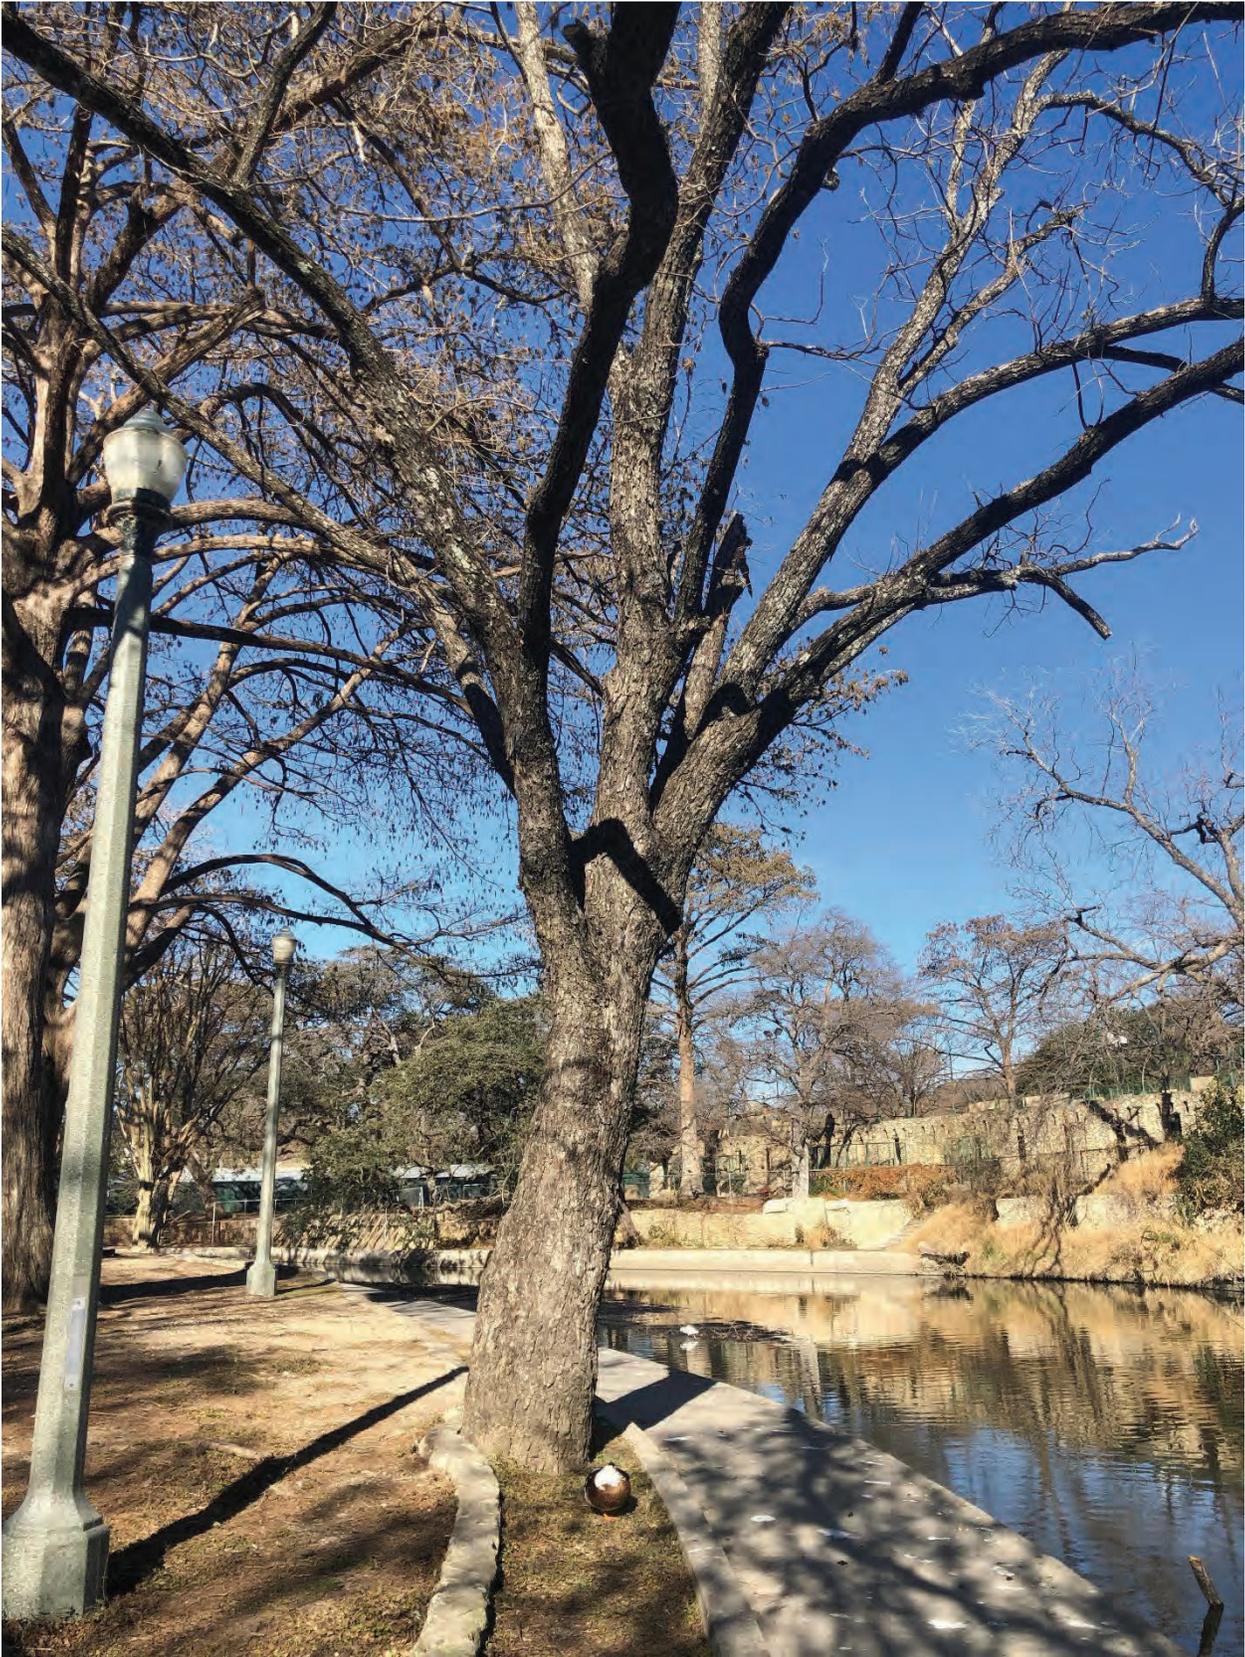
*Figure 25: Tree No. 122, 22-inch Pecan proposed to be removed. Proximity to Cultural Resources, 0 inches to 8 inches.*

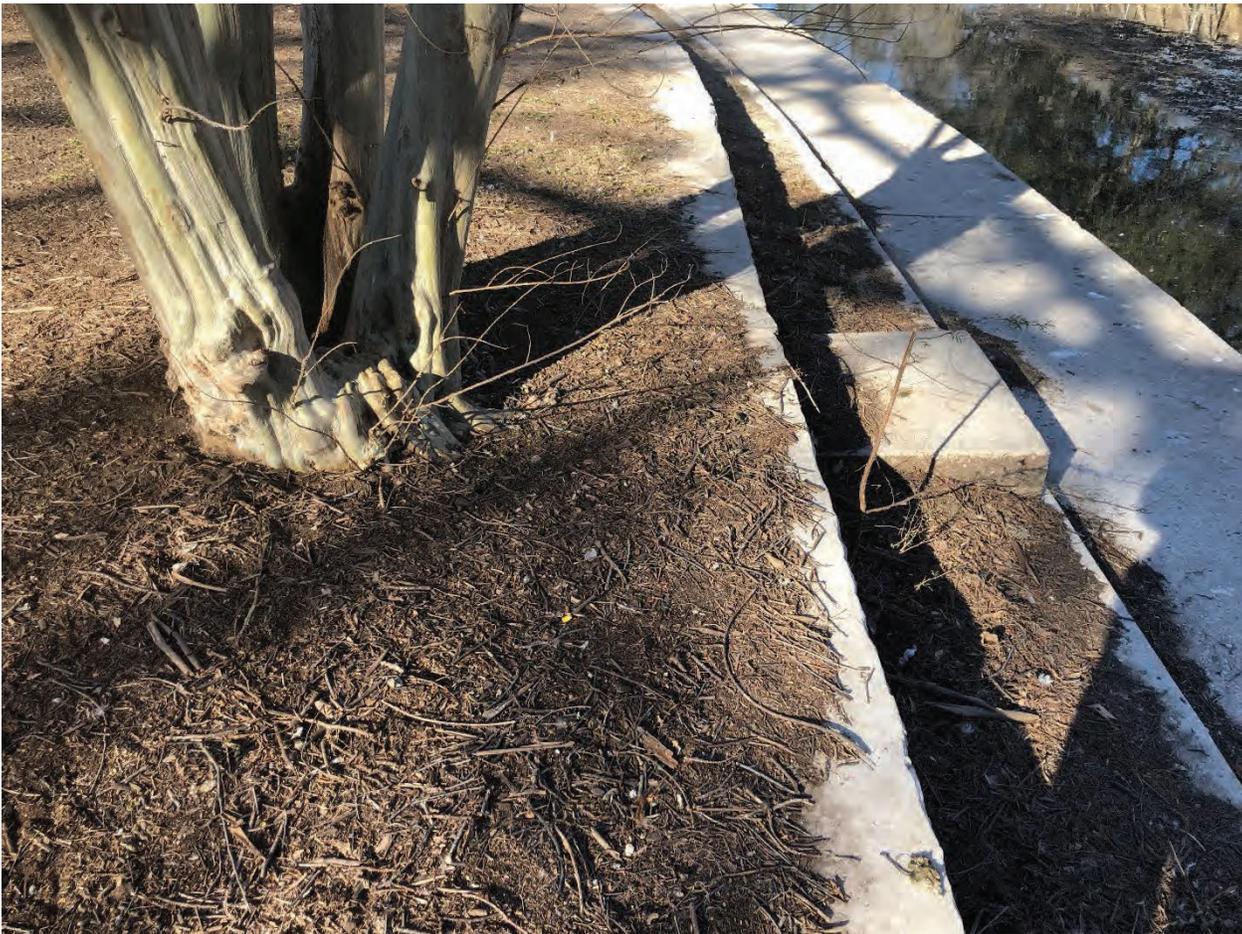
*Figure 26: Tree No. 125, 27-inch Crepe Myrtle proposed to be removed. Proximity to Cultural Resource: Less than 1 foot.*
