# Executive Committee

# TEXAS HISTORICAL COMMISSION

## AGENDA EXECUTIVE COMMITTEE

**3. Brackenridge Park, Lambert Beach area, San Antonio, Bexar County**

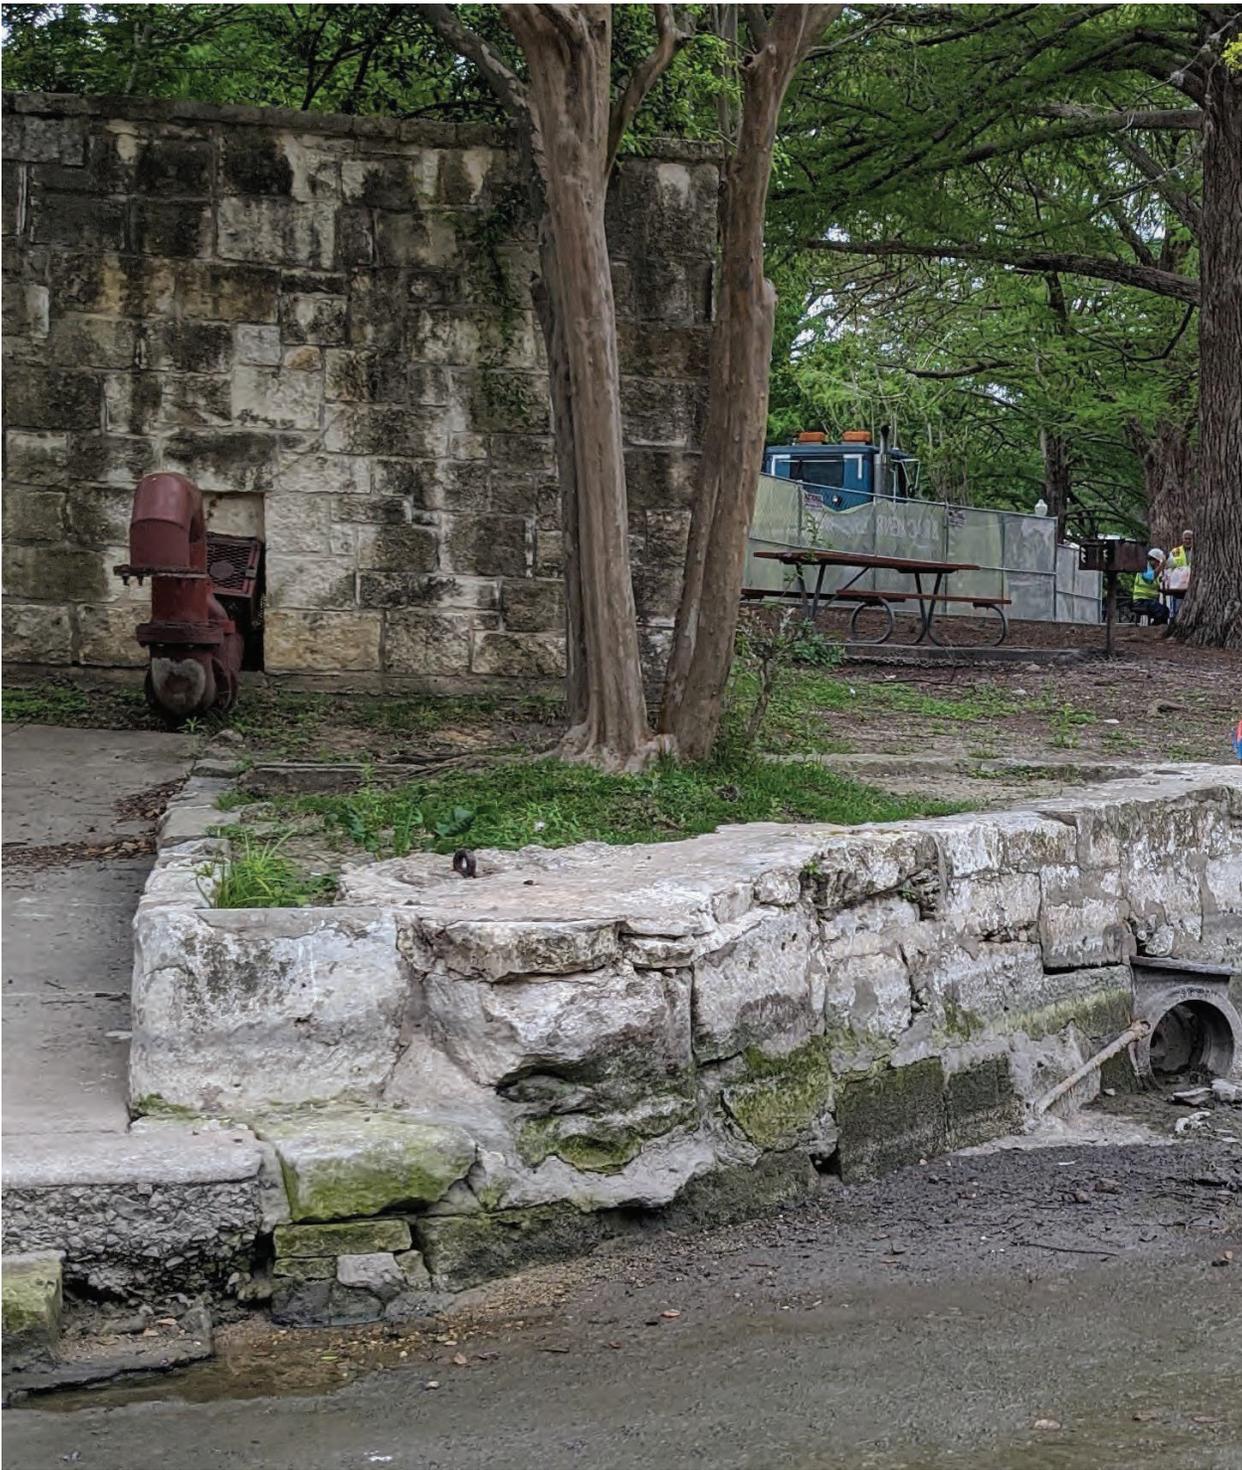
Figure 27: Tree No. 215, 19-inch Crepe Myrtle proposed to be removed. Proximity to Cultural Resources: Less than 3 feet.

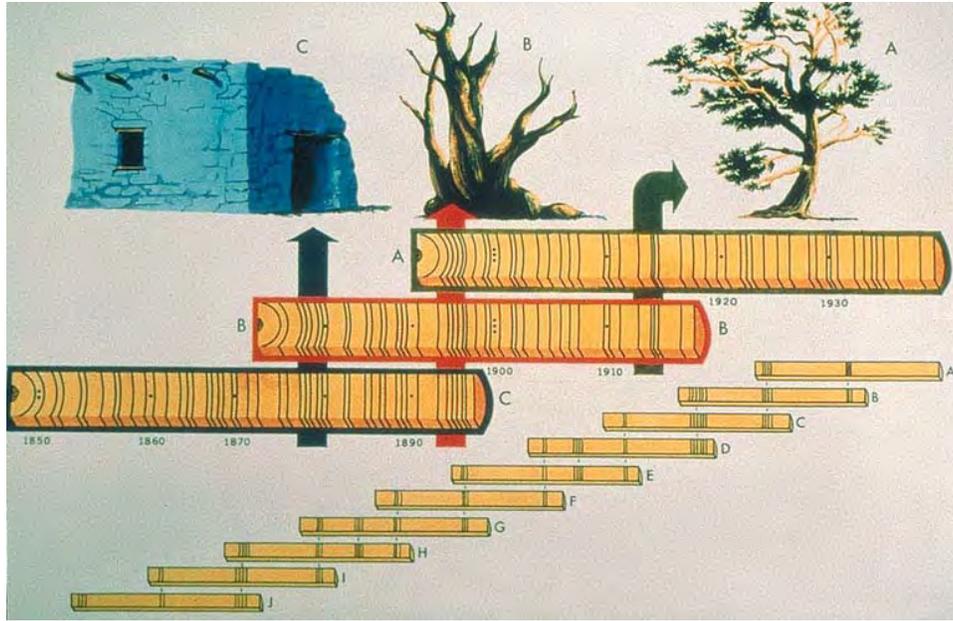
Figure 1. Patterns of tree ring-width variability are used to provide annual dates to historic structures by comparing them with living and dead trees. Courtesy of NOAA Paleoclimatology Program.

Trees put on annual growth rings and the variation in ring width each year, caused by the tree's response to environmental factors, such as precipitation and temperature, creates unique patterns of wide and narrow rings throughout a tree's lifespan. Trees that were alive during the same period and were exposed to the same environmental conditions have similar patterns in growth that can be matched through time. This process of pattern matching is used to crossdate living trees, dead trees, and archaeological timbers and is part of the science of tree-rings known as dendrochronology (Figure 1; Speer, 2010).

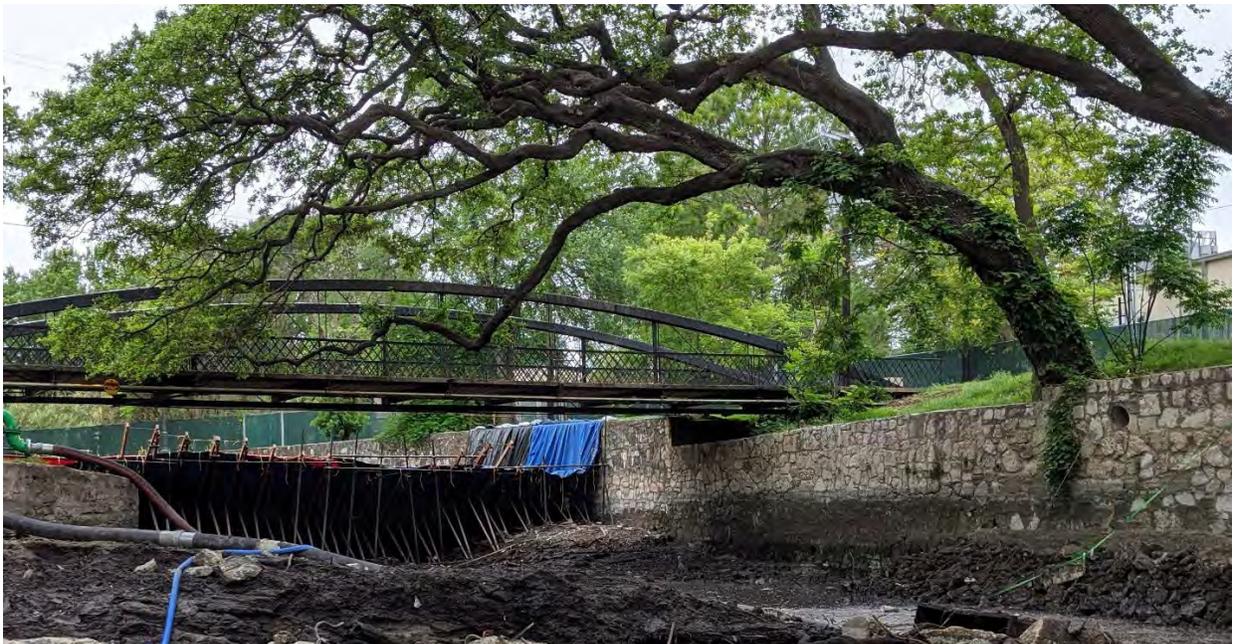
Figure 2. Photo of tree #95, a live oak (*Quercus virginiana/fusiformis*) successfully sampled at Brackenridge Park. Photo courtesy of City of San Antonio Parks and Recreation.

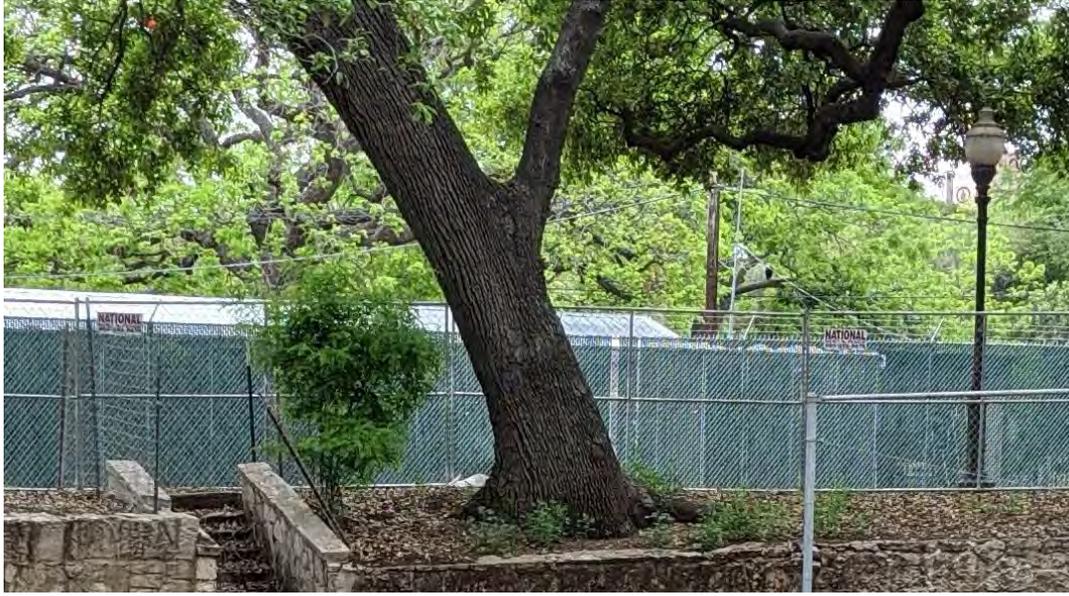
Figure 3. Photo of tree #100, a live oak (*Quercus virginiana/fusiformis*) successfully sampled at Brackenridge Park. Photo courtesy of City of San Antonio Parks and Recreation.

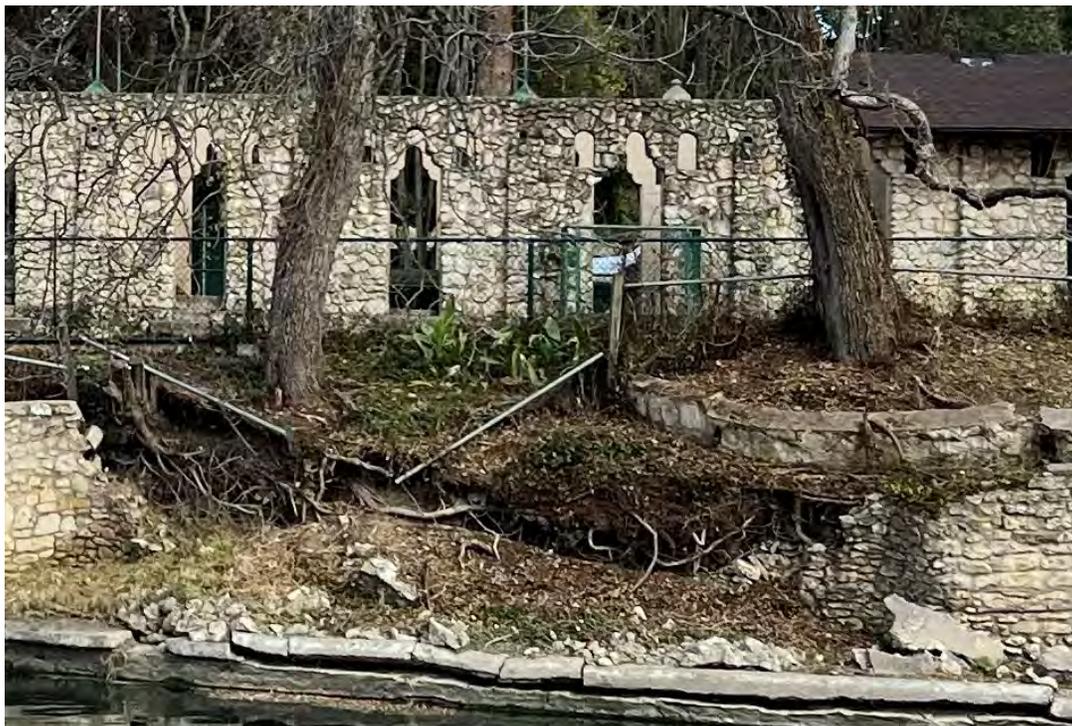
Figure 4. Photo of pecan (*Carya illinoensis*) trees #139 (left) and #140 (right). Tree #139 was successfully sampled. Tree #140 was hollow and not sampled. Photo courtesy of City of San Antonio Parks and Recreation.

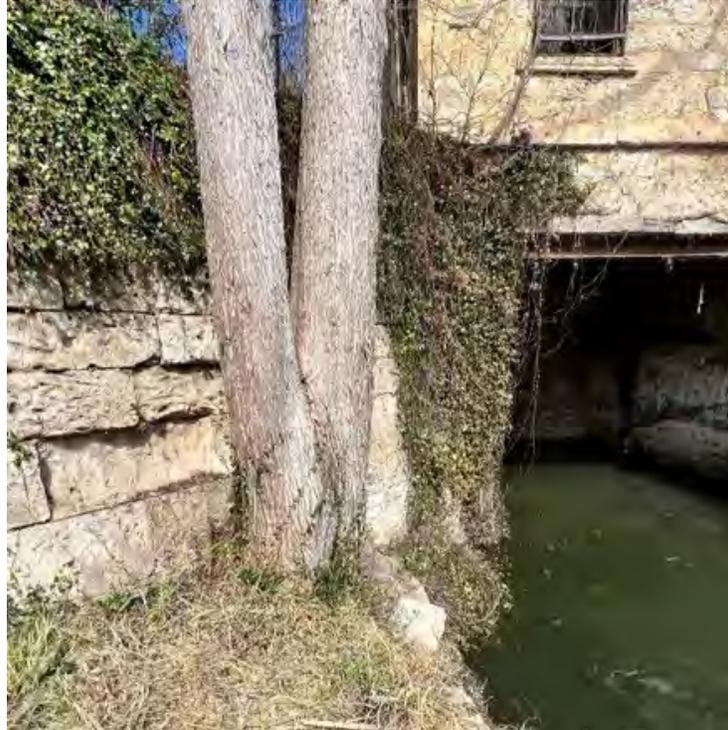
Figure 5. Photo of tree #141, a bald cypress (*Taxodium distichum*) successfully sampled at Brackenridge Park. Photo courtesy of City of San Antonio Parks and Recreation.

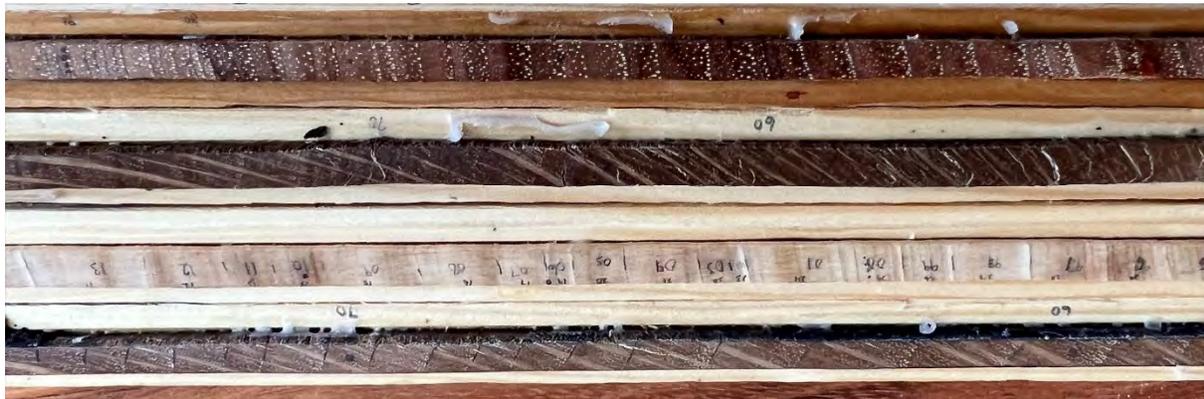
Figure 6. Photo of core four tree core samples. (Top to bottom: #139, #95, #141, #100)

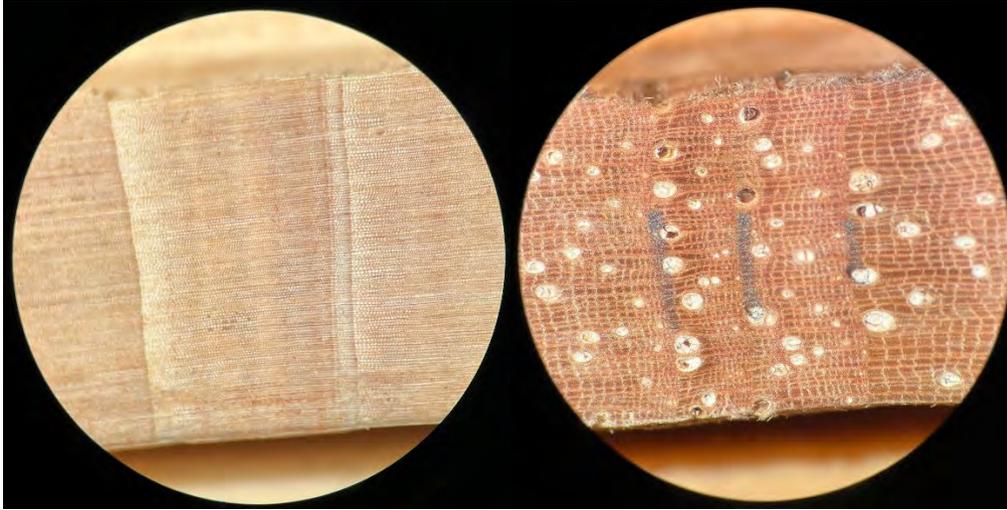
Figure 7. Photo of tree cores #141 (left) and #139 (right) under the microscope.

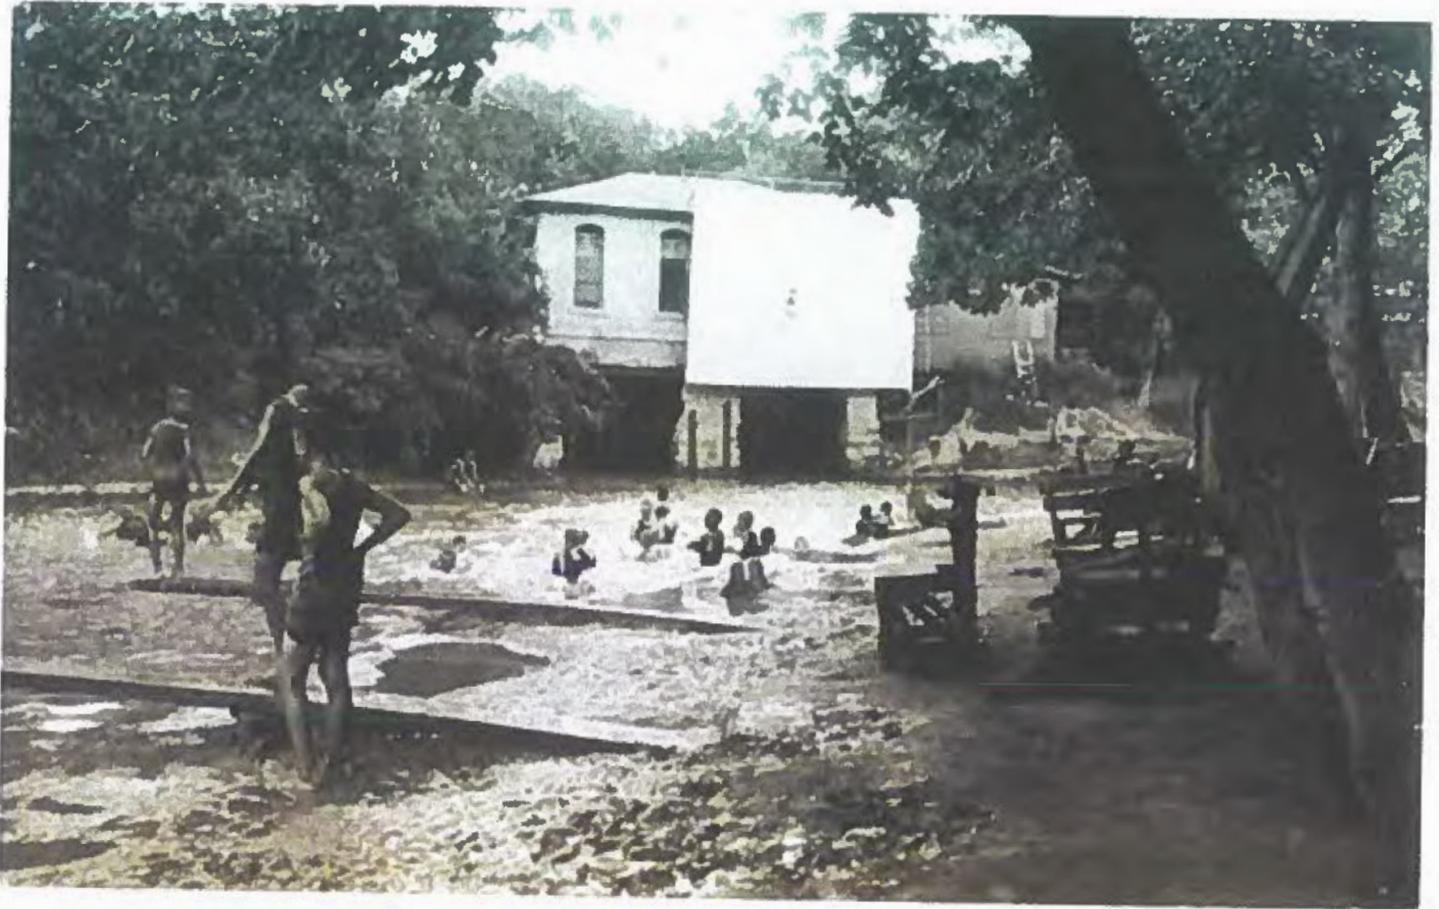
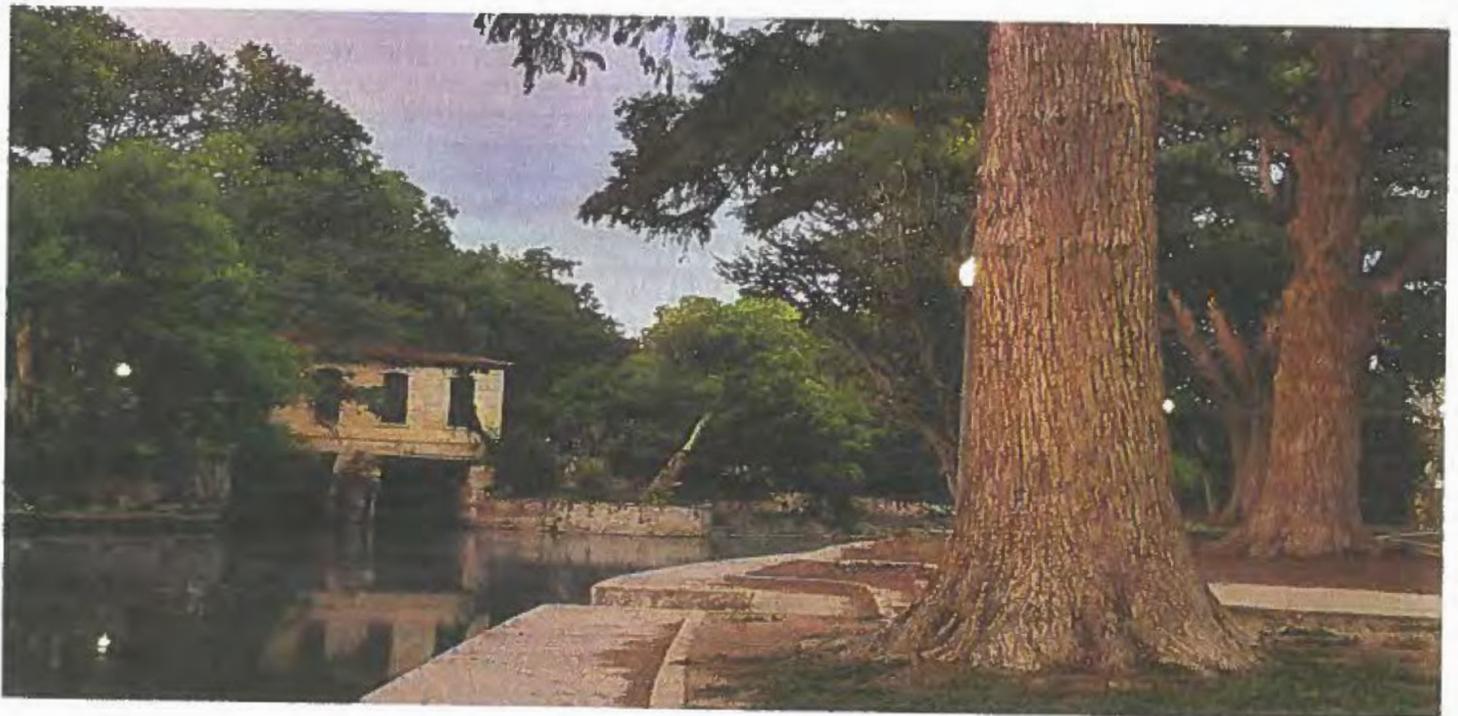
## Brackenridge Park Pumphouse

**Above Photo: National Register of Historic Places 1920s**

**Below Photo: Summer of 2022**

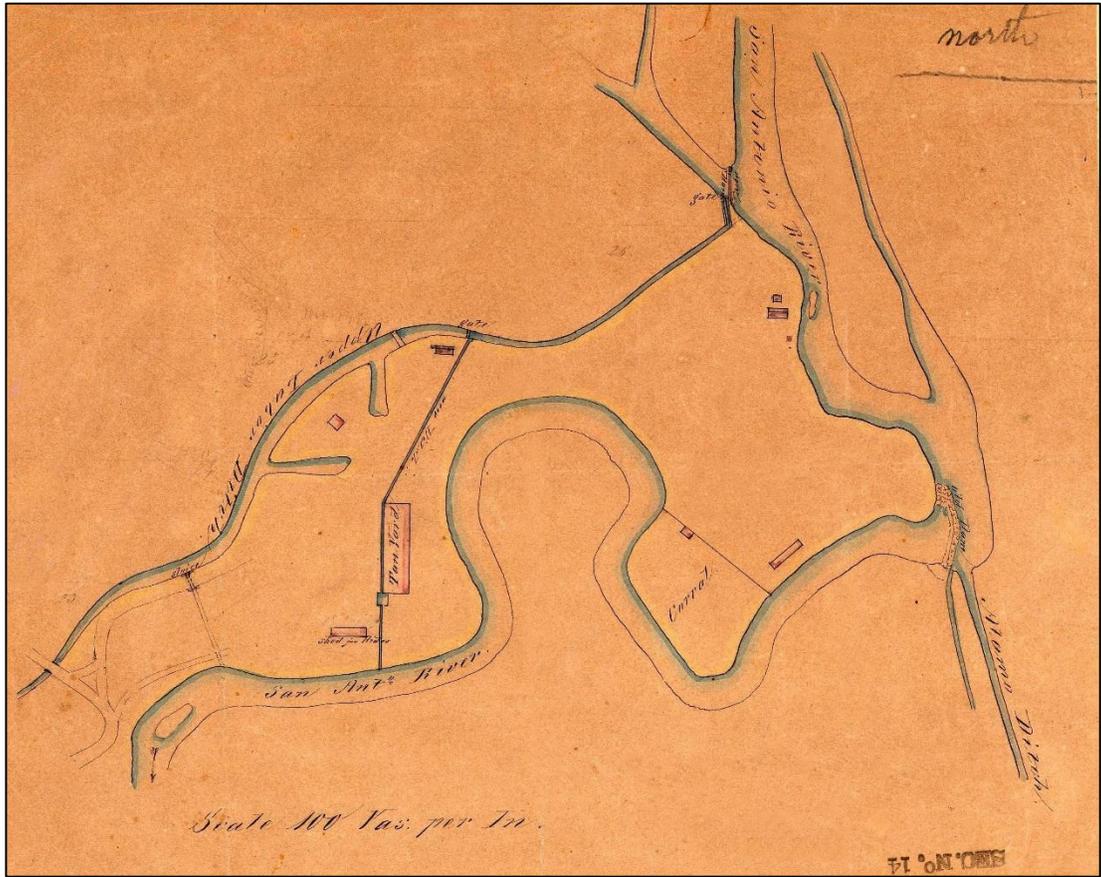
Figure 3 1865-1869 Friesleben map of Confederate Tannery

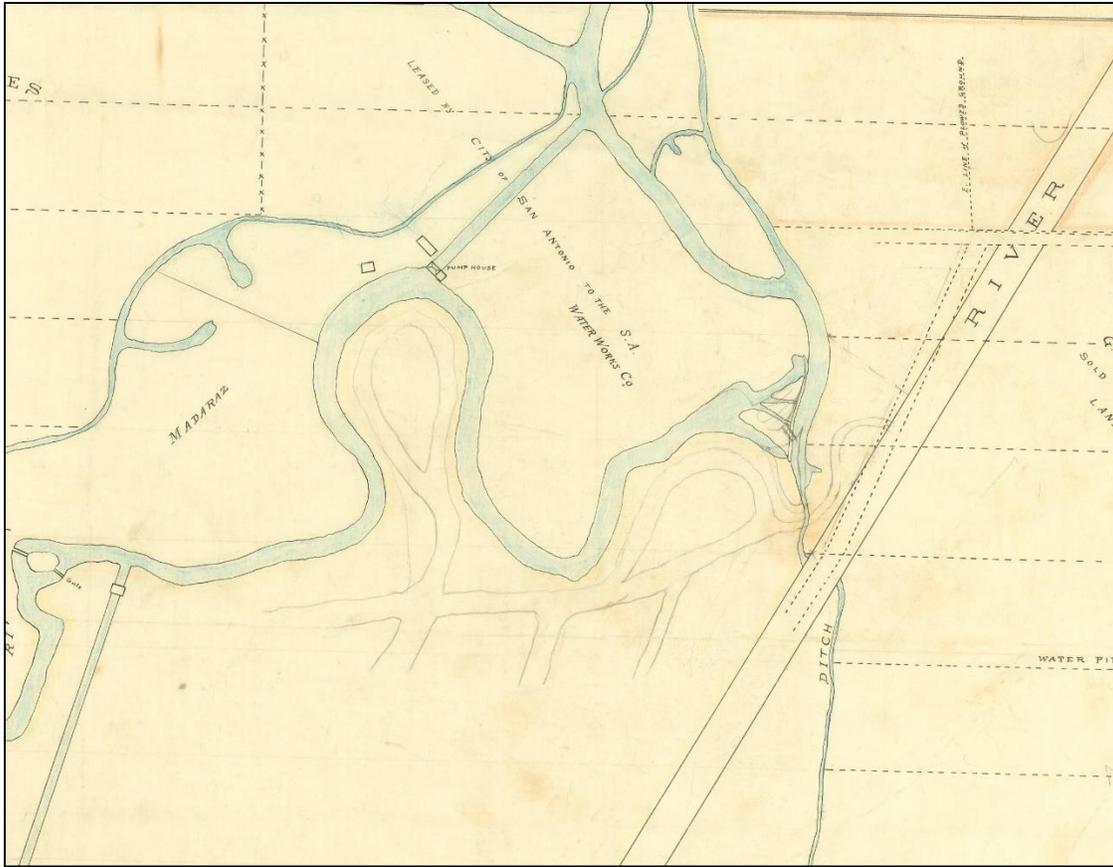
Figure 4 1890 Map showing project APE with Pump House

By 1908, the City had acquired the property (**Figure 5**), and within the next decade, would develop the area as Lambert Beach. A 1912 Sanborn map (**Figure 6**) shows an inset of the pump house, but the remainder of the project APE is not depicted. Subsequent Sanborn maps are unavailable online at the Library of Congress.

This map review indicates that historic-age archaeological deposits associated with the nineteenth century structures on the 1890 map could be present within the project area. In addition, deposits associated with the development of Lambert Beach may be present. As a result, there is a high probability for historic archaeological deposits to be present within the project APE.

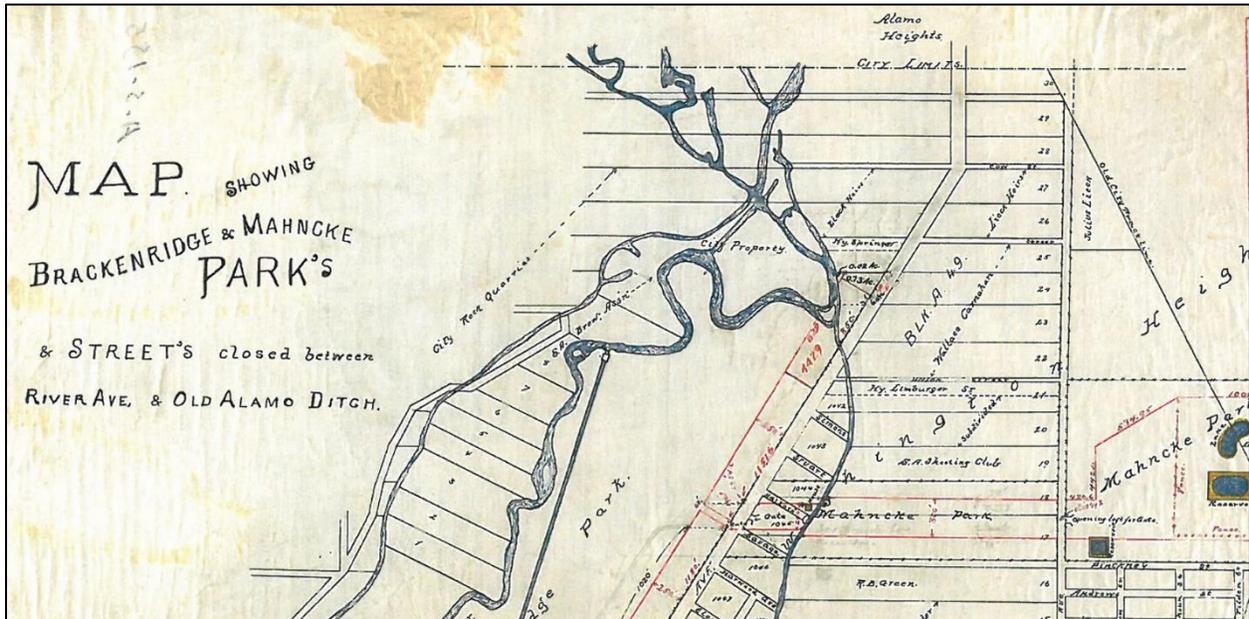
Figure 5 Portion of a 1908 City Map showing the project APE

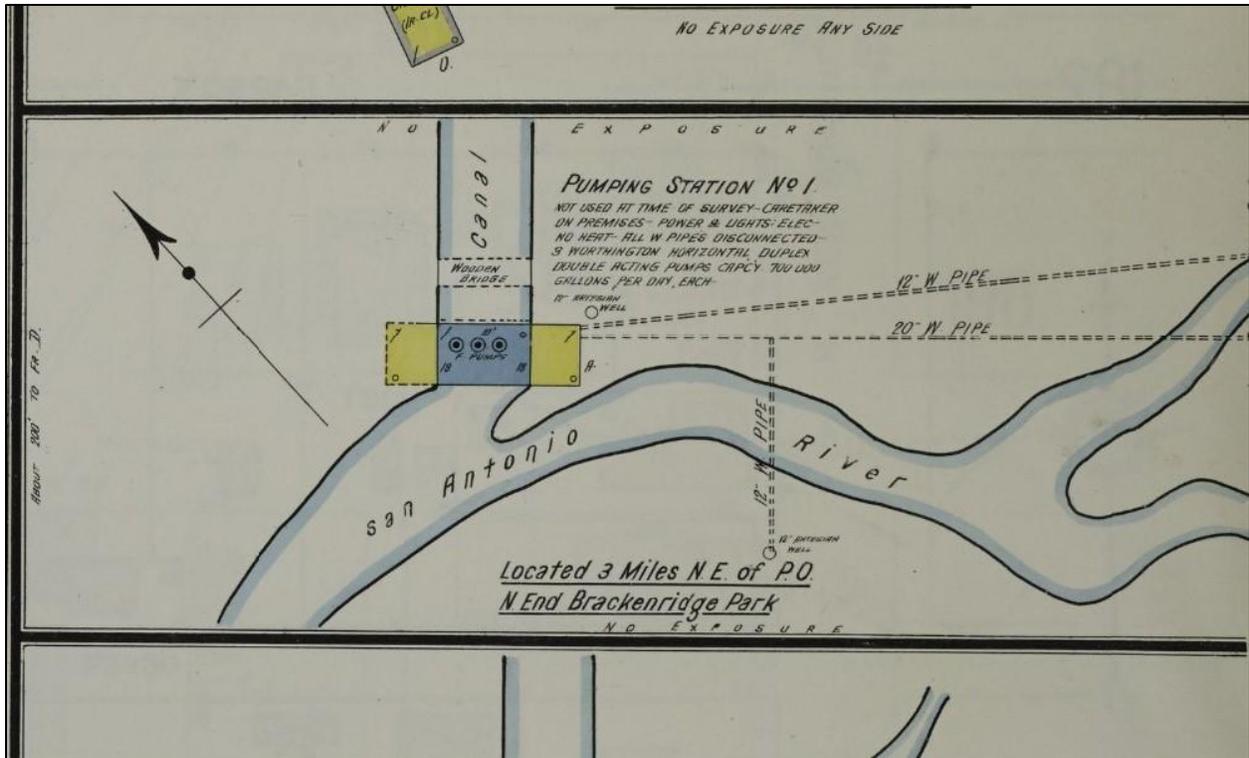
Figure 6 1912 Sanborn map showing the pump house within the project APE
