ALAN REED

Historic Resources Inventory Form—Route 66

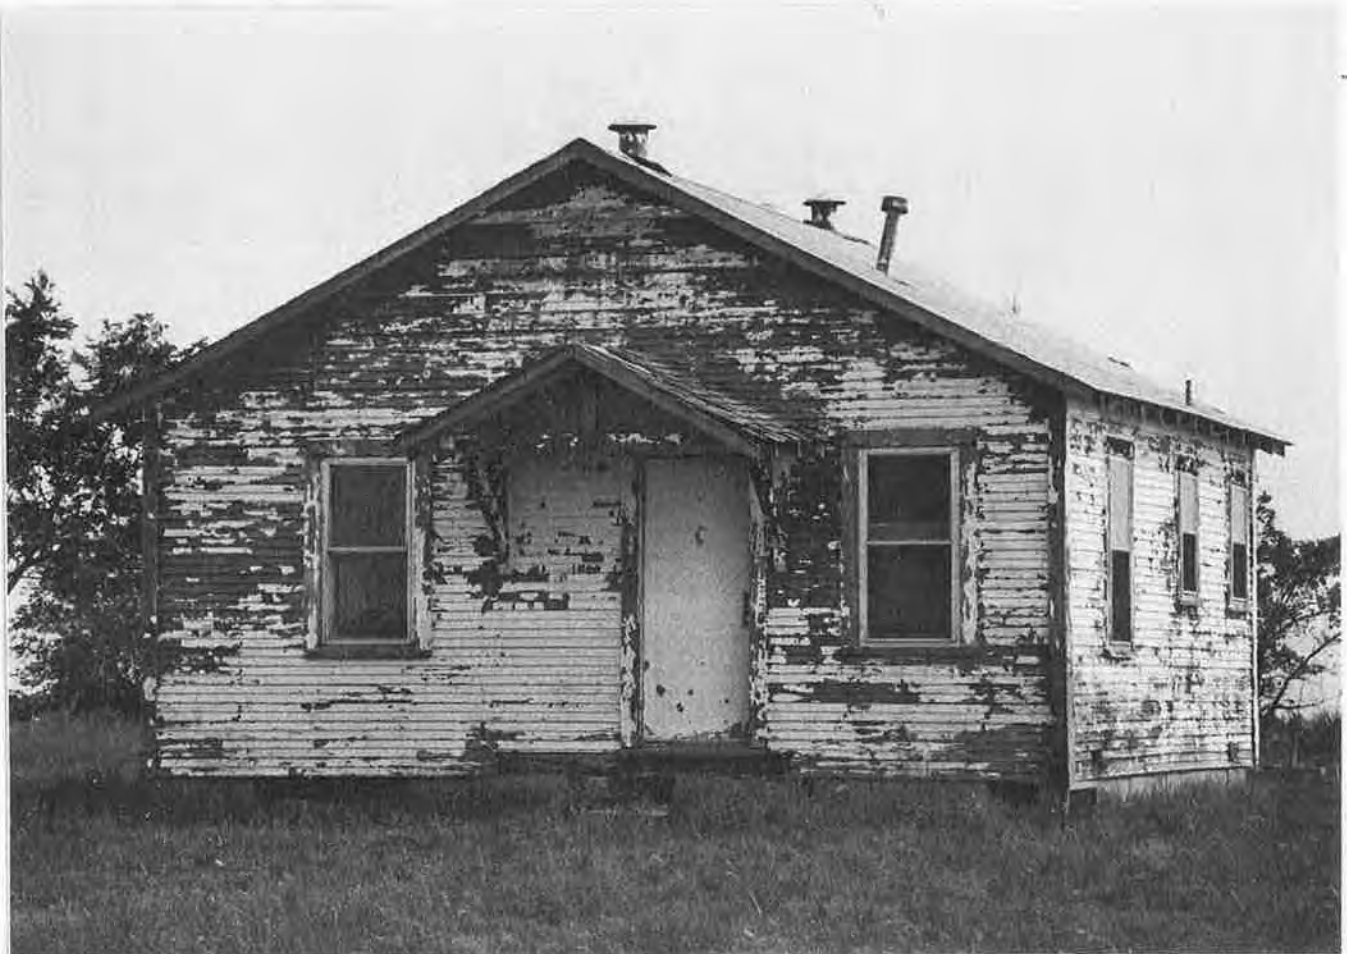
179-AL-1
PHOTO 9.3480-5
FACING SW

may have been moved to this location

Wall façade drop siding (horiz); wood Foundation rais'd on block footing

General Architectural Description simple vernacular wood-frame bldg. Looks to have been a school house. Likely moved to this location as evidenced by foundation (it looks like conc block) though possibly a house.

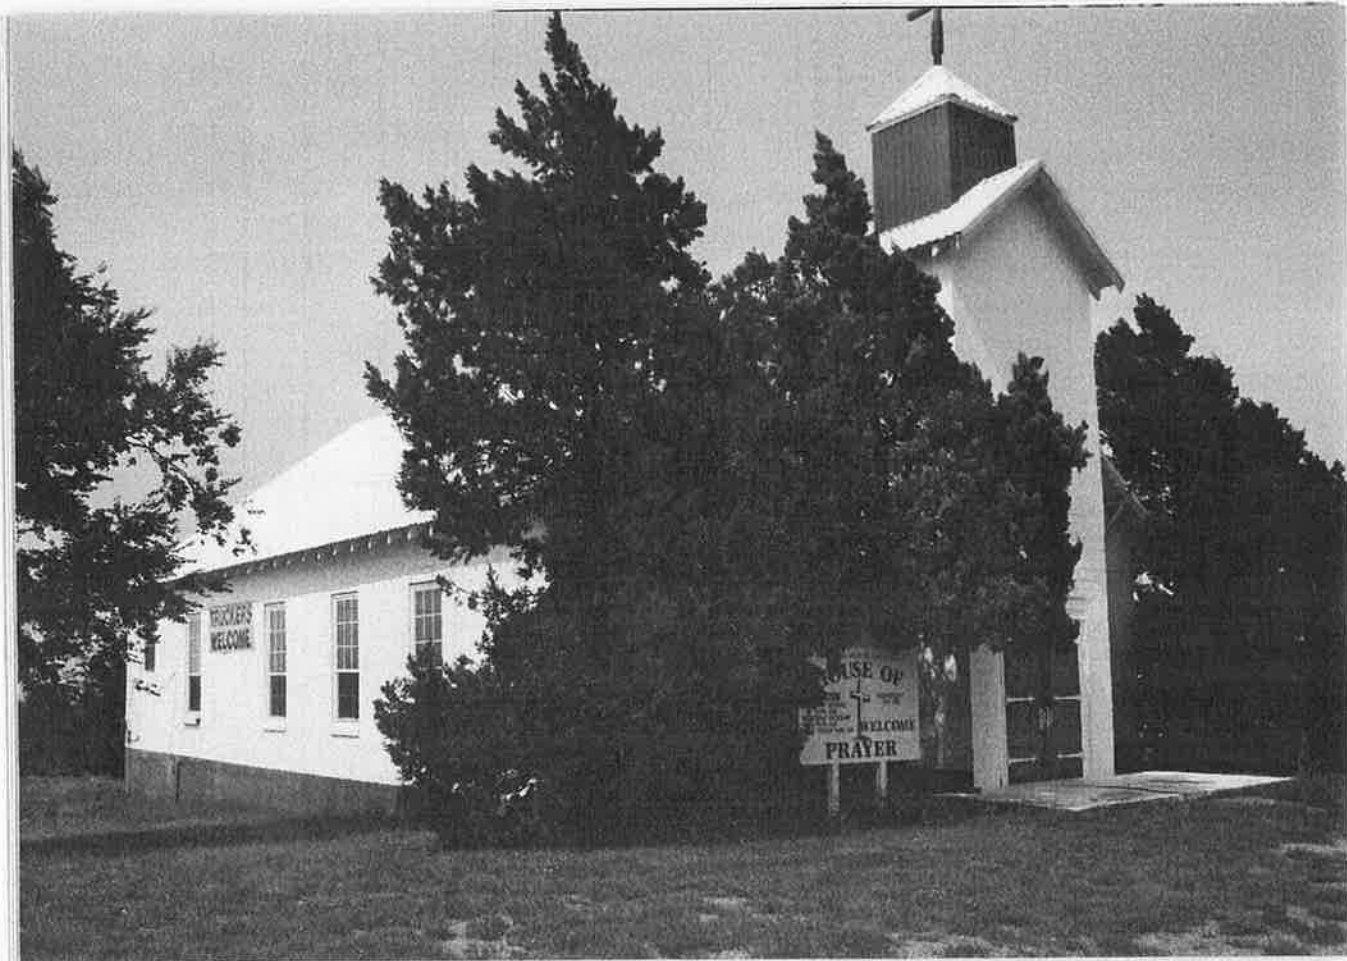
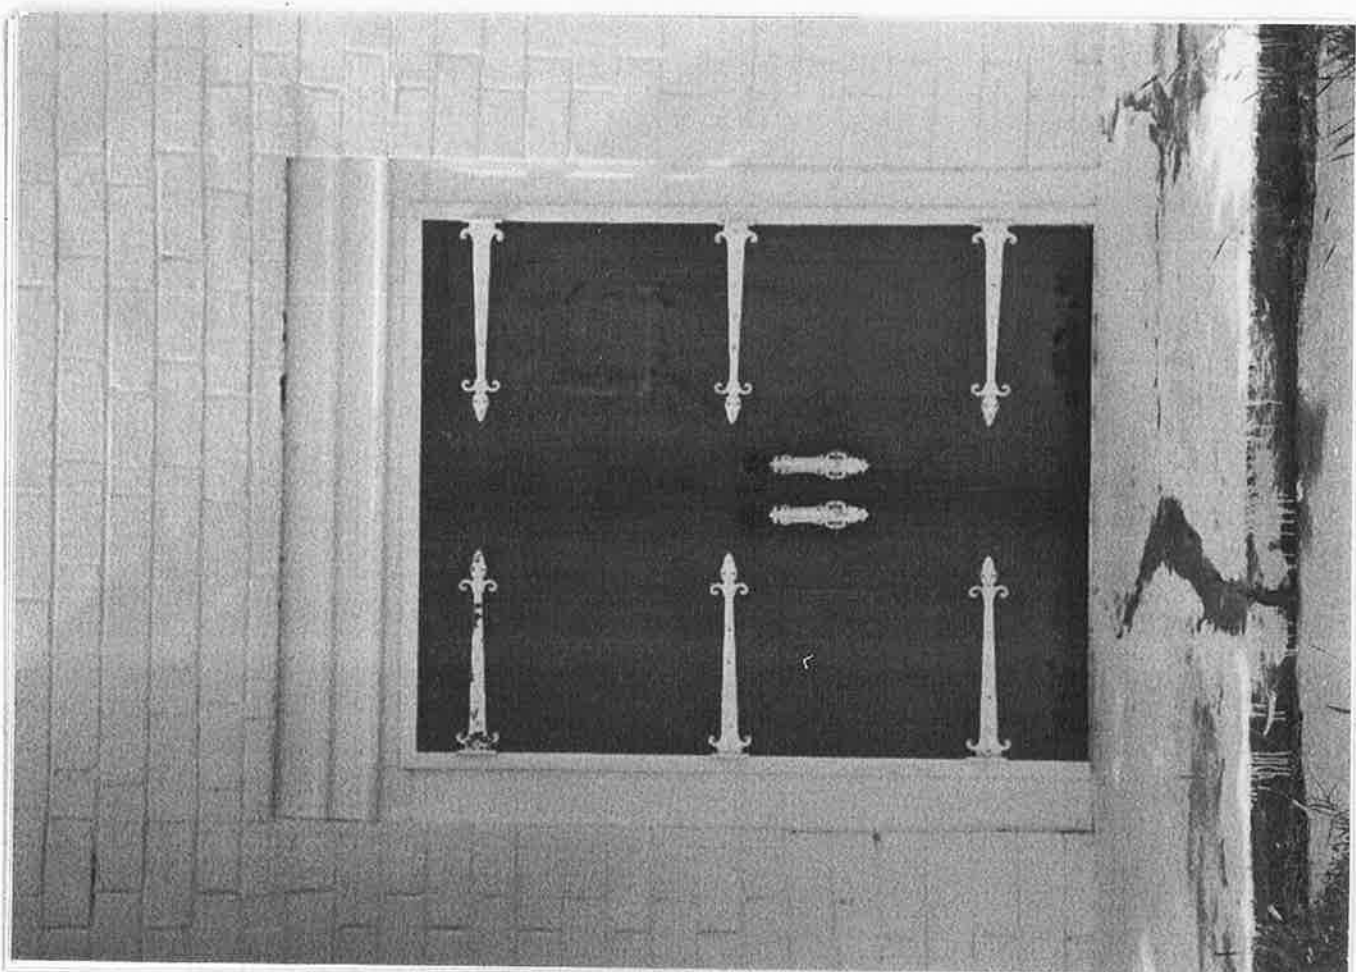
General Architectural Description church form (but could be an adapted bldg). Show
roof addition @ NE end. Mandor on E side. Roof & Bell tower could be added
on if this bldg was previously something else.

Photo Data: Roll 9 Frame 4, 3, 2 Feature looking N
4 = front 3 = door detail 2 = look NE

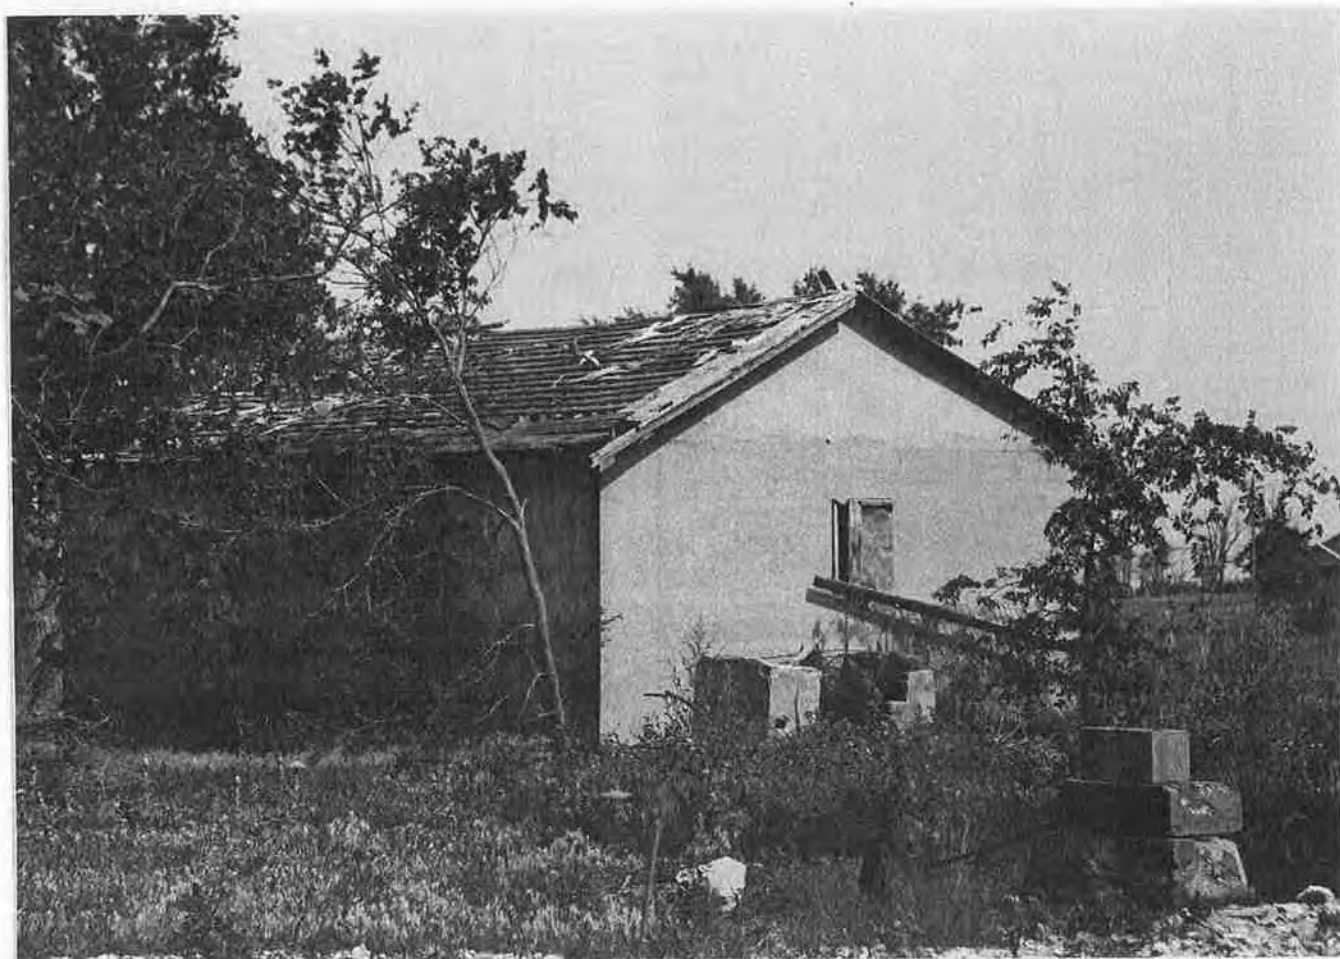
179-AL-3
 PHOTO 9-3480-1
 FACING SE

Stylistic Influence(s) _____
 Roof type side gable w/ exposed rafters Materials wood framing (shingles gne)
 Wall façade stucco Foundation _____
 Window type boarded Materials _____
 Door type obscured Materials _____
 Porch type N/A Materials _____
 Number of Stories 1 Plan _____
 Chimney(s) _____

General Architectural Description Simple vernacular domestic bldg. Brick structure
on side that could have been out door case w/ a - prob not a
chimney

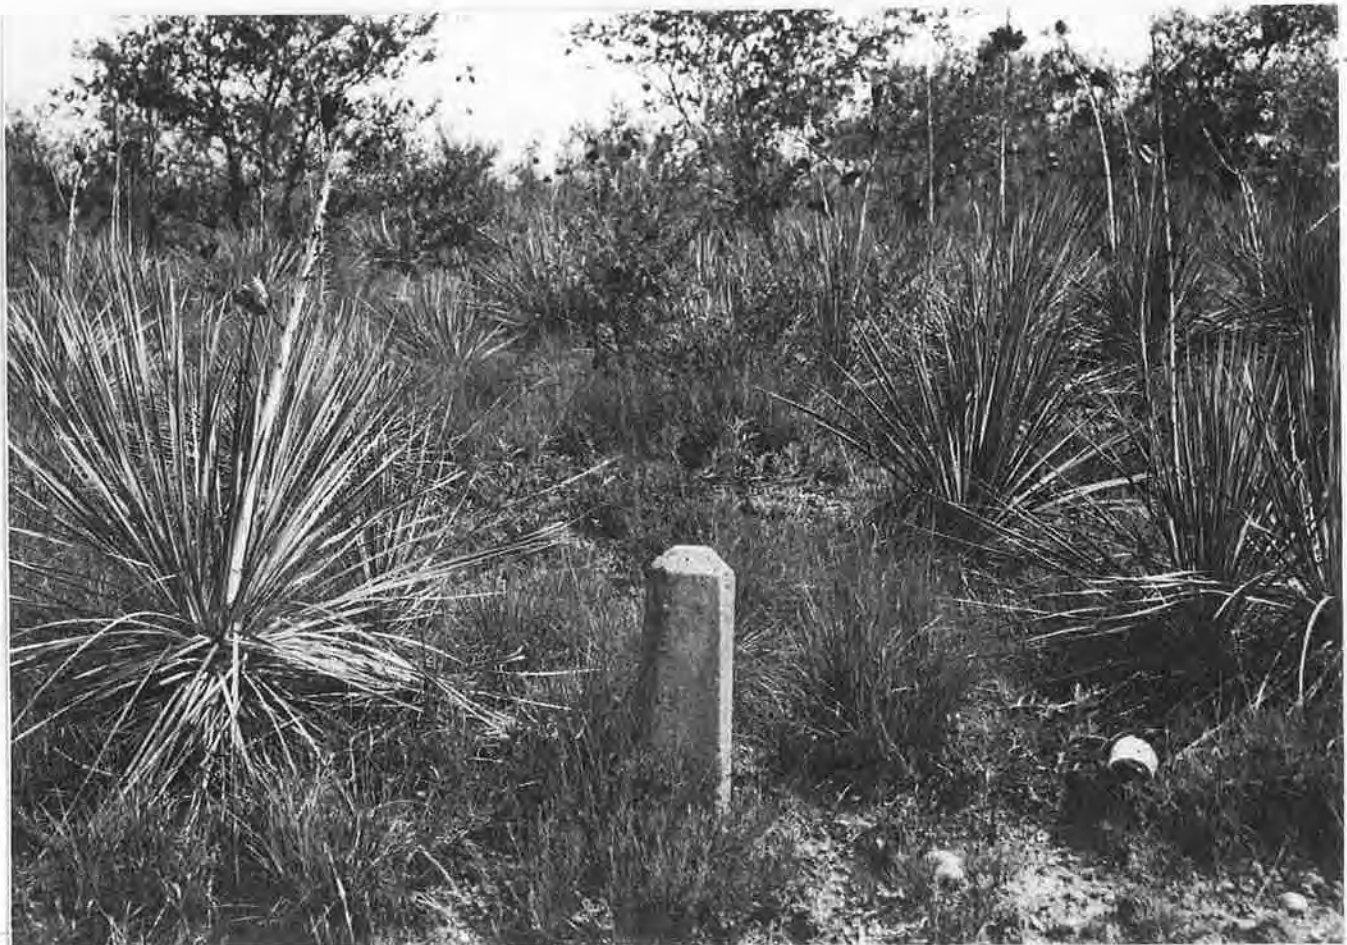
179-AL-4
PHOTO 10-2475-36
FACING SOUTH

General Architectural Description concrete obelisk 1 1/2' high on S. side of
road just past #37 across from church

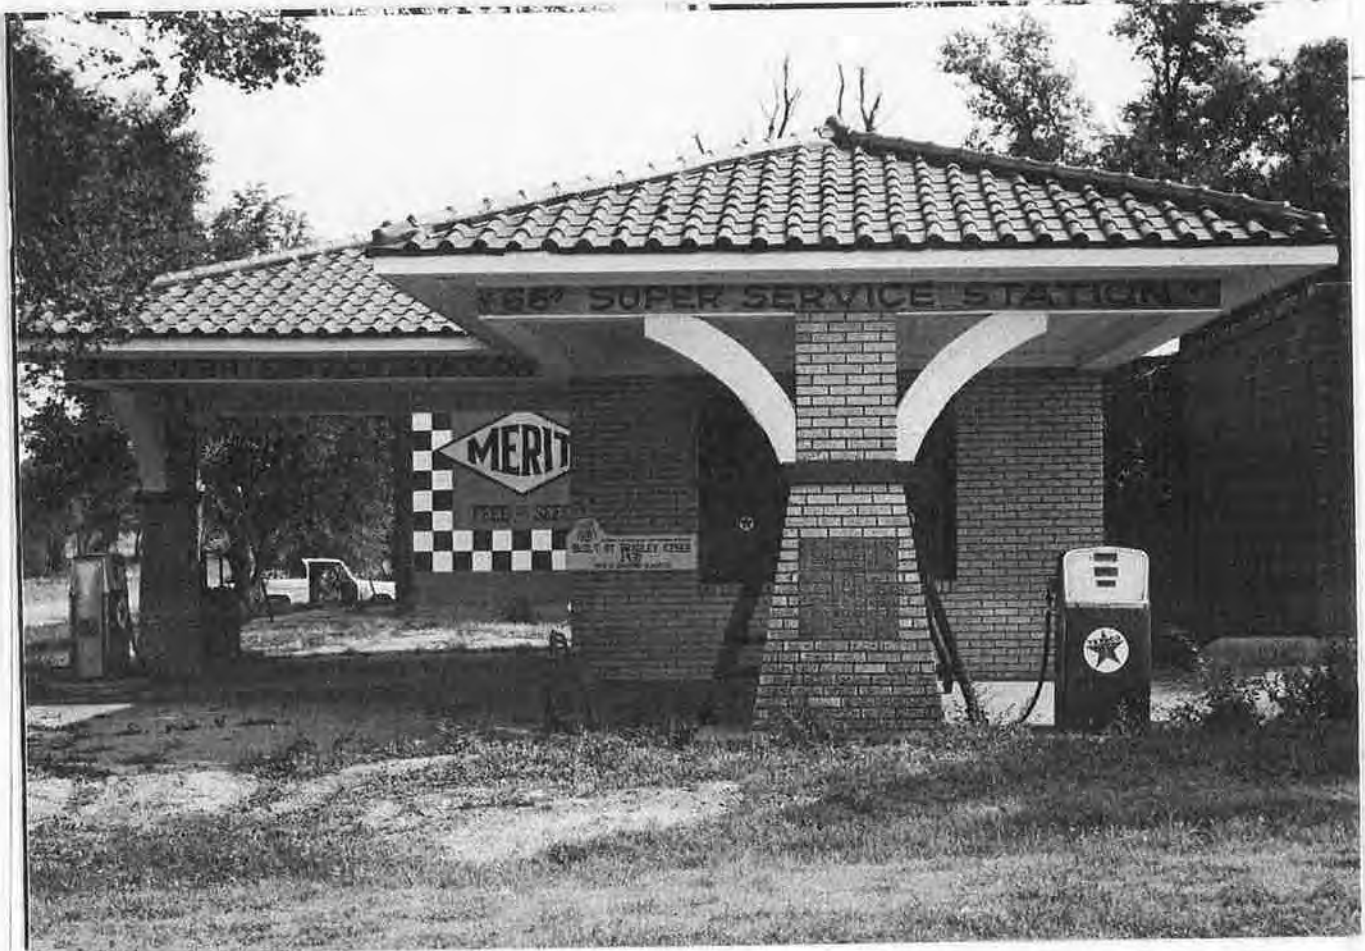
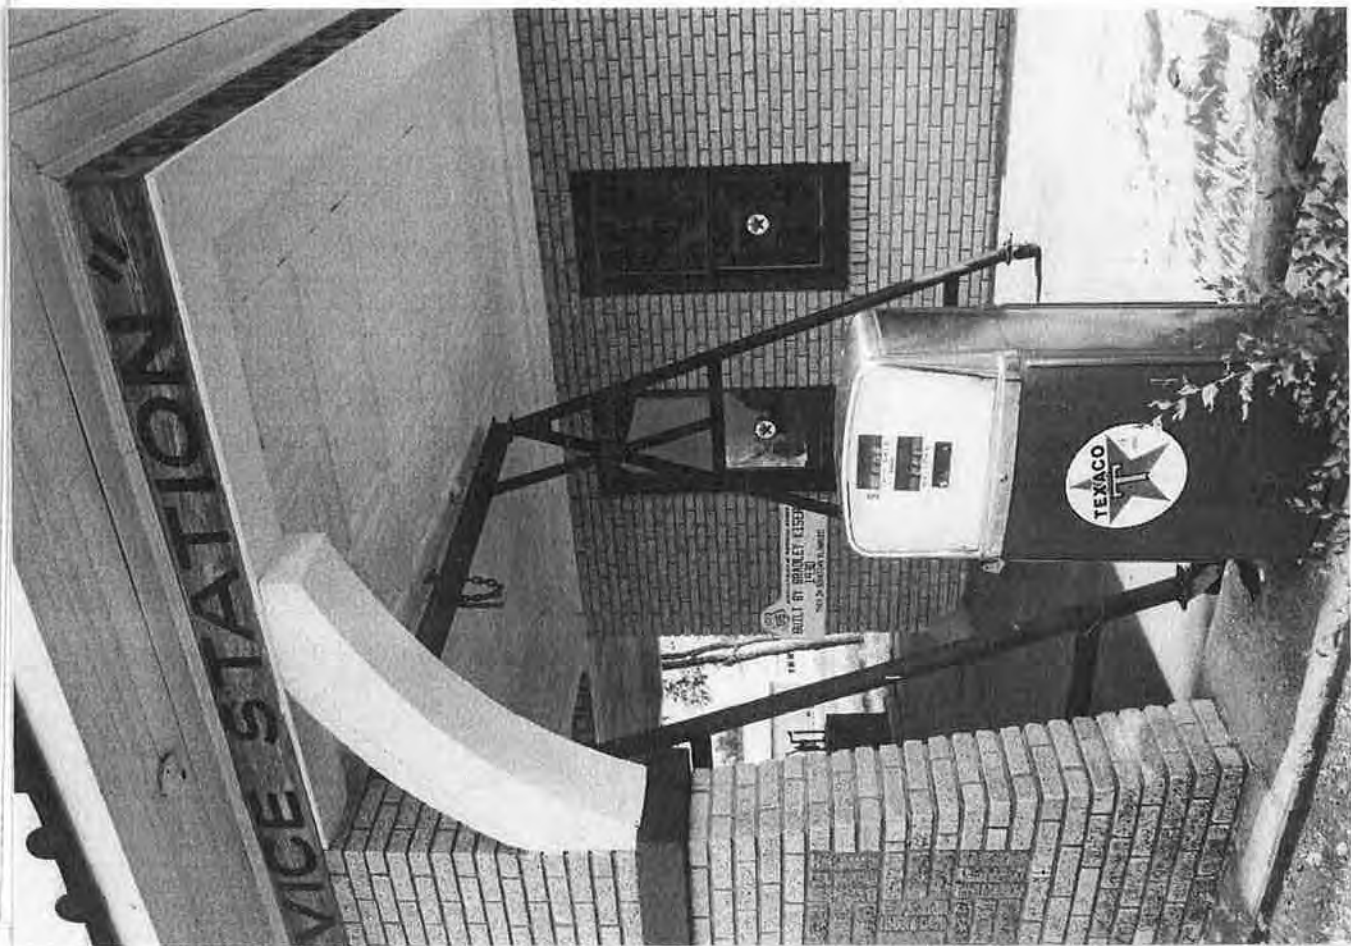
Roof type hipped Materials Spanish tile (now painted) → prob metal flashed into these steps, just like the station in Mex

General Architectural Description Unusual features include canopy. piers are brick piers, tapering from top to bottom & flanked on each side w/ curved wood brackets. At intersection of bracket & bottom of pier is square wooden collar (painted & hatch window & set casing & gas pumps). Underside of canopy is coved.

Photo Data: Roll 10 Frame 35 Feature 35 - look S; 34 - detail of canopy, 31 overall looking SW.

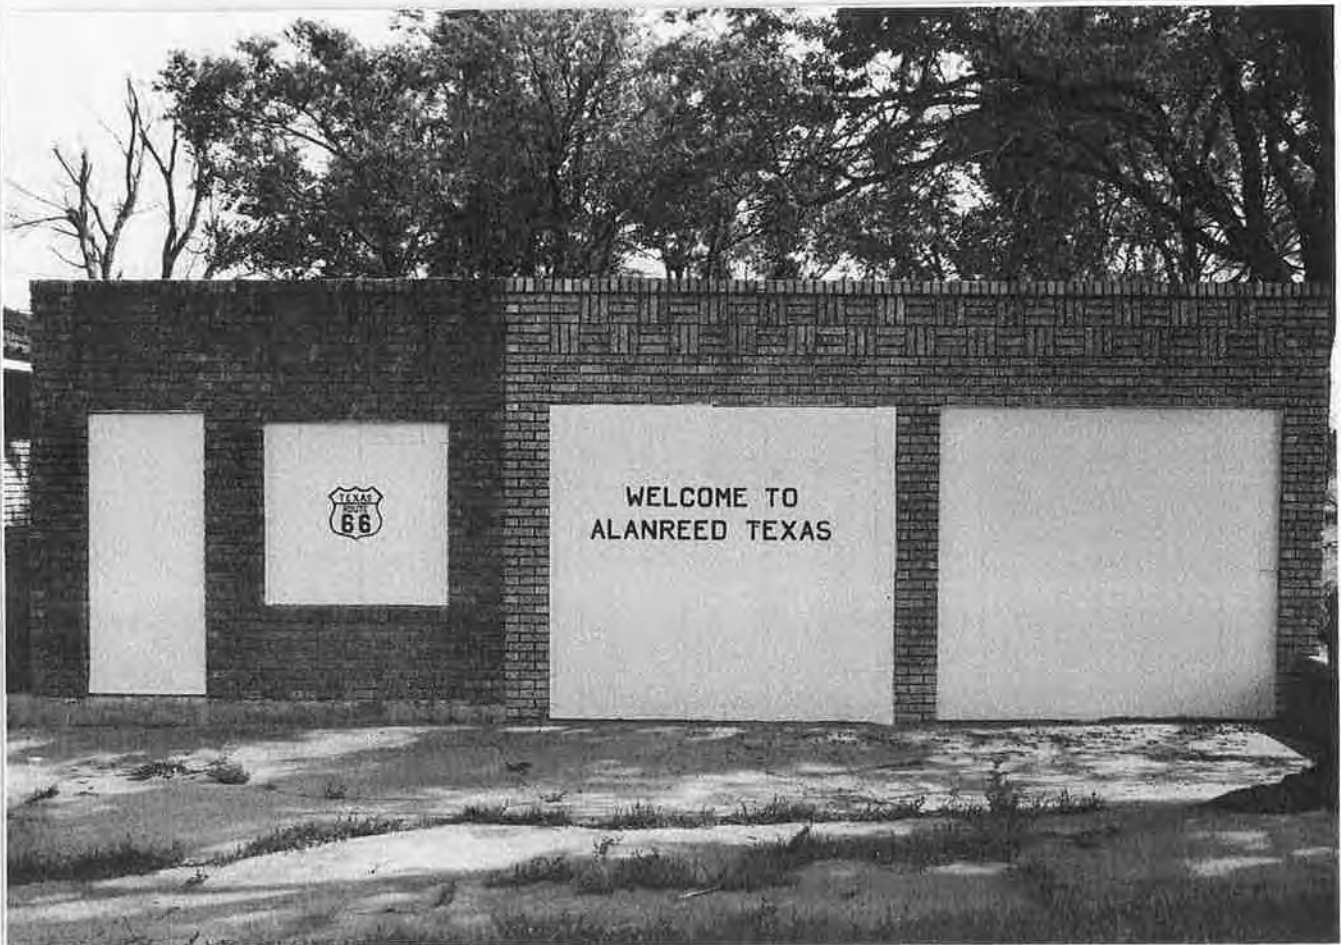
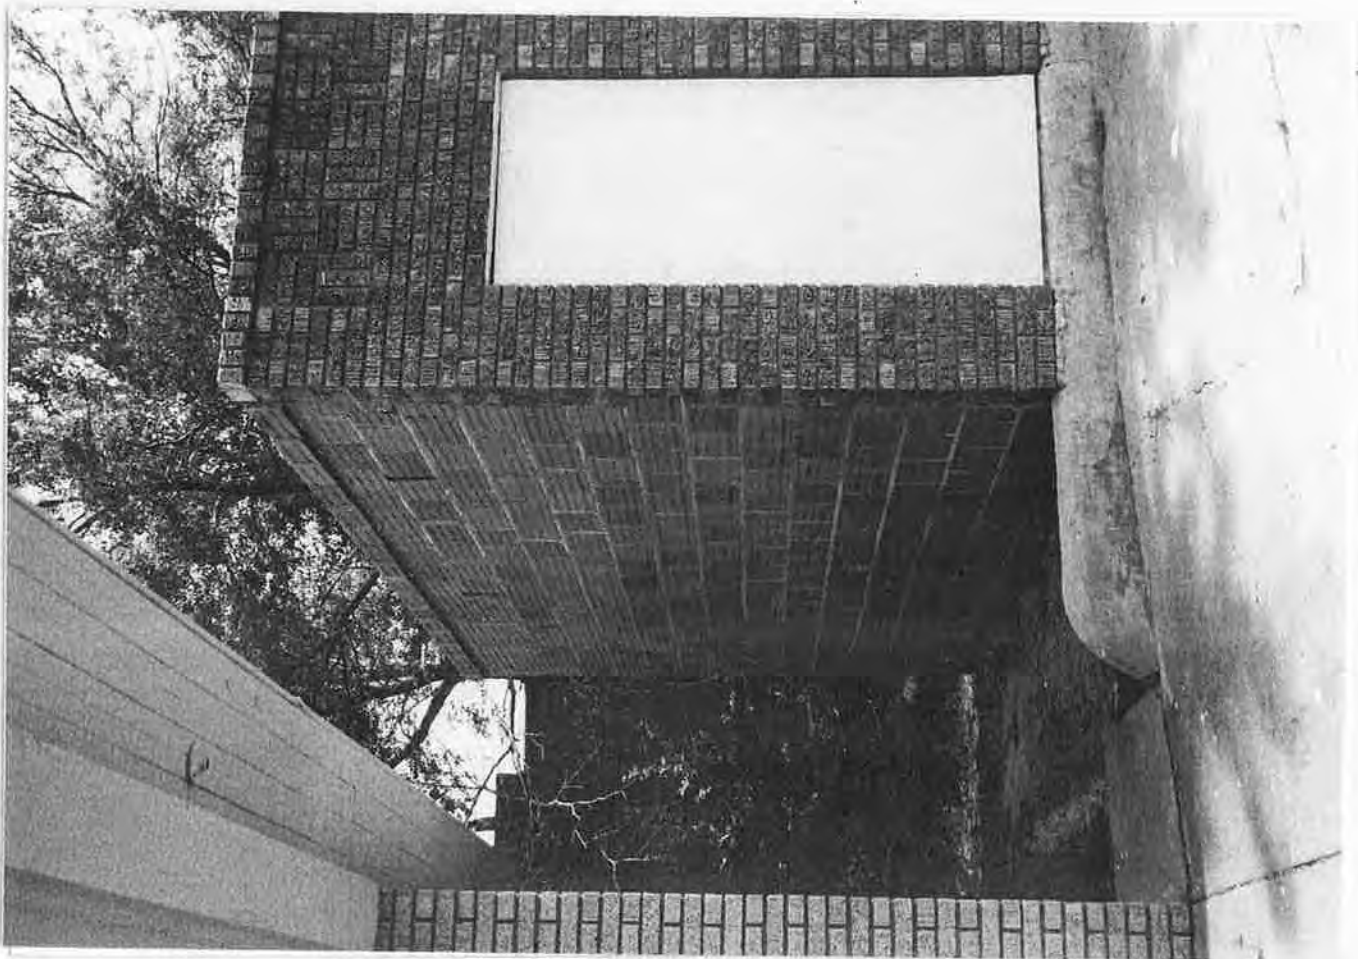
General Architectural Description 2 Bay service garage. One main door &

small window on front. Brick laid in regular courses w/ except for
brick @ parapet. alternating 3 soldier, 3 stretcher

to form
square design. Garage bays on W side have lighter brick than
main door/window bay (the former matches service station). Walls front is rough
faced brick (or very bare terra?) but sides are diff. W side is white stucco; east
side is exposed red clay tile (corrugated, prob. hollow) is visible.

Photo Data: Roll 10 Frame 32, 32 Feature 33 - look S from 32 detail of E
elevation (look W)

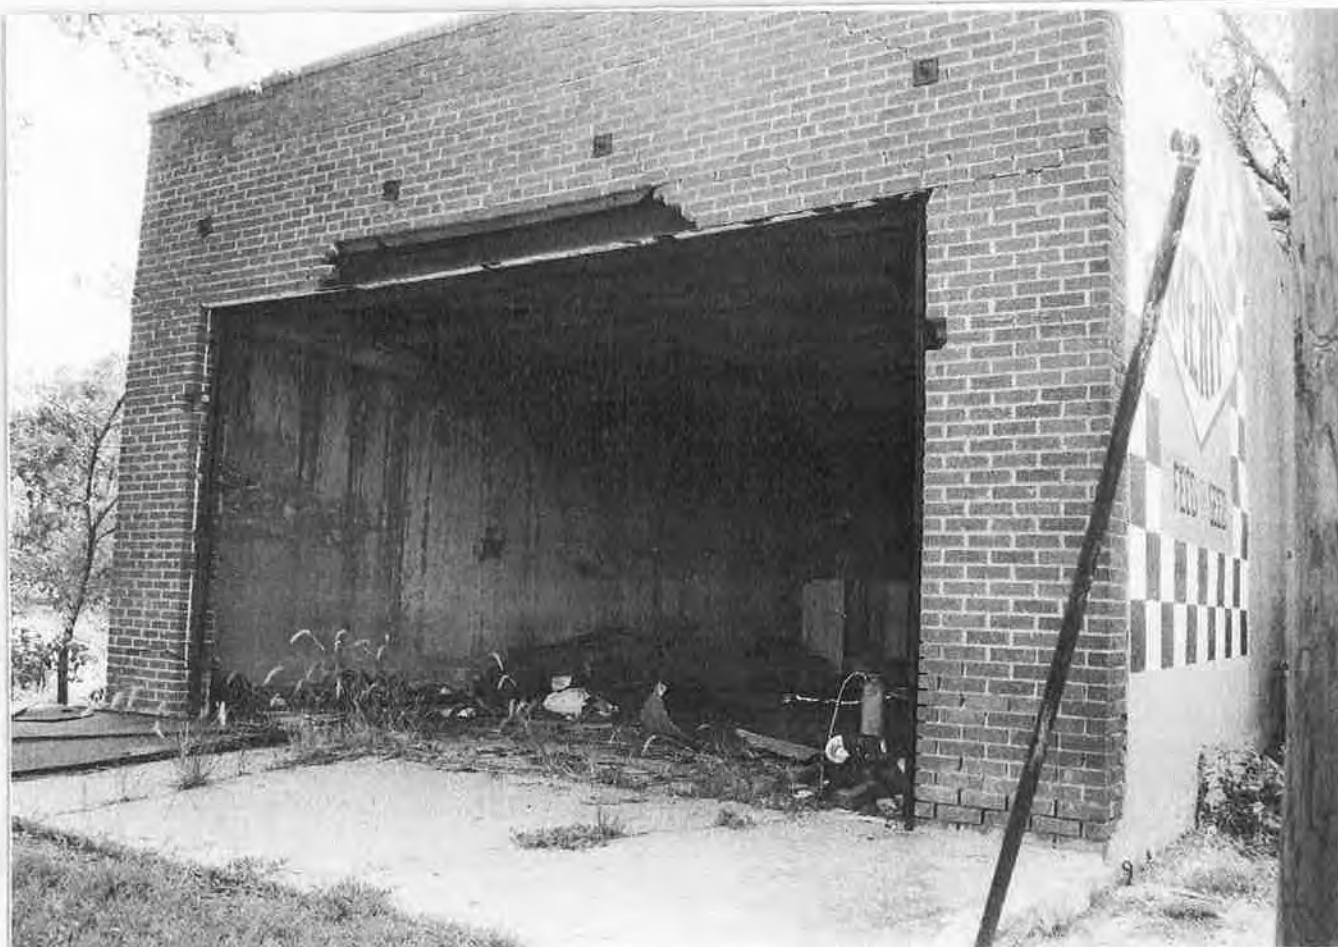
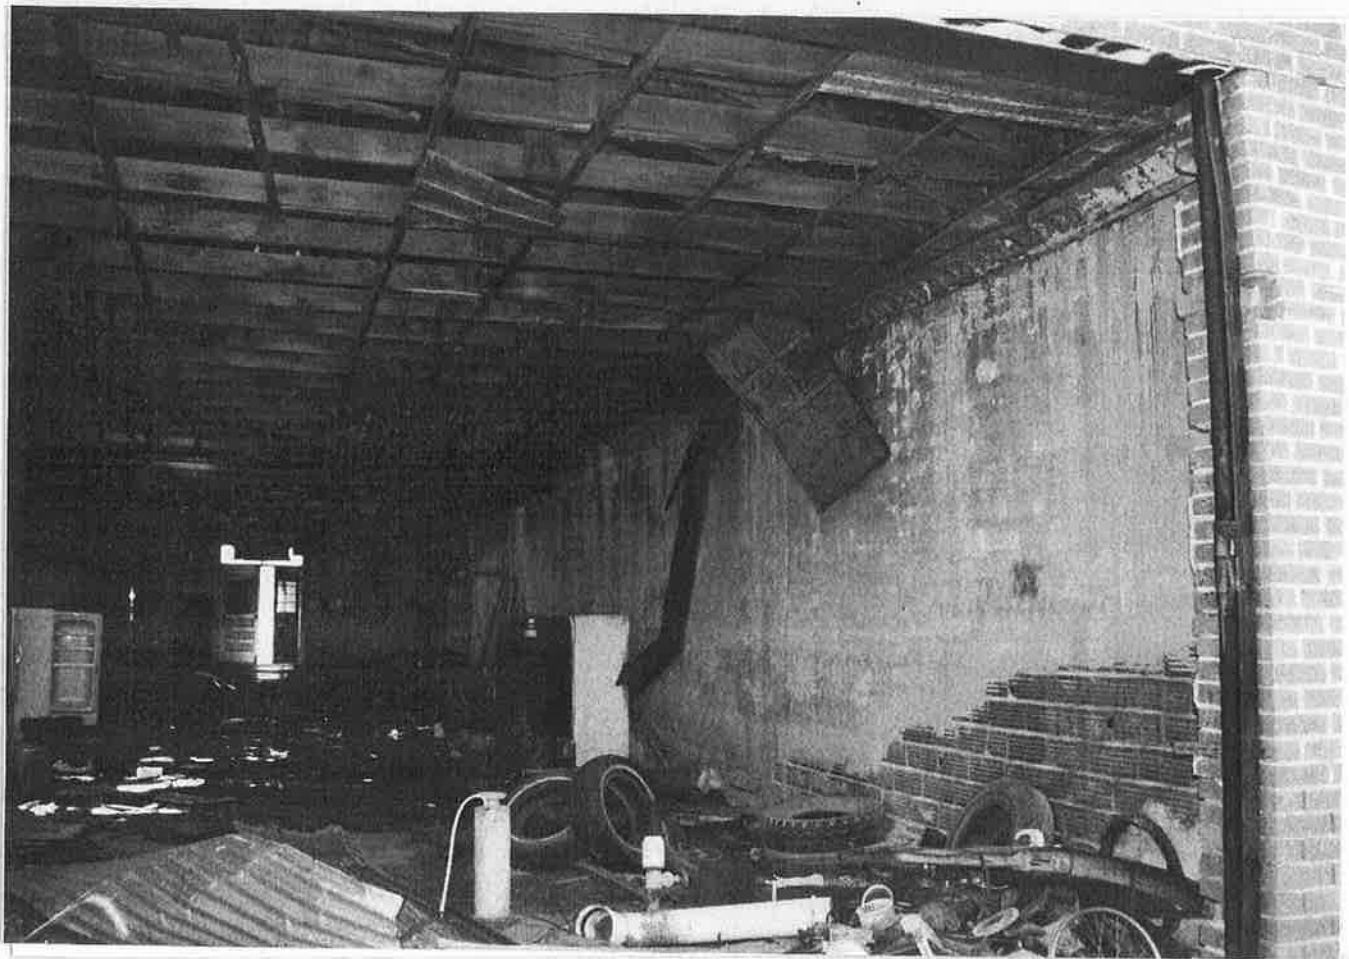
General Architectural Description brick in facade is red rather than

rough-faced & buff - does not match service station). Visible int

s.d. walls show it is made of same red clay tile as the auto garage. (It also

Remnants of tin covered ceiling visible (changing from wood joists on ceiling)

Photo Data: Roll 10 Frame 30/29 Feature 300 looking W 29 - inter detail looking

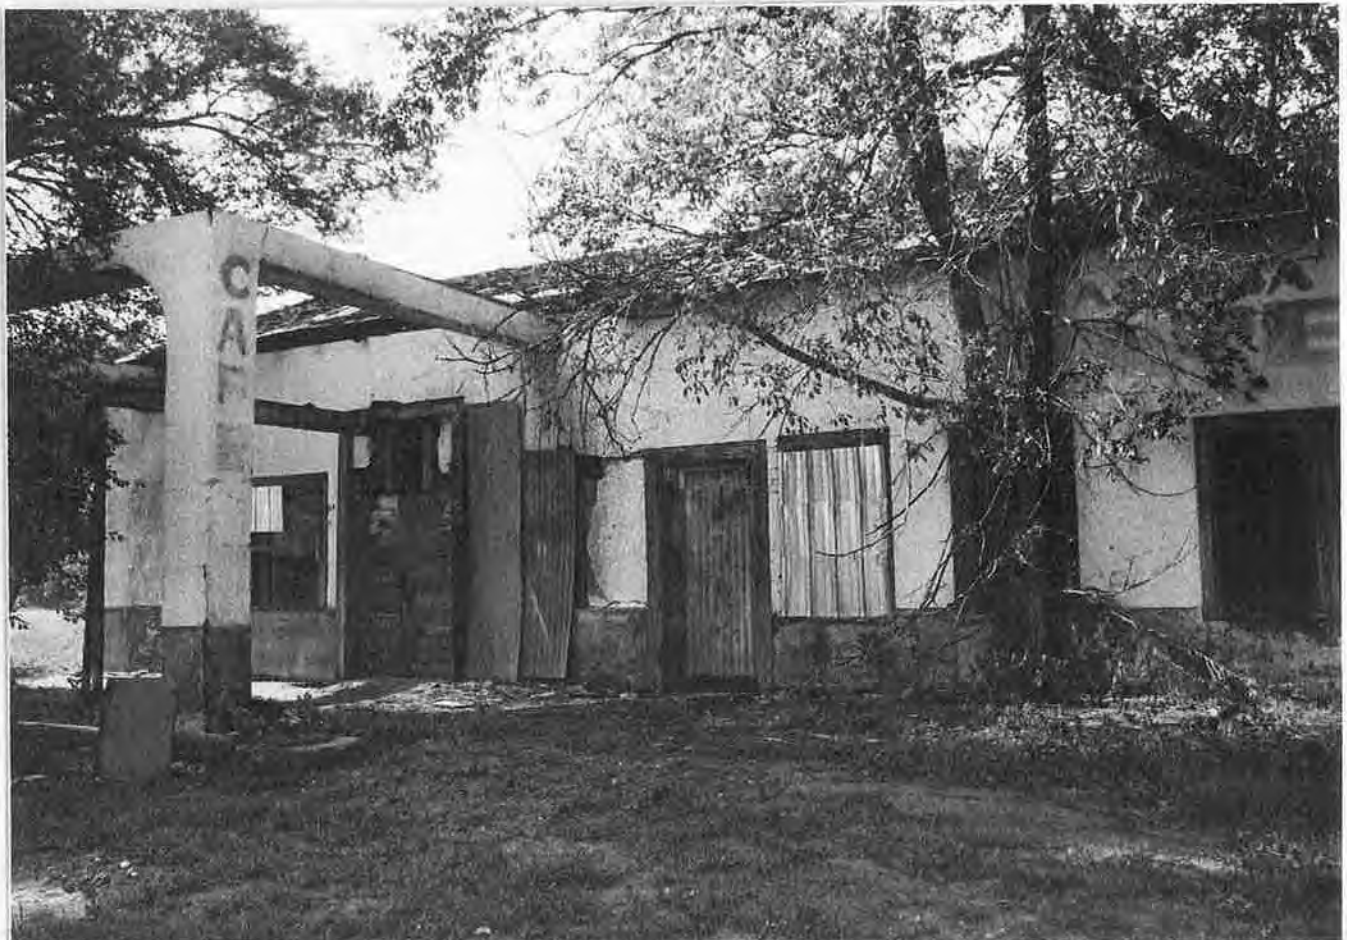
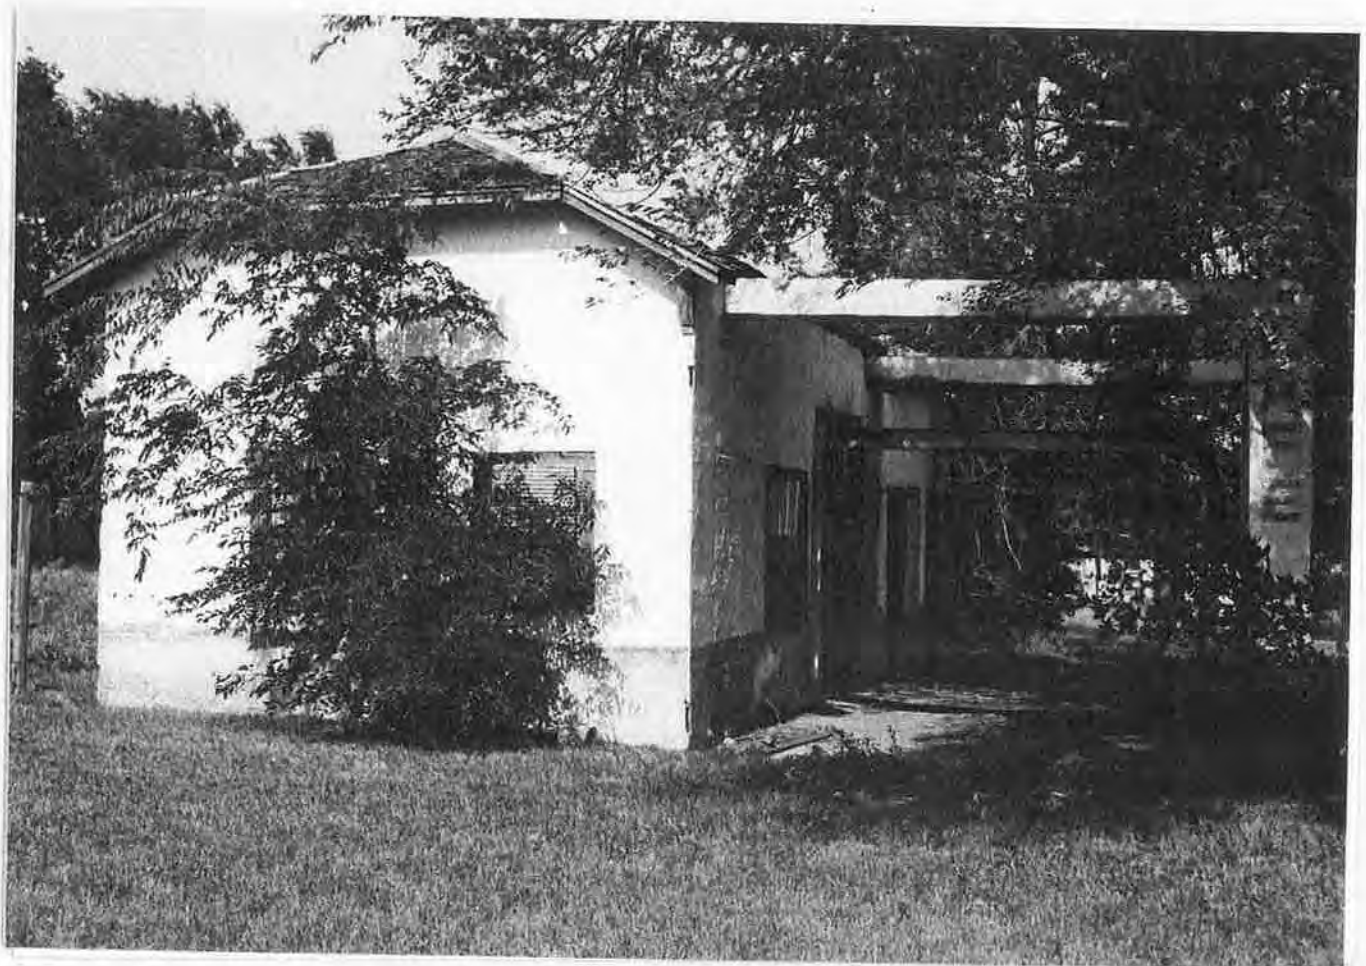
Window type wood sash Eboarded up - glass is missing Materials _____

General Architectural Description 1 unit deep cafe w/ canopy. Car drive under canopy. pump man still visible. 'Magnolia Cafe' painted on front. East end was probably cafe. East elevation has another man door.

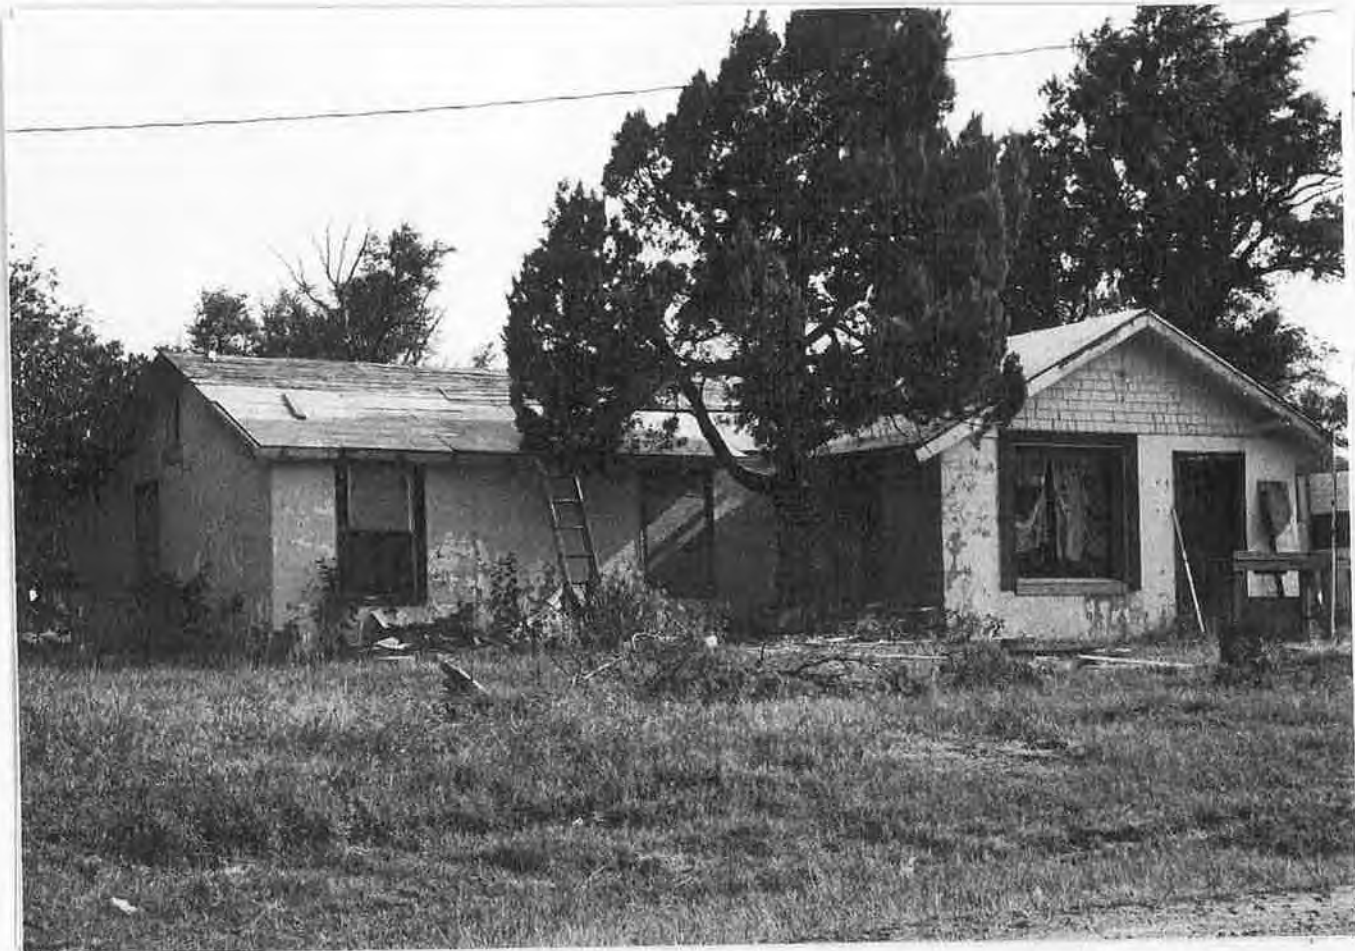
Photo Data: Roll 10 Frame 19 Feature _____

Roof type cross gable Materials only wood decking is intact

Wall façade stucco. shingle e gable end of N facing wing Foundation _____

NOTE. CRAZY OWNER didn't want bldg photographed - description hard to get!

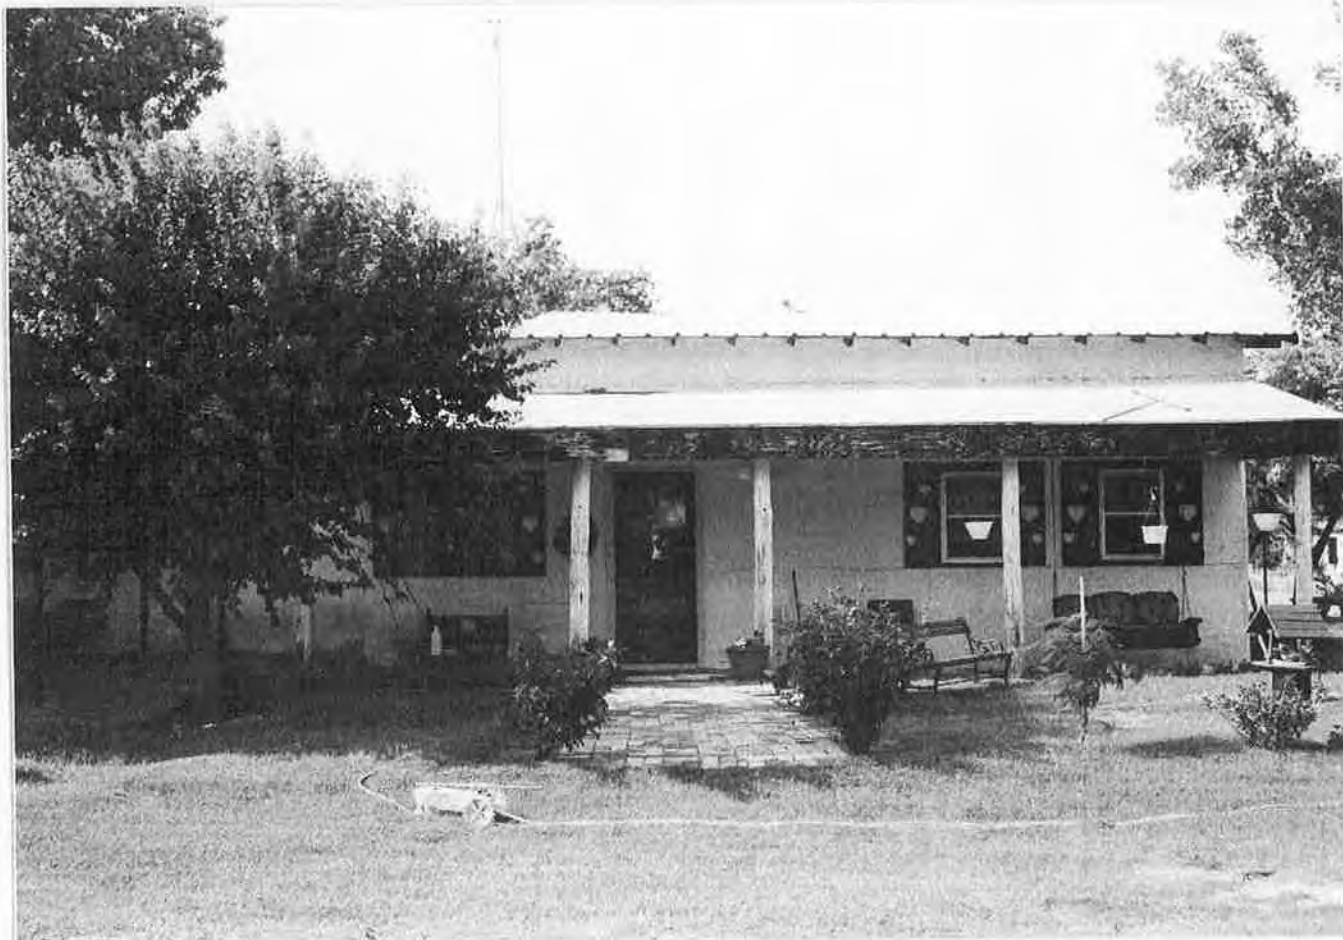
179-AL-9

General Architectural Description service station converted into home (per owner who met on street). Single unit deep, no evidence of function remains although form is not domestic

Photo Data: Roll 10 Frame 26 Feature look N

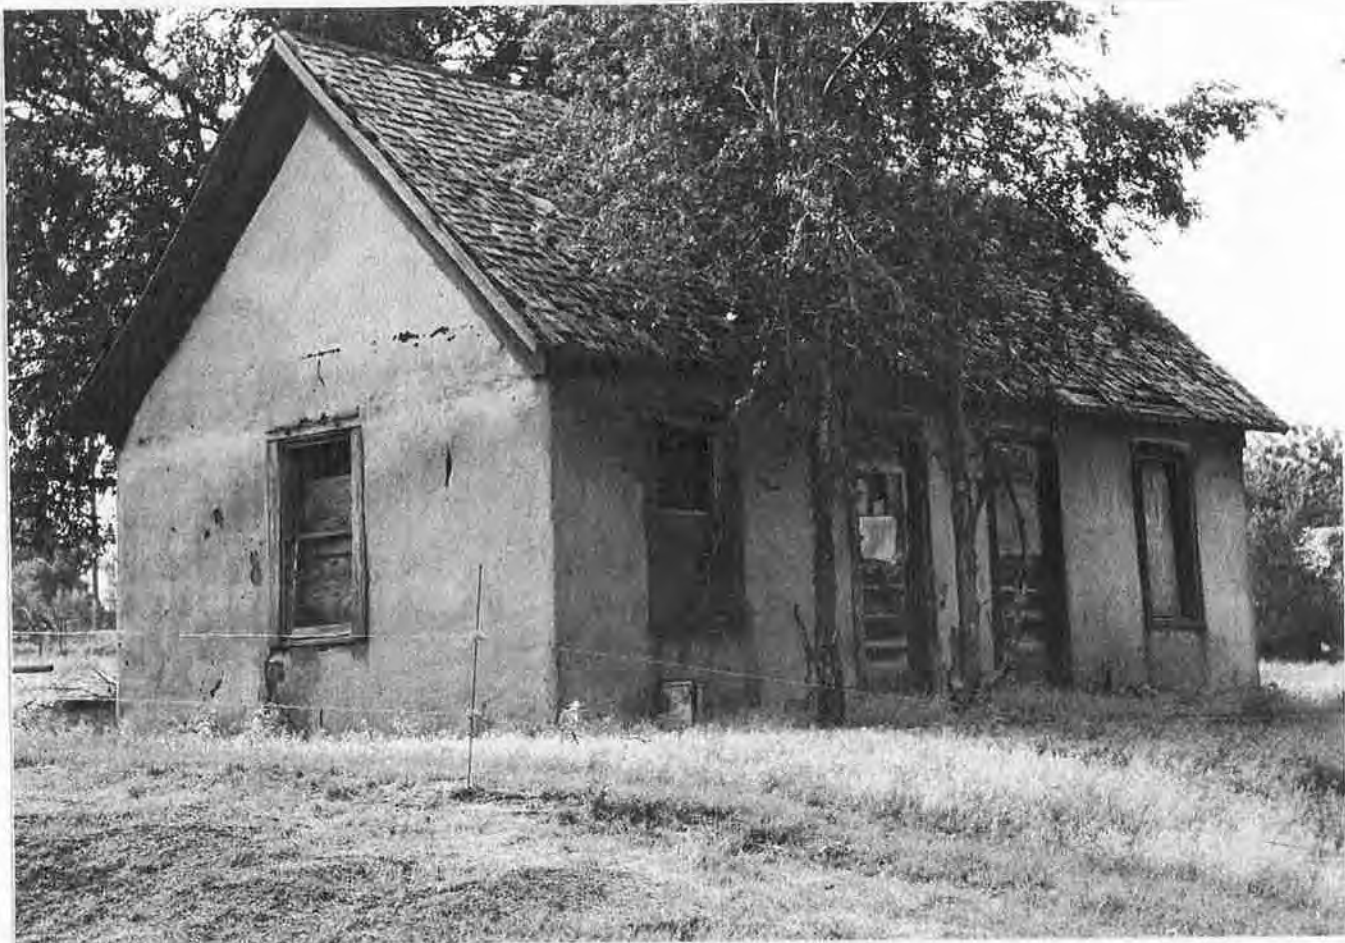
179-AL-10

General Architectural Description looks to be a 2-unit ^{room} tourist cabin
cleared lot suggests may have been 2nd unit cabin

Photo Data: Roll 10 Frame 24 Feature look W

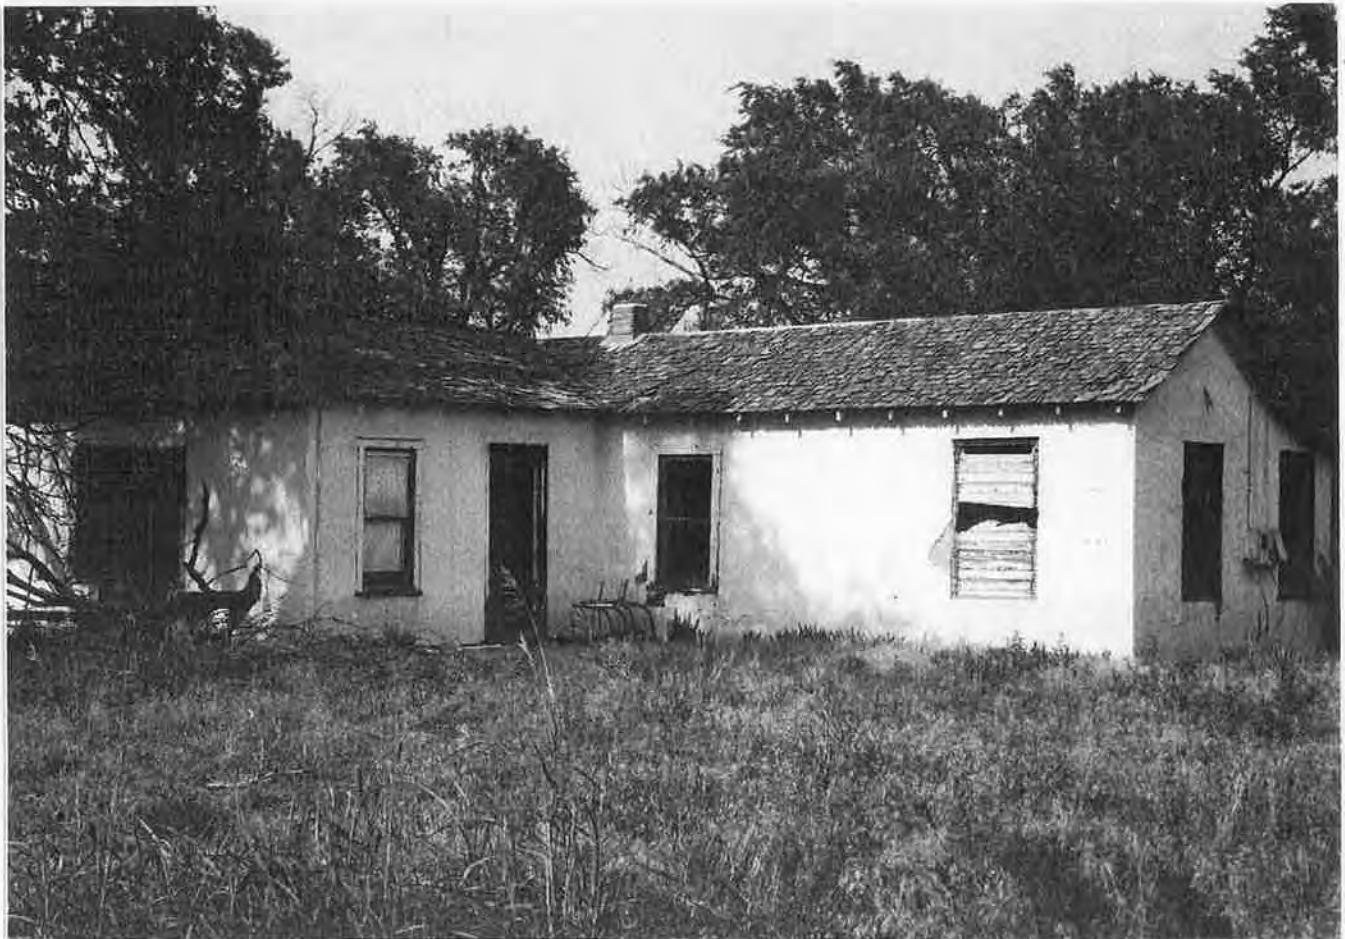
179-AL-11
 PHOTO 10-3475-23
 FACING EAST

Roof type cross gable / hip w/ evaporative end. Materials wood shingle

Window type 1/2 wood sash - W end may have had plate glass window - opening suggests this Materials _____

Chimney(s) brick chimney @ roof intersection
