ALAN REED

Historic Resources Inventory Form—Route 66

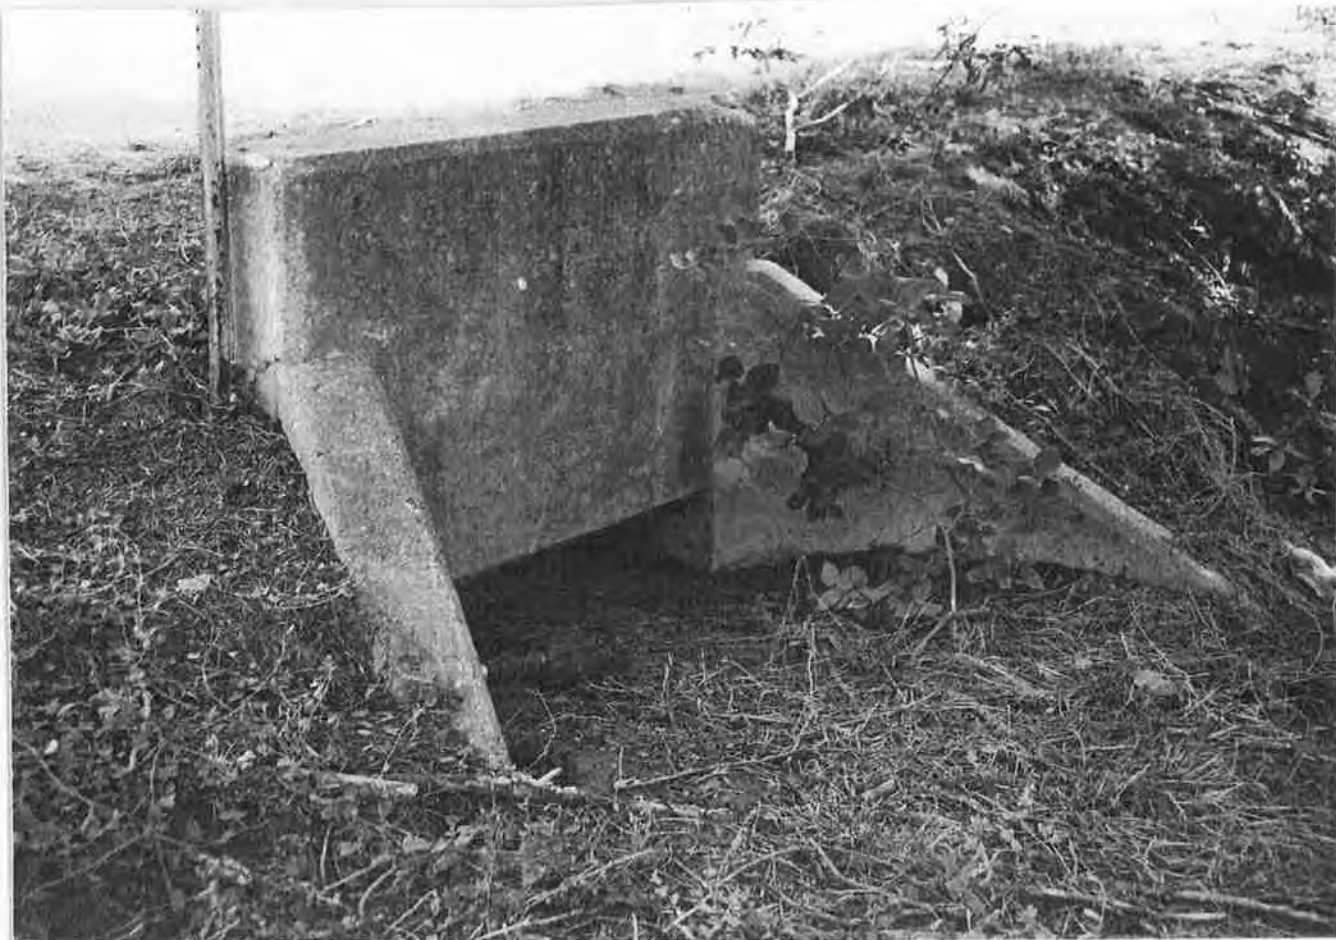
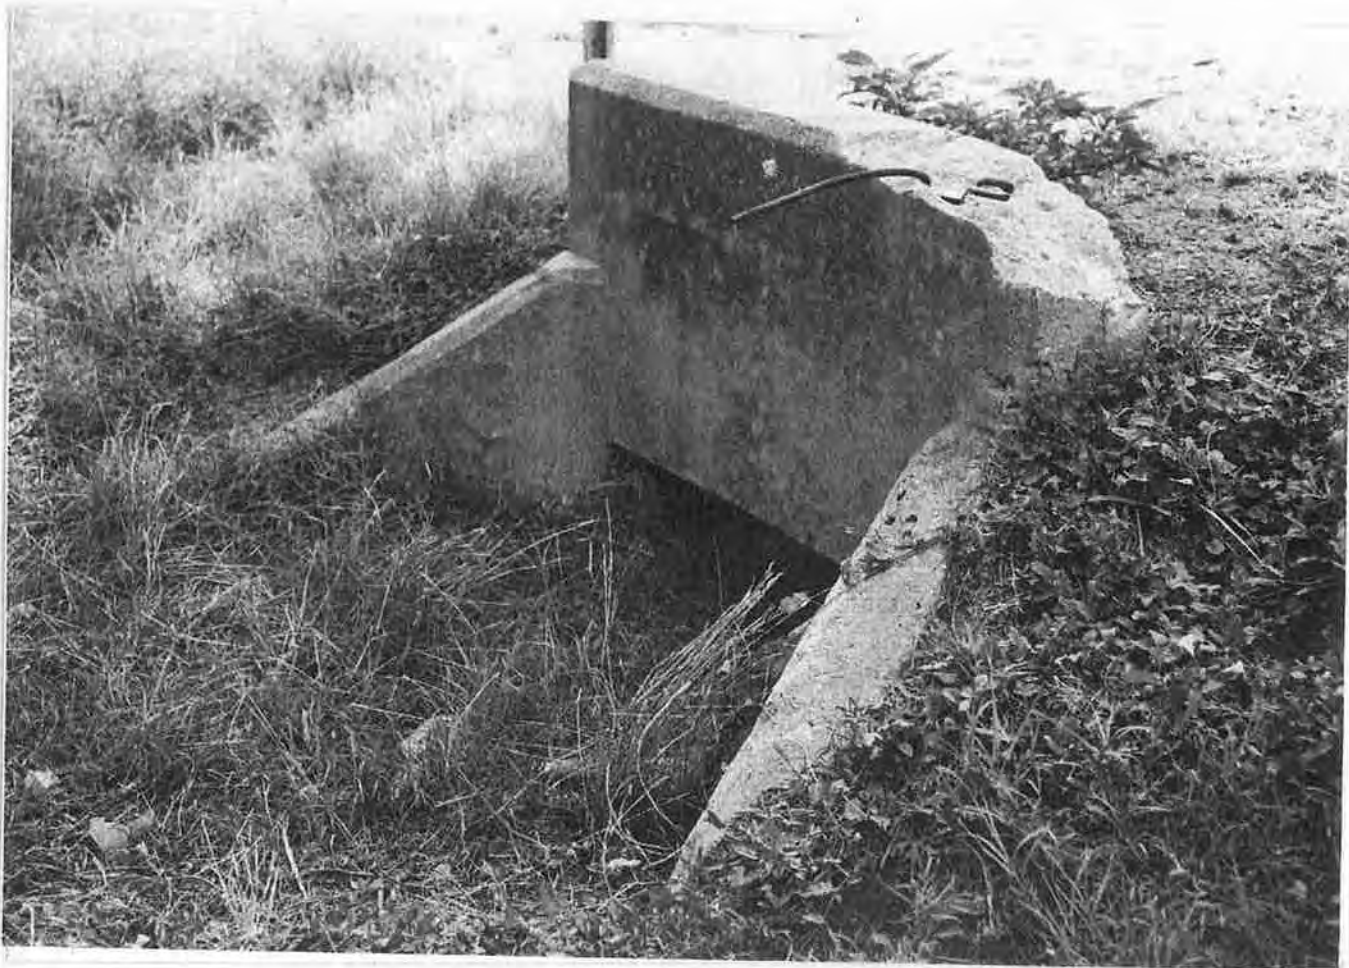
General Architectural Description CONC

Photo Data: Roll _____ Frame 22, 21 Feature 22 = North culv looking S
21 = South culv look N

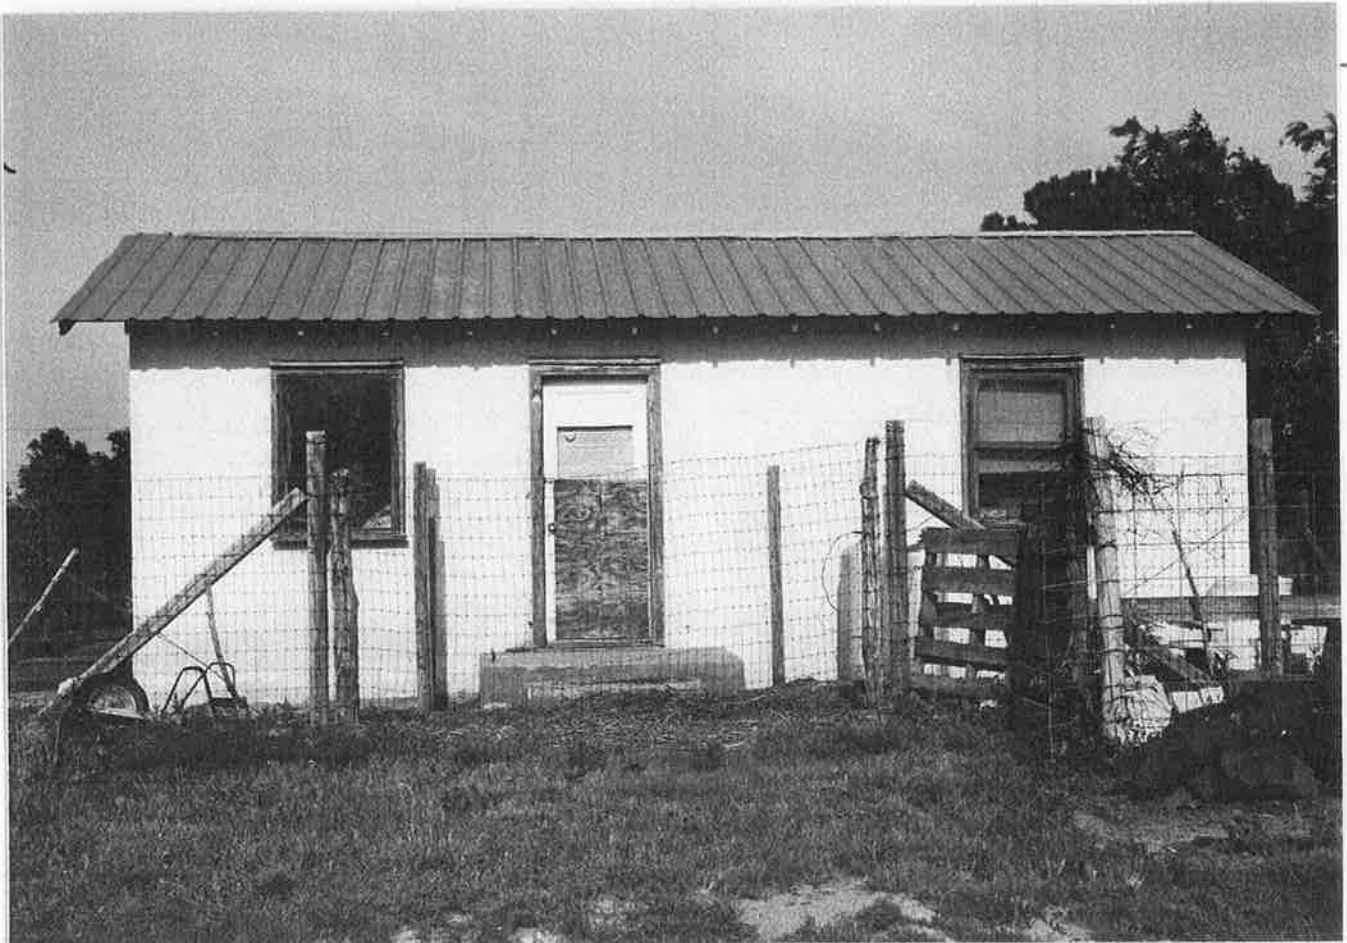
179-AL-13
PHOTO 10-3475-19
FACING WEST

General Architectural Description typical sm cottage resembling tourist cabin.

owner uses it as barn but said it was old house

moved in to this location

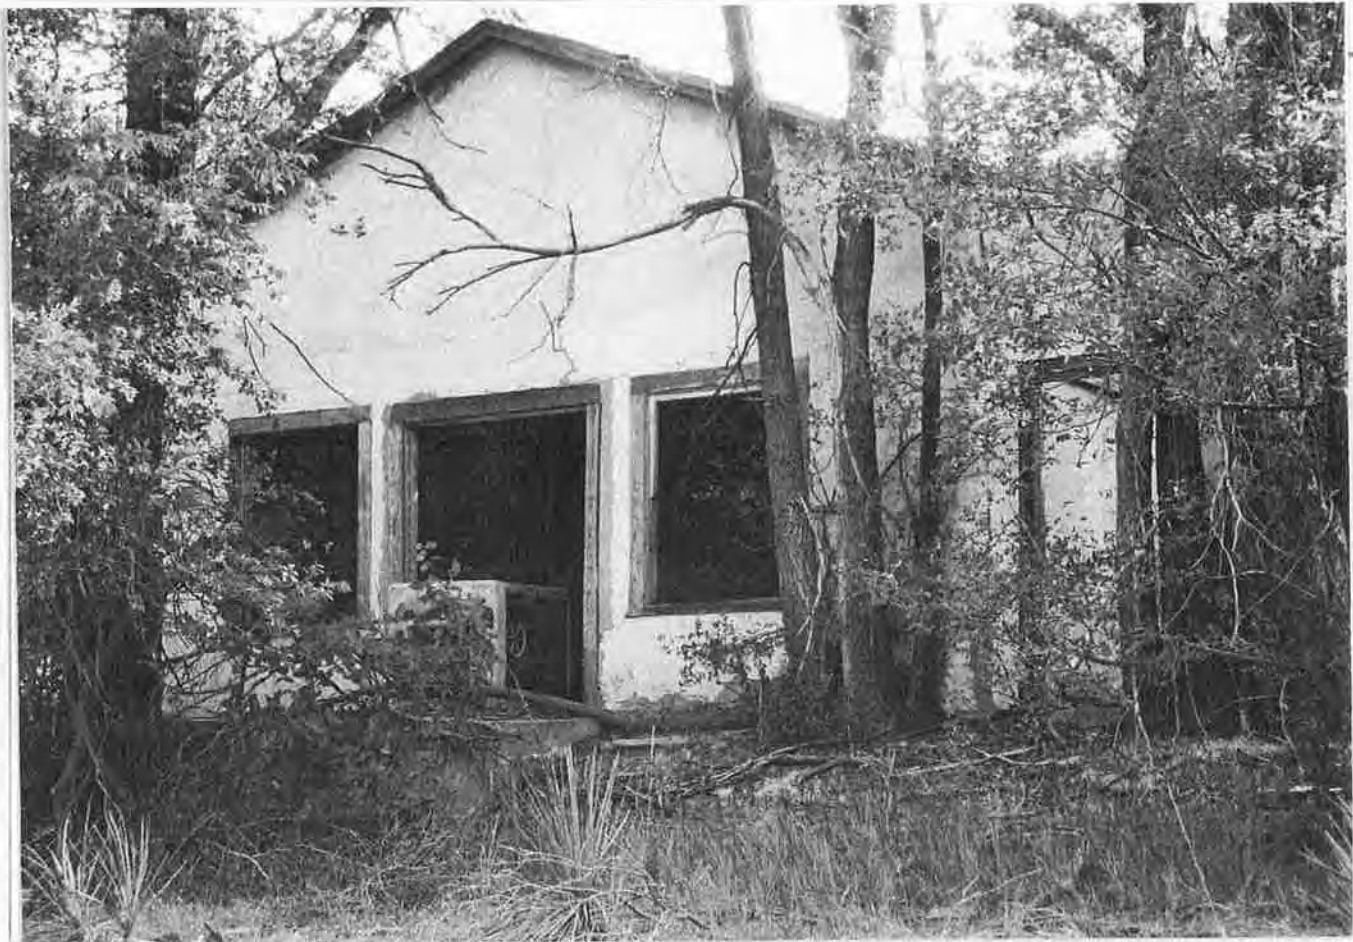
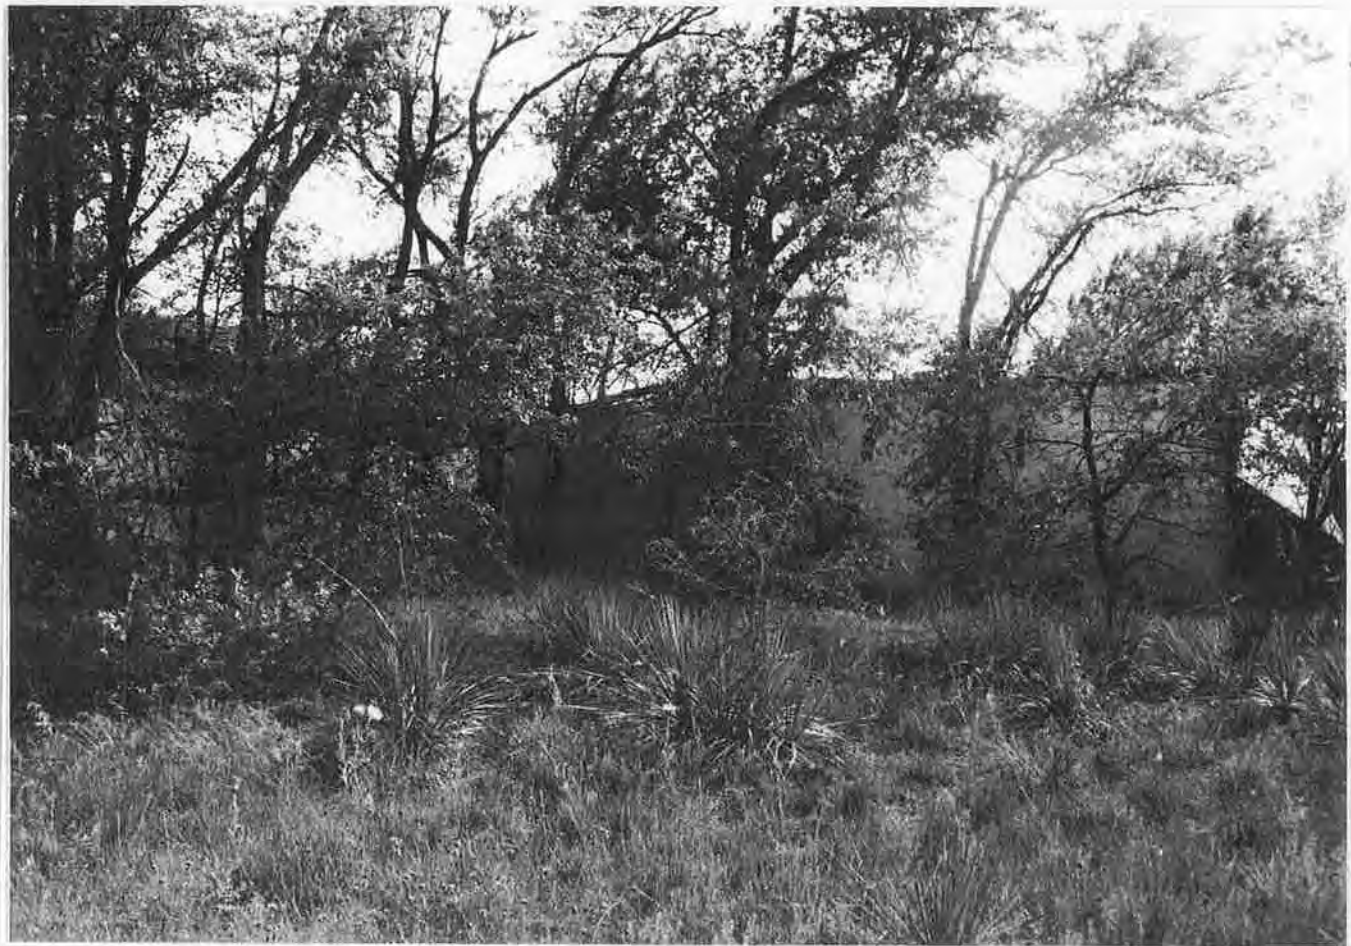
General Architectural Description bdg is dilapidated

Photo Data: Roll 10 Frame 18, 17 Feature 18 - main section look W; 17 ^{projecting} wing looking W

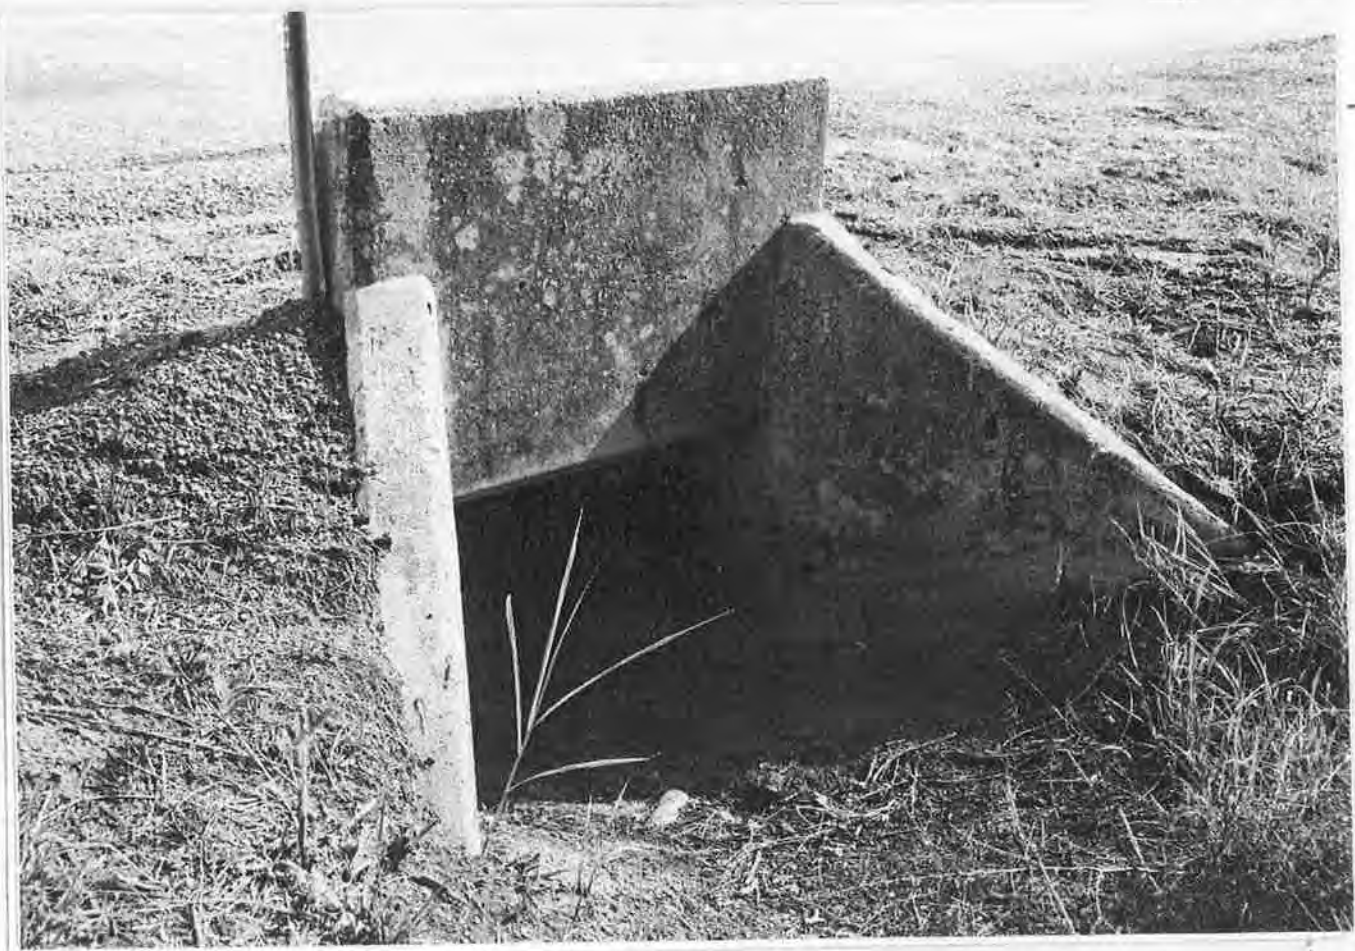
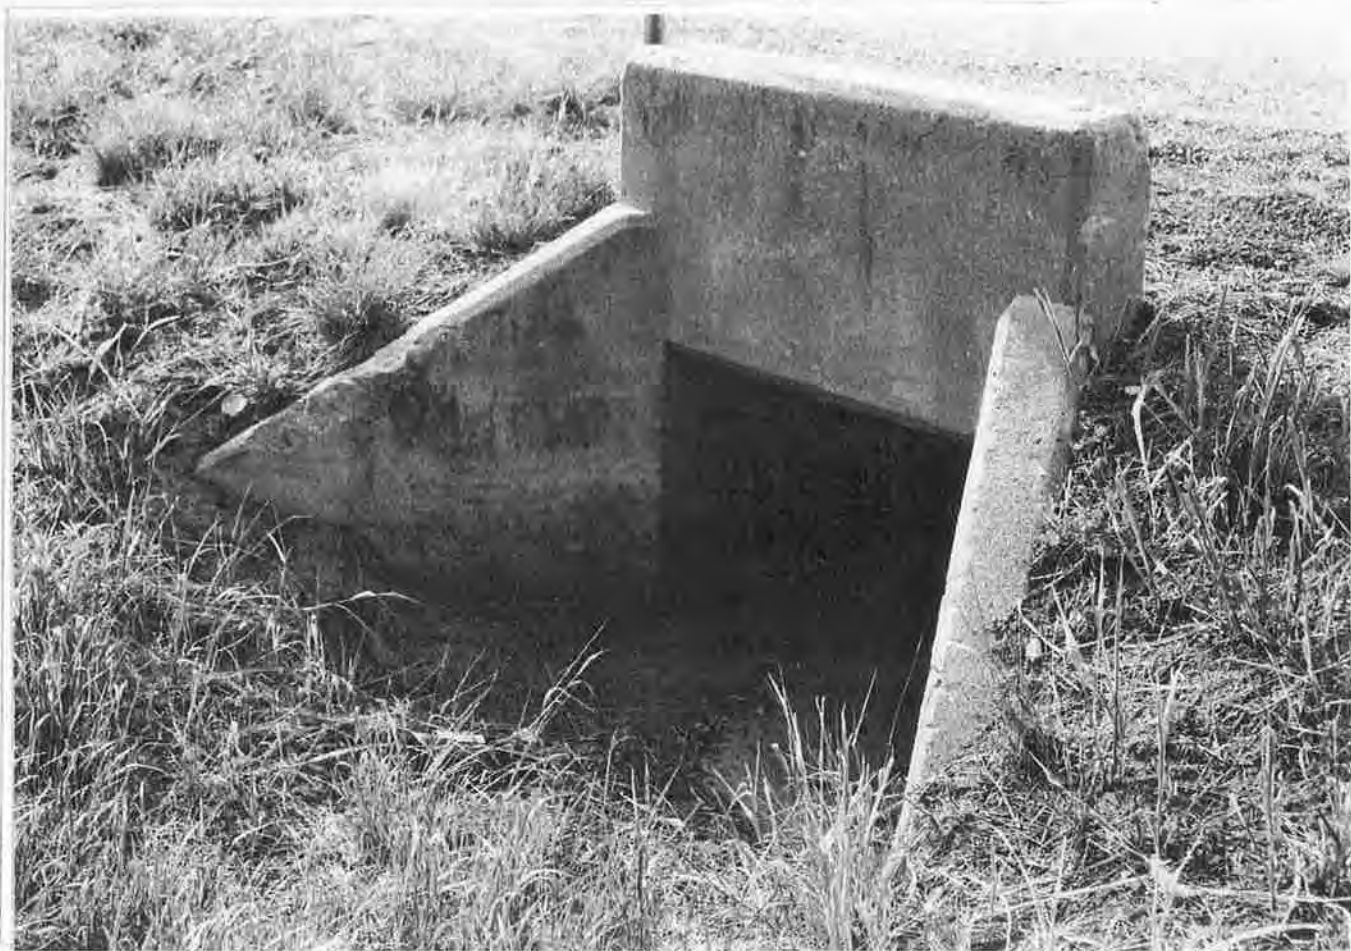
General Architectural Description conc columns on N & S sides of
road

Photo Data: Roll 10 Frame 16, 15 Feature 16 (N) look south 15 (S) looking N

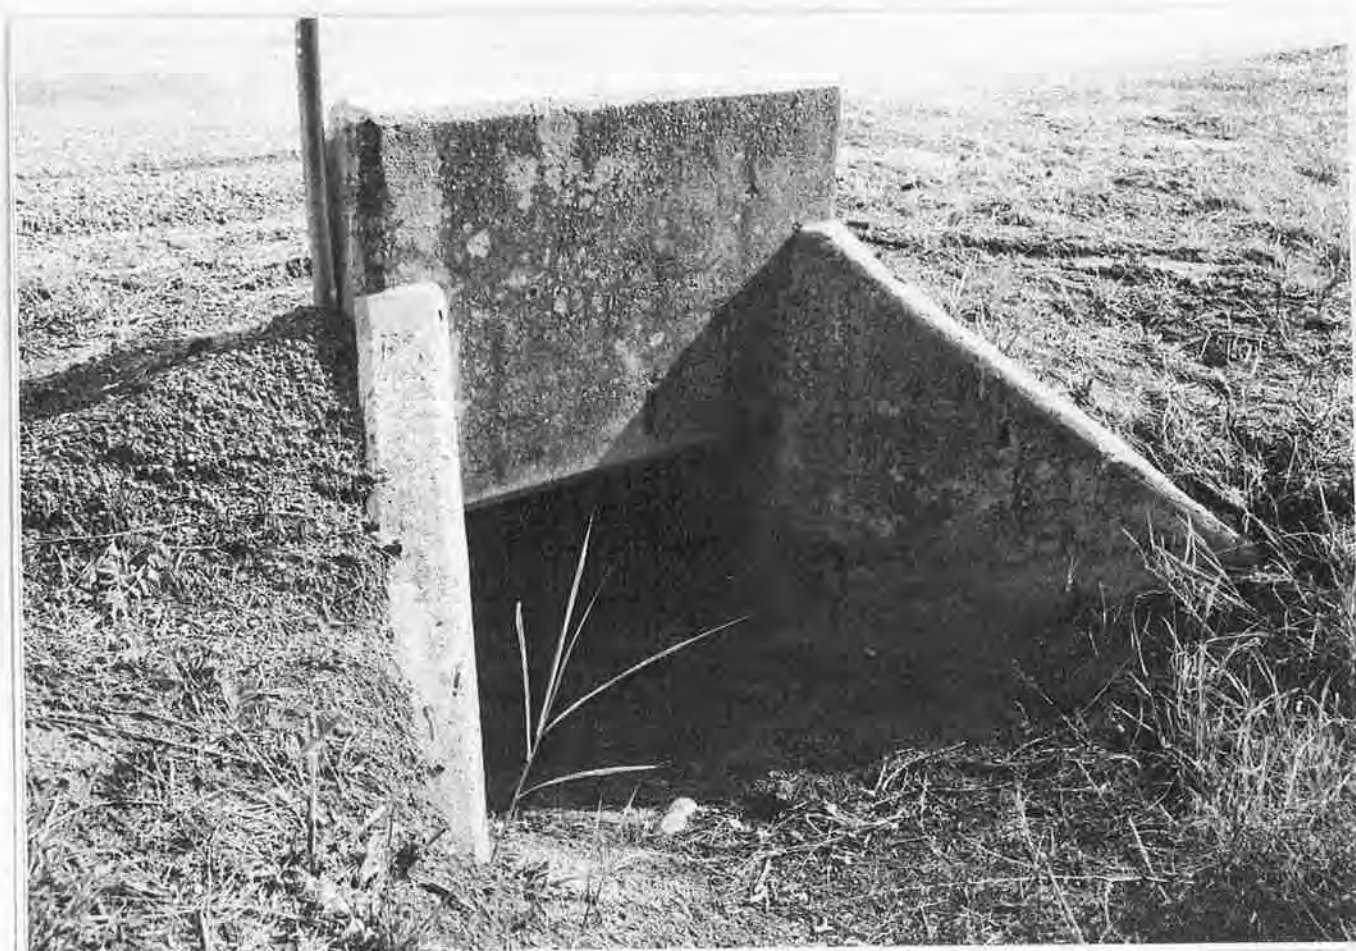
Photo Data: Roll 10 Frame 14, 15 Feature 16 (N) look south 15 (S) looking N

General Architectural Description CONC columns on N & S sides of
road

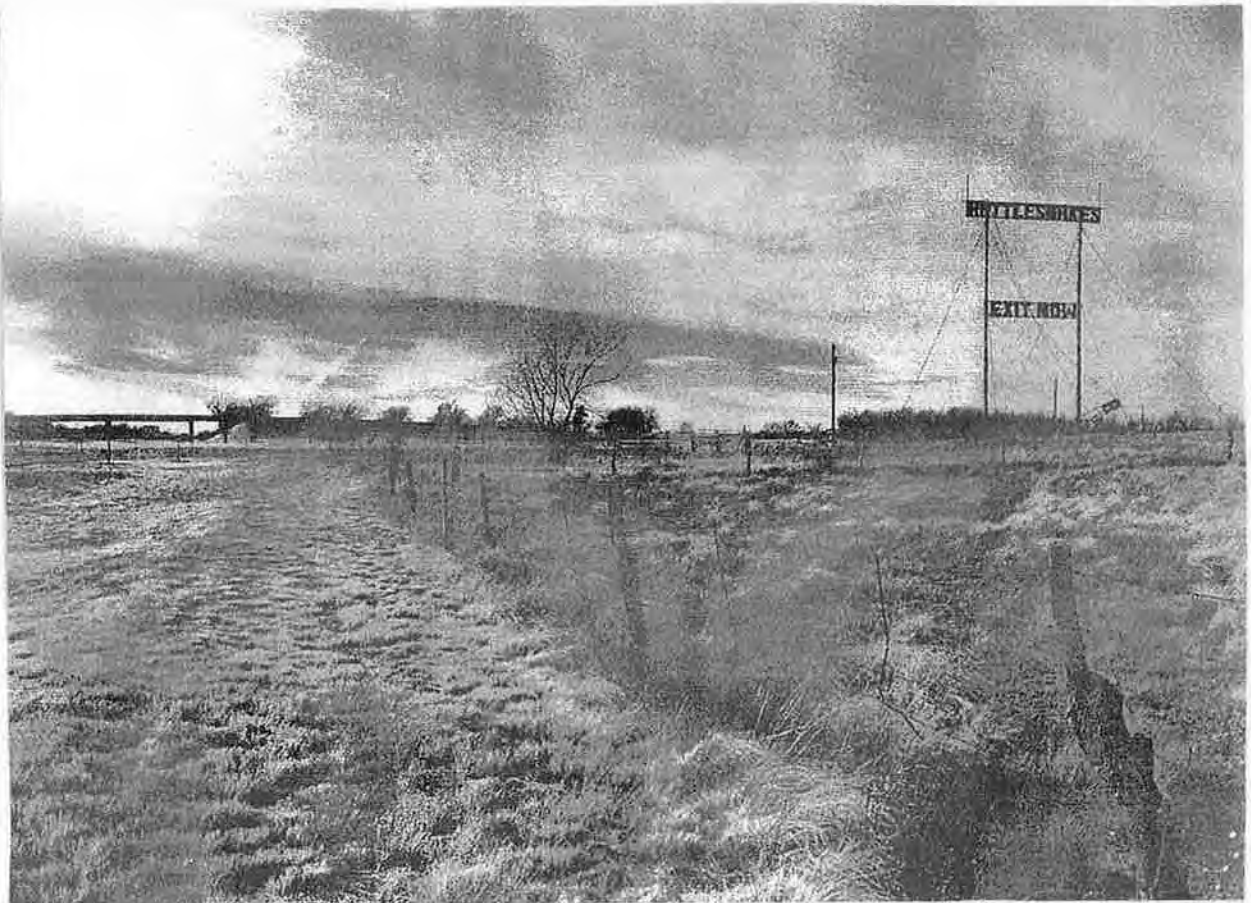
General Architectural Description *Only sign frame remains.*

Bridges all missing
