Historic Resources Inventory Form—Route 66

County POTTER City AMARILLO Inventory # 375-AM-NE
NOT INVENTORIED 844
 Historic Name PIGGY WIGGLY SIGN PHOTO CARD
 Current Name PIGGY WIGGLY SIGN
 Address AMA Blvd E side (behind/adj to County Motel)
 Lot(s): _____ Block: _____ Addition: _____
 Owners Address _____
 Resource type Building Structure Site Object District
 Landscape/Site Features _____
 Outbuildings _____
 Function: Current Use _____ Historic Use _____
 Construction Date: _____ Actual Estimated
 Architect _____ Builder _____
 Possible Threat(s) Demolition Development Neglect Alteration Vacant Utility Expansion
 Integrity Location Design Materials Workmanship Setting Feeling Association
 USGS Quad #: _____ Year: _____ UTM Zone: _____ Easting: _____ Northing: _____
 Priority High Medium Low Recorder Monica Penick Date(s) 7/16/2002

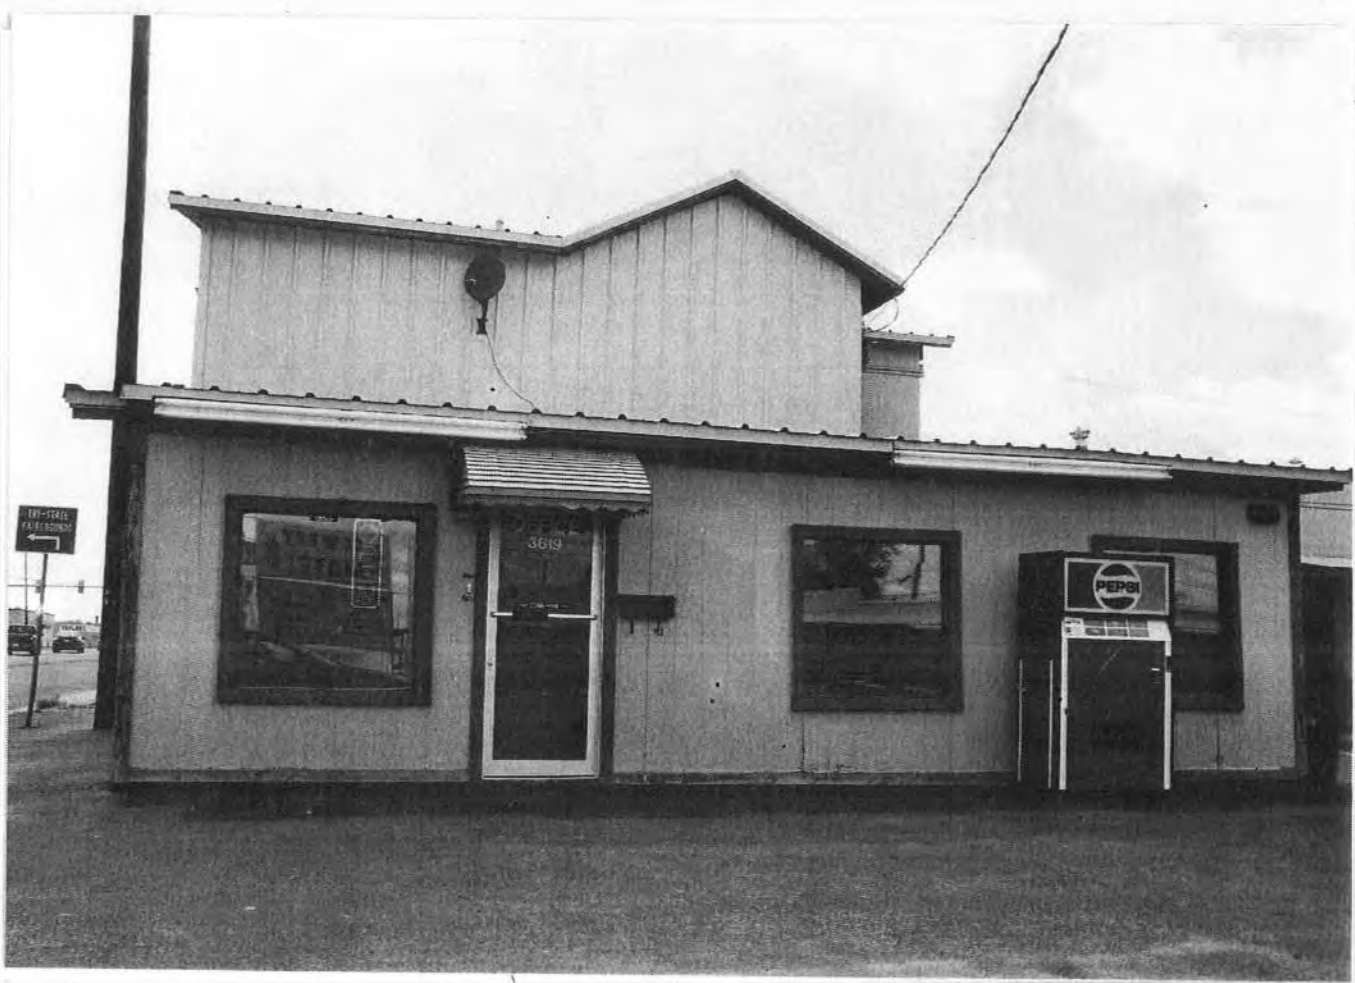
375-AM-73B
24-3761-20
FACING NORTH

Photo Data: Roll 24 Frame _____ Feature 76 19 typical unit look N

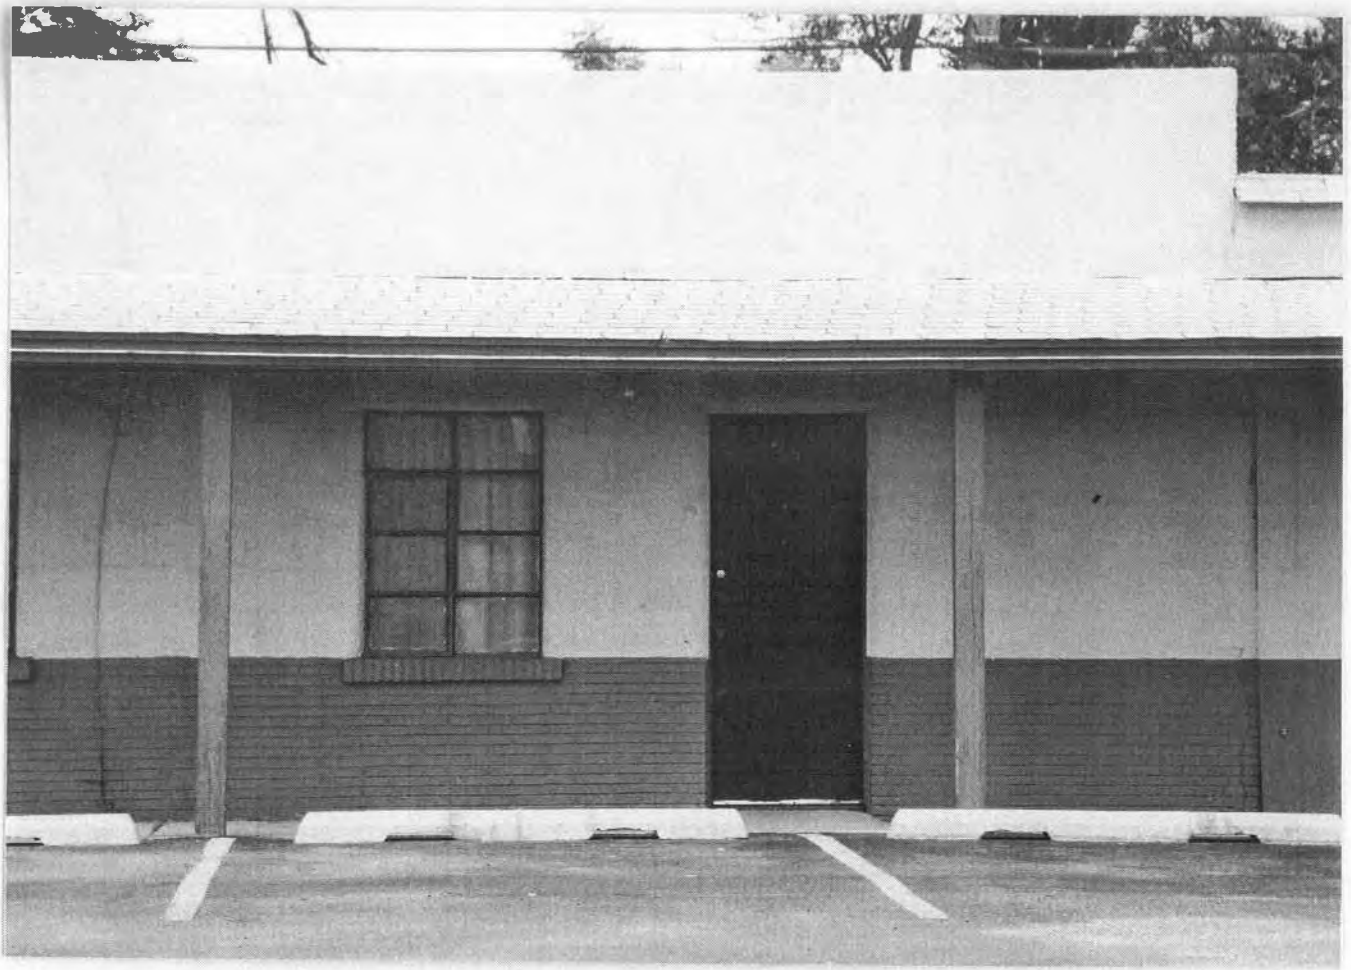
375-AM-73B
24-3761-19
FACING NORTH

19 188 full-in unit look N

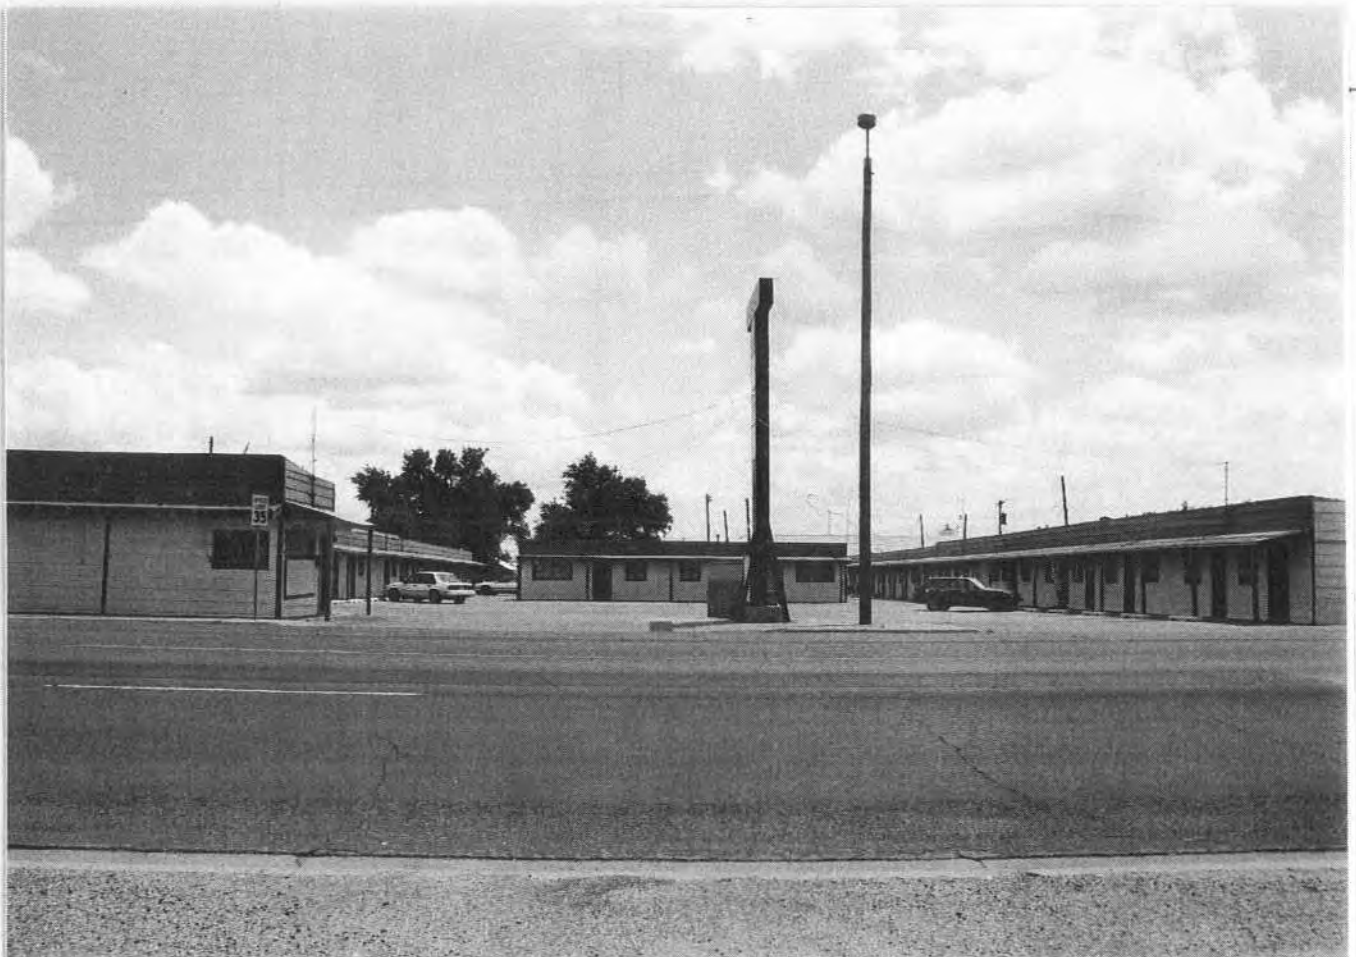
375-AM - NOT SURVEYED
24-3761-10
FACING EAST

Photo Data: Roll 24 Frame _____ Feature _____ 10 look E
look

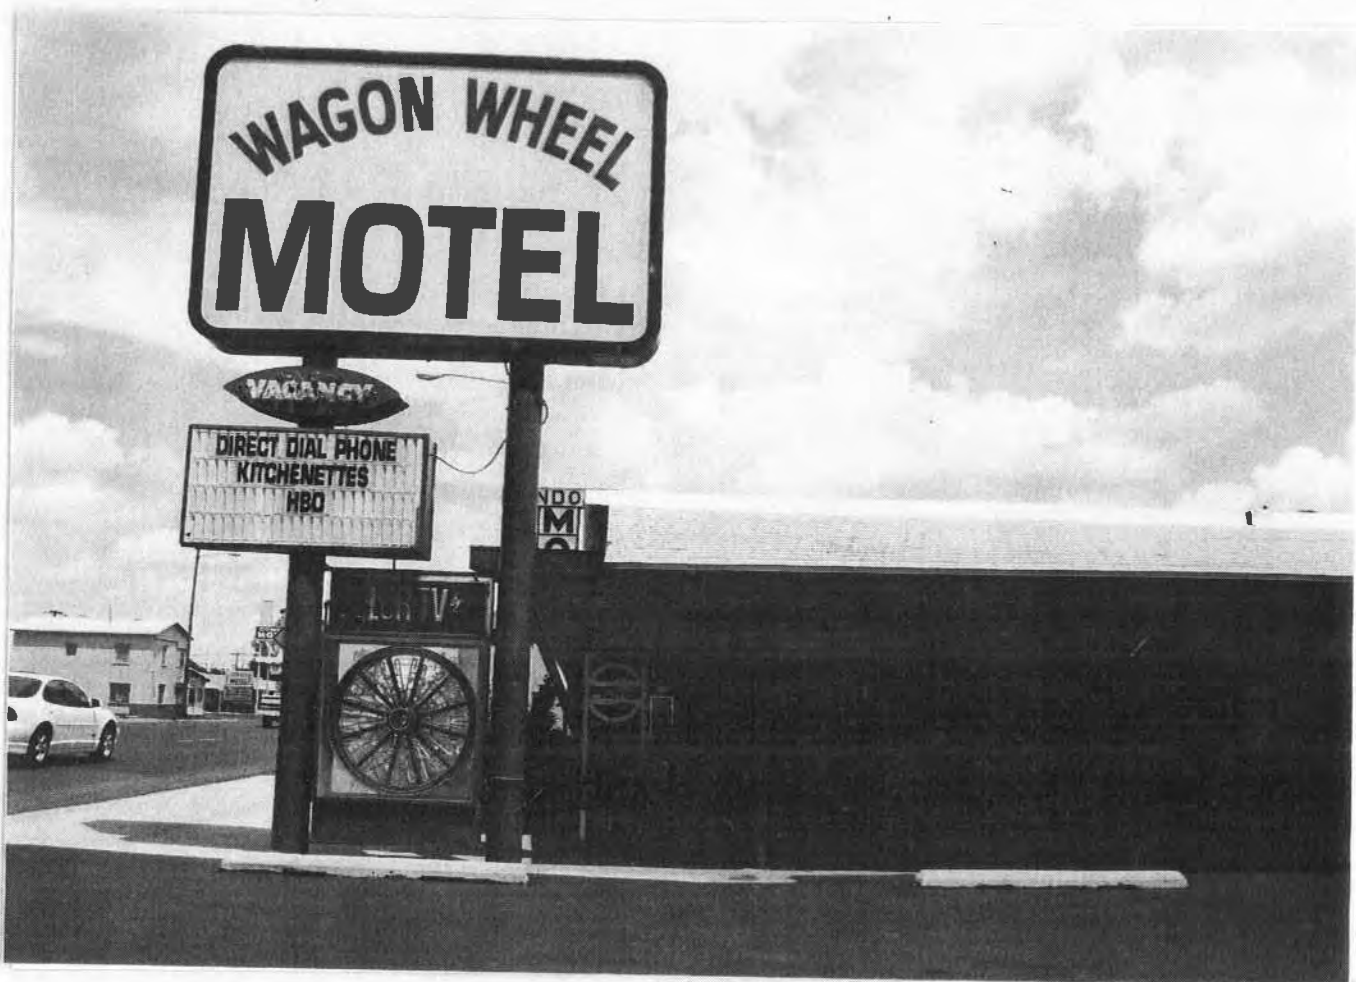
375-AM-75
24-3761-7
FACING EAST

Photo Data: Roll <u>24</u>	Frame _____	Feature <u>11 overall</u>	<u>look S</u>
		<u>9 office</u>	<u>look E</u>
		<u>8 typical N units</u>	<u>E</u>
		<u>7 typic S units</u>	<u>E</u>

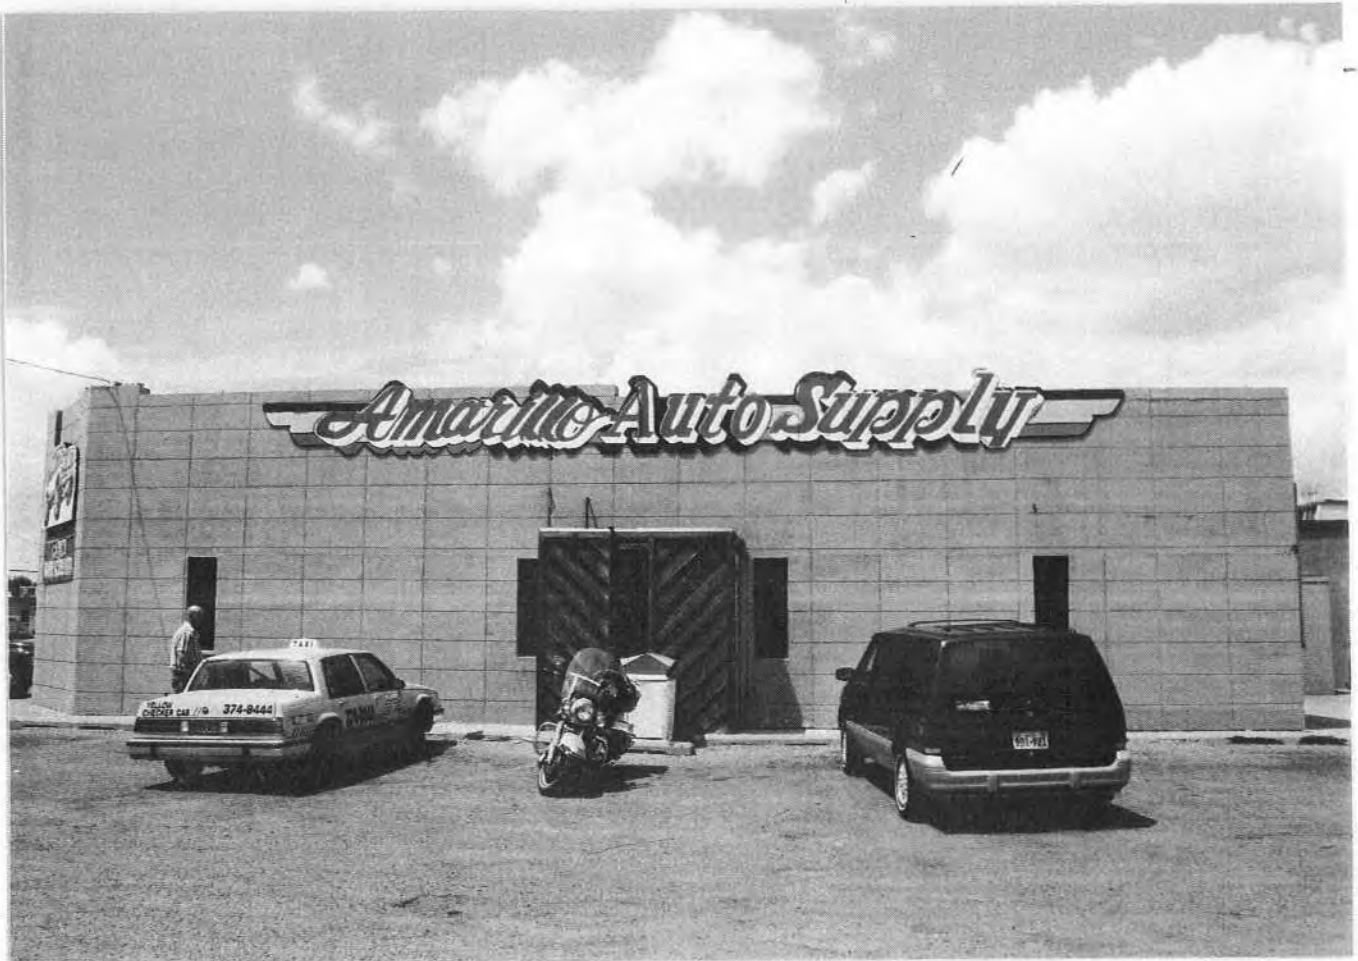
375 - AM - 76
24 - 3761 - 12
FACING NORTH

integrity severely compromised by slipcover & blocking in windows & doors.

Photo Data: Roll	Frame	Feature	Look
24		14 store front looking E	look E
		13 rear of W ck	look E
		12 front	look N

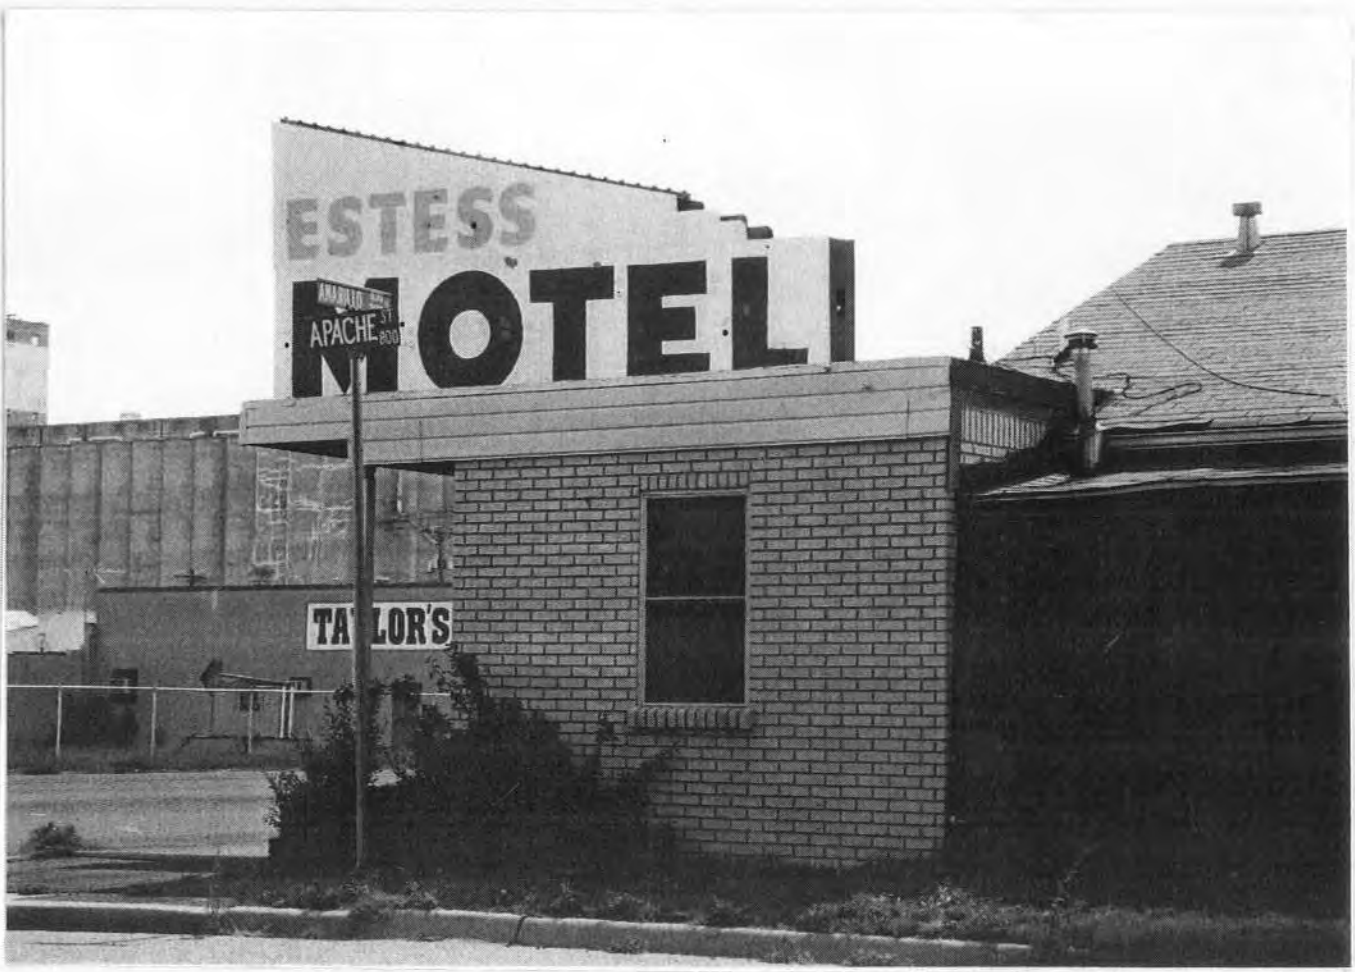
375-AM-70B
24-3761-2
FACING WEST

units are diff - W wing has 1/2 wood sash windows & infill bays. (#1)

2 typical #1 Look W

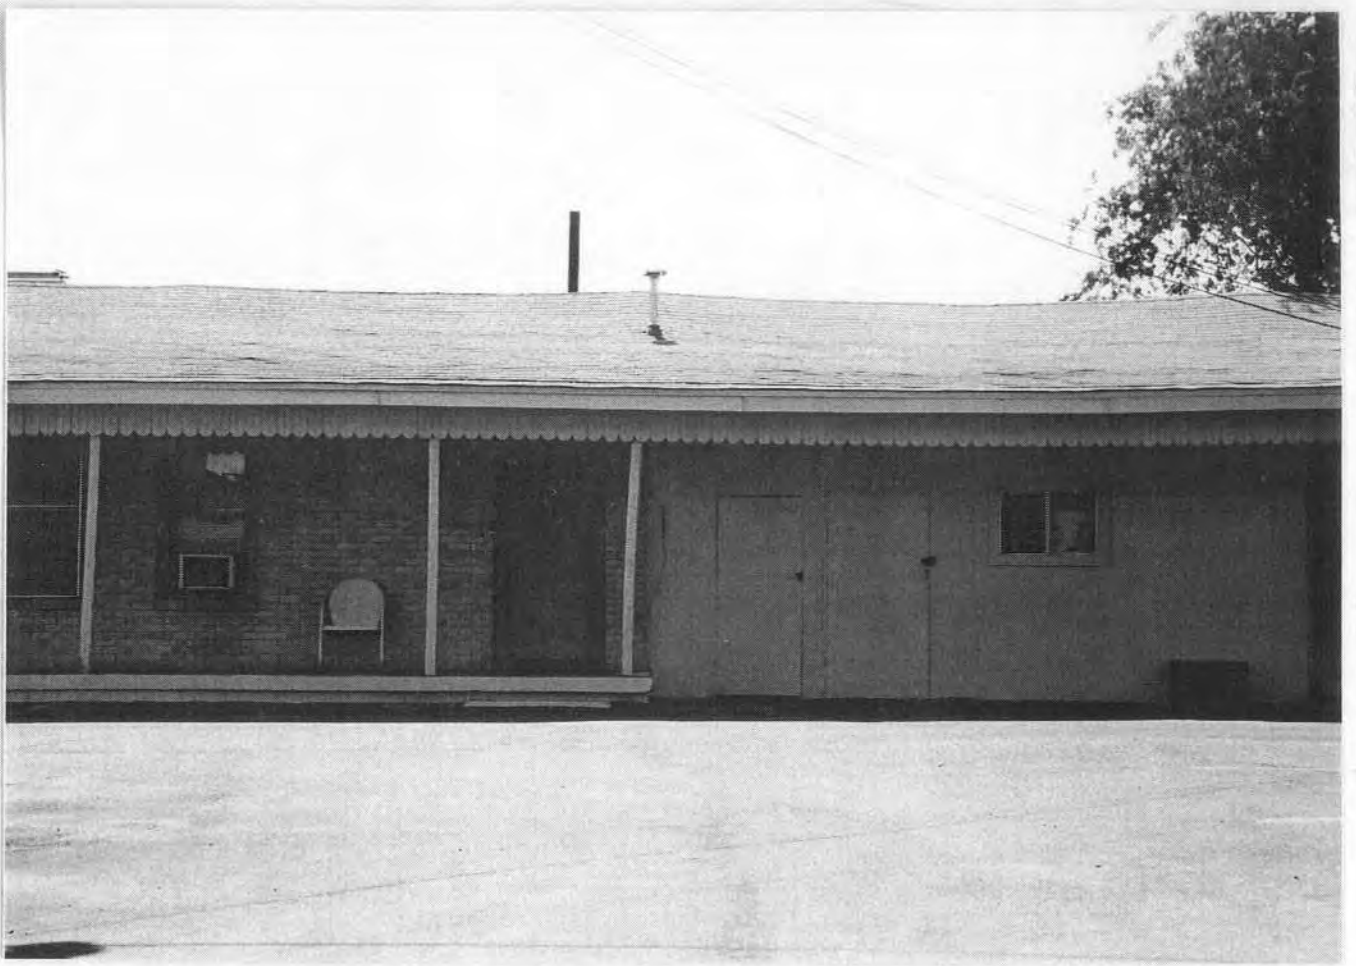
375-AM-70B
24-3761-1
FACING NW

N wing has 2 metal casement windows (#2) see photo 1

1 typical unit #2 Look NW

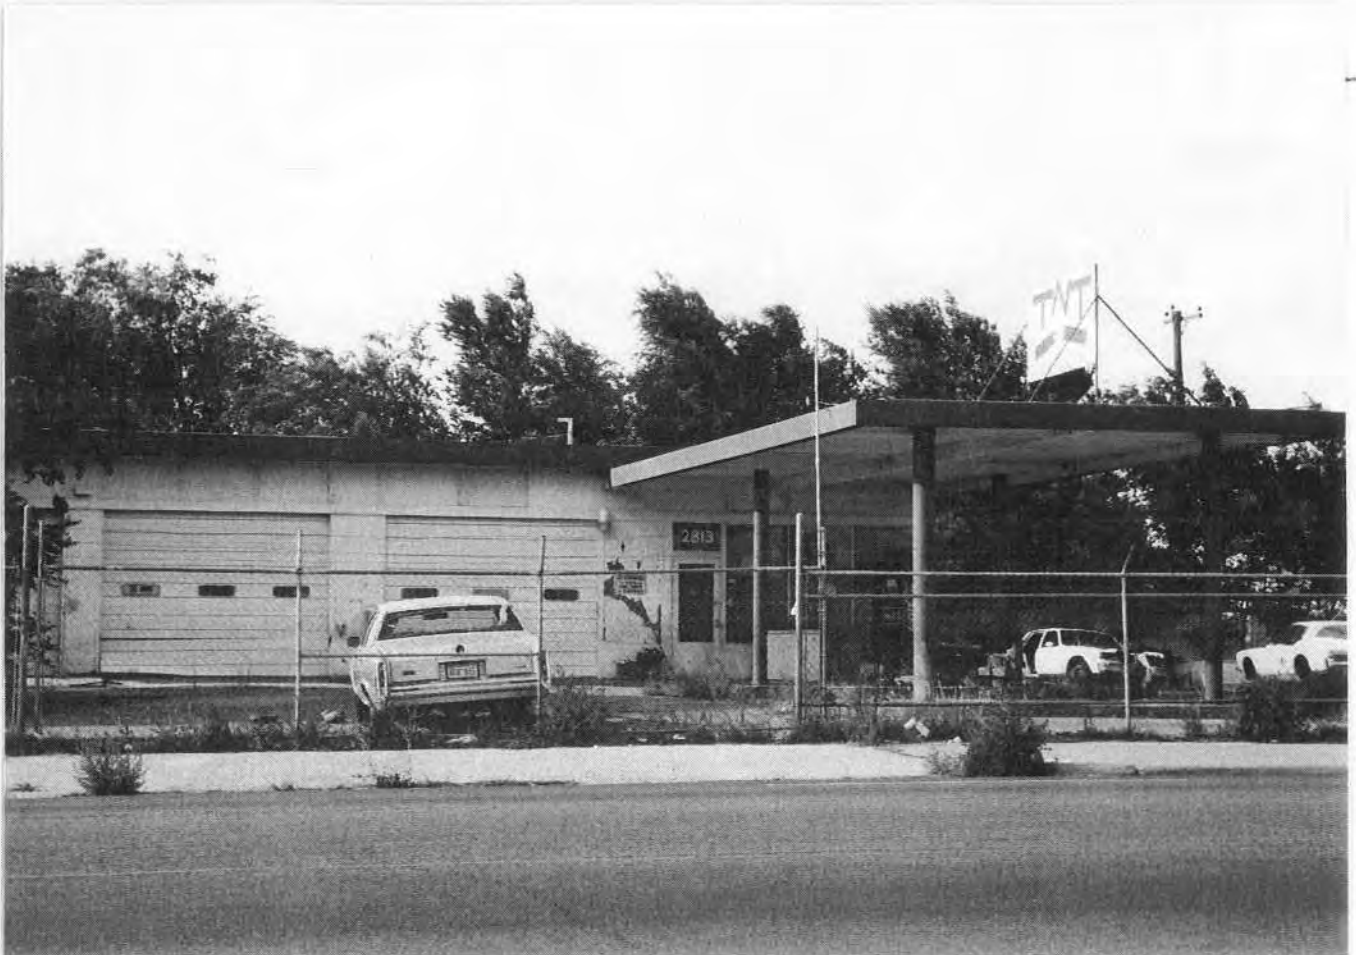
375 AM-9
25-3763-5
FACING NORTH

County Potter City Anadarko Inventory # 375 - AM - 95
Historic Name ^{Address} Location of Green Gate Court (1945 [last address changed to 2813 in 1955] / 2017 listed as Standard
Current Name TNT Auto Body ^{Oil Gas Station (1960, 1965)}
Address 2813 ANA Blvd
Lot(s): _____ Block: _____ Addition: _____
Owners Address _____
Resource type Building Structure Site Object District
Landscape/Site Features pump islands
Outbuildings _____
Function: Current Use Auto Historic Use gas
Construction Date: 1960 Actual Estimated
Architect _____ Builder _____
Possible Threat(s) Demolition Development Neglect Alteration Vacant Utility Expansion
Integrity Location Design Materials Workmanship Setting Feeling Association
USGS Quad #: _____ Year: _____ UTM Zone: _____ Easting: _____ Northing: _____
Priority High Medium Low Recorder Monica Penick Date(s) 7/16/2002

Roof type flat Materials _____

Wall facade PLYWOODED OVER Foundation _____

Window type plate in metal Materials _____

Door type office. frames glazed in wood frame metal overhead door Materials _____

Porch type canopy on ^{steel} posts (wood frame?) Materials _____

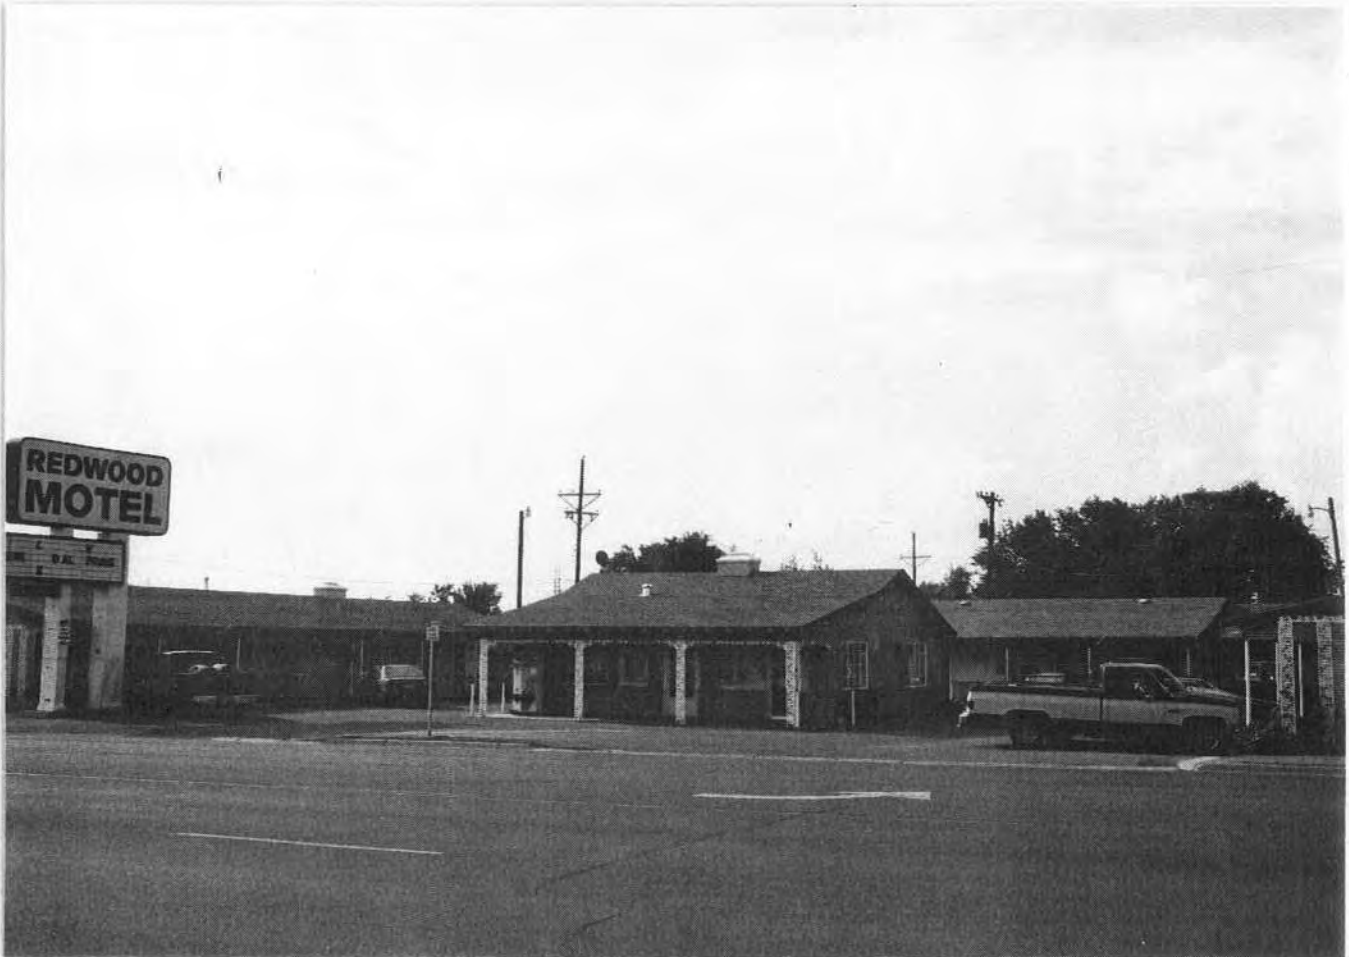
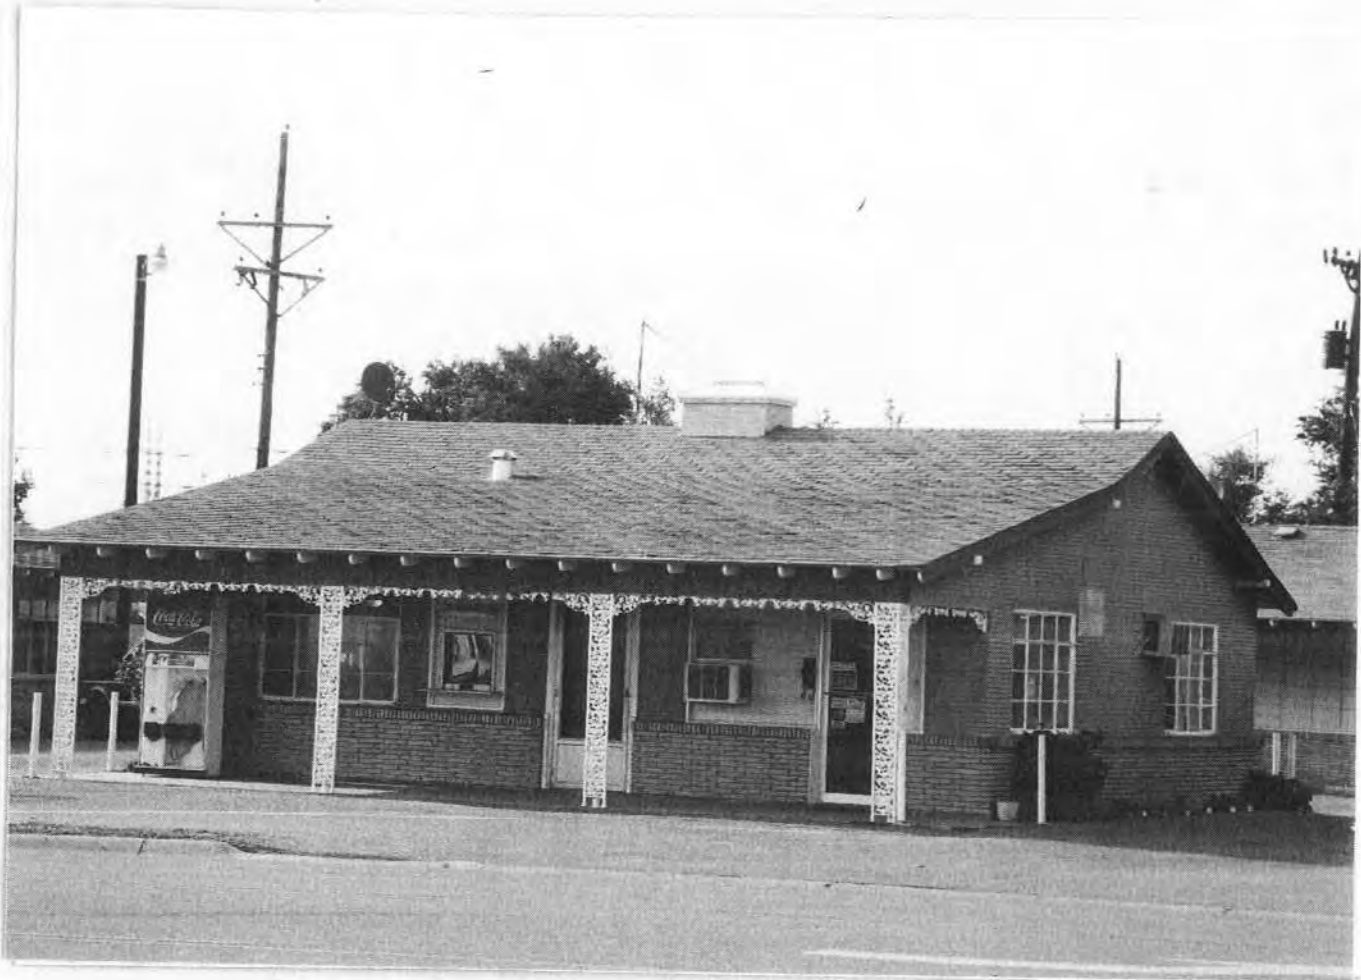
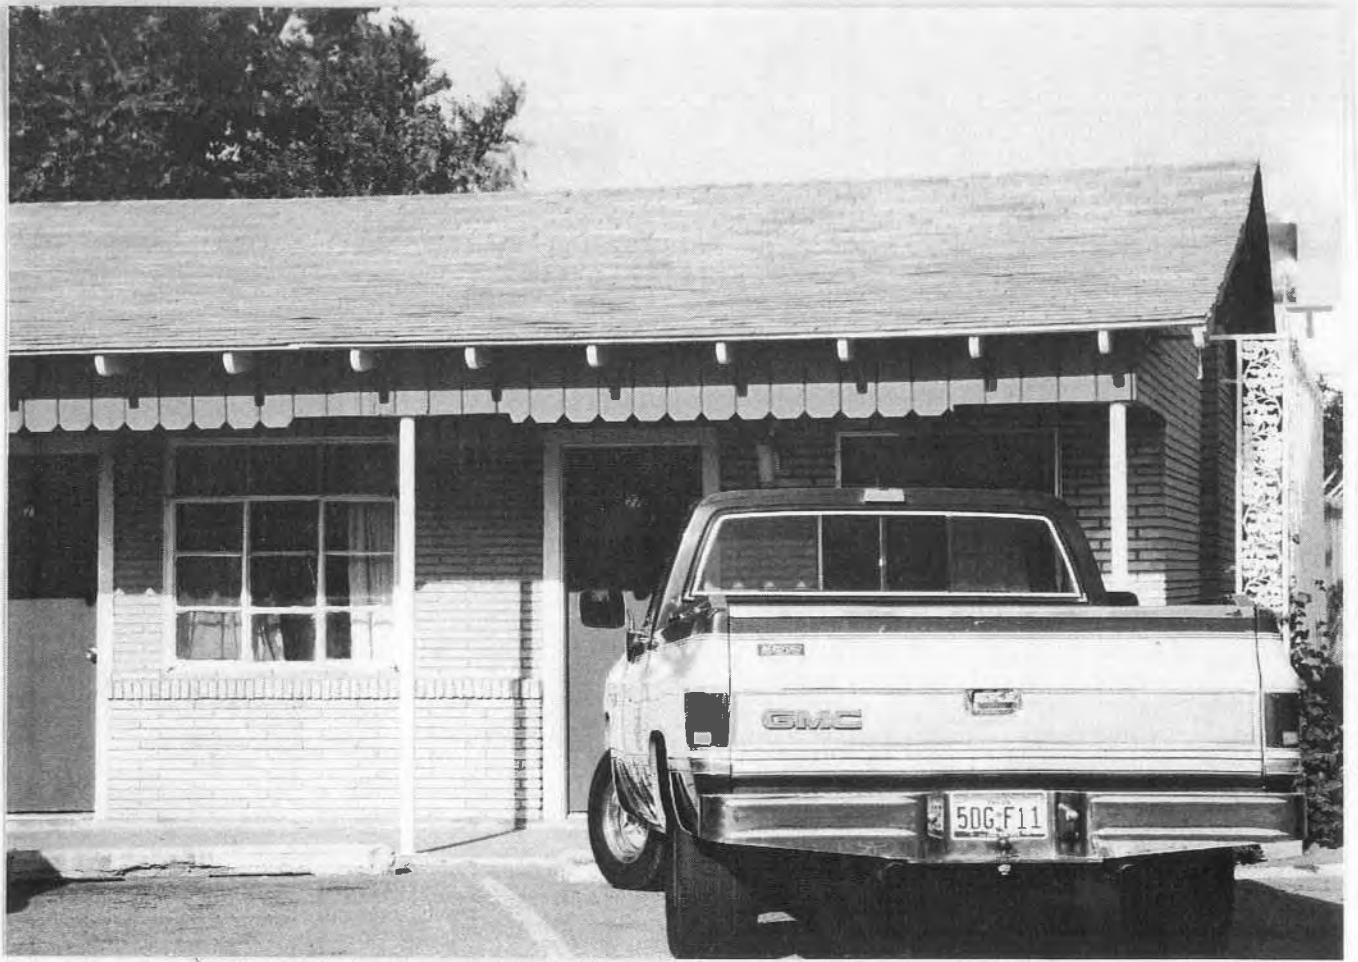
Photo Data: Roll	<u>25</u>	Frame	_____	Feature	<u>7 detail</u>	look	<u>NW</u>
					<u>6 drive</u>	look	<u>N</u>
					<u>2 typ unit</u>	look	<u>E</u>

County Pottaw City Amiteville Inventory # 375 AM-96A
Historic Name Redwood Motel (1955-present) B
Current Name Redwood Motel
Address 2801 AMA Blvd
Lot(s): _____ Block: _____ Addition: _____
Owners Address _____
Resource type Building Structure Site Object District
Landscape/Site Features _____
Outbuildings _____
Function: Current Use down motel Historic Use down motel
Construction Date: 1955 Actual Estimated
Architect _____ Builder _____
Possible Threat(s) Demolition Development Neglect Alteration Vacant Utility Expansion
Integrity Location Design Materials Workmanship Setting Feeling Association
USGS Quad #: _____ Year: _____ UTM Zone: _____ Easting: _____ Northing: _____
Priority High Medium Low Recorder Monica Penick Date(s) 7/16/2002

Roof type ¹⁰ (A) side gable w/ exp raft-ends

Wall facade buff brick (veneer)

Window type metal casement

Door type (A) 1/2 glass 1/2 solid (B) solid

Porch type over hanging eave on dec iron

General Architectural Description decorative vert fascia boards

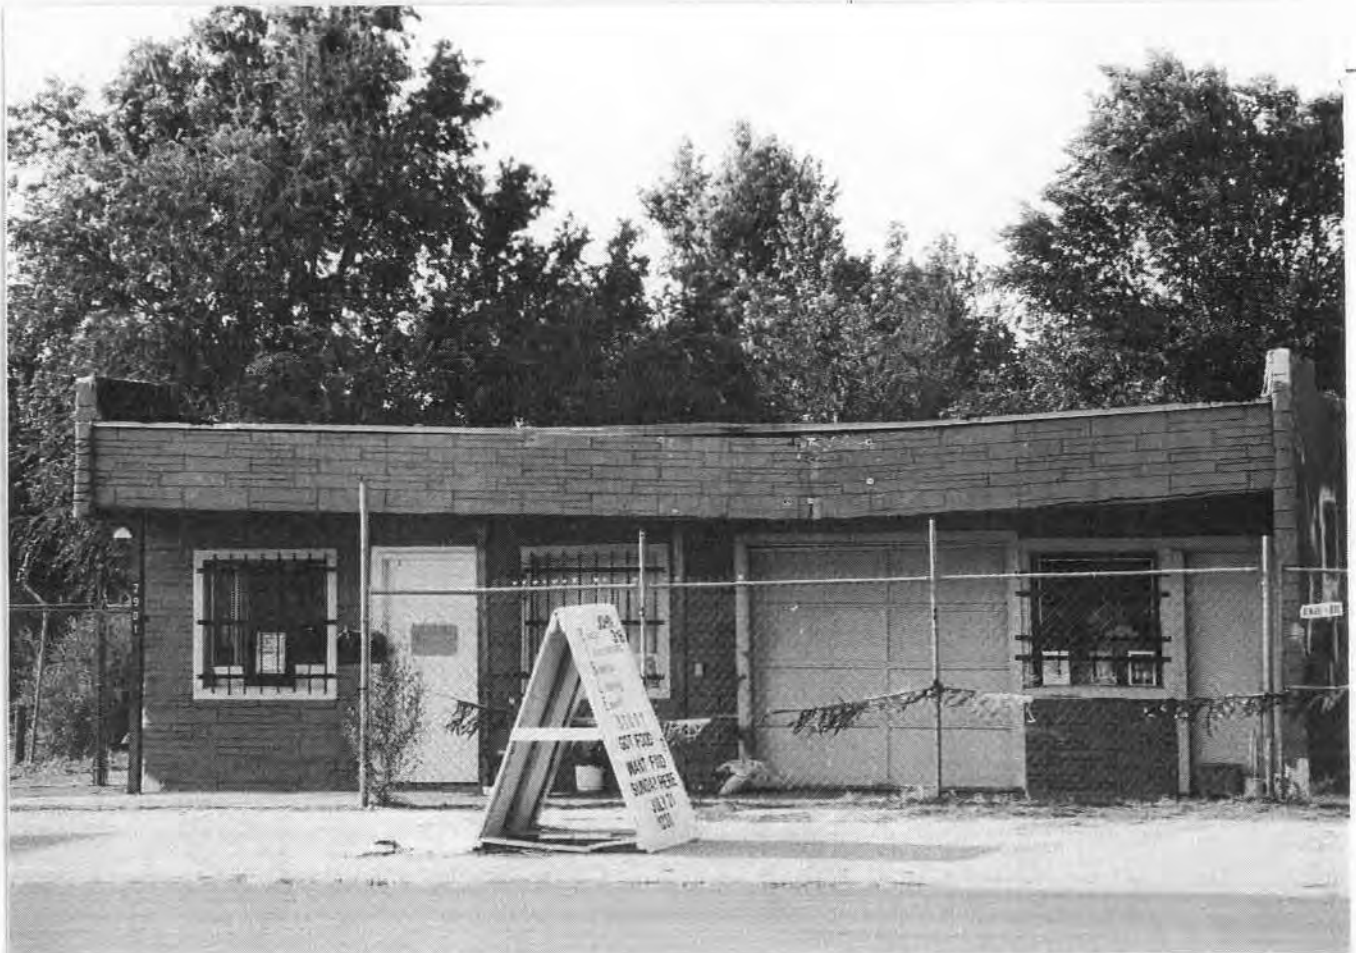
County Potter City Amorville Inventory # 375-AM-97
 Historic Name Alvics Food Store (1945-51); High Plains Food Store (1955) ^{out of sequence}
 Current Name Wounded Hearts Outreach Mission Terry's Cafe (1960); Jane May Cafe (1965)
 Address 2901 (??) Amor Blvd CN. sid. adjacent to Las Palmas
 Lot(s): _____ Block: _____ Addition: _____
 Owners Address _____
 Resource type Building Structure Site Object District
 Landscape/Site Features _____
 Outbuildings _____
 Function: Current Use Comm / non-profit org Historic Use Comm / grocery, restaurant
 Construction Date: 1945 Actual Estimated
 Architect _____ Builder _____
 Possible Threat(s) Demolition Development Neglect Alteration Vacant Utility Expansion
 Integrity Location Design Materials Workmanship Setting Feeling Association
 USGS Quad #: _____ Year: _____ UTM Zone: _____ Easting: _____ Northing: _____
 Priority High Medium Low Recorder Monica Penick Date(s) 7/16/2002

Roof type flat w/ parapet

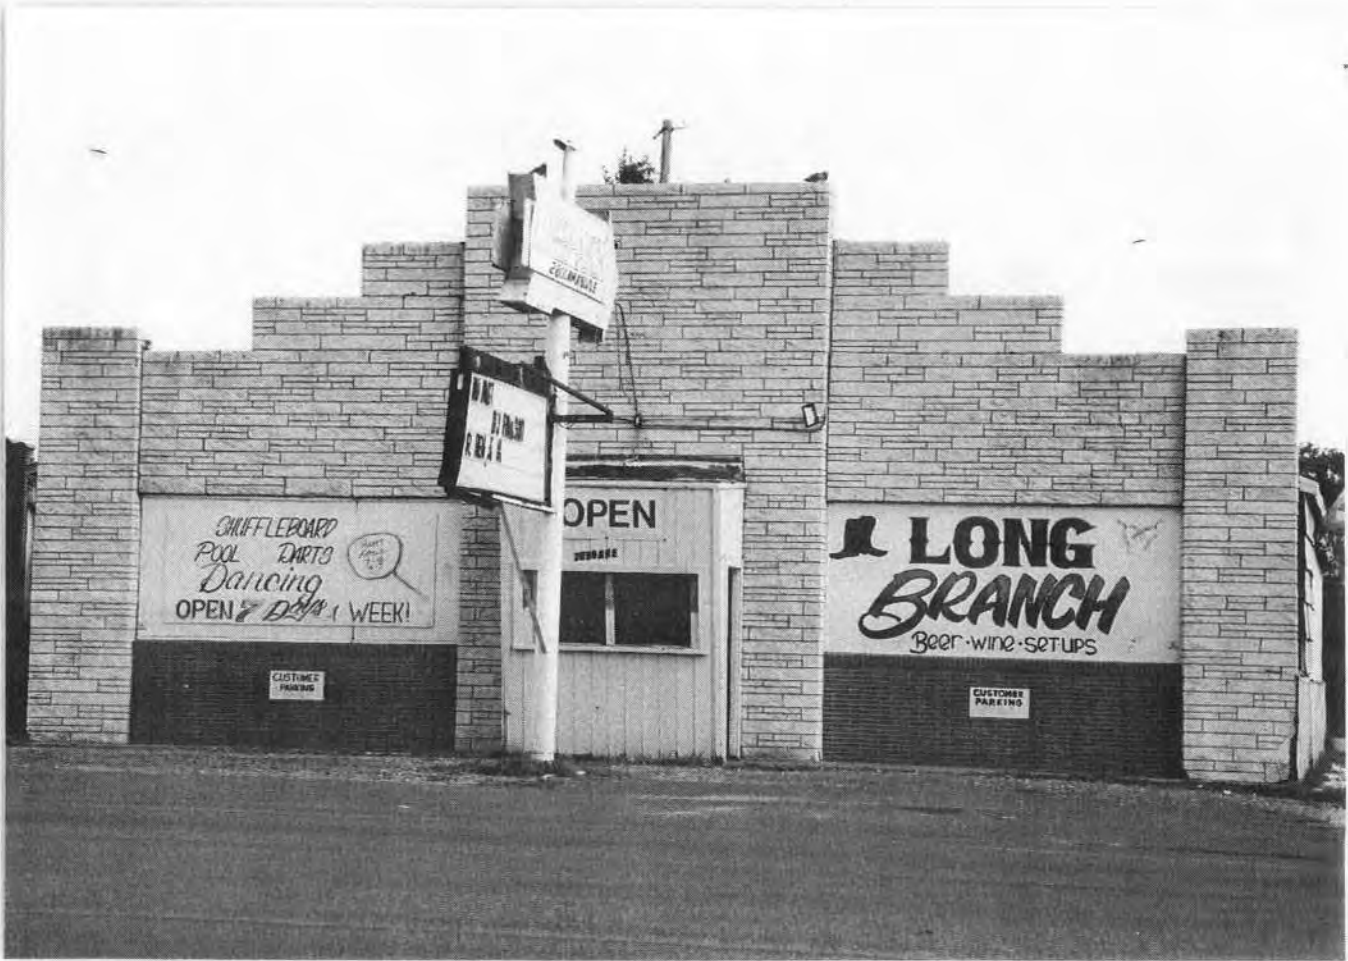
County Pitkin City Amarillo Inventory # 375-AM-98
 Historic Name Amarillo Trans & Stage Co (1945), White Way Food Store (1951), Dawell's Steak House (1955-1960)
 Current Name Long Branch DA Steak House (1965)
 Address 2400 Am Blvd
 Lot(s): _____ Block: _____ Addition: _____
 Owners Address _____
 Resource type Building Structure Site Object District
 Landscape/Site Features sign
 Outbuildings _____
 Function: Current Use BAR Historic Use Conv / ^{Side by} Restaurant
 Construction Date: 1945 w/ alterations Actual Estimated
 Architect _____ Builder _____
 Possible Threat(s) Demolition Development Neglect Alteration Vacant Utility Expansion
 Integrity Location Design Materials Workmanship Setting Feeling Association
 USGS Quad #: _____ Year: _____ UTM Zone: _____ Easting: _____ Northing: _____
 Priority High Medium Low Recorder Monica Penick Date(s) 7/16/2002

Roof type front gable w/ stepped parapet Materials _____

Wall facade scored stucco (to look like ashlar) Foundation _____

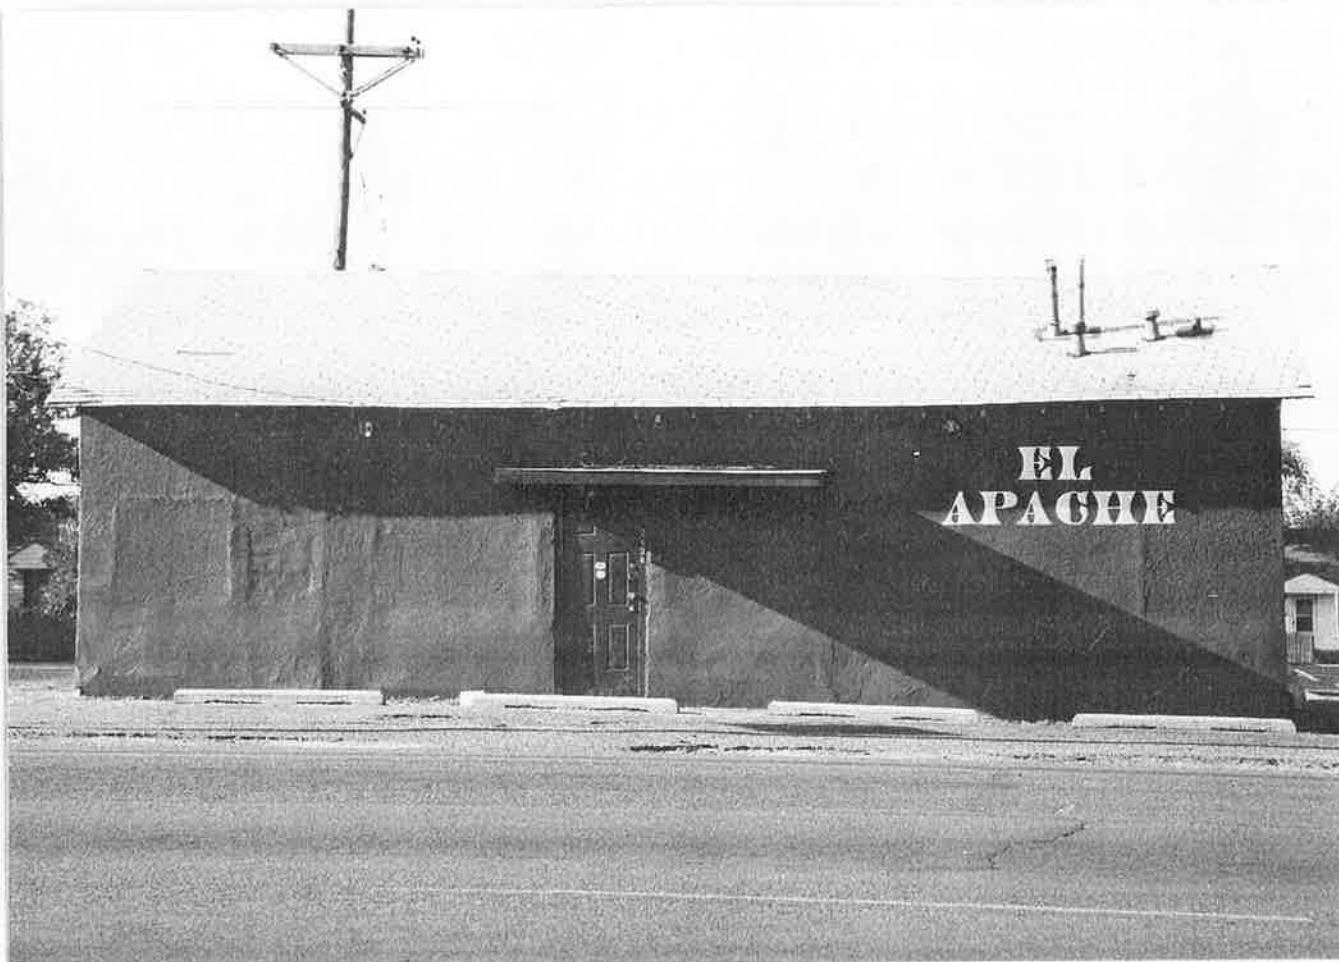
County POTTER City ARMELLO Inventory # 375-AM 99
 Historic Name Ridgeway Package Co Liquor (1951-1965 as liquor) / Burnell Service Station
 Current Name El Apache (1939)
 Address 2628 Ann Blvd (S side)
 Lot(s): _____ Block: _____ Addition: _____
 Owners Address _____
 Resource type Building Structure Site Object District
 Landscape/Site Features _____
 Outbuildings _____
 Function: Current Use Comm Historic Use Comm
 Construction Date: 1939 (significantly altered) Actual Estimated
 Architect _____ Builder _____
 Possible Threat(s) Demolition Development Neglect Alteration Vacant Utility Expansion
 Integrity Location Design Materials Workmanship Setting Feeling Association
 USGS Quad #: _____ Year: _____ UTM Zone: _____ Easting: _____ Northing: _____
 Priority High Medium Low Recorder Monica Penick Date(s) 7/12/2002

Stylistic Influence(s) SPAN.

Roof type Side gable w/ dup raft ends

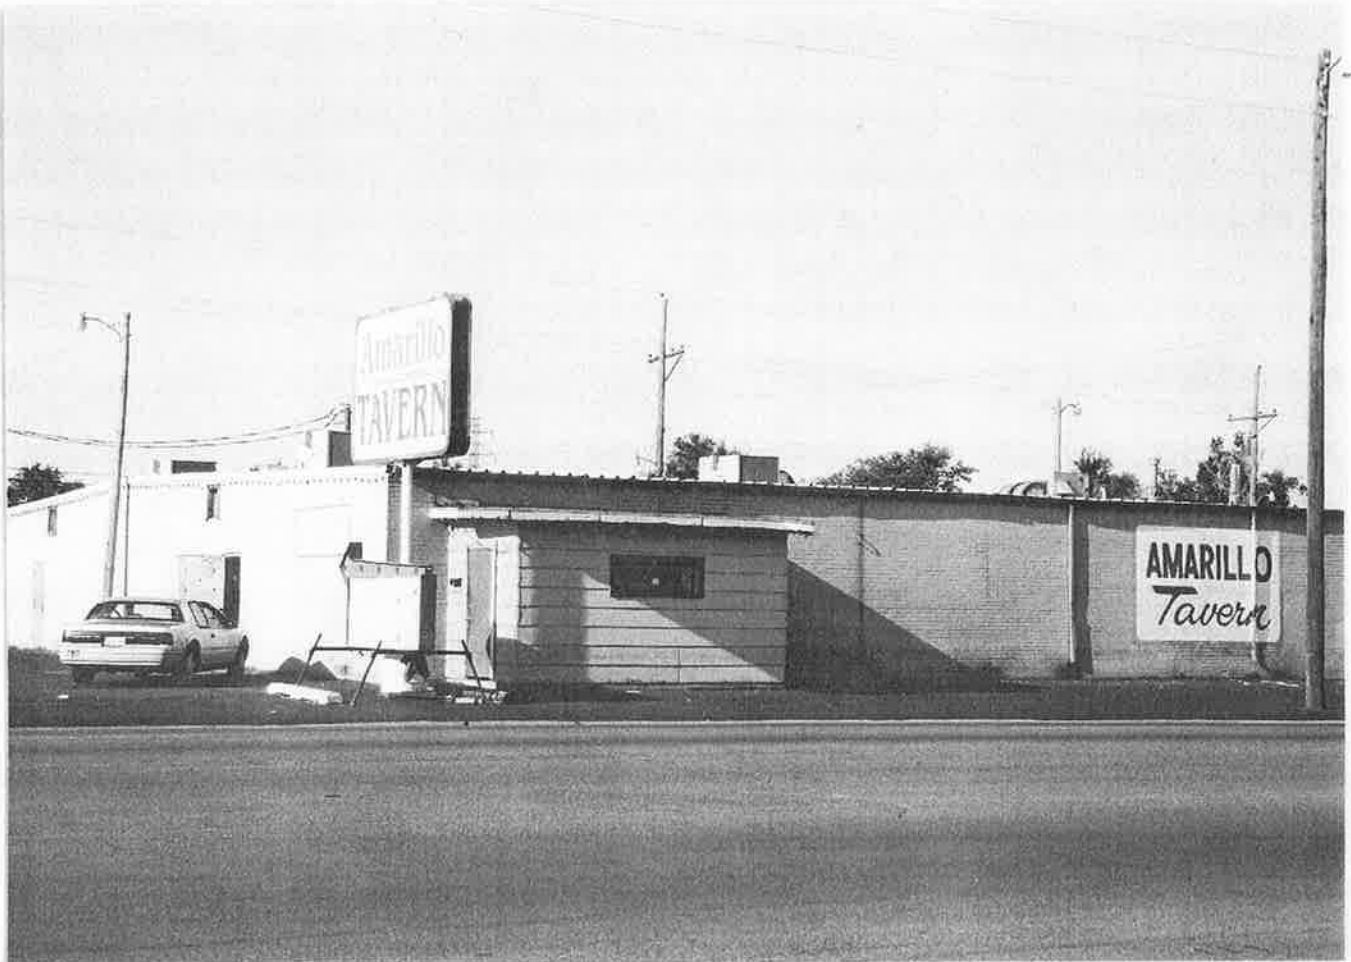
County POTTER City AMARILLO Inventory # 375 - AM 160
Historic Name AVALON CLUB (1945-1960) AVA-LON BALLROOM (1965)
Current Name AMARILLO TAVERN
Address 2624 AMA Blvd (E. side)
Lot(s): _____ Block: _____ Addition: _____
Owners Address _____
Resource type Building Structure Site Object District
Landscape/Site Features _____
Outbuildings _____
Function: Current Use Comm / bar Historic Use Comm /
Construction Date: 1945 Actual Estimated
Architect _____ Builder _____
Possible Threat(s) Demolition Development Neglect Alteration Vacant Utility Expansion
Integrity Location Design Materials Workmanship Setting Feeling Association
USGS Quad #: _____ Year: _____ UTM Zone: _____ Easting: _____ Northing: _____
Priority High Medium Low Recorder Monica Penick Date(s) 7/17/2002

Roof type side gable Materials corr metal

Wall facade pane brick Foundation _____
