Historic Resources Inventory Form—Route 66

County POTTER City AMARILLO Inventory # 375-AM-NE
NOT INVENTORIED 844
 Historic Name PIGGY WIGGLY SIGN PHOTO CARD
 Current Name PIGGY WIGGLY SIGN
 Address AMA Blvd E side (behind/adj to County Motel)
 Lot(s): _____ Block: _____ Addition: _____
 Owners Address _____
 Resource type Building Structure Site Object District
 Landscape/Site Features _____
 Outbuildings _____
 Function: Current Use _____ Historic Use _____
 Construction Date: _____ Actual Estimated
 Architect _____ Builder _____
 Possible Threat(s) Demolition Development Neglect Alteration Vacant Utility Expansion
 Integrity Location Design Materials Workmanship Setting Feeling Association
 USGS Quad #: _____ Year: _____ UTM Zone: _____ Easting: _____ Northing: _____
 Priority High Medium Low Recorder Monica Penick Date(s) 7/16/2002

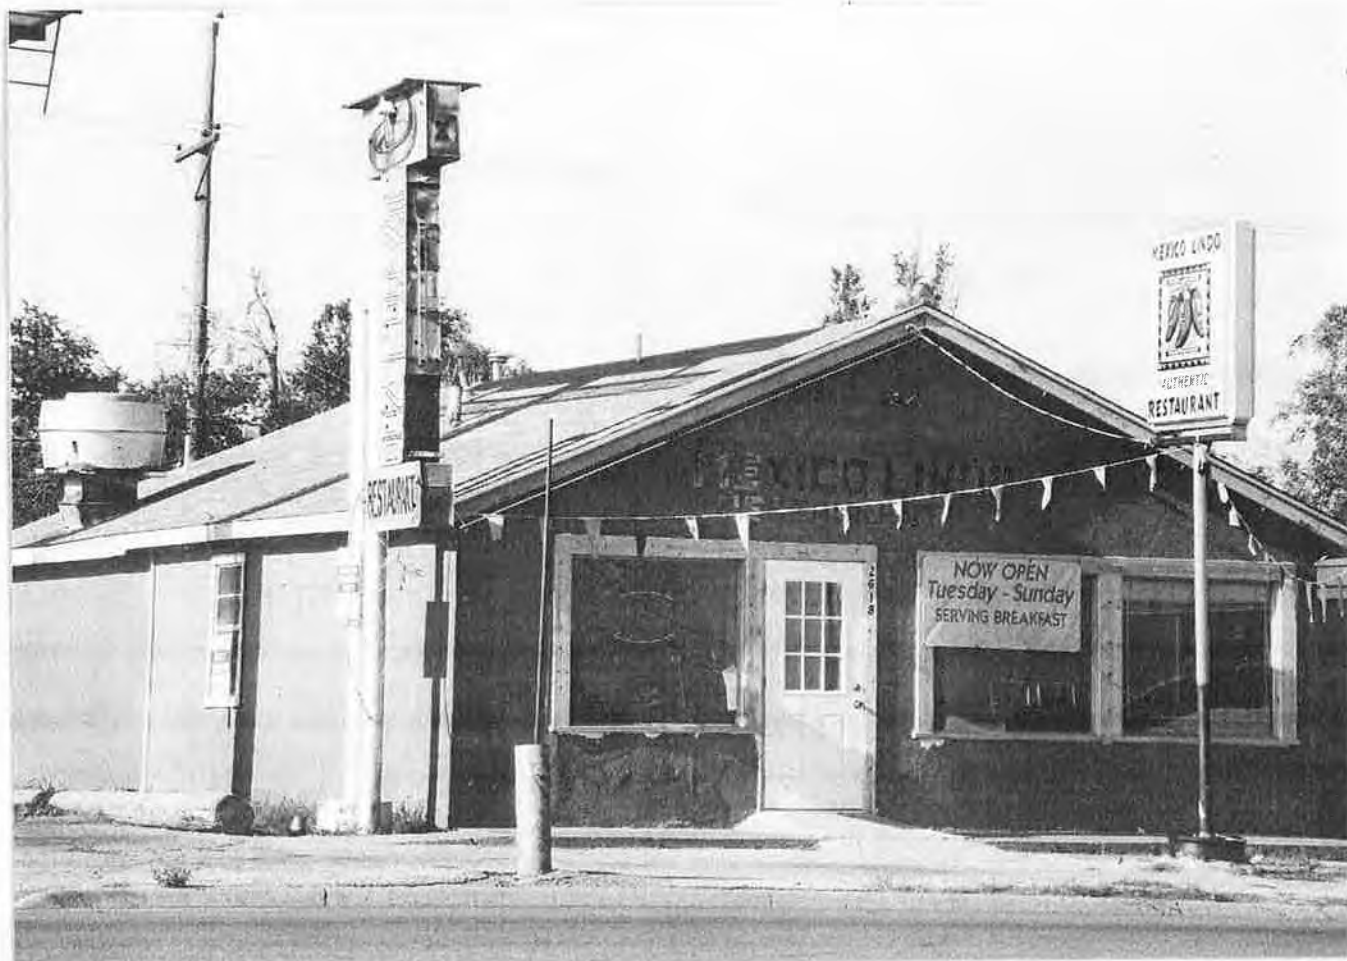
County Potter City Amarillo Inventory # 375 - AM - 101
 Historic Name Ranch House Package Store (1955), Guy's Liquors (1960-1965 at least)
 Current Name Mexico Linda Restaurant
 Address 2618 Am Blvd
 Lot(s): _____ Block: _____ Addition: _____
 Owners Address _____
 Resource type Building Structure Site Object District
 Landscape/Site Features Sign
 Outbuildings _____
 Function: Current Use comm Historic Use residential / commercial
 Construction Date: 1940 (listed as residence in 1945) Actual Estimated
 Architect _____ Builder _____
 Possible Threat(s) Demolition Development Neglect Alteration Vacant Utility Expansion
 Integrity Location Design Materials Workmanship Setting Feeling Association
 USGS Quad #: _____ Year: _____ UTM Zone: _____ Easting: _____ Northing: _____
 Priority High Medium Low Recorder Monica Penick Date(s) 7/17/2002

Stylistic Influence(s) _____
 Roof type front gable Materials concrete shingles
 Wall facade stucco Foundation _____
 Window type plate in wood Materials _____
 Door type (non-orig) multi-light over 2 panels Materials metal frame
 Porch type N/A Materials _____
 Number of Stories 1 Plan _____
 Chimney(s) _____

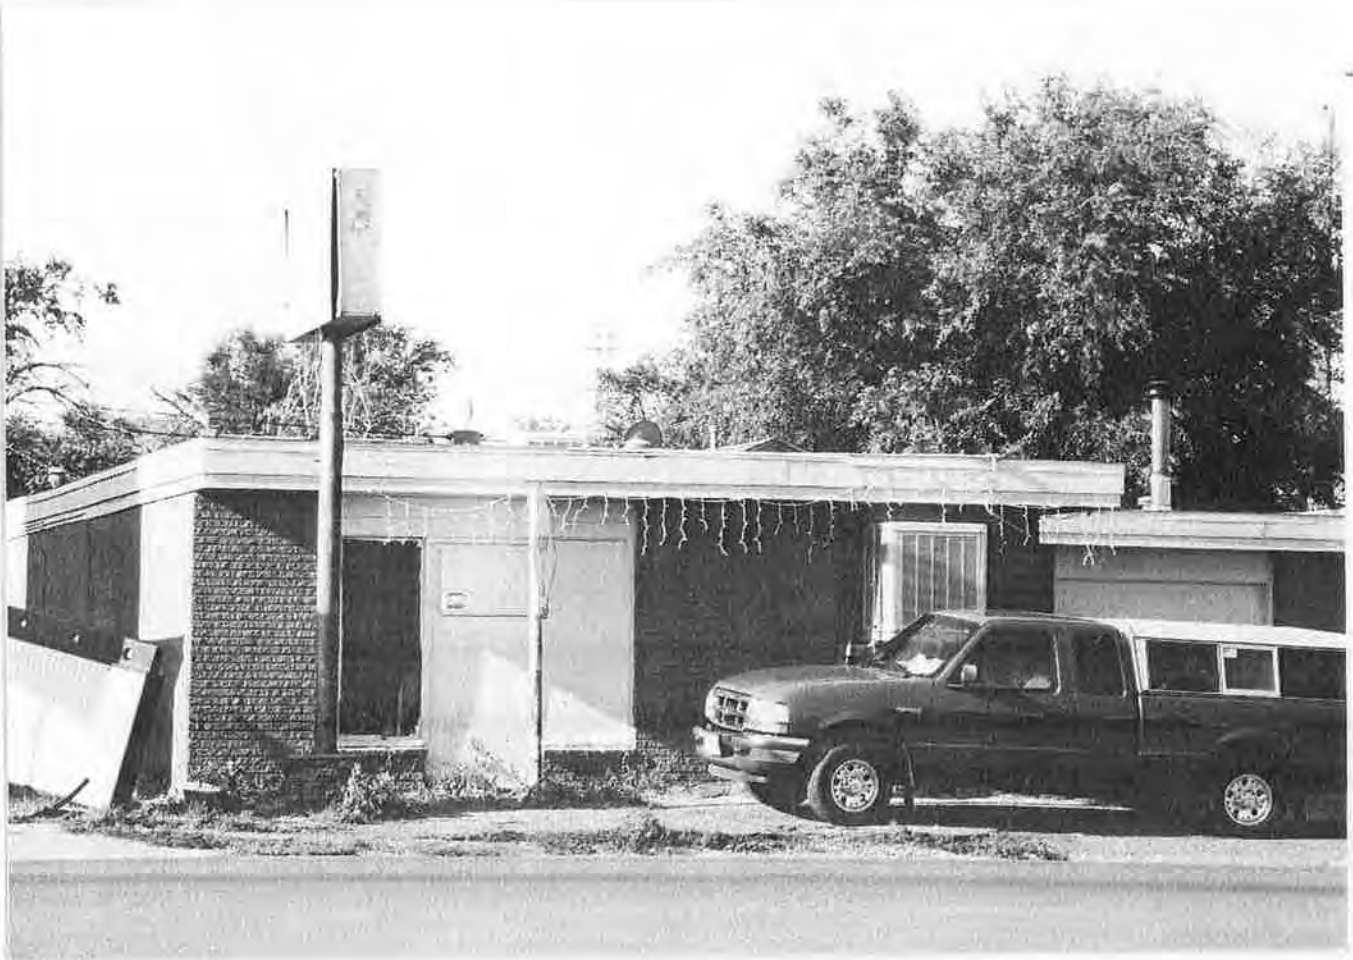
County POTTER City Amarillo Inventory # 375-AM-102
Historic Name Art's Cafe? (1954-1966 (1963) 2614)
Current Name Ludis Lounge
Address 2614 (7) - Ama Blvd (S. Side)
Lot(s): _____ Block: _____ Addition: _____
Owners Address _____
Resource type Building Structure Site Object District
Landscape/Site Features Sign
Outbuildings _____
Function: Current Use Comm Historic Use Comm
Construction Date: 1950 Actual Estimated
Architect _____ Builder _____
Possible Threat(s) Demolition Development Neglect Alteration Vacant Utility Expansion
Integrity Location Design Materials Workmanship Setting Feeling Association
USGS Quad #: _____ Year: _____ UTM Zone: _____ Easting: _____ Northing: _____
Priority High Medium Low Recorder Monica Penick Date(s) 7/7/2002

Roof type flat w/ exaggerated metal fascia Materials _____

Wall facade brick Foundation _____

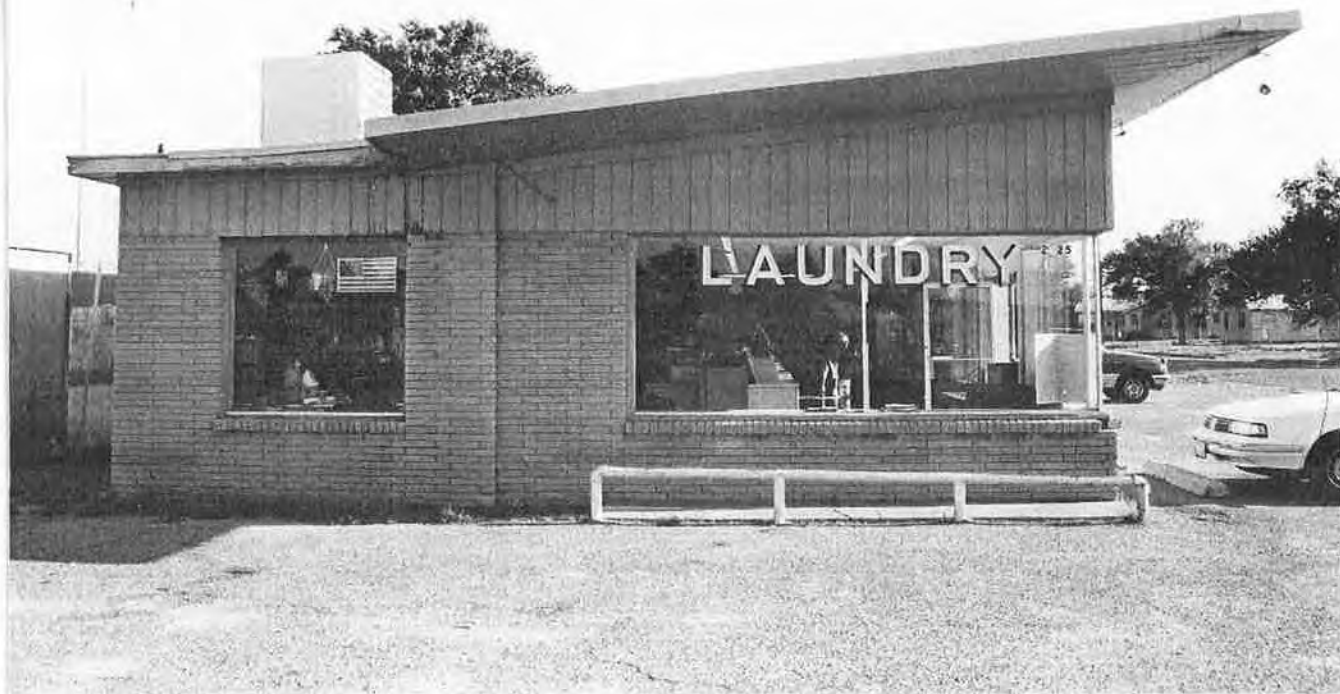
County POTTER City AMARILLO Inventory # 395-AM-103
 Historic Name G & G Package Store (1955); Automatic Wash & Dry (1960-1965 at least)
 Current Name LAUNDRY
 Address 2625 AMARILLO BLVD (N side)
 Lot(s): _____ Block: _____ Addition: _____
 Owners Address _____
 Resource type Building Structure Site Object District
 Landscape/Site Features _____
 Outbuildings _____
 Function: Current Use laund Historic Use laund
 Construction Date: 1955 Actual Estimated
 Architect _____ Builder _____
 Possible Threat(s) Demolition Development Neglect Alteration Vacant Utility Expansion
 Integrity Location Design Materials Workmanship Setting Feeling Association
 USGS Quad #: _____ Year: _____ UTM Zone: _____ Easting: _____ Northing: _____
 Priority High Medium Low Recorder Monica Penick Date(s) 7/12/2002

Roof type shed w/ upturned fascia @ eave Materials _____

Wall facade front: buff brick, side: conc Foundation _____

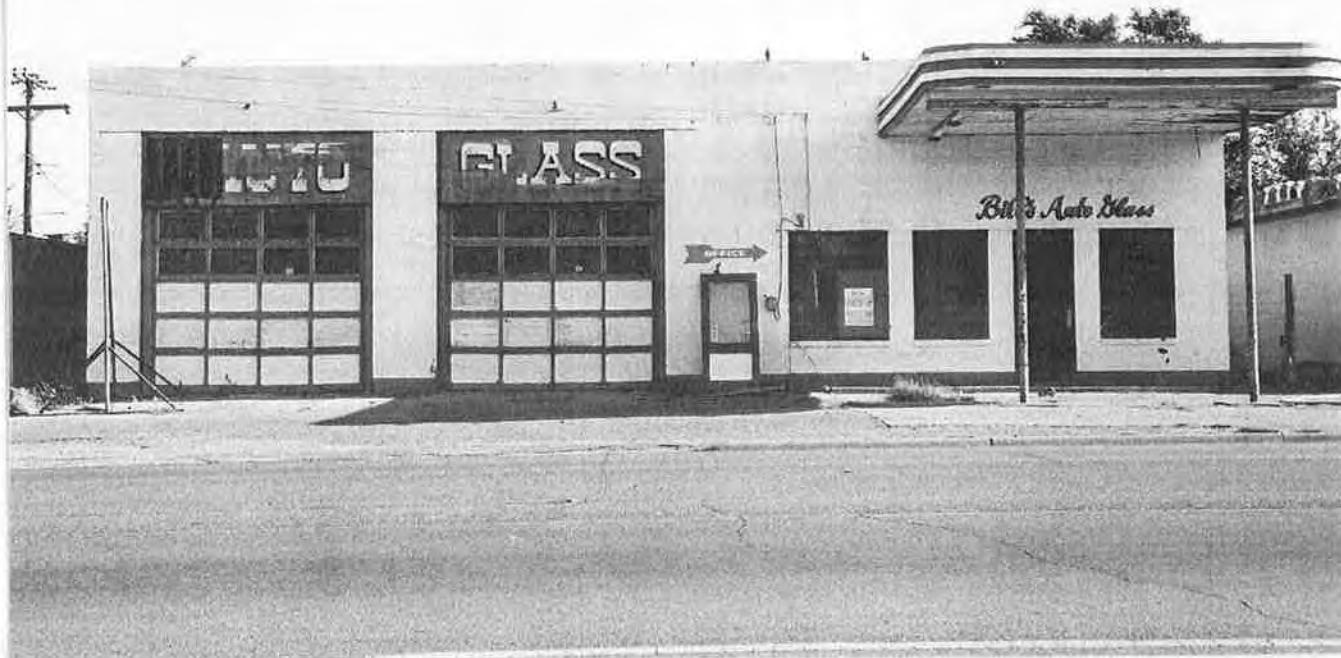
County TARRANT City AMARILLO Inventory # 375-AM-104
 Historic Name McPherson Service Station (1945), Parsley's Wrecking Yard (1951-1959) ^{Auto Shop} ^{VACANT 1960-65}
 Current Name Bill's Auto Glass
 Address 2403 AMA Blvd
 Lot(s): _____ Block: _____ Addition: _____
 Owners Address _____
 Resource type Building Structure Site Object District
 Landscape/Site Features pump island visible
 Outbuildings _____
 Function: Current Use Auto Historic Use gas / garage
 Construction Date: 1945 Actual Estimated
 Architect _____ Builder _____
 Possible Threat(s) Demolition Development Neglect Alteration Vacant Utility Expansion
 Integrity Location Design Materials Workmanship Setting Feeling Association
 USGS Quad #: _____ Year: _____ UTM Zone: _____ Easting: _____ Northing: _____
 Priority High Medium Low Recorder Monica Penick Date(s) 7/17/2002

Roof type flat Materials _____

Wall facade concrete block Foundation _____

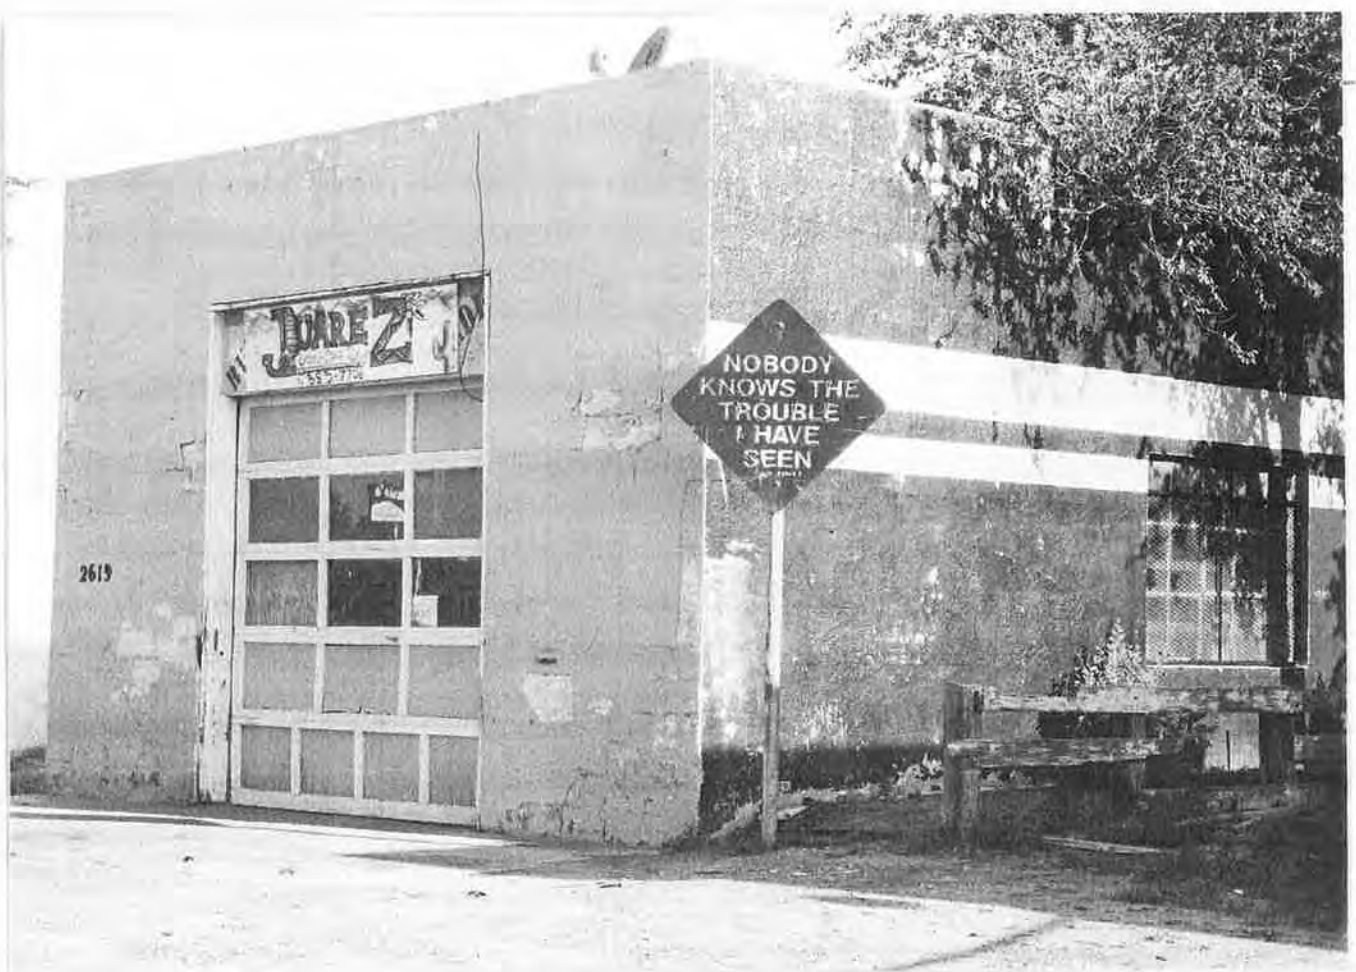
County POTTER City AMARILLO Inventory # 395-AM-105
Historic Name Richardson's Garage (1955-1965 or 1965)
Current Name JUAREZ Used Car Sales
Address 2619 AMA Blvd (N S.D.)
Lot(s): _____ Block: _____ Addition: _____
Owners Address _____
Resource type Building Structure Site Object District
Landscape/Site Features _____
Outbuildings _____
Function: Current Use 10mm Historic Use Com
Construction Date: 1954 Actual Estimated
Architect _____ Builder _____
Possible Threat(s) Demolition Development Neglect Alteration Vacant Utility Expansion
Integrity Location Design Materials Workmanship Setting Feeling Association
USGS Quad #: _____ Year: _____ UTM Zone: _____ Easting: _____ Northing: _____
Priority High Medium Low Recorder Monica Penick Date(s) 7/12/2002

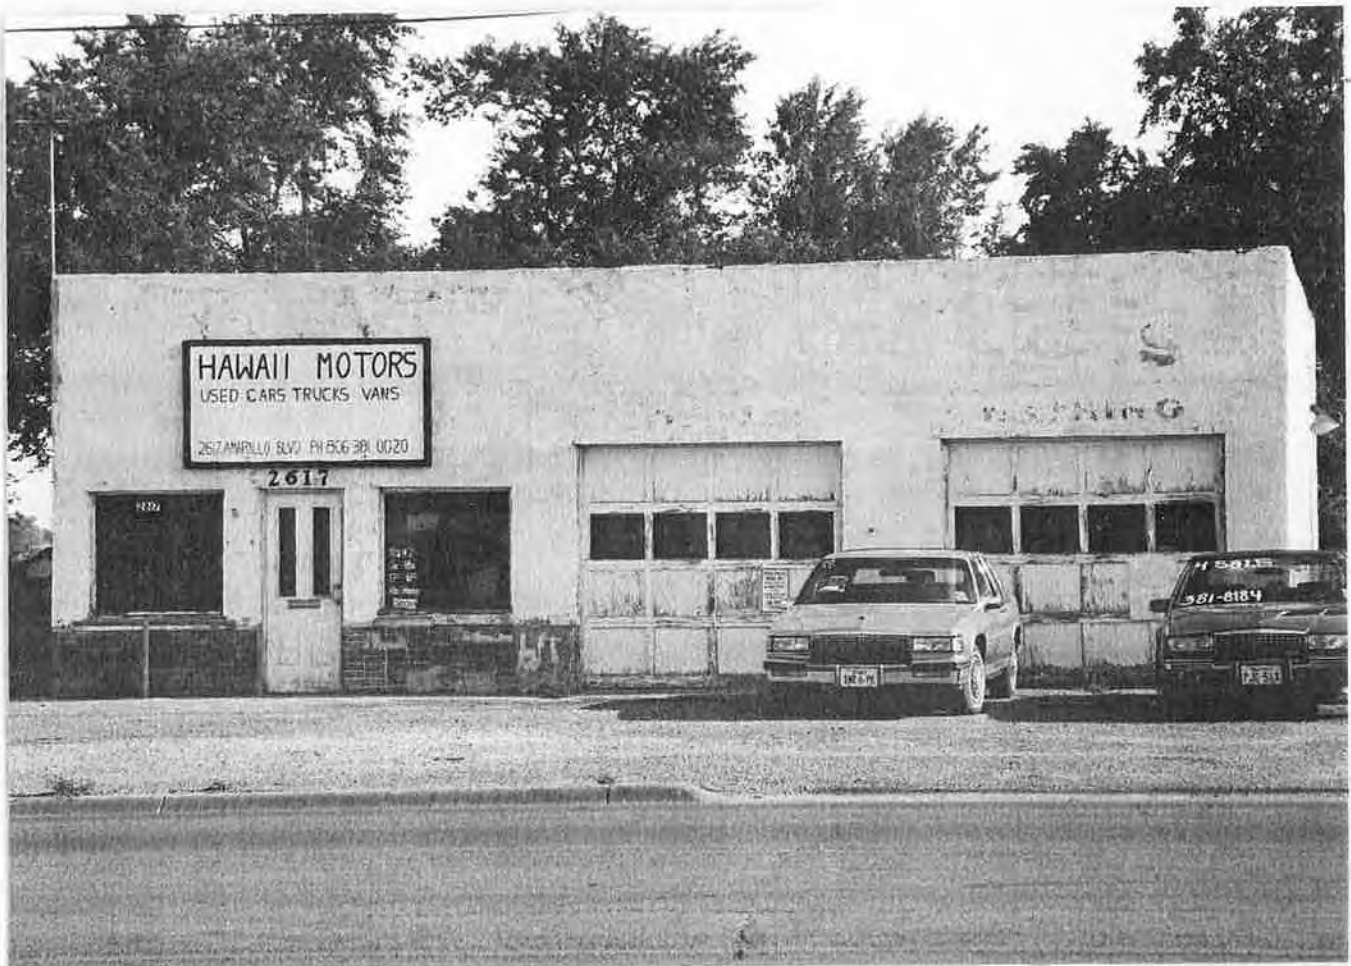
County POTER City AMARILLO Inventory # 375-AM-106
 Historic Name Ted Wade Service Station (1951) Hulton Service Sta (1955) Lovett Super Sta (1960)
 Current Name HAWAII MOTORS E & L Tire (1965)
 Address 2617 AMARILLO Blvd (N. side)
 Lot(s): _____ Block: _____ Addition: _____
 Owners Address _____
 Resource type Building Structure Site Object District
 Landscape/Site Features _____
 Outbuildings _____
 Function: Current Use Auto garage Historic Use Auto garage
 Construction Date: 1950 Actual Estimated
 Architect _____ Builder _____
 Possible Threat(s) Demolition Development Neglect Alteration Vacant Utility Expansion
 Integrity Location Design Materials Workmanship Setting Feeling Association
 USGS Quad #: _____ Year: _____ UTM Zone: _____ Easting: _____ Northing: _____
 Priority High Medium Low Recorder Monica Penick Date(s) 7/19/2002

Roof type flat Materials _____

Wall facade Stucco w/ brick sill Foundation under windows

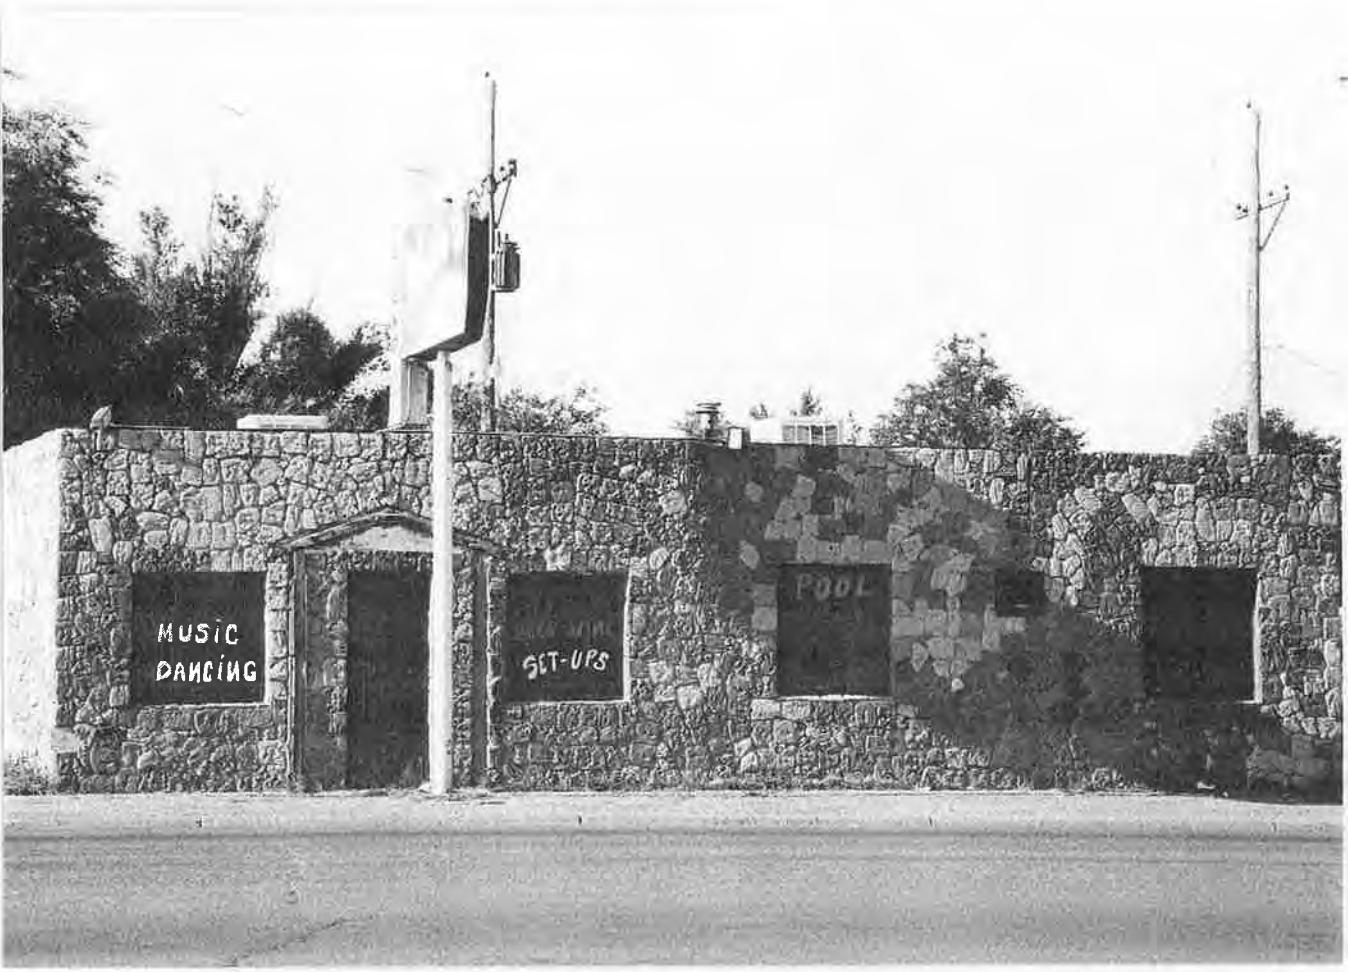
County POTTER City AMARILLO Inventory # 375-AM-107
Historic Name ARTS LOUNGE (1955-1965 at least) OUT OF SEQ
Current Name MARIO'S ON THE BLVD - TEJANO CLUB
Address 2612 AMA Blvd
Lot(s): _____ Block: _____ Addition: _____
Owners Address _____
Resource type Building Structure Site Object District
Landscape/Site Features SIGN
Outbuildings _____
Function: Current Use BAR Historic Use CLUB / BAR
Construction Date: 1955 Actual Estimated
Architect _____ Builder _____
Possible Threat(s) Demolition Development Neglect Alteration Vacant Utility Expansion
Integrity Location Design Materials Workmanship Setting Feeling Association
USGS Quad #: _____ Year: _____ UTM Zone: _____ Easting: _____ Northing: _____
Priority High Medium Low Recorder Monica Penick Date(s) 7/17/2002

Roof type Flat

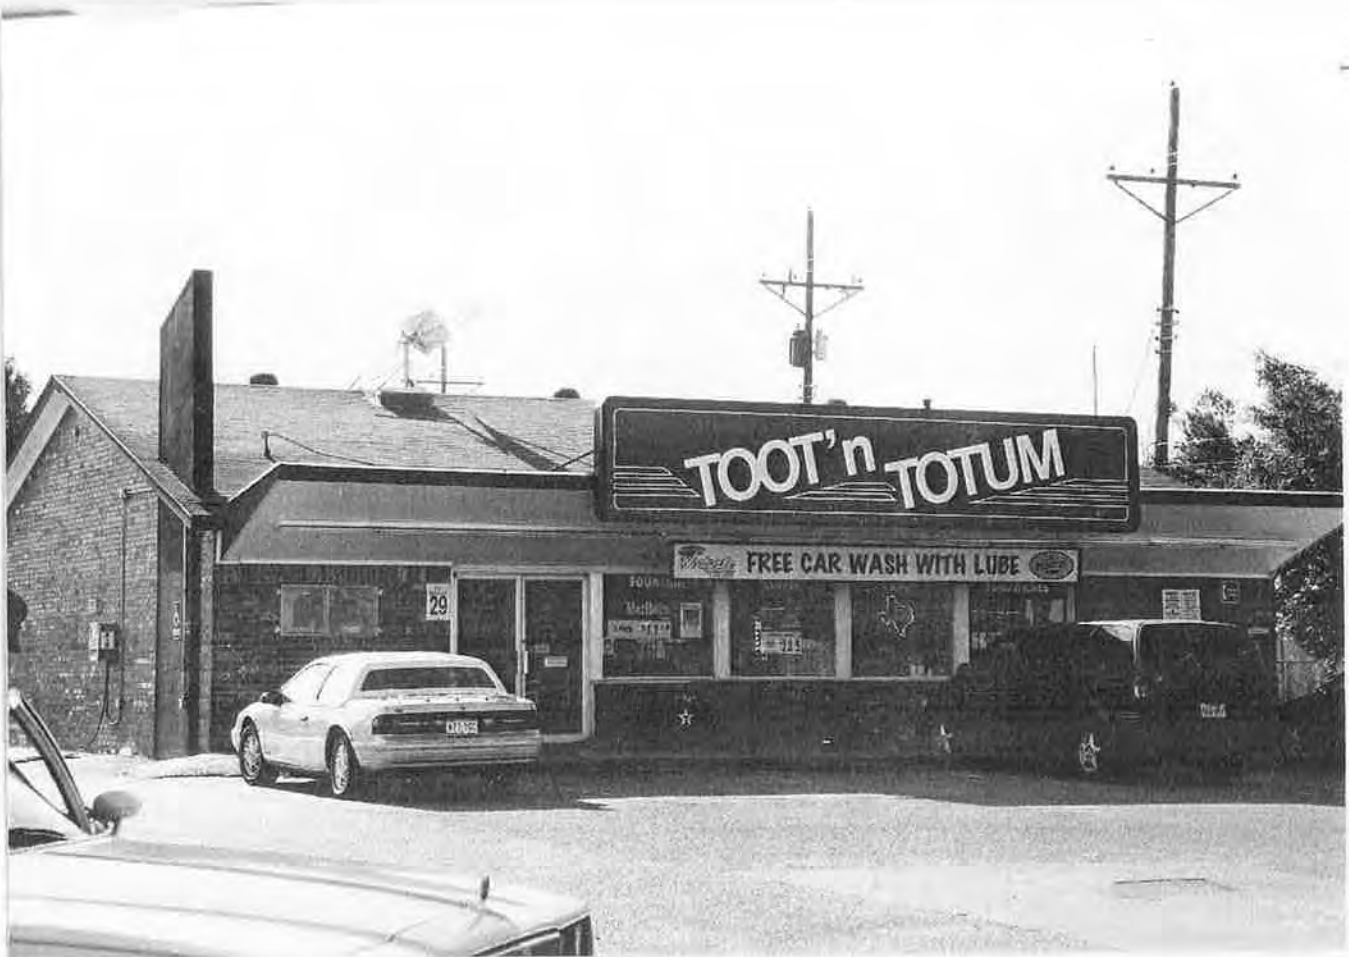
County POTTER City AMARILLO Inventory # 375 - AM - 108
Historic Name Site of Jacobs Service Station (1940); Cozy Cafe & Trailer Park (1951-1959) Car Rental (1960)
Current Name Texaco / Toot 'n Totum Spuds Auto Sales (1965)
Address 2600 AMA Blvd
Lot(s): _____ Block: _____ Addition: _____
Owners Address _____
Resource type Building Structure Site Object District
Landscape/Site Features _____
Outbuildings _____
Function: Current Use comm Historic Use comm / domestic
Construction Date: 1965 Actual Estimated
Architect _____ Builder _____
Possible Threat(s) Demolition Development Neglect Alteration Vacant Utility Expansion
Integrity Location Design Materials Workmanship Setting Feeling Association
USGS Quad #: _____ Year: _____ UTM Zone: _____ Easting: _____ Northing: _____
Priority High Medium Low Recorder Monica Penick Date(s) 7/17/2002

Roof type side gable w/ upward turned Materials lattice on main (W) elevation

Wall facade brick Foundation _____

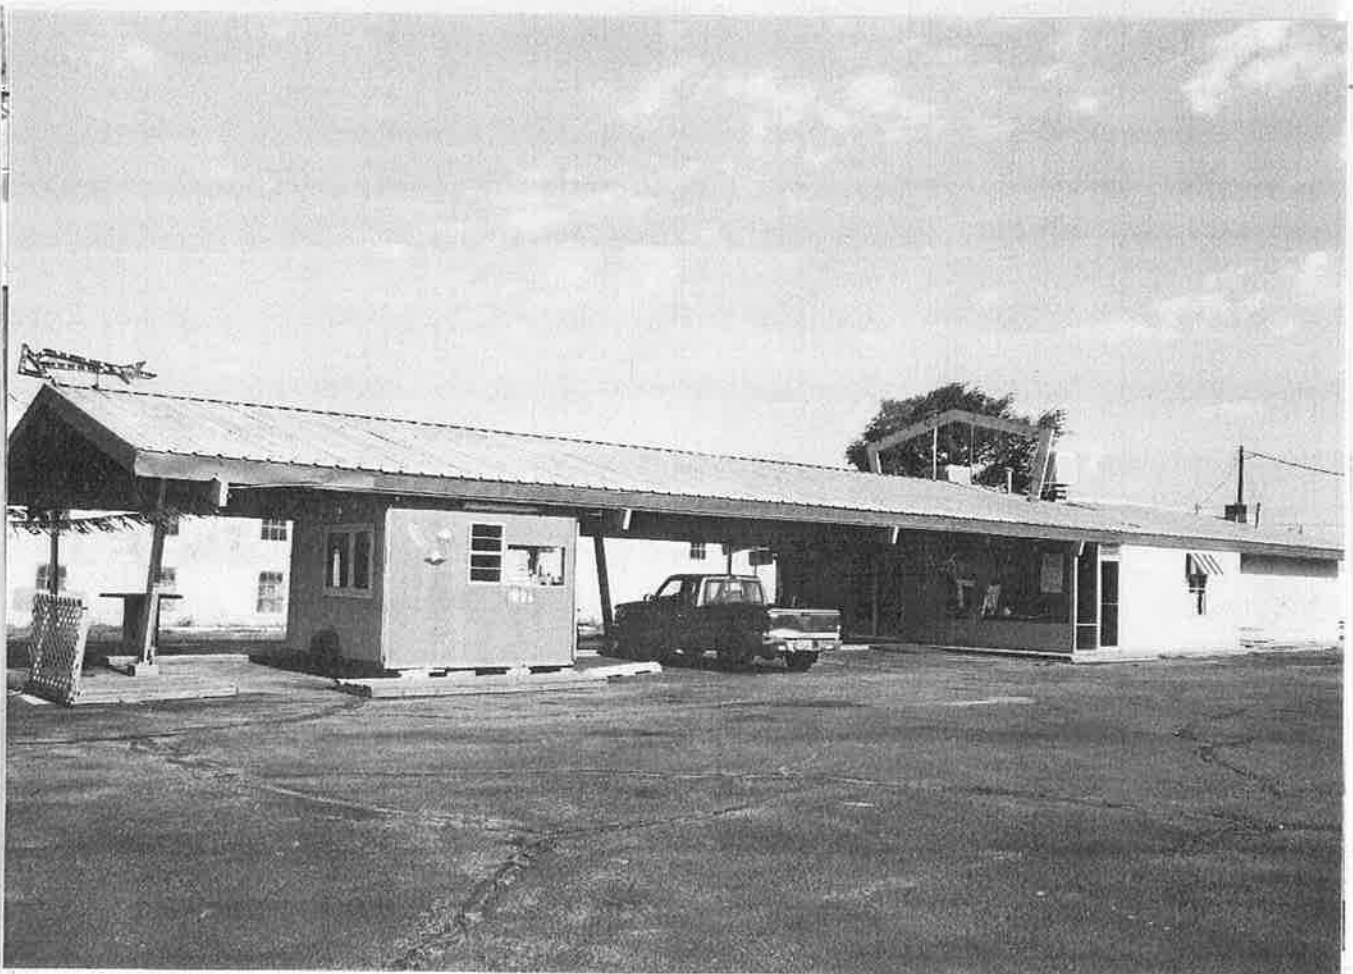
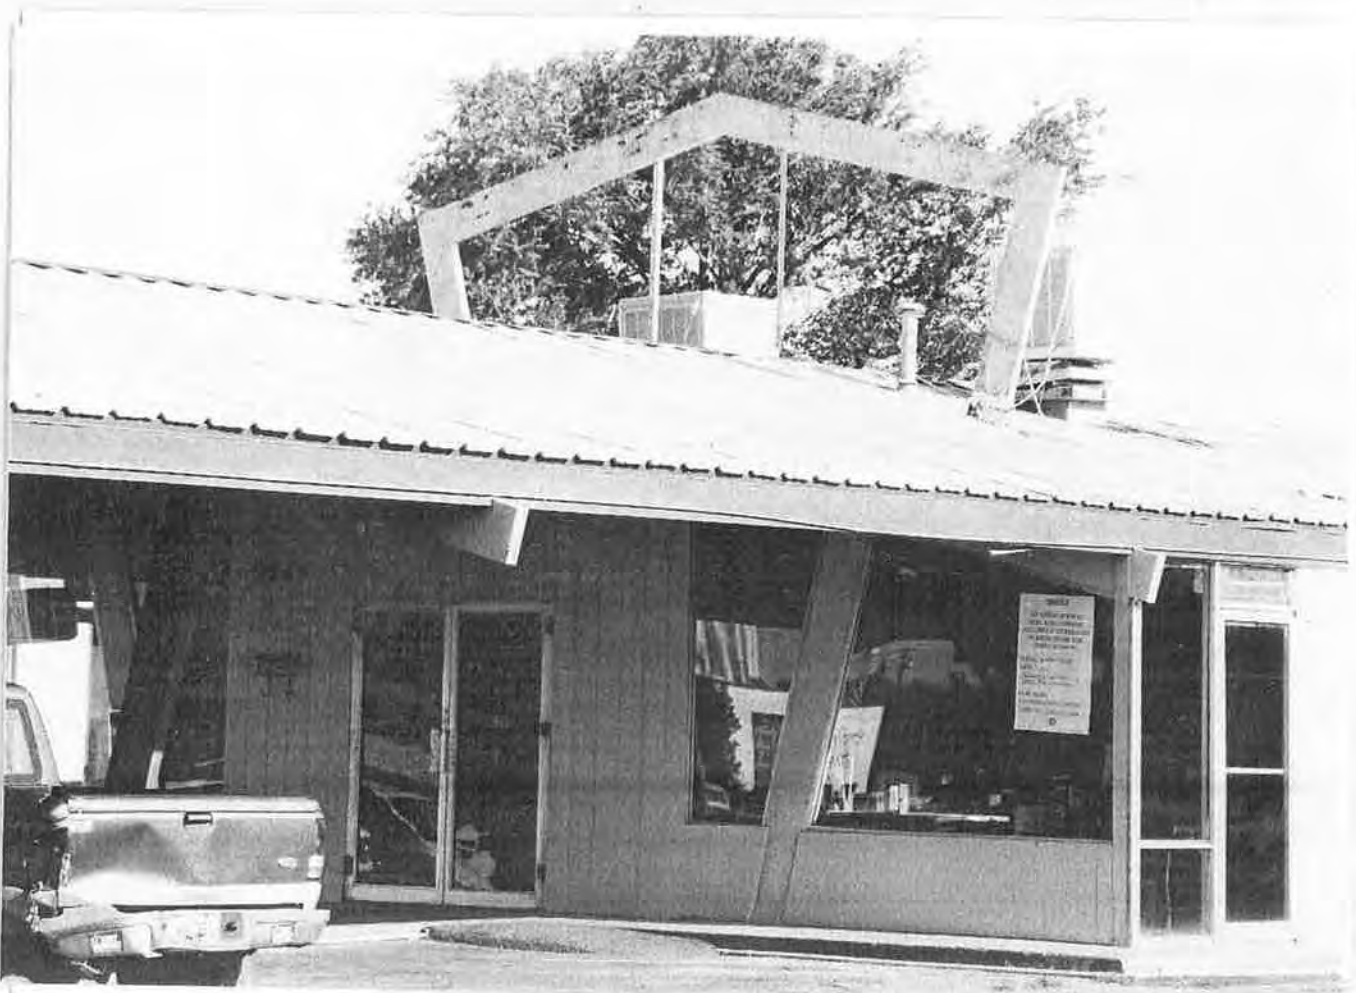
County POTTER City AMARILLO Inventory # 395-AM-109
 Historic Name [No listing]
 Current Name TACOS DON MIGUEL
 Address 2509 AMAR BLVD (N side)
 Lot(s): _____ Block: _____ Addition: _____
 Owners Address _____
 Resource type Building Structure Site Object District
 Landscape/Site Features sign -
 Outbuildings kiosk under car port - metal & jets & flat windows (on wheels)
 Function: Current Use RESTAURANT Historic Use drive in restaurant
 Construction Date: 1955 Actual Estimated
 Architect _____ Builder _____
 Possible Threat(s) Demolition Development Neglect Alteration Vacant Utility Expansion
 Integrity Location Design Materials Workmanship Setting Feeling Association
 USGS Quad #: _____ Year: _____ UTM Zone: _____ Easting: _____ Northing: _____
 Priority High Medium Low Recorder Monica Penick Date(s) 7/17/2002

Roof type front gable Materials corr metal

Wall facade plywood Foundation _____

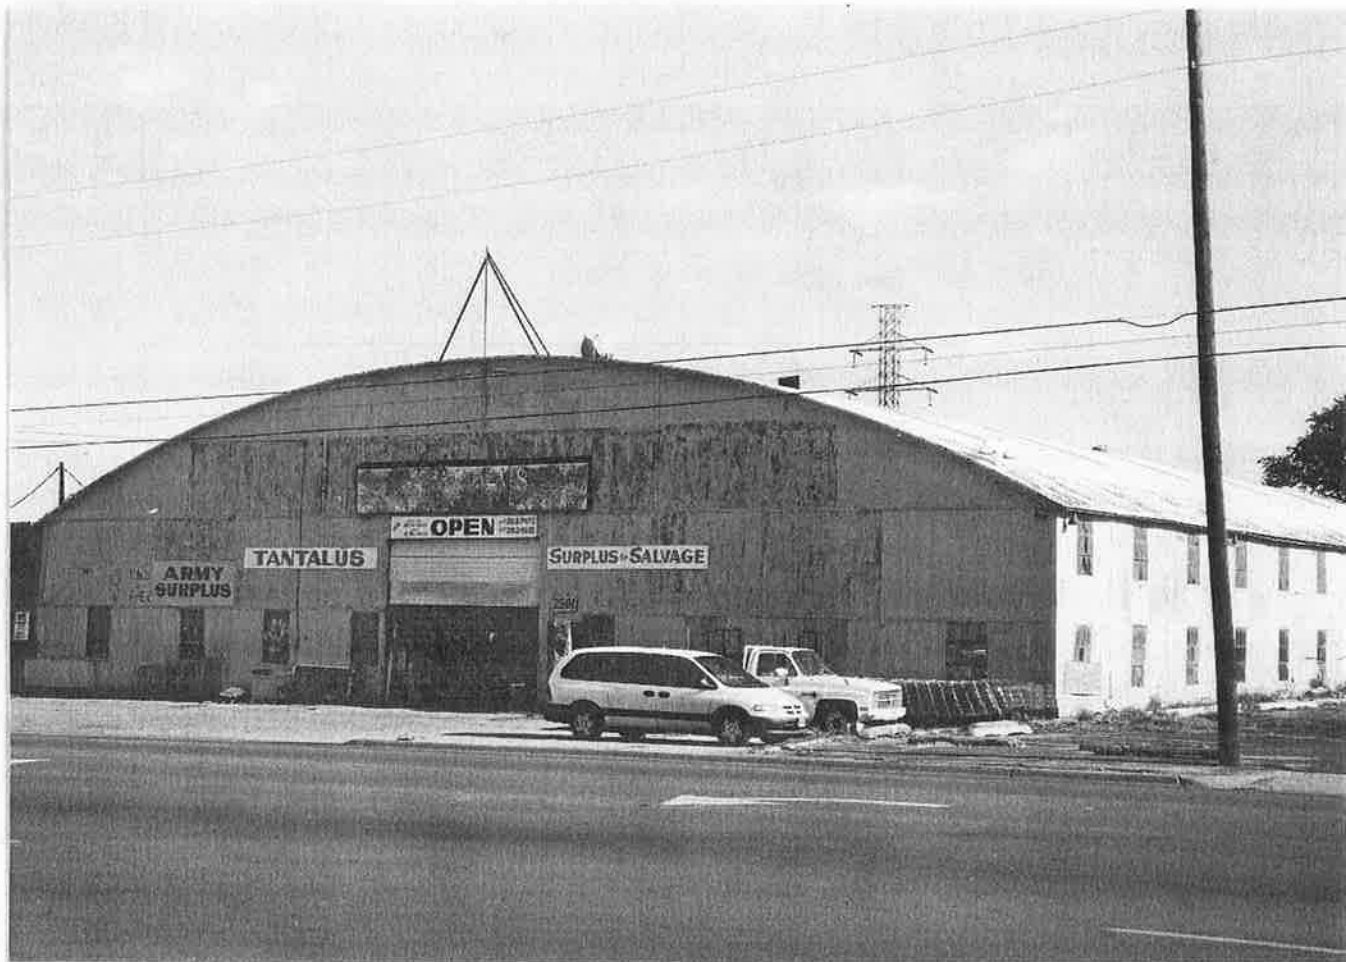
County POTTER City Amarillo Inventory # 375-AM-110
 Historic Name McMillan, Inc (truck & auto) (1951-1957), Shelton Equip & Machine Co (1960) Army - Govt
 Current Name TANTALUS Surplus & Salvage Manufactures of Tx Trucks (1965)
 Address 2501 AMA Blvd
 Lot(s): _____ Block: _____ Addition: _____
 Owners Address _____
 Resource type Building Structure Site Object District
 Landscape/Site Features _____
 Outbuildings _____
 Function: Current Use common Historic Use common
 Construction Date: 1947 Actual Estimated
 Architect _____ Builder _____
 Possible Threat(s) Demolition Development Neglect Alteration Vacant Utility Expansion
 Integrity Location Design Materials Workmanship Setting Feeling Association
 USGS Quad #: _____ Year: _____ UTM Zone: _____ Easting: _____ Northing: _____
 Priority High Medium Low Recorder Monica Penick Date(s) 7/17/2002

Roof type bound Materials corr metal

Wall facade corr metal Foundation _____

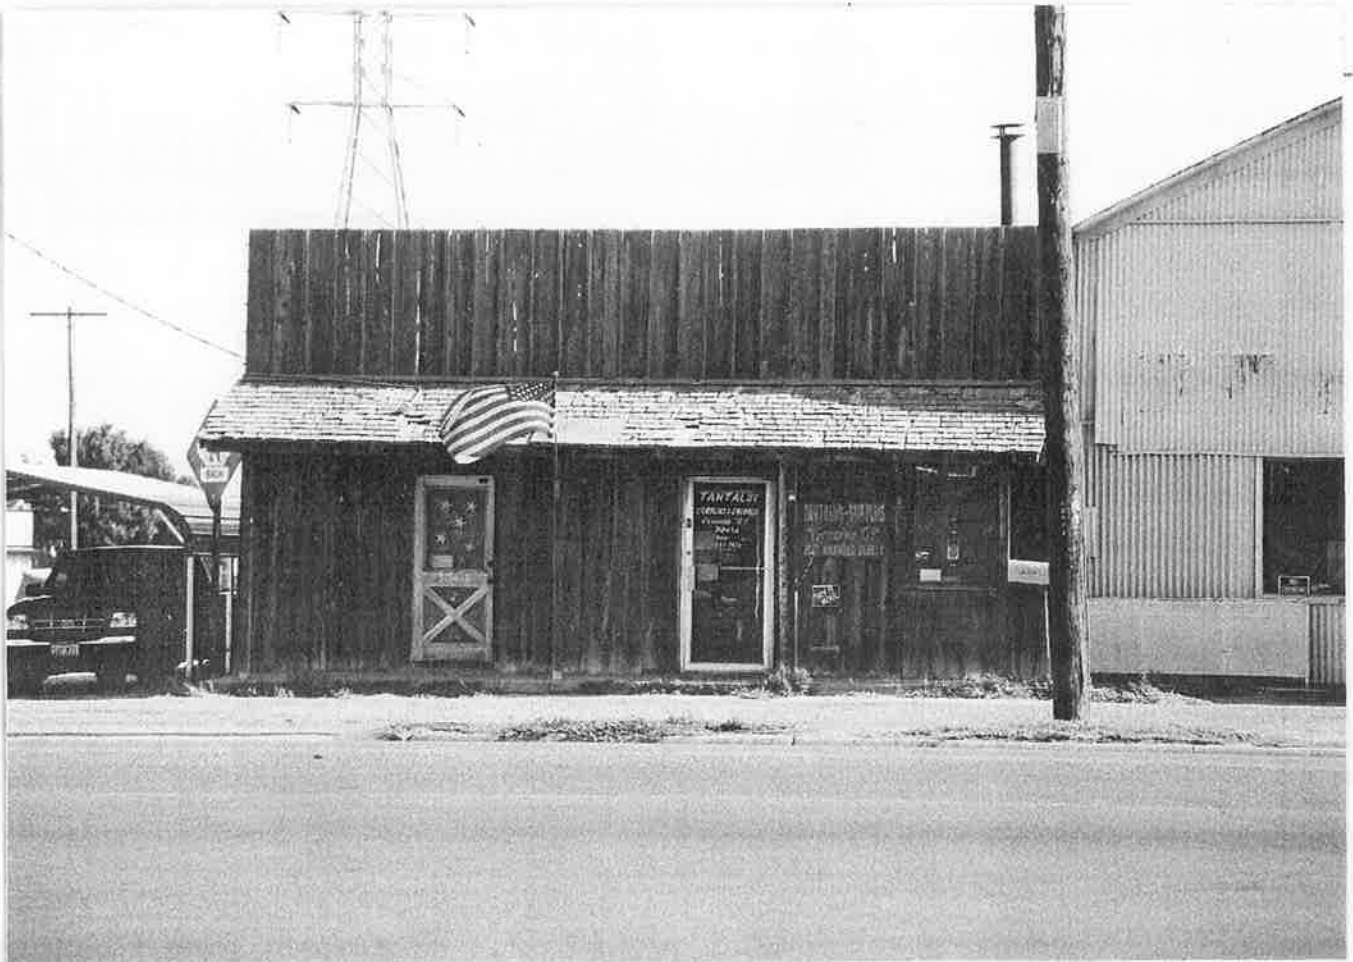
County Pottaw City Amarellus Inventory # 375-AM 111
Historic Name (see # 110)
Current Name Tantalus
Address 2501 AMA BLVD (N side adj to Tantalus Quarry)
Lot(s): _____ Block: _____ Addition: _____
Owners Address _____
Resource type Building Structure Site Object District
Landscape/Site Features _____
Outbuildings _____
Function: Current Use Comm Historic Use Comm
Construction Date: 1960 Actual Estimated
Architect _____ Builder _____
Possible Threat(s) Demolition Development Neglect Alteration Vacant Utility Expansion
Integrity Location Design Materials Workmanship Setting Feeling Association
USGS Quad #: _____ Year: _____ UTM Zone: _____ Easting: _____ Northing: _____
Priority High Medium Low Recorder Monica Penick Date(s) 7/17/2002

Roof type w/ false front

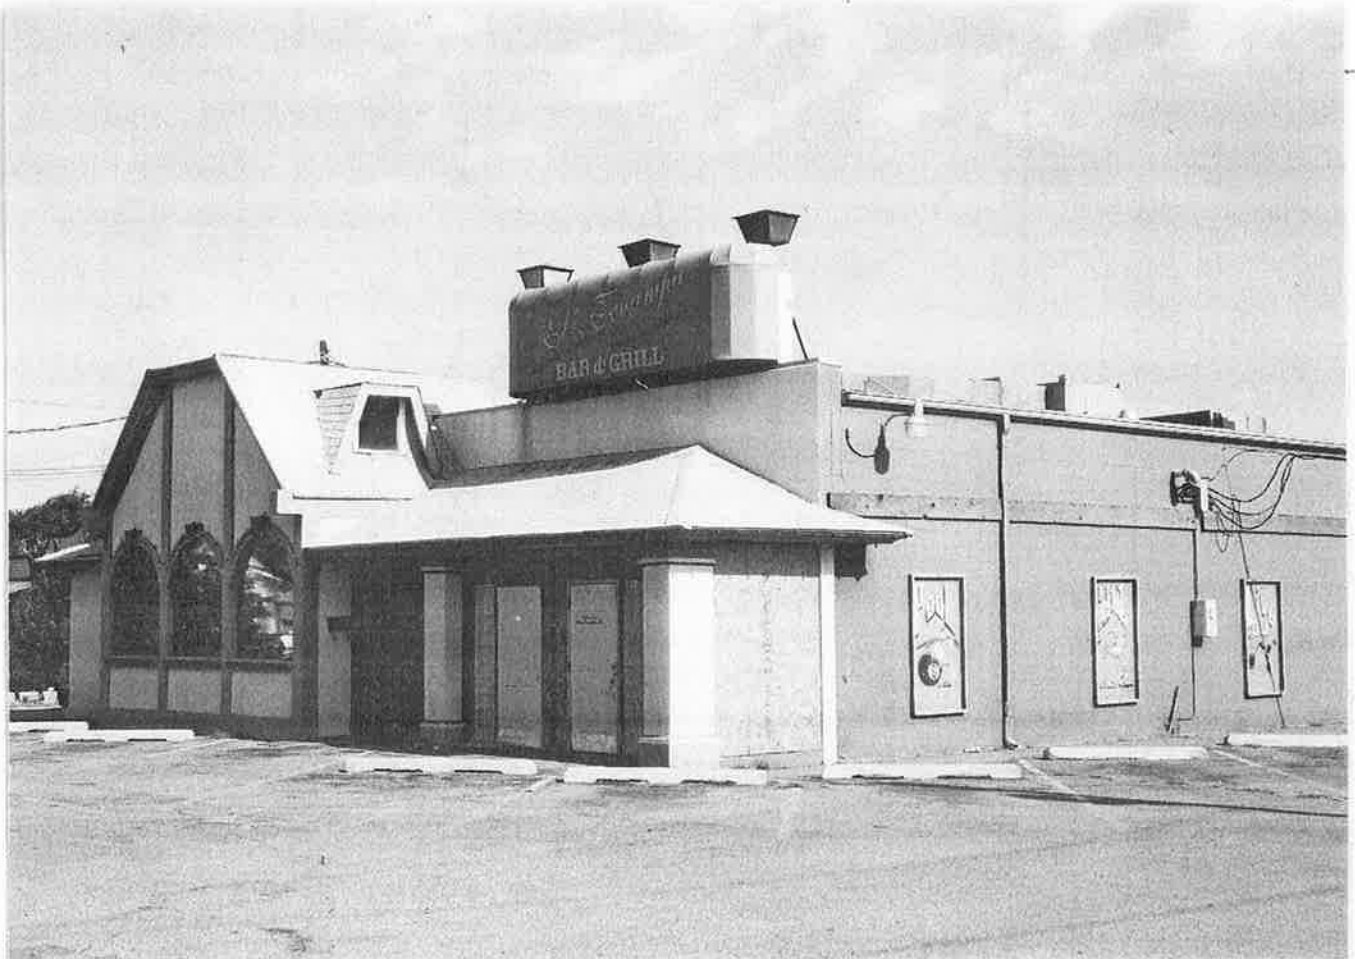
County POTTER City AMARILLO Inventory # 375 AM-112
 Historic Name SITE of AMARILLO Well & ARTS (1940) AMARILLO COURSE / TOURIST COURSE (1945-54) MISS. MIKE
 Current Name EL TENEMPA BAR & GRILL
 Address 2417 AMARILLO BLVD (N. SIDE adj to DINGSTADT)
 Lot(s): _____ Block: _____ Addition: _____
 Owners Address _____
 Resource type Building Structure Site Object District
 Landscape/Site Features _____
 Outbuildings _____
 Function: Current Use RESTAURANT Historic Use BAR & DOMESTIC / HOTEL
 Construction Date: 1965 [TOWER WAS PART of REST. COMPLEX PROJECT] Actual Estimated
 Architect _____ Builder _____
 Possible Threat(s) Demolition Development Neglect Alteration Vacant Utility Expansion
 Integrity Location Design Materials Workmanship Setting Feeling Association
 USGS Quad #: _____ Year: _____ UTM Zone: _____ Easting: _____ Northing: _____
 Priority High Medium Low Recorder Monica Penick Date(s) 7/17/2002

Roof type front: combo of gambrel & hip, rear = flat
