Historic Resources Inventory Form—Route 66

County POTTER City AMARILLO Inventory # 375-AM-NE
NOT INVENTORIED 844
 Historic Name PIGGY WIGGLY SIGN PHOTO CARD
 Current Name PIGGY WIGGLY SIGN
 Address AMA Blvd E side (behind/adj to County Motel)
 Lot(s): _____ Block: _____ Addition: _____
 Owners Address _____
 Resource type Building Structure Site Object District
 Landscape/Site Features _____
 Outbuildings _____
 Function: Current Use _____ Historic Use _____
 Construction Date: _____ Actual Estimated
 Architect _____ Builder _____
 Possible Threat(s) Demolition Development Neglect Alteration Vacant Utility Expansion
 Integrity Location Design Materials Workmanship Setting Feeling Association
 USGS Quad #: _____ Year: _____ UTM Zone: _____ Easting: _____ Northing: _____
 Priority High Medium Low Recorder Monica Penick Date(s) 7/16/2002

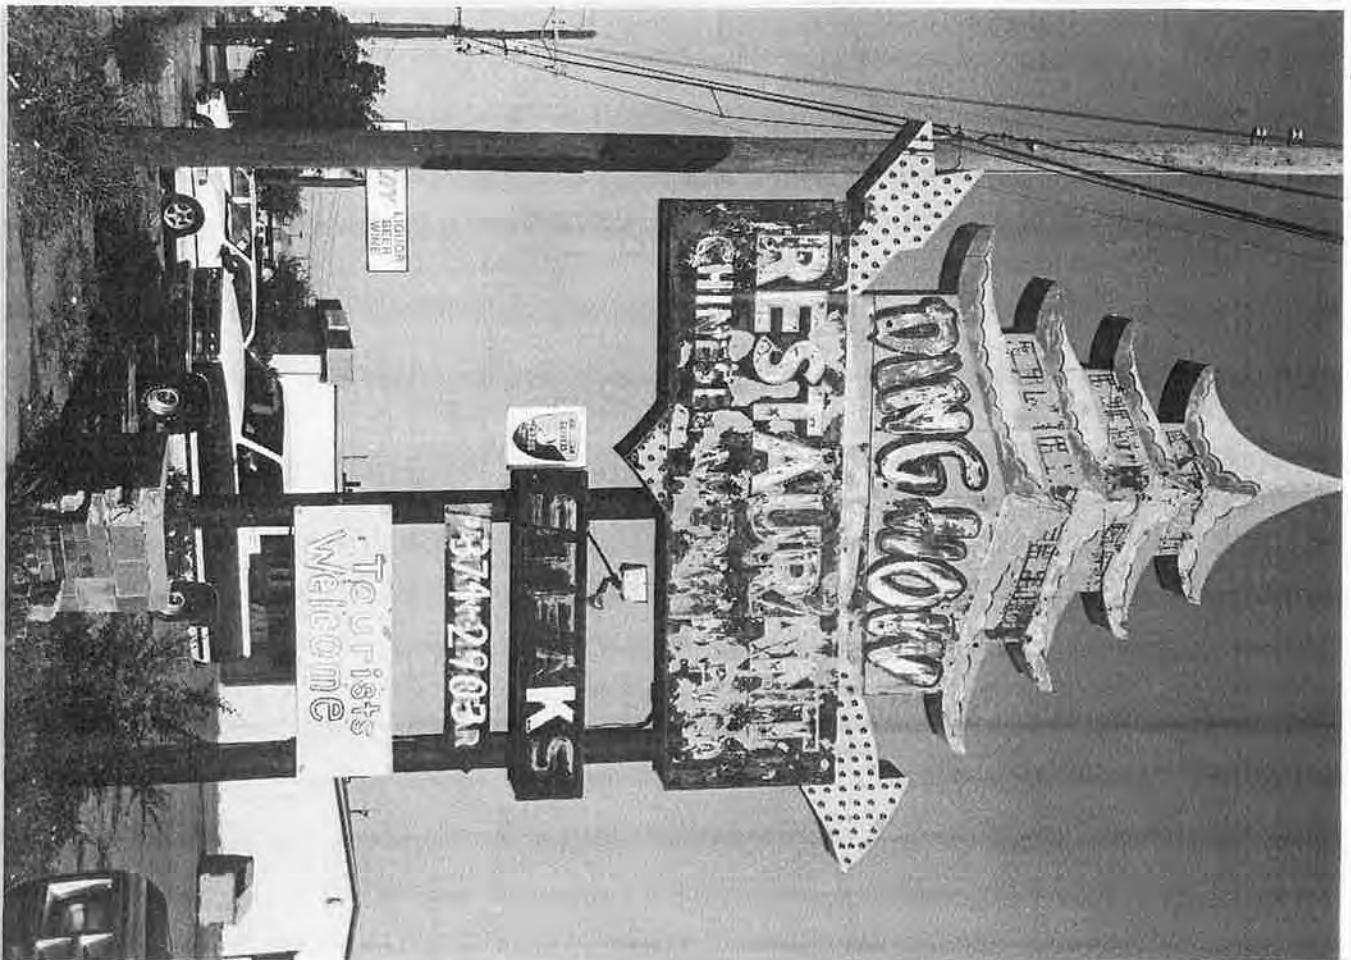
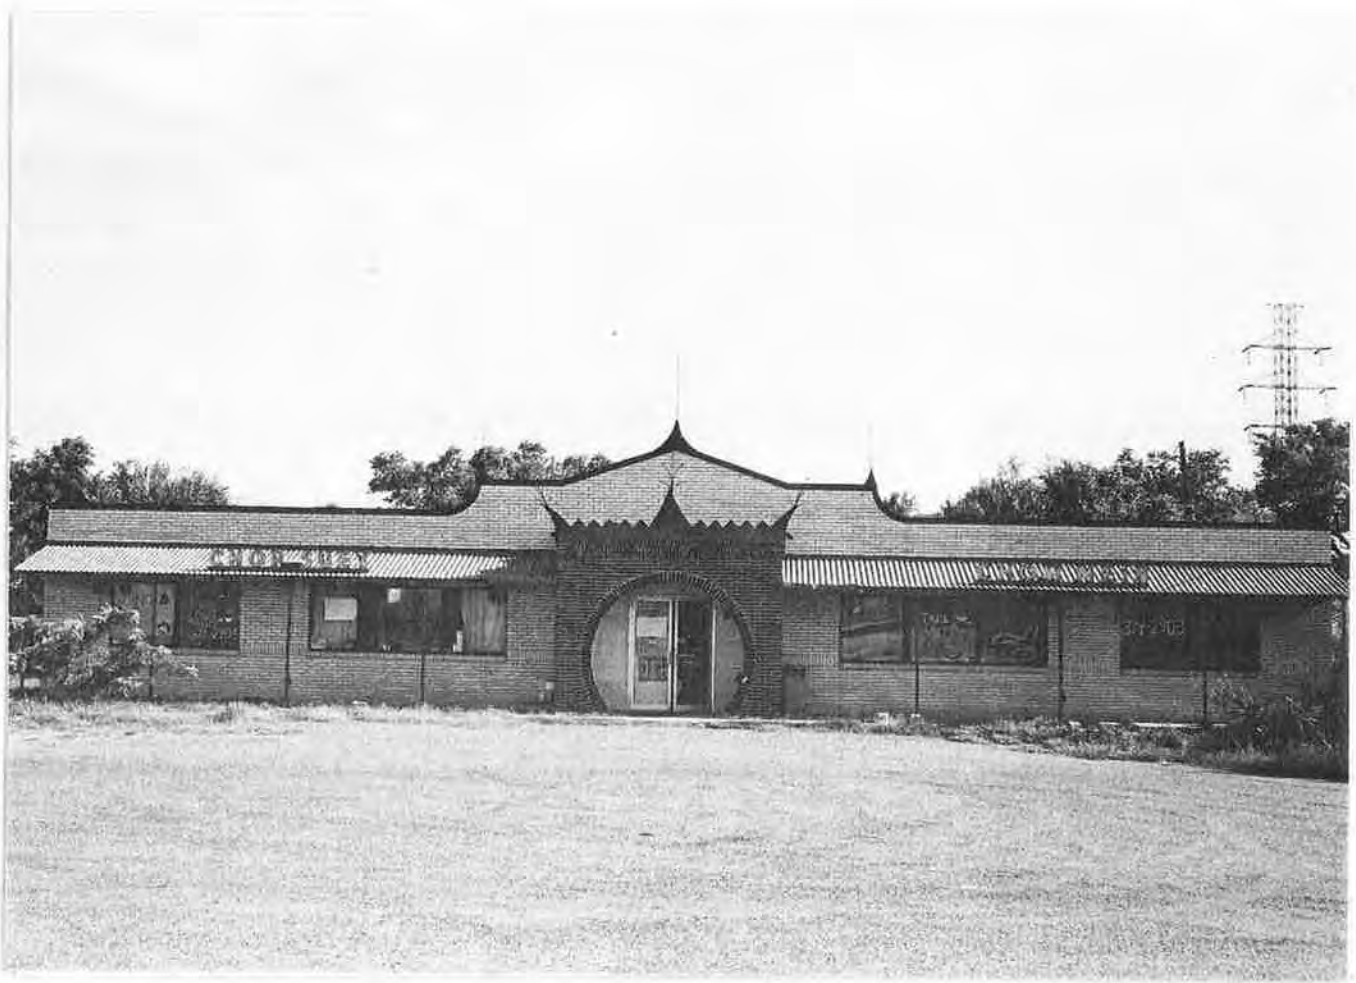
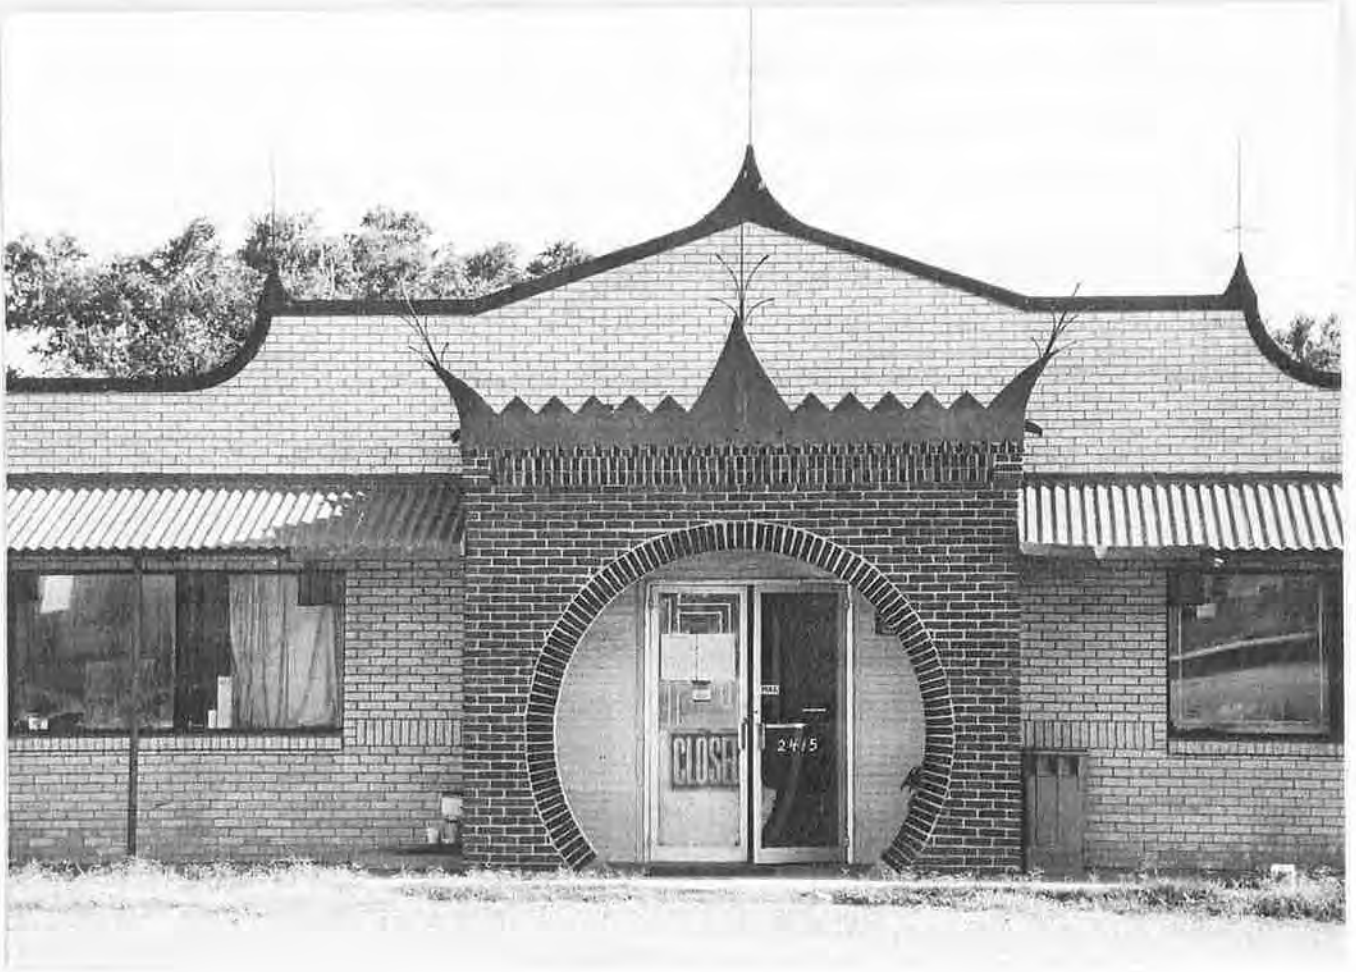
Photo Data: Roll	Frame	Feature	Look
<u>26</u>		<u>sign</u>	<u>look N</u>
		<u>overall</u>	<u>look N</u>
		<u>entrance detail</u>	<u>look N</u>

Roof type w/ chinese intl parapet

General Architectural Description Graphics: free standing letters of canopy 'CHOP SOEX'
fridants for acroteria

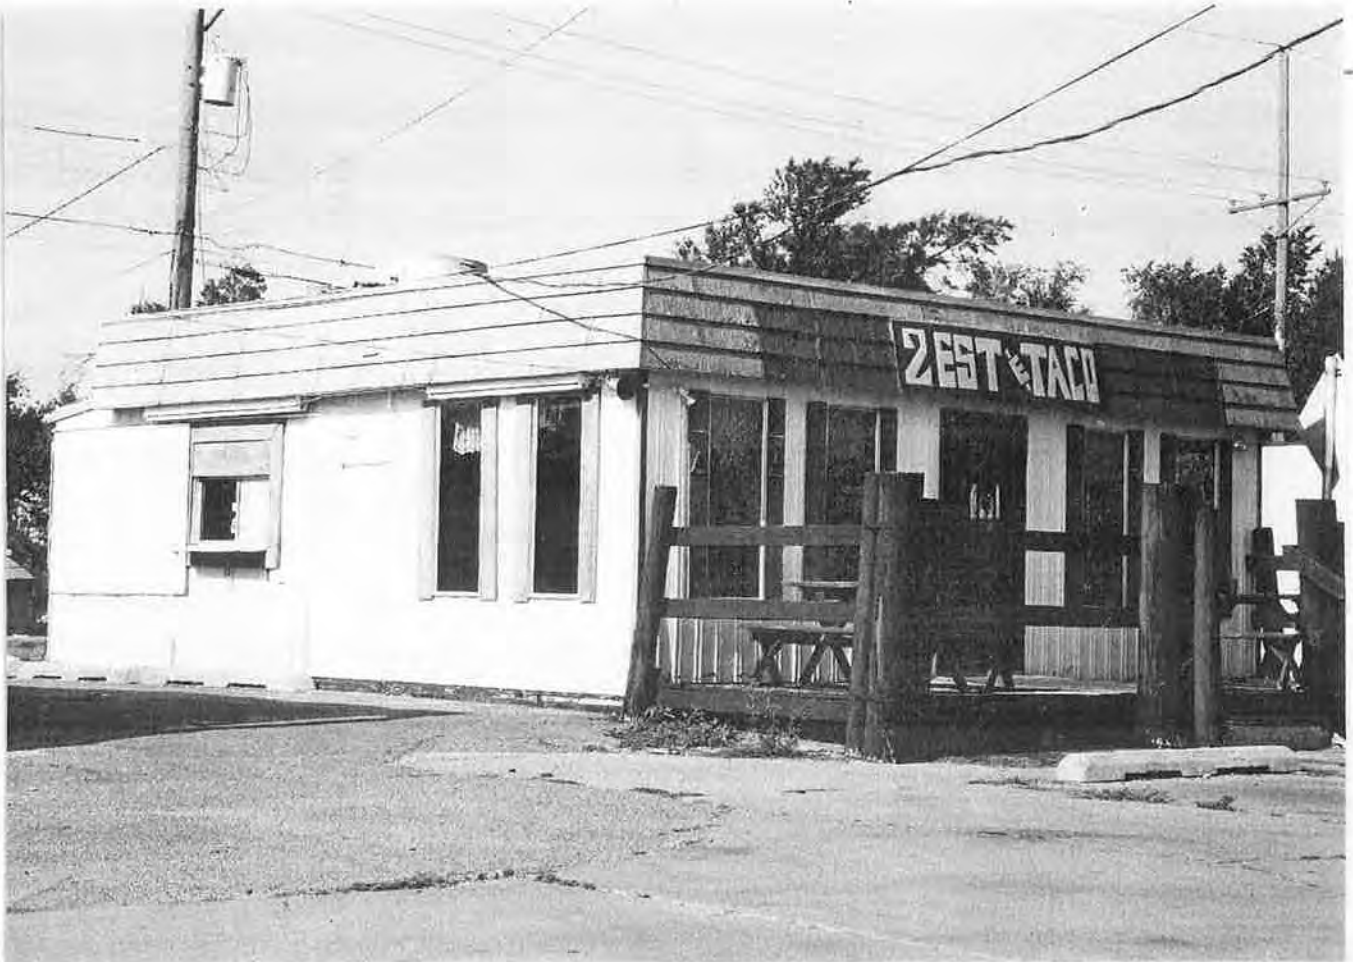
County POTTER City AMARILLO Inventory # 375-AM-114
Historic Name Low building erected 1945 for a service station
Current Name WEST TACO
Address 2418 AMA BLVD
Lot(s): _____ Block: _____ Addition: _____
Owners Address _____
Resource type Building Structure Site Object District
Landscape/Site Features sign
Outbuildings _____
Function: Current Use commercial Historic Use _____
Construction Date: 1940 Actual Estimated
Architect _____ Builder _____
Possible-Threat(s) Demolition Development Neglect Alteration Vacant Utility Expansion
Integrity Location Design Materials Workmanship Setting Feeling Association
USGS Quad #: _____ Year: _____ UTM Zone: _____ Easting: _____ Northing: _____
Priority High Medium Low Recorder Monica Penick Date(s) 7/19/2002

Roof type Flat w/ mansard style Materials parapet (shingle w/ tank strips)

Wall facade vert. corr metal Foundation _____

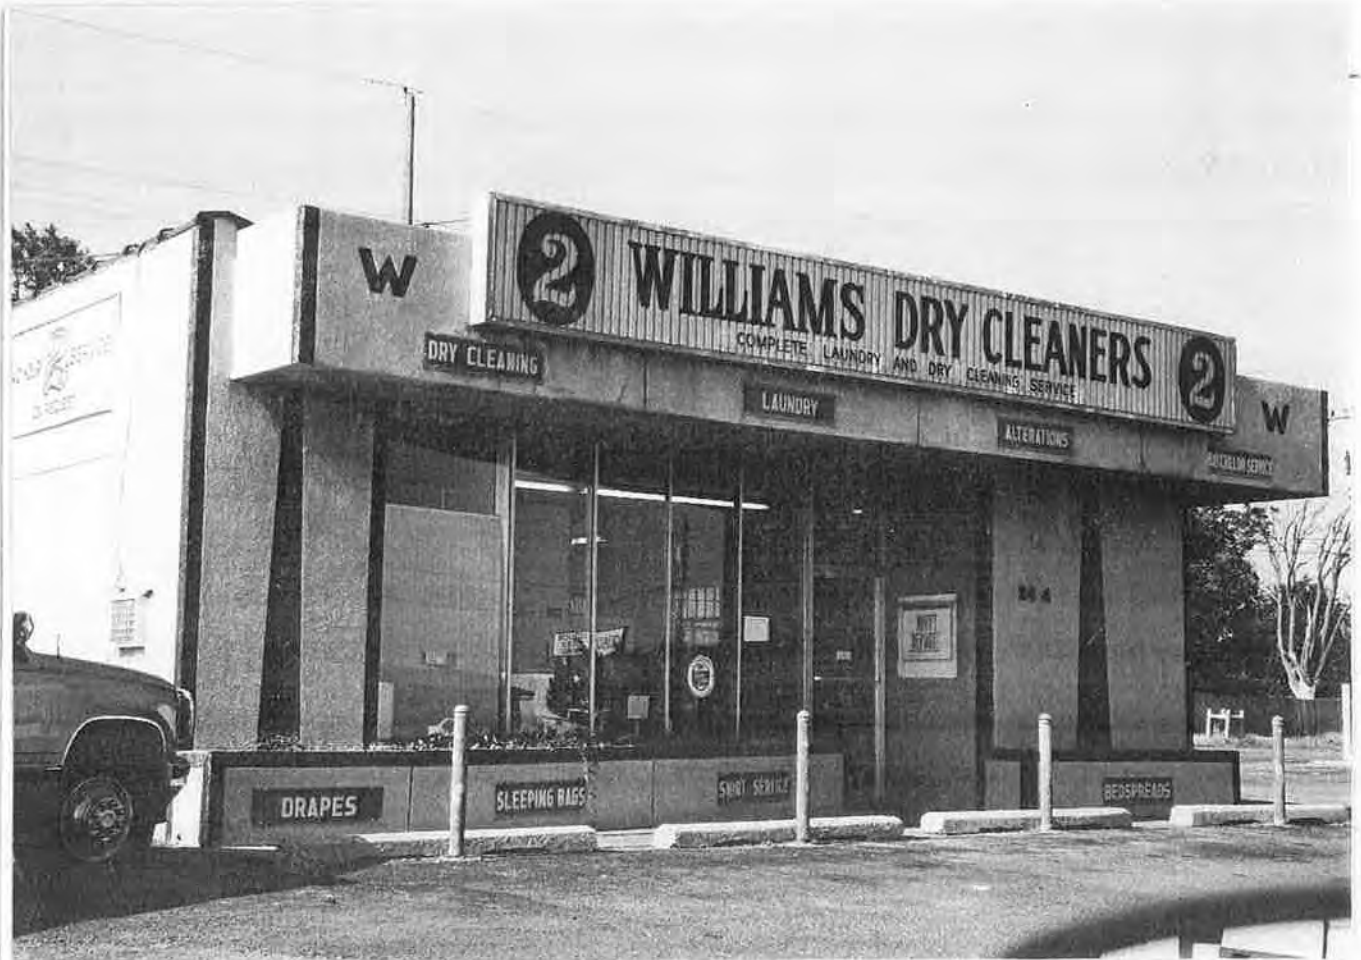
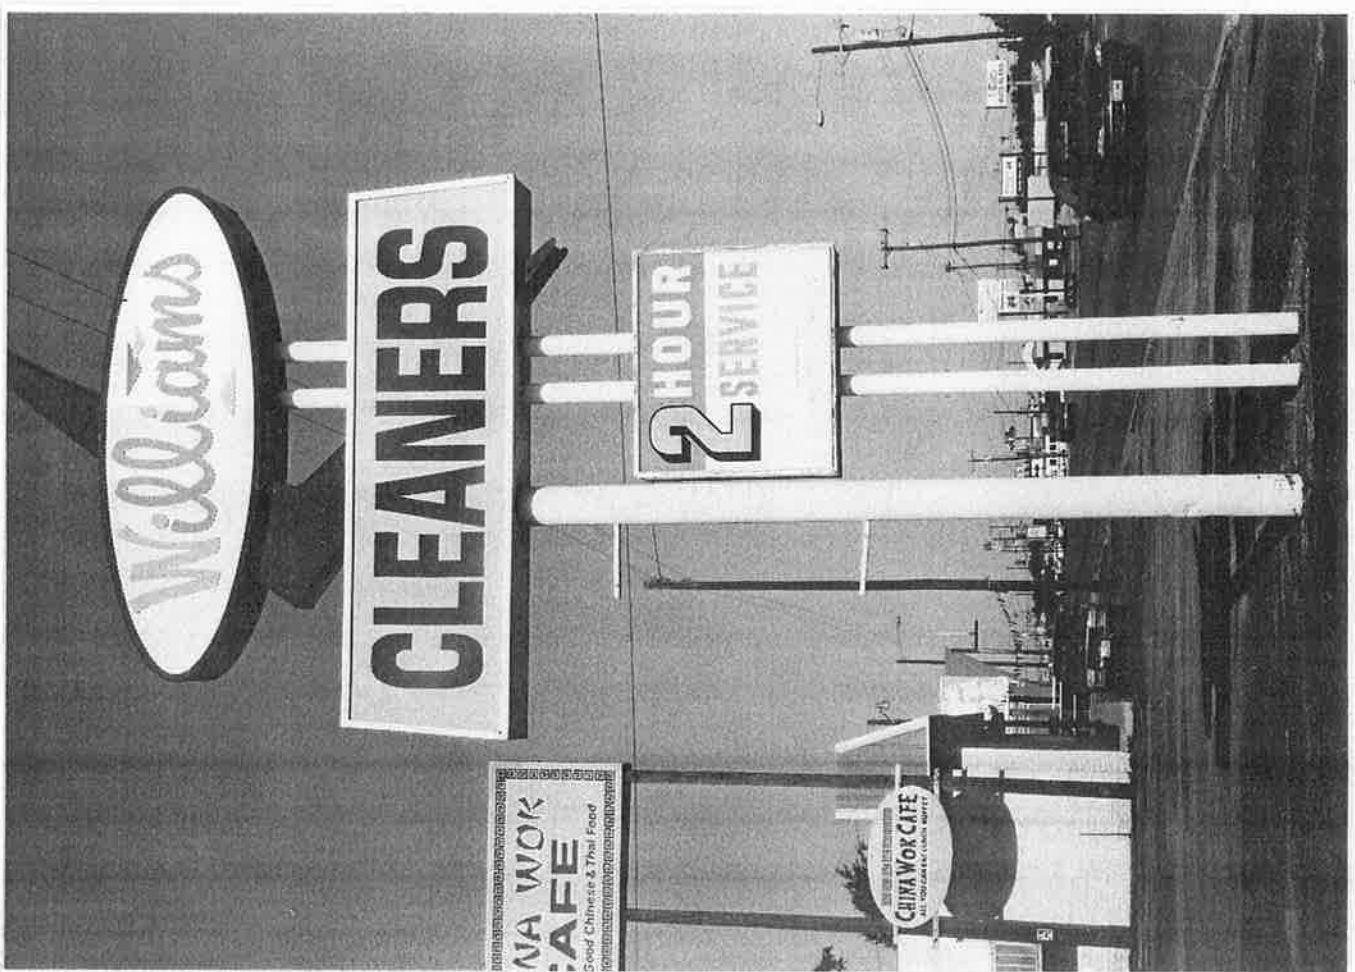
Photo Data: Roll 26 Frame _____ Feature 13 SIGN LOOK W

County POTTER City AMARILLO Inventory # 375-AM-115
 Historic Name George Drive-In (1955); Williams Dry Cleaners (1960-present)
 Current Name Williams Dry Cleaners
 Address 2414 AMA Blvd (S. Sid across from Drug How)
 Lot(s): _____ Block: _____ Addition: _____
 Owners Address _____
 Resource type Building Structure Site Object District
 Landscape/Site Features _____
 Outbuildings sign
 Function: Current Use Commercial Historic Use Commercial
 Construction Date: 1957 Actual Estimated
 Architect _____ Builder _____
 Possible Threat(s) Demolition Development Neglect Alteration Vacant Utility Expansion
 Integrity Location Design Materials Workmanship Setting Feeling Association
 USGS Quad #: _____ Year: _____ UTM Zone: _____ Easting: _____ Northing: _____
 Priority High Medium Low Recorder Monica Penick Date(s) 7/17/2002

Roof type Flat w/ No. one Materials _____

Wall facade stucco; sides - concrete block Foundation front has window wall

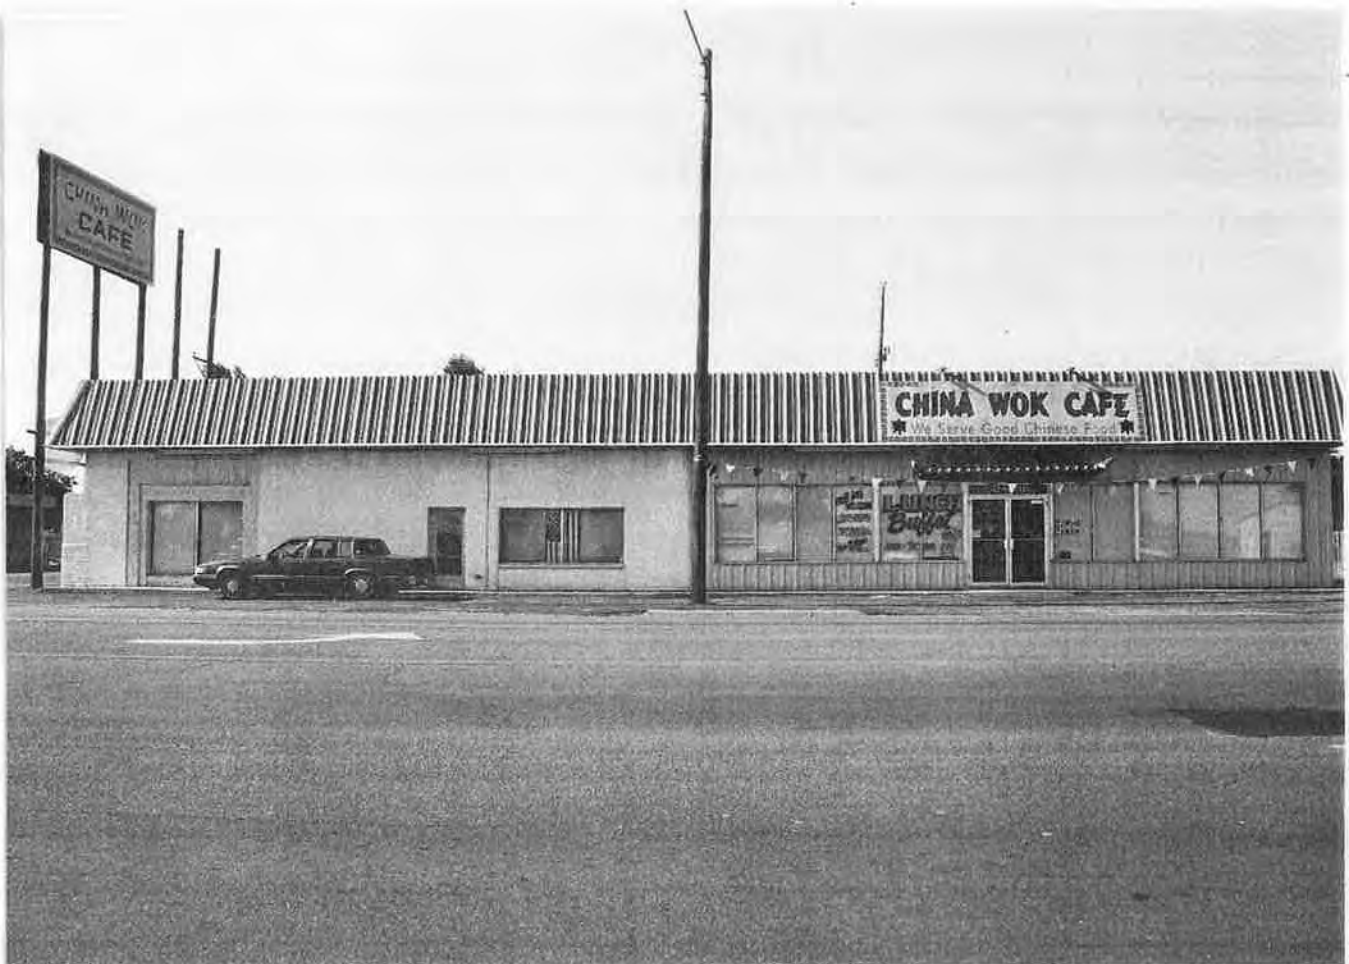
Stylistic Influence(s) _____
 Roof type flat w/ protruding fascia (corr metal) Materials _____
 Wall facade sides = conc block Foundation _____
 Window type _____ Materials _____
 Door type See below Materials _____
 Porch type _____ Materials _____
 Number of Stories 1 Plan _____
 Chimney(s) _____

General Architectural Description slip covered, 2 apparent store fronts
E/2 = stucco; plate — ; framed glazed in metal
w/2 = corr metal; plate in metal; dbl door fully glazed in metal
w/ transom

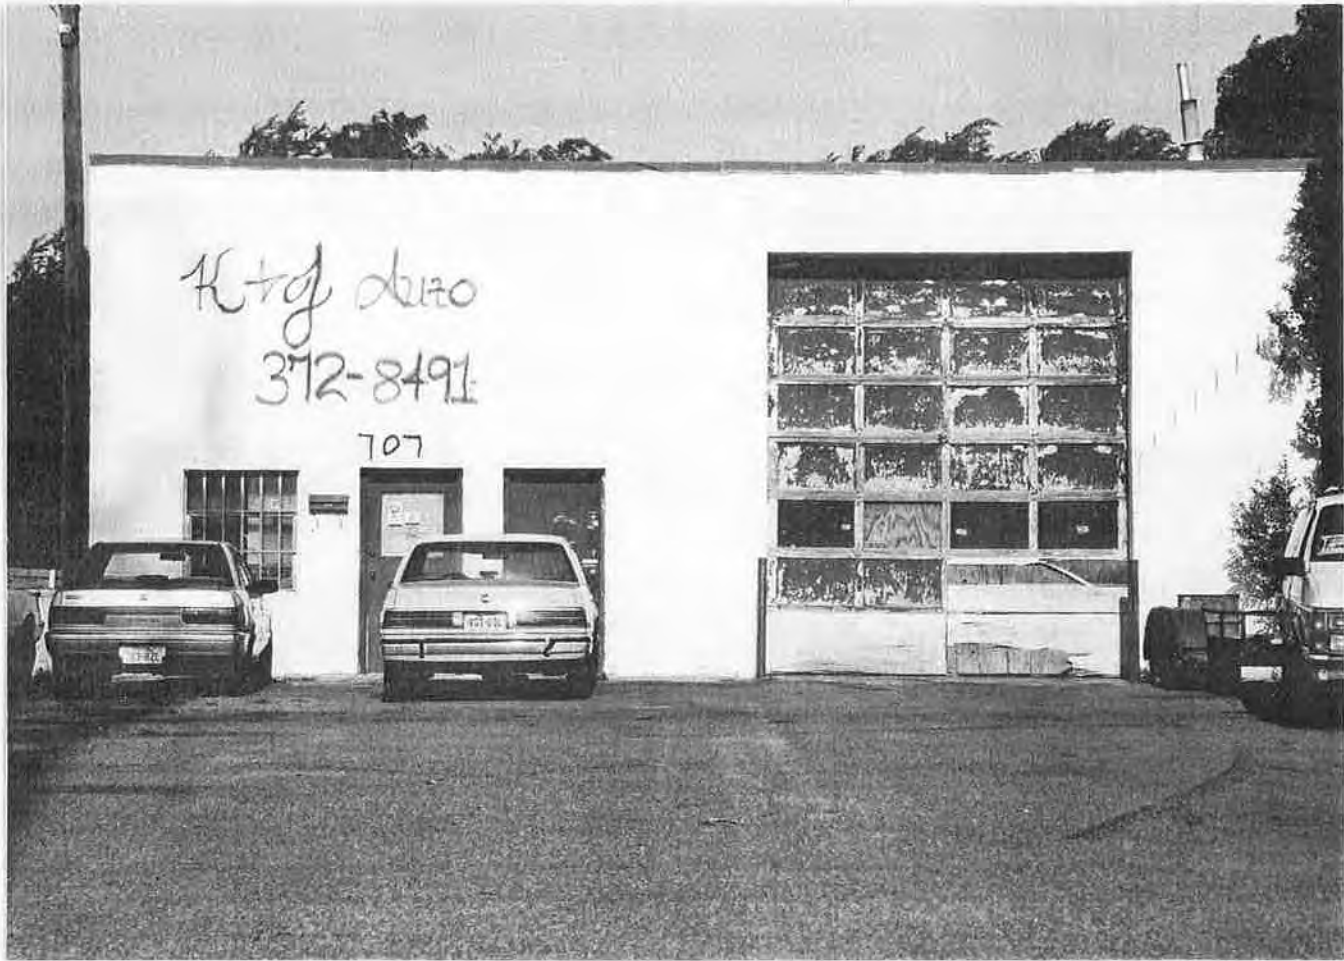
Current Name KTG Auto Repair

Roof type Flat Materials _____

Wall facade conc block Foundation _____

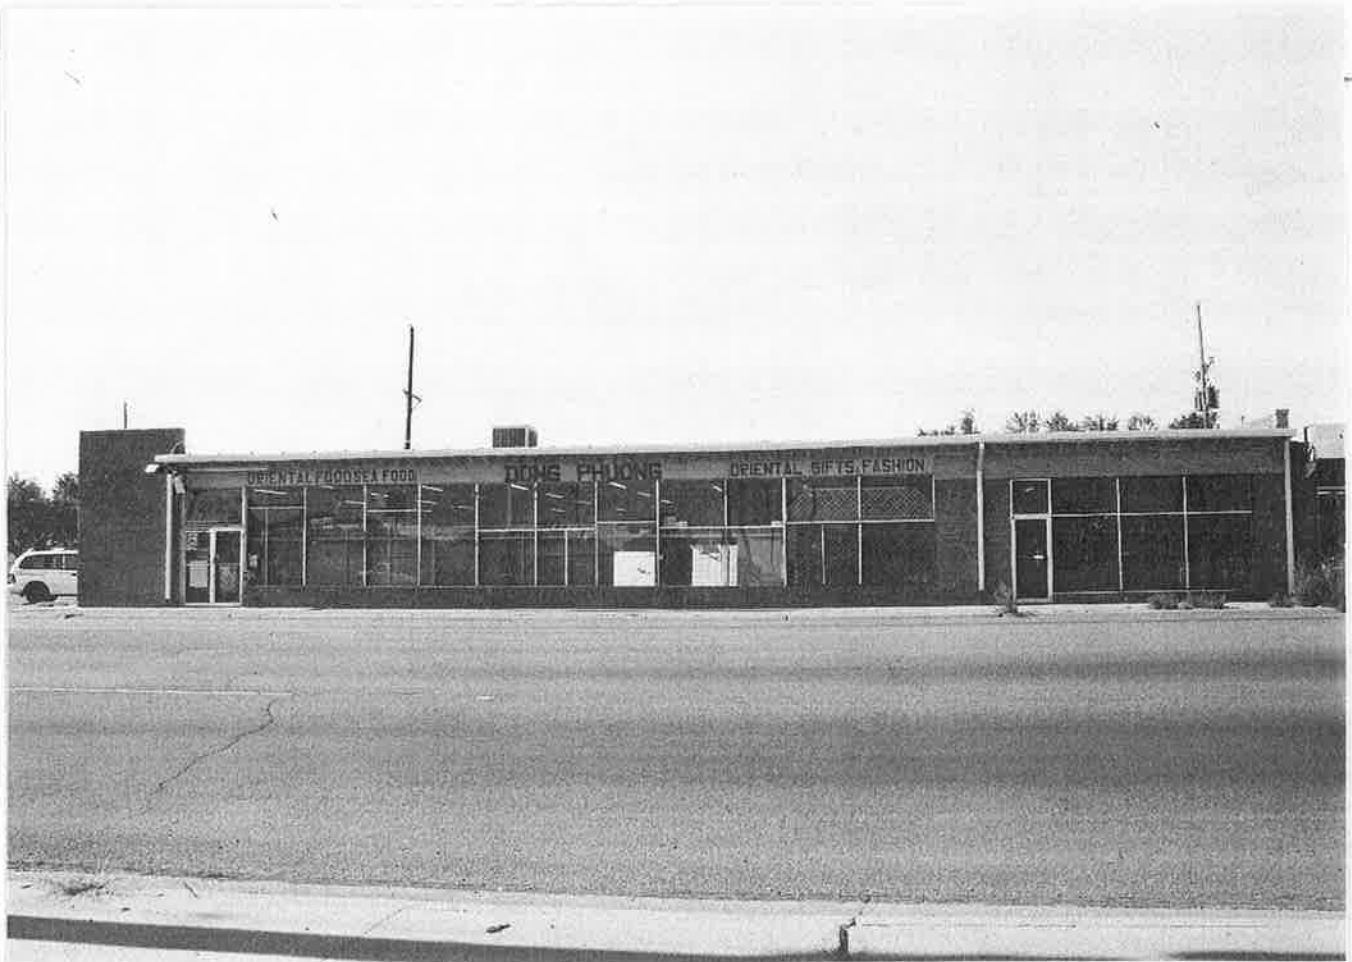
Stylistic Influence(s) _____
 Roof type flat w/ parapet Materials _____
 Wall facade rough brick faux ashlar Foundation _____
 Window type window wall - Plater's metal Materials _____
 Door type fully glazed in metal - one set double; one single door Materials _____
 Porch type overhanging eave/soffit w/ exposed joists (makes covered walkway) Materials _____
 Number of Stories _____ Plan _____
 Chimney(s) _____

General Architectural Description projecting side wall panel on E end of front facade (but is 1/2 of facade)

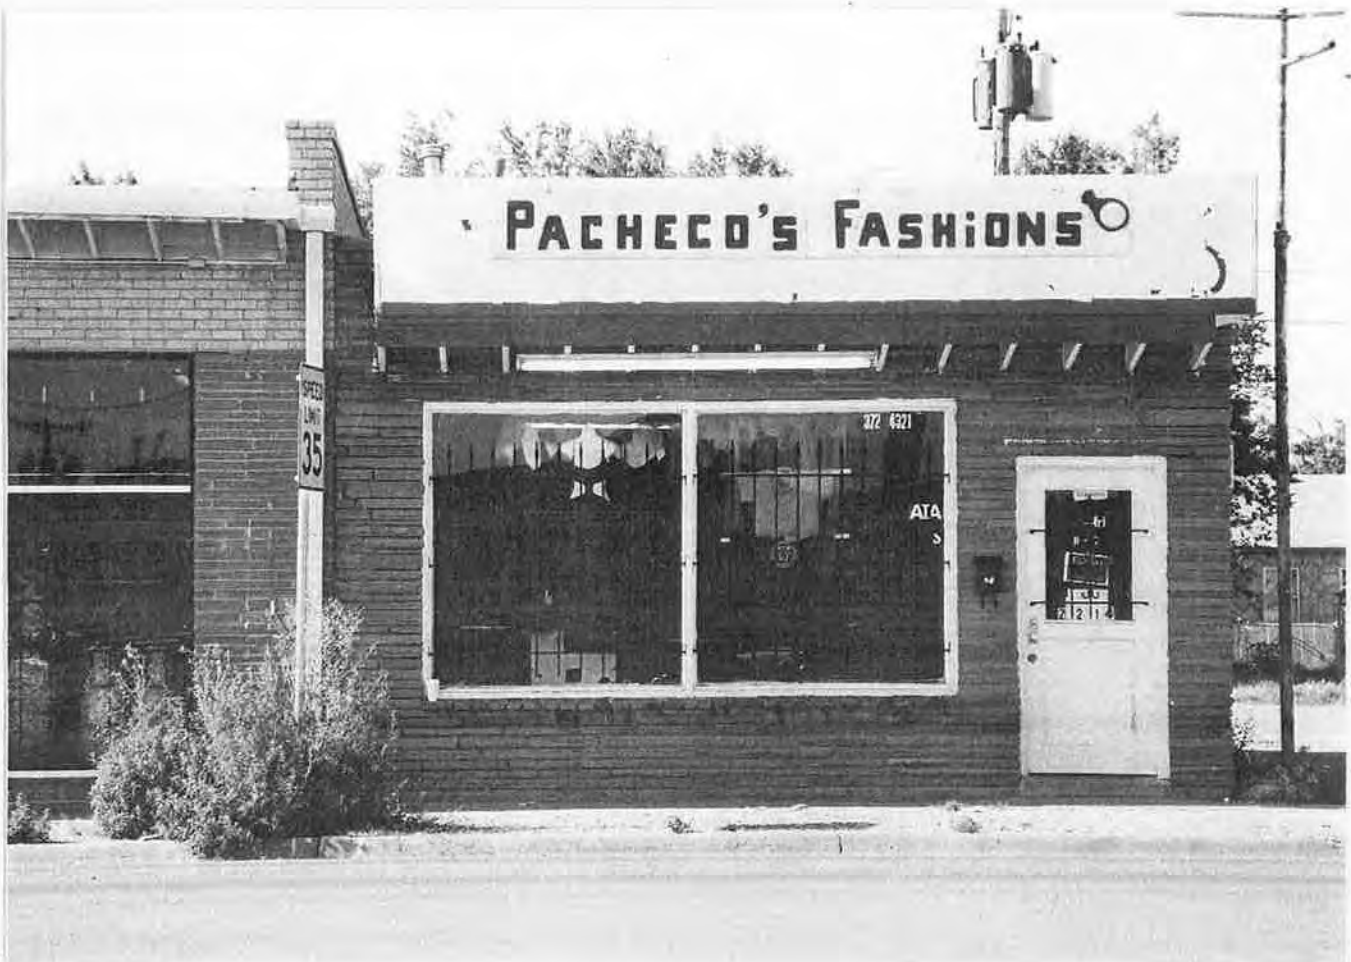
Roof type flat w/ parapet & eaves Materials concrete

Wall facade faux ashlar Foundation _____

Window type plate in wood Materials _____

Door type 1/2 glass 1/2 panel wood frame Materials _____

Porch type archway with columns Materials type porch

General Architectural Description 1 unit store front attached to lg. commercial strip bldg. same style.

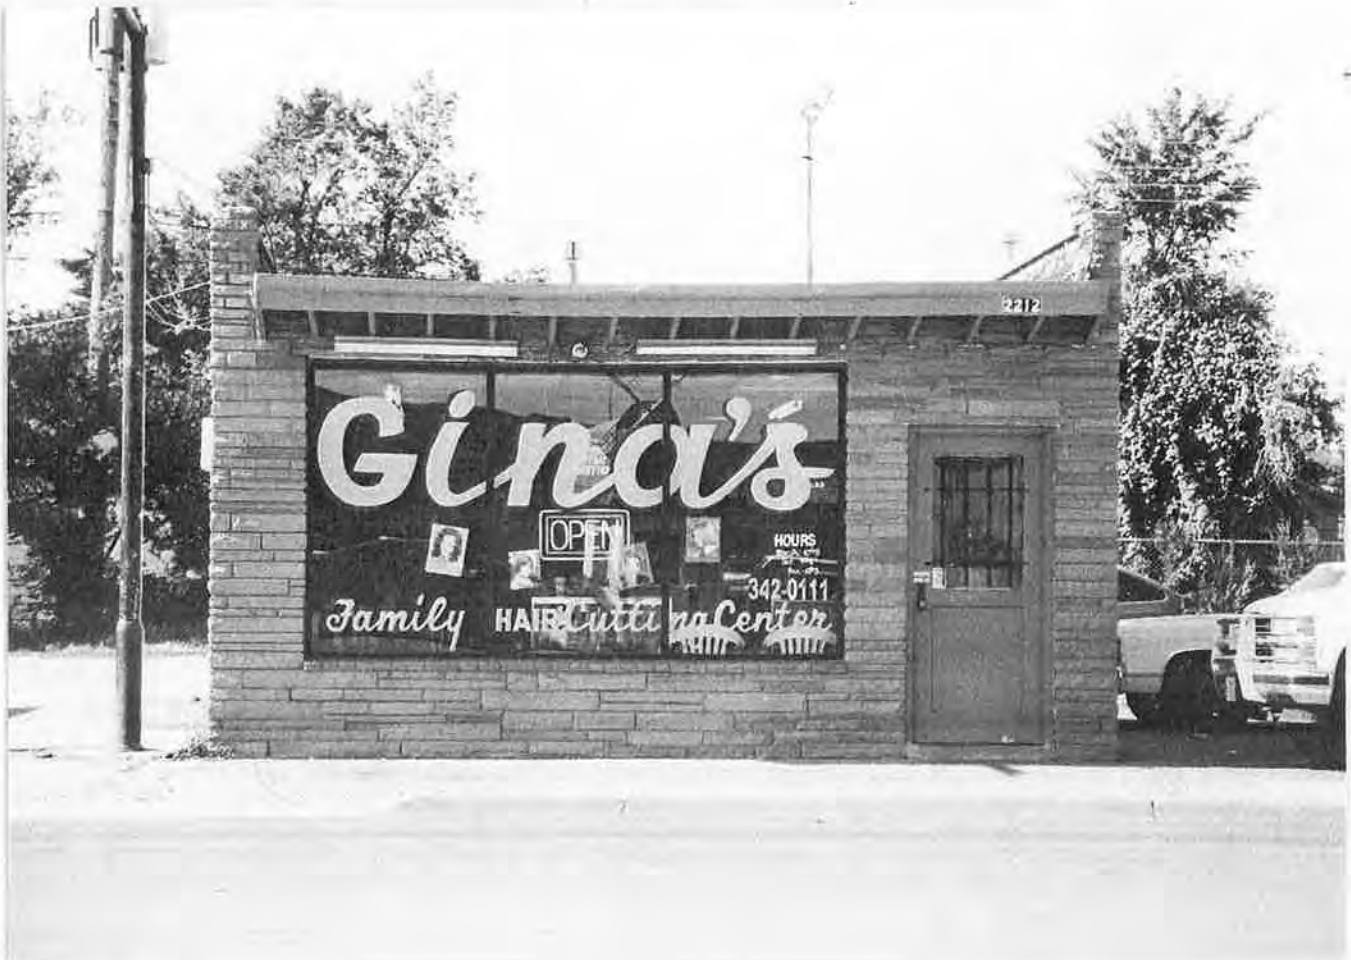
Roof type Flat w/ extended sidewall parapets Materials _____

Wall facade faux ashlar Foundation _____

Window type 3 part plate in metal Materials _____

Door type 1/2 glazed 1/2 panel, wood frame Materials _____

Porch type extending fascia/sillit w/ ext ^{uses} Materials _____

General Architectural Description same style as E part of this block -

1 part commercial block arranged in strip. Single unit store

fronts were perhaps older block along this block.

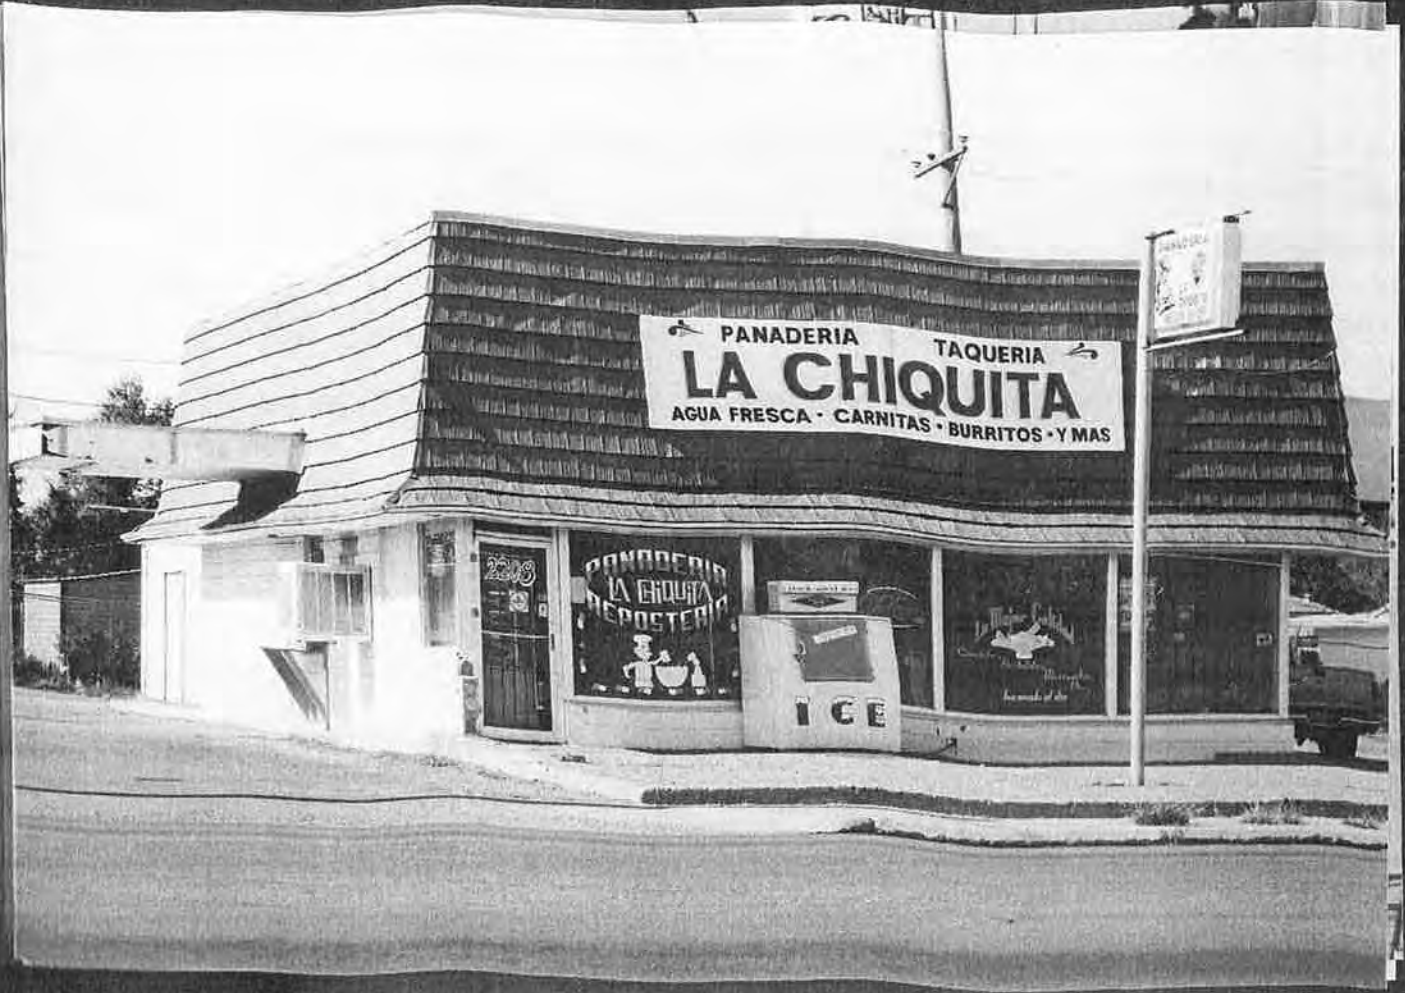
Roof type flat w/ mansard cap

Materials synth. shingles (red)

Wall facade horiz synth. siding; low

Window type plate in metal

Door type fully glazed in metal

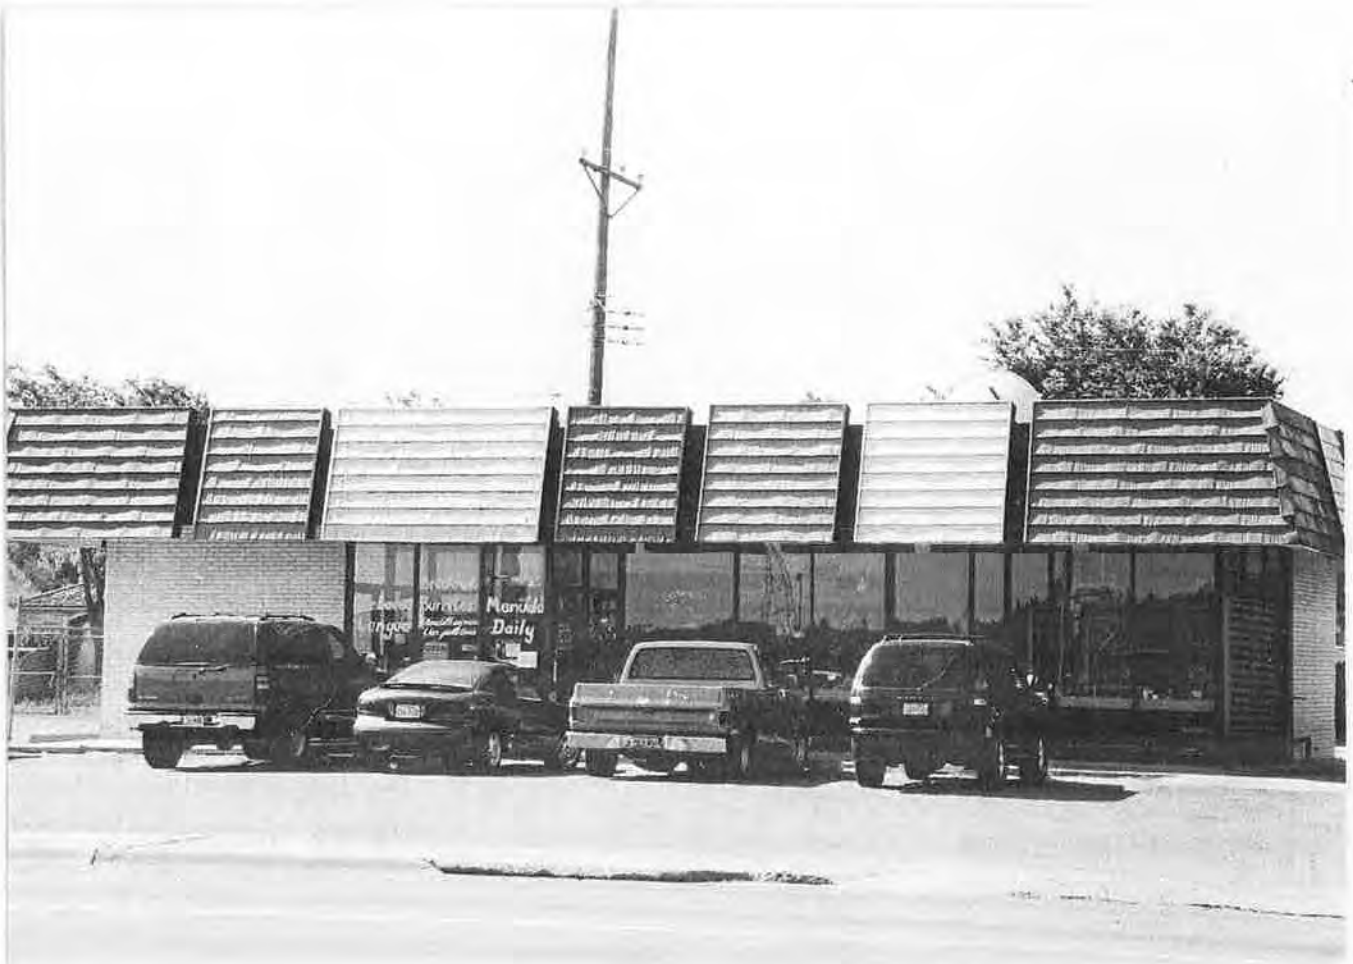
Stylistic Influence(s) _____
 Roof type flat w/ mansard facade (shingled w/ synth. shingles) Materials _____
 Wall facade brick Foundation _____
 Window type plate in metal Materials _____
 Door type projecting entrance bay w/ entrance Materials W - doors - fully glazed w/ metal
 Porch type overhanging eaves Materials w/ sidelight
 Number of Stories 1 Plan Triverson
 Chimney(s) _____

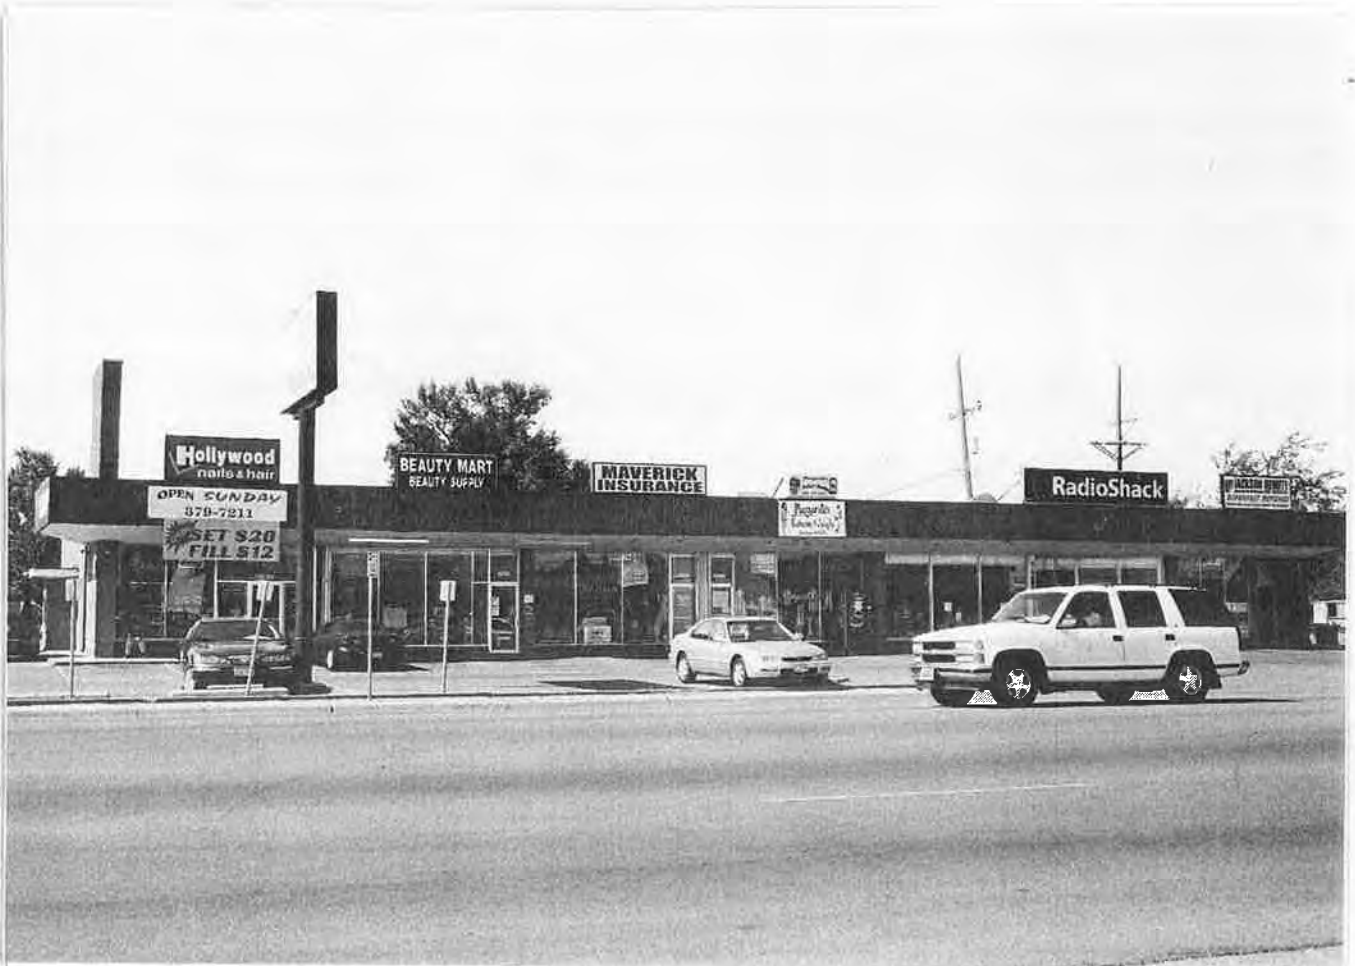
Roof type flat w/ parapet-type fascia (basics corr metal) Materials _____

General Architectural Description commercial strip w/ 4 bays & 7 storefronts
mostly window walls (plate in metal frame; doors = fully glazed in
metal frame w/ transoms) Each bay divided by brick pier
brick in side walls. protruding pylon @ E end.

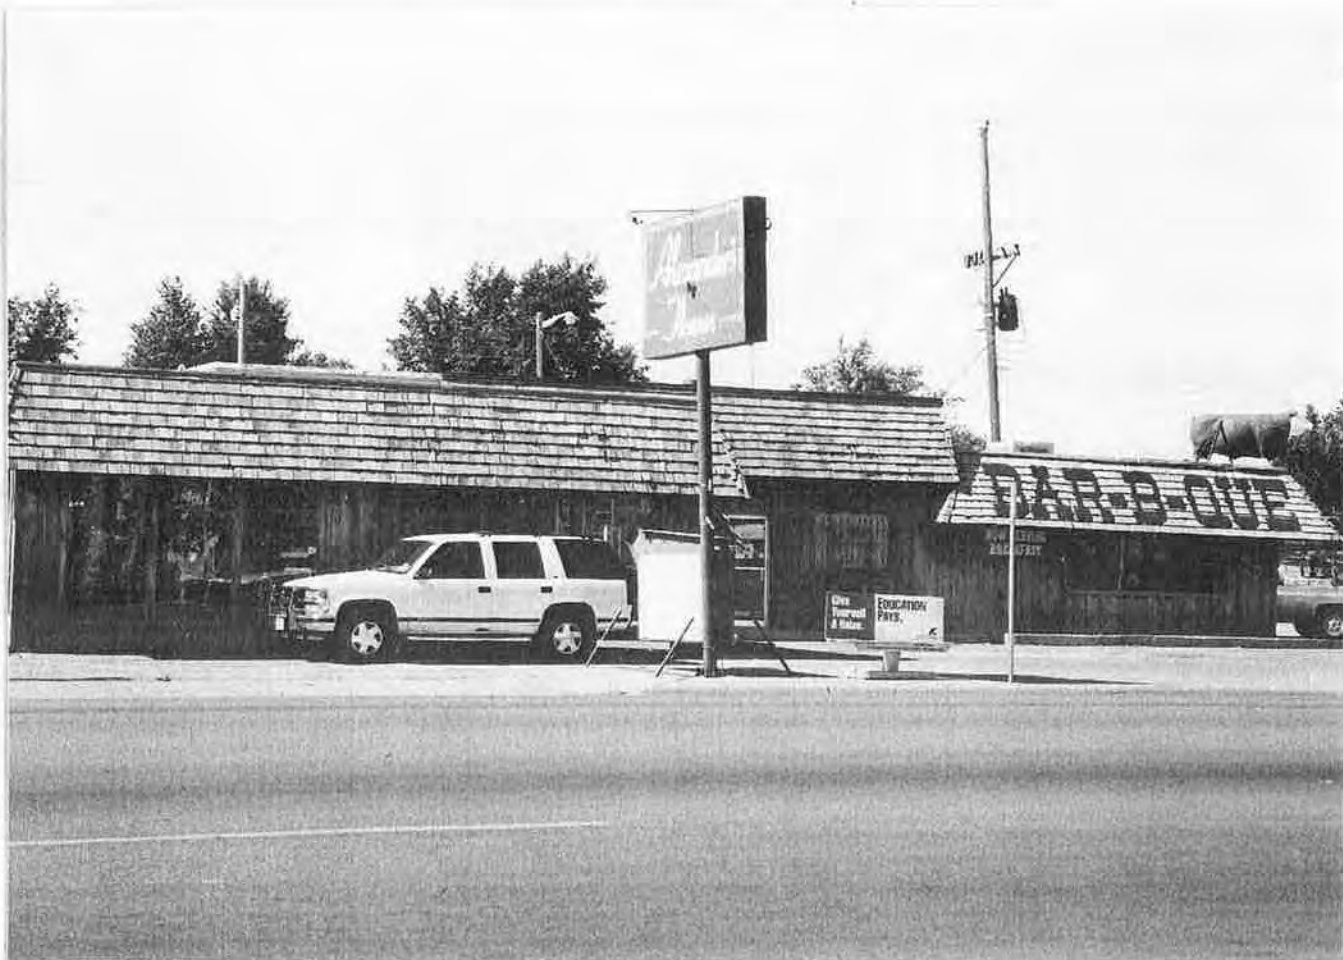
Stylistic Influence(s) _____
 Roof type flat w/ mansard style maroon (shingled, wood) Materials _____
 Wall facade board & batten Foundation _____
 Window type _____ Materials _____
 Door type See below Materials _____
 Porch type _____ Materials _____
 Number of Stories _____ Plan _____
 Chimney(s) _____

General Architectural Description 2 part bldg - some things same see above & below

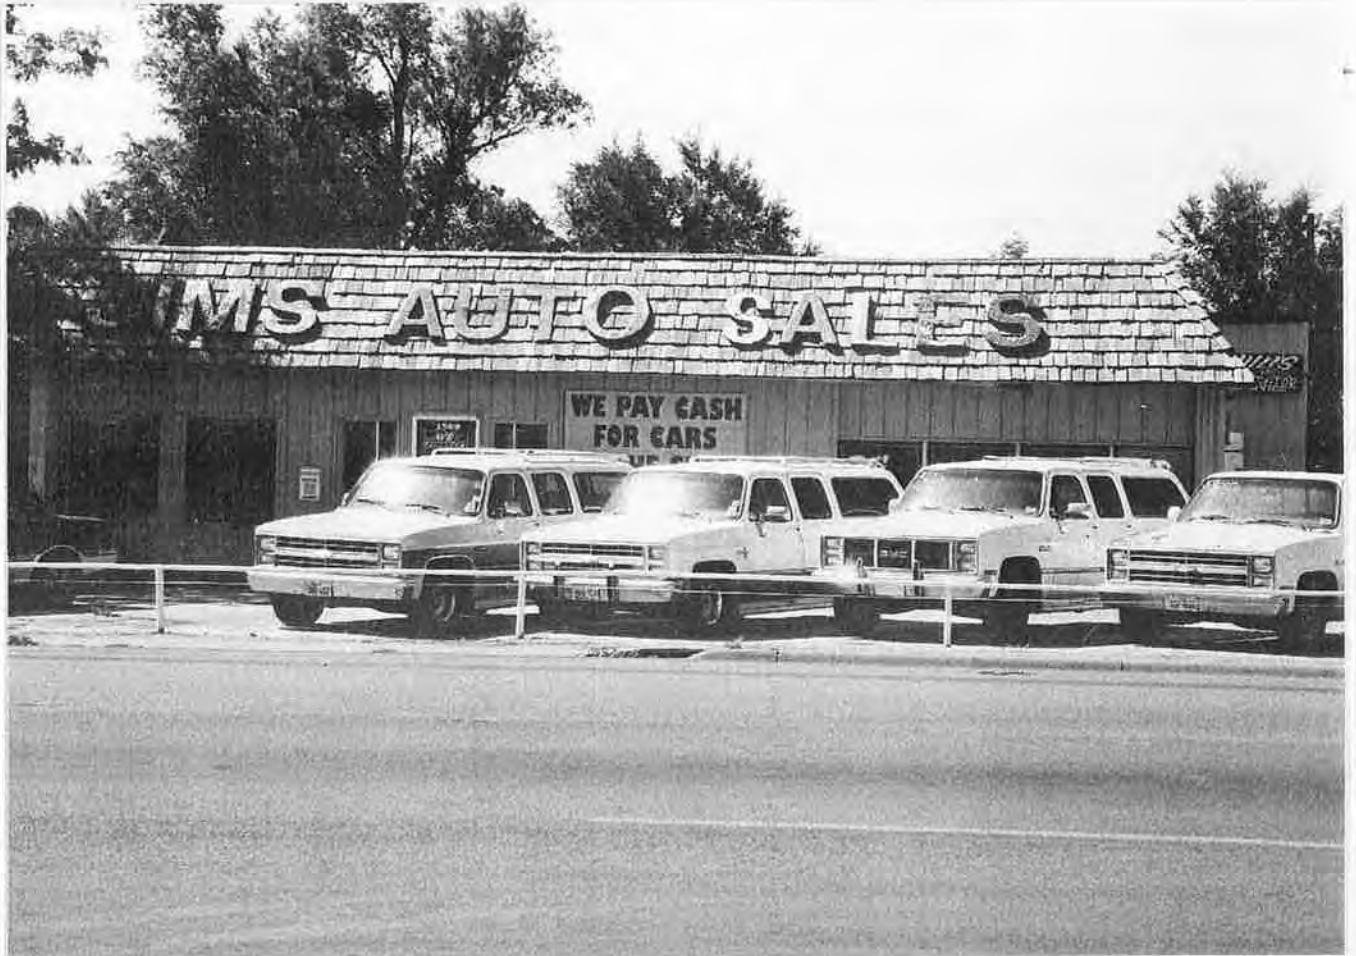
Stylistic Influence(s) _____
 Roof type flat w/ mansard style ~~flat~~ Materials Cornice
 Wall facade non orig corr metal Foundation _____
 Window type plate in metal Materials _____
 Door type fully glazed in metal Materials _____
 Porch type _____ Materials _____
 Number of Stories 1 Plan _____
 Chimney(s) _____

General Architectural Description old bldg for n. now sl. covered. Garage bay in rear (S)
