Historic Resources Inventory Form—Route 66

County POTTER City AMARILLO Inventory # 375-AM-NE
NOT INVENTORIED 844
 Historic Name PIGGY WIGGLY SIGN PHOTO CARD
 Current Name PIGGY WIGGLY SIGN
 Address AMA Blvd E side (behind/adj to County Motel)
 Lot(s): _____ Block: _____ Addition: _____
 Owners Address _____
 Resource type Building Structure Site Object District
 Landscape/Site Features _____
 Outbuildings _____
 Function: Current Use _____ Historic Use _____
 Construction Date: _____ Actual Estimated
 Architect _____ Builder _____
 Possible Threat(s) Demolition Development Neglect Alteration Vacant Utility Expansion
 Integrity Location Design Materials Workmanship Setting Feeling Association
 USGS Quad #: _____ Year: _____ UTM Zone: _____ Easting: _____ Northing: _____
 Priority High Medium Low Recorder Monica Penick Date(s) 7/16/2002

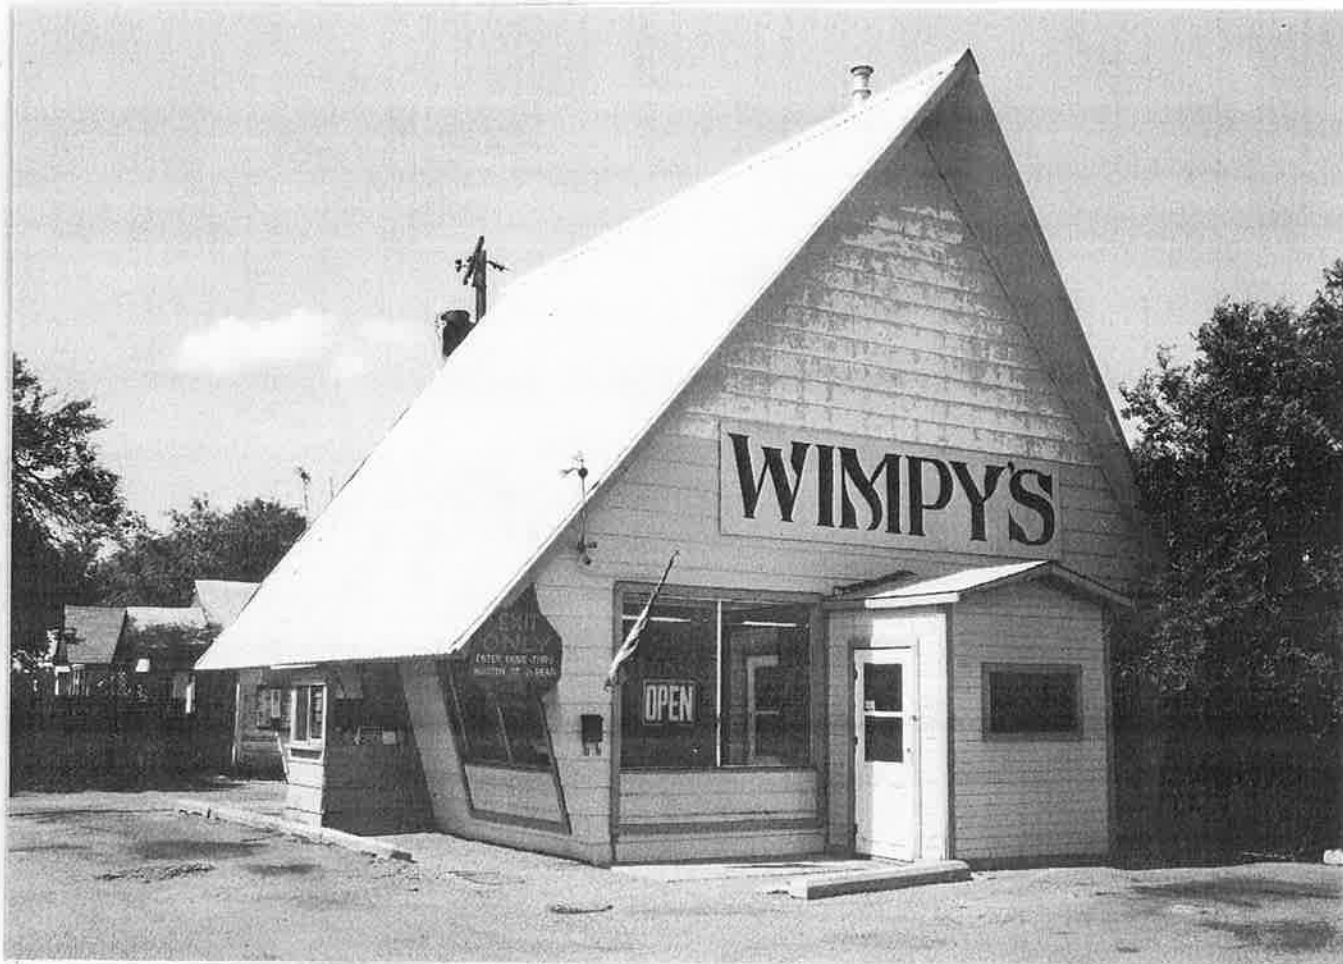
Roof type front gable (almost 1 frame) Materials _____

Wall facade horiz synth siding Foundation _____

General Architectural Description drive thru window bay on E etc - w/ slides

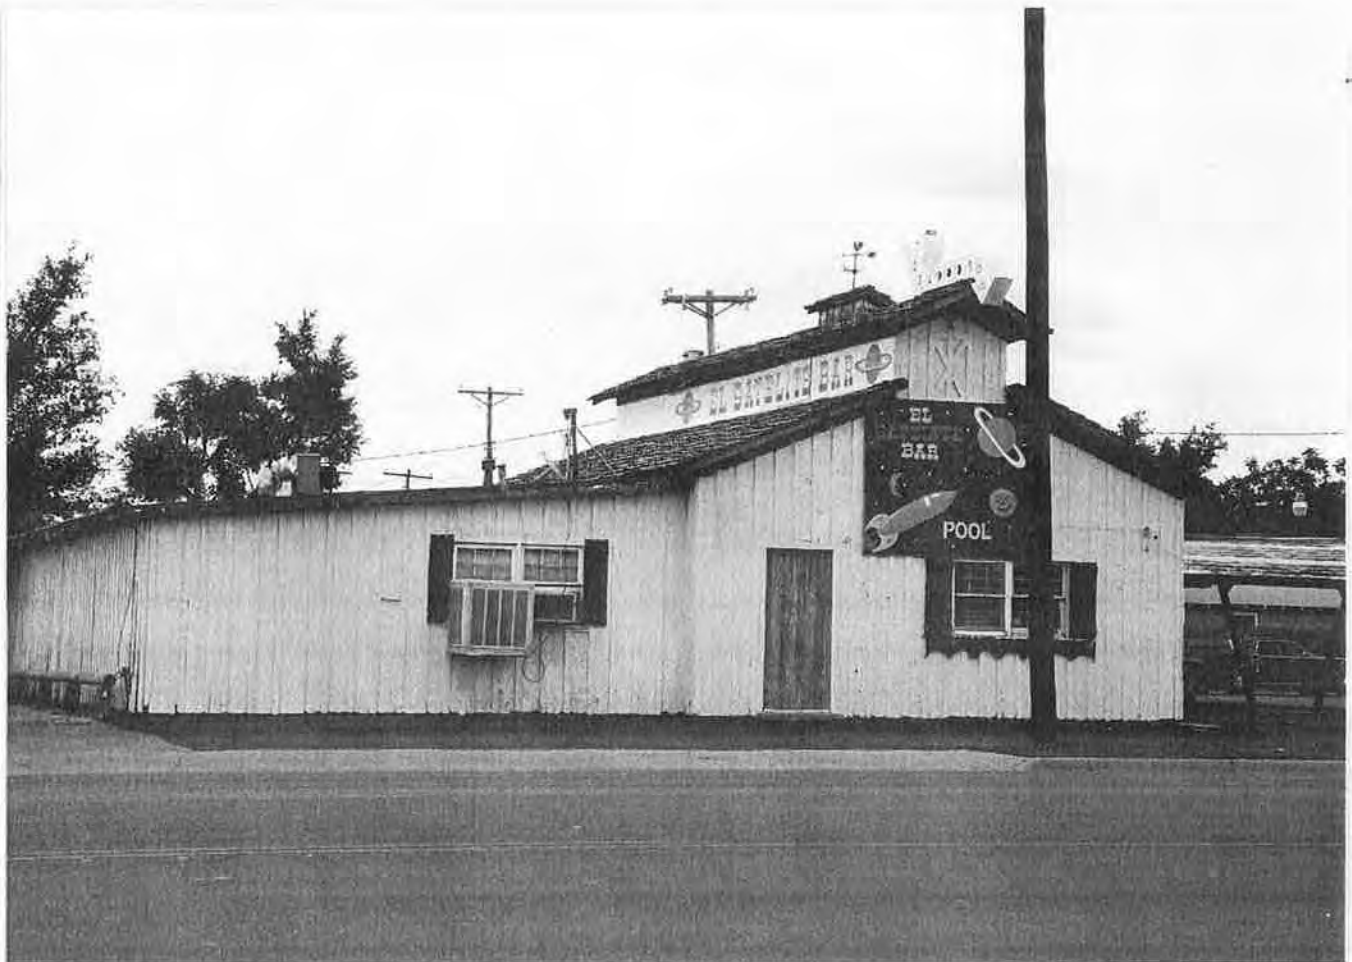
Roof type gable on gable w/ shed add to E Materials wood shingle

Wall facade board & batten Foundation _____

Porch type canopy to W - ~~front~~ ^{found} gable on (card) ^(3 ways) steel poles w/ metal decking Materials _____

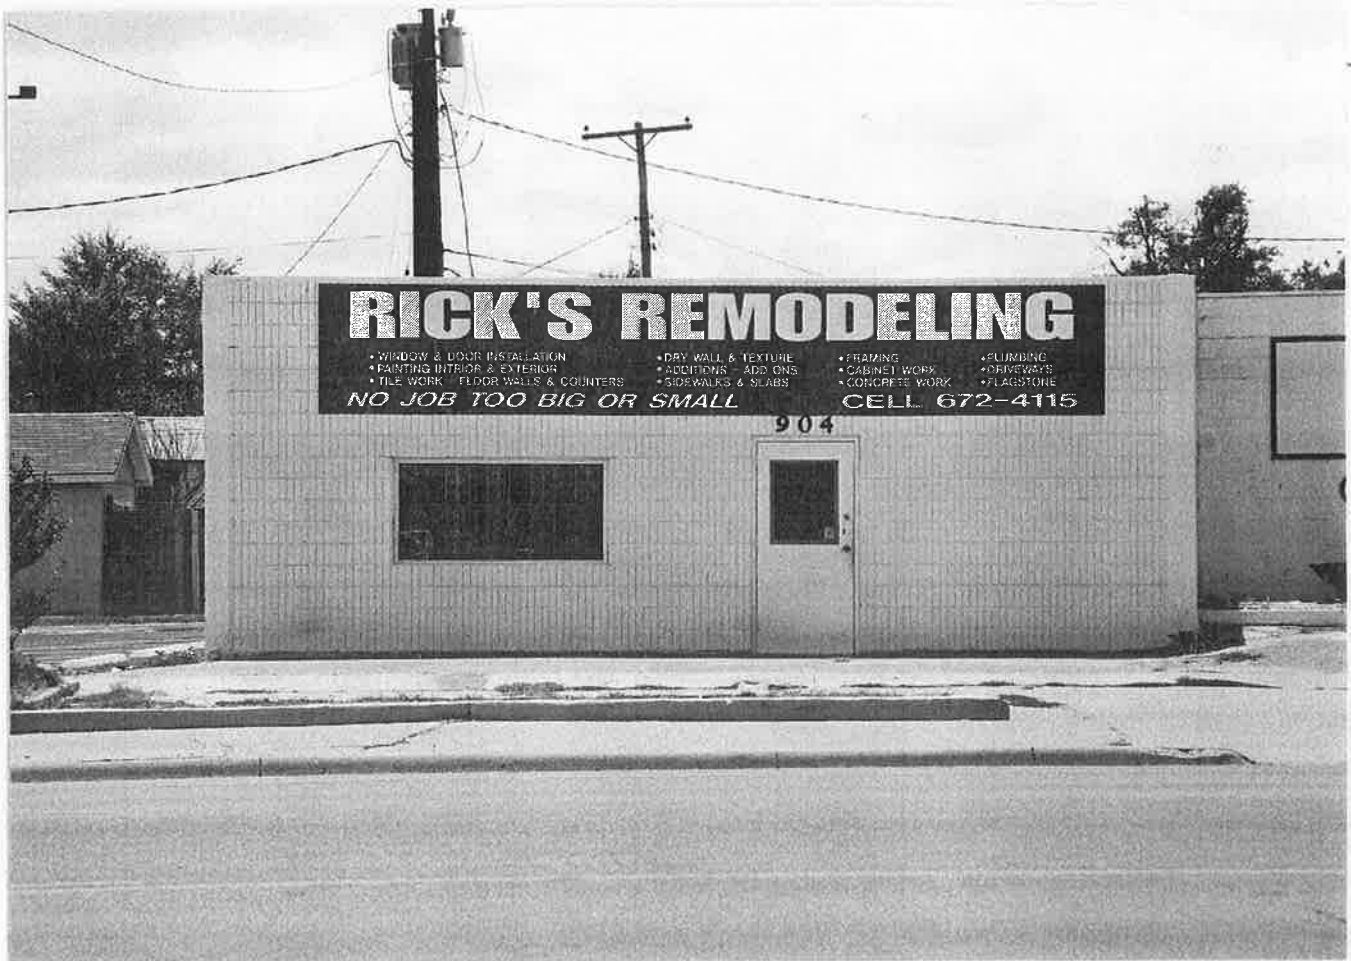
Roof type flat Materials _____

Wall facade vertical ~~glazed~~ tiles brick (solid) Foundation _____

Window type plate in metal Materials _____

Door type 1/2 glass 1/2 solid Materials _____

General Architectural Description part of a 4 bay commercial
strip though terrain uneven 5' flat lines separate

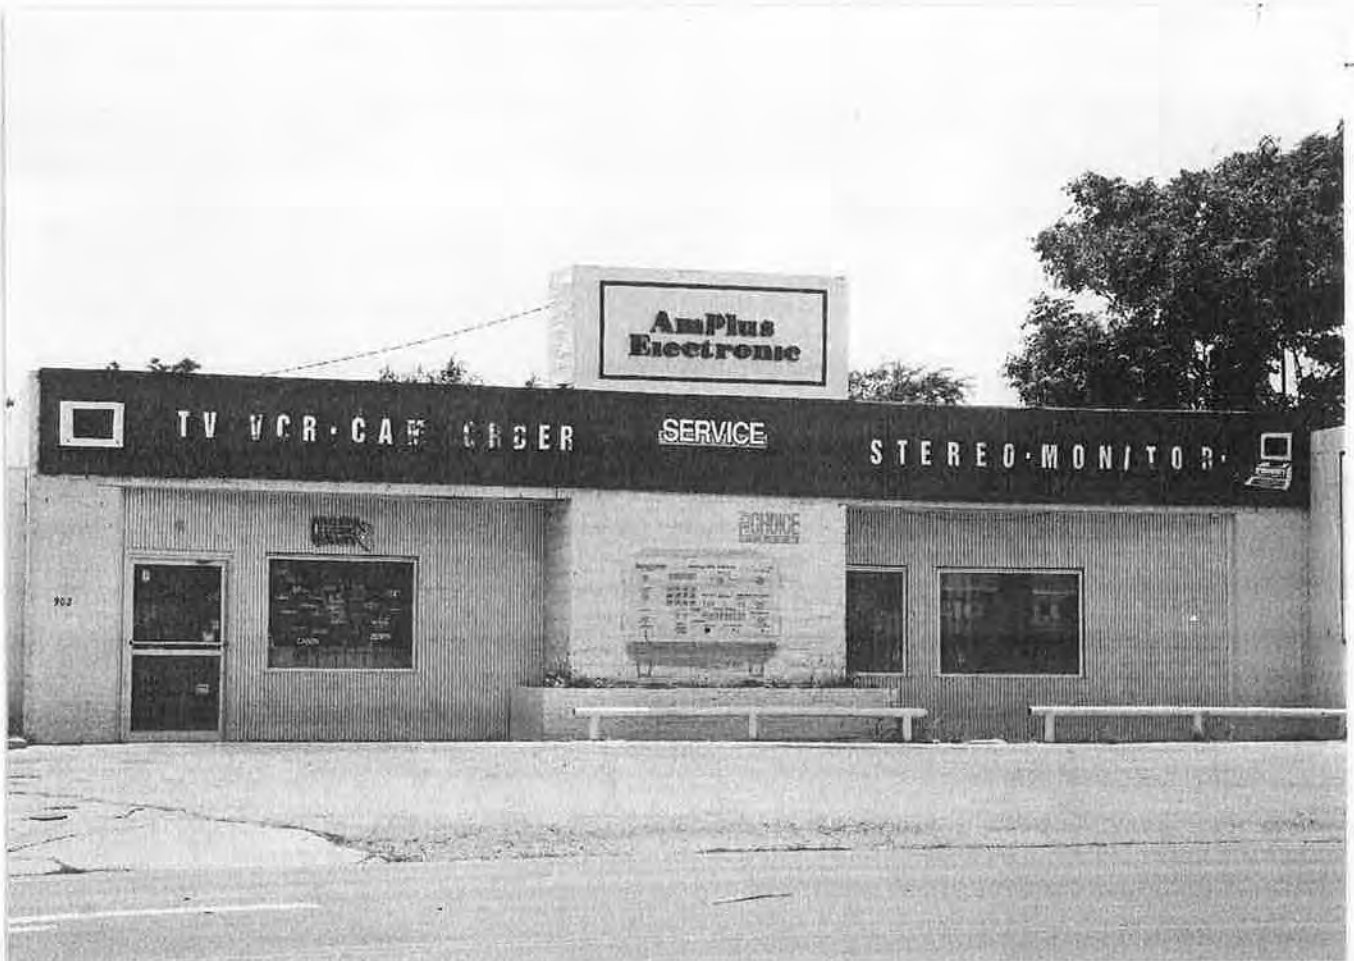
Roof type flat w/ masonry style columns Materials _____

Wall facade brick & ~~concrete~~ score Foundation concrete (vertical columns)

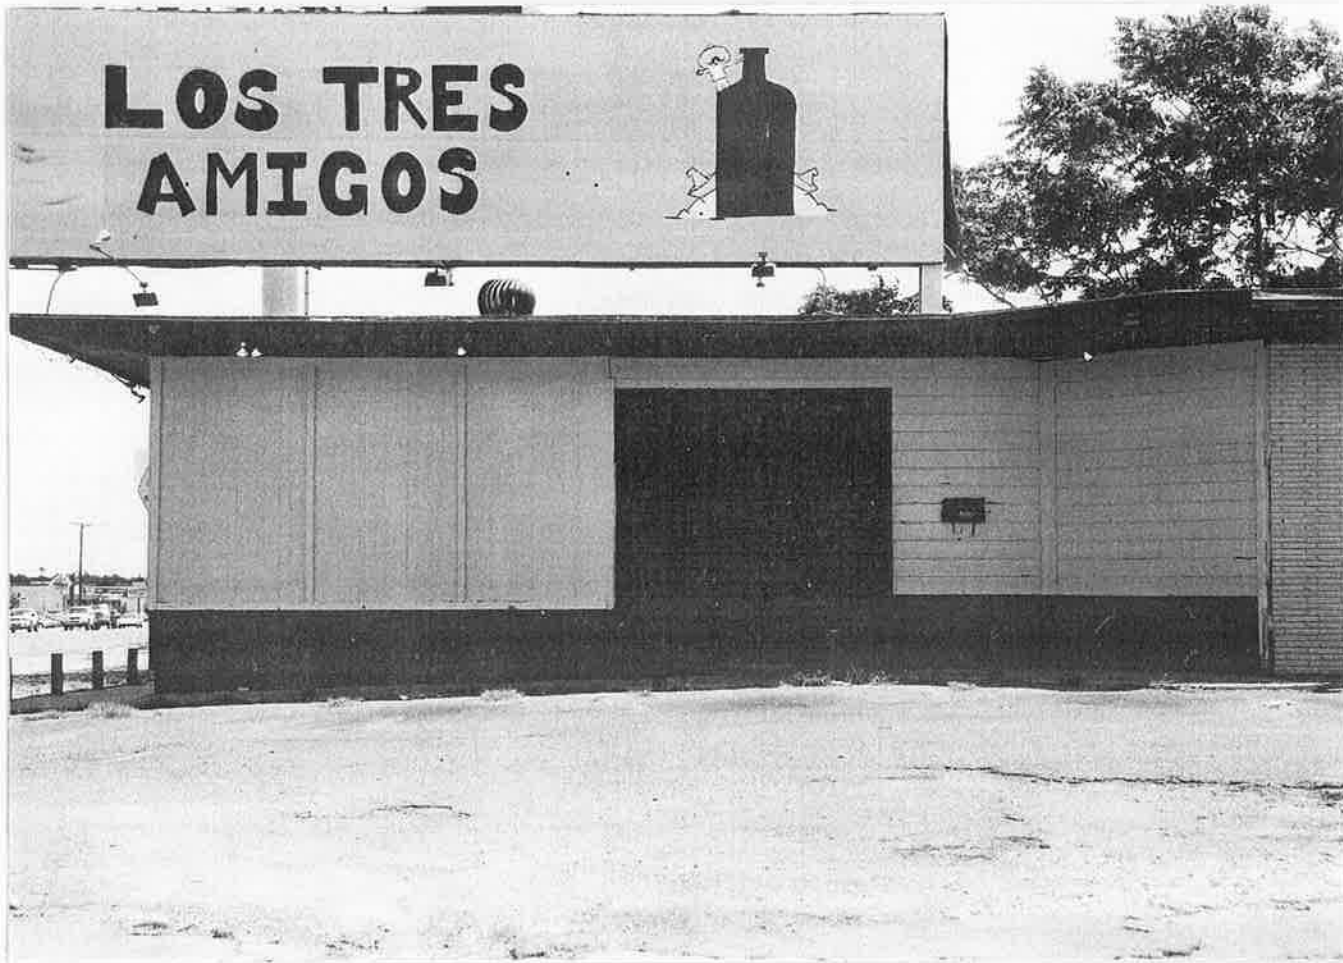
Roof type flat w/ sidewalk parapet Materials _____

Wall facade front: horiz wood siding; side: conc block Foundation brick veneer on W

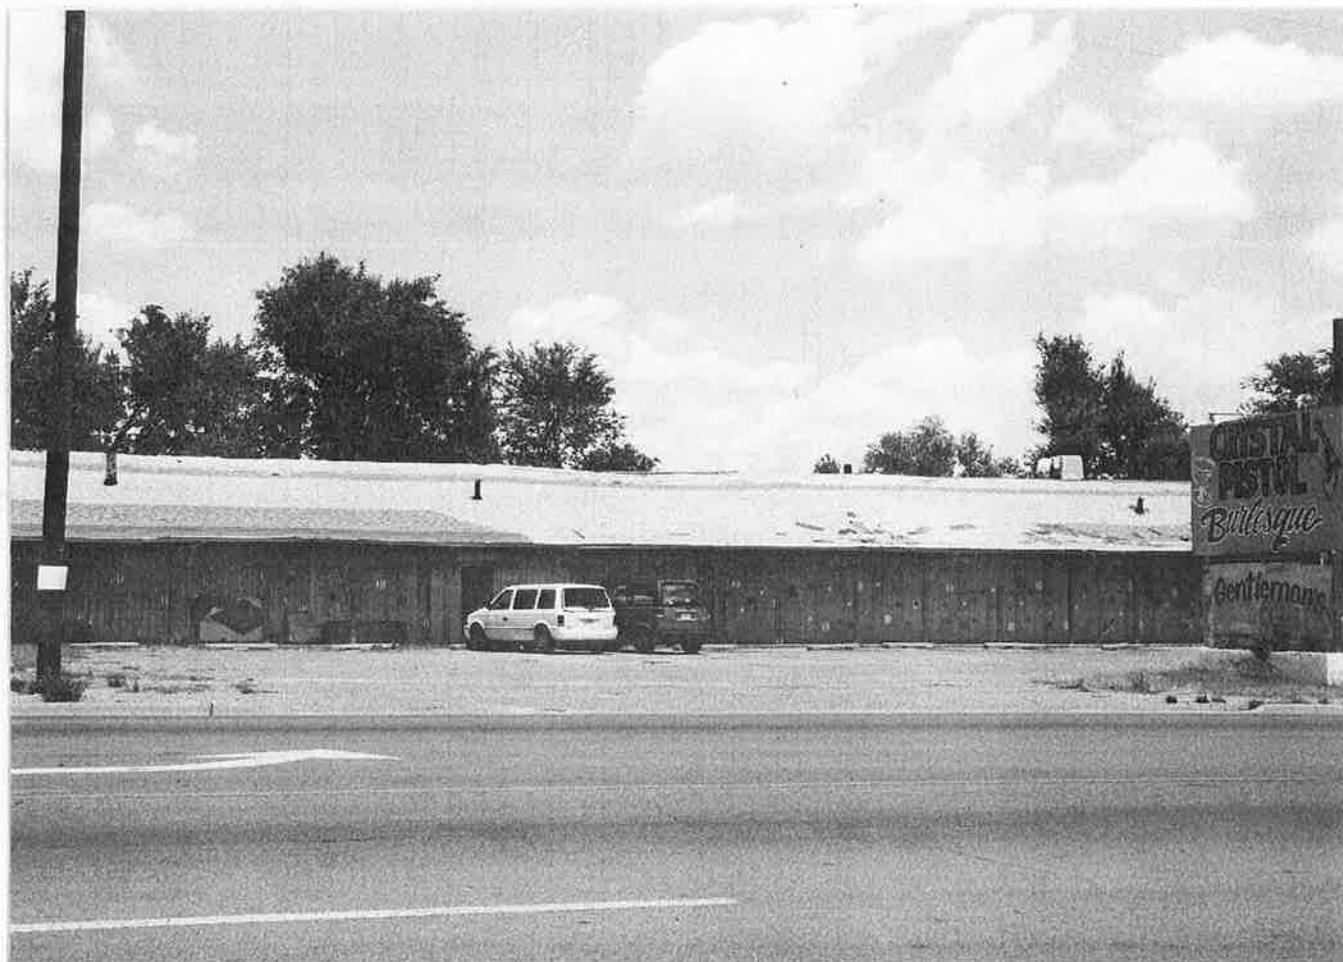
Roof type side gable Materials Comp Shingle

Wall facade front: corr metal side: stucco Foundation _____

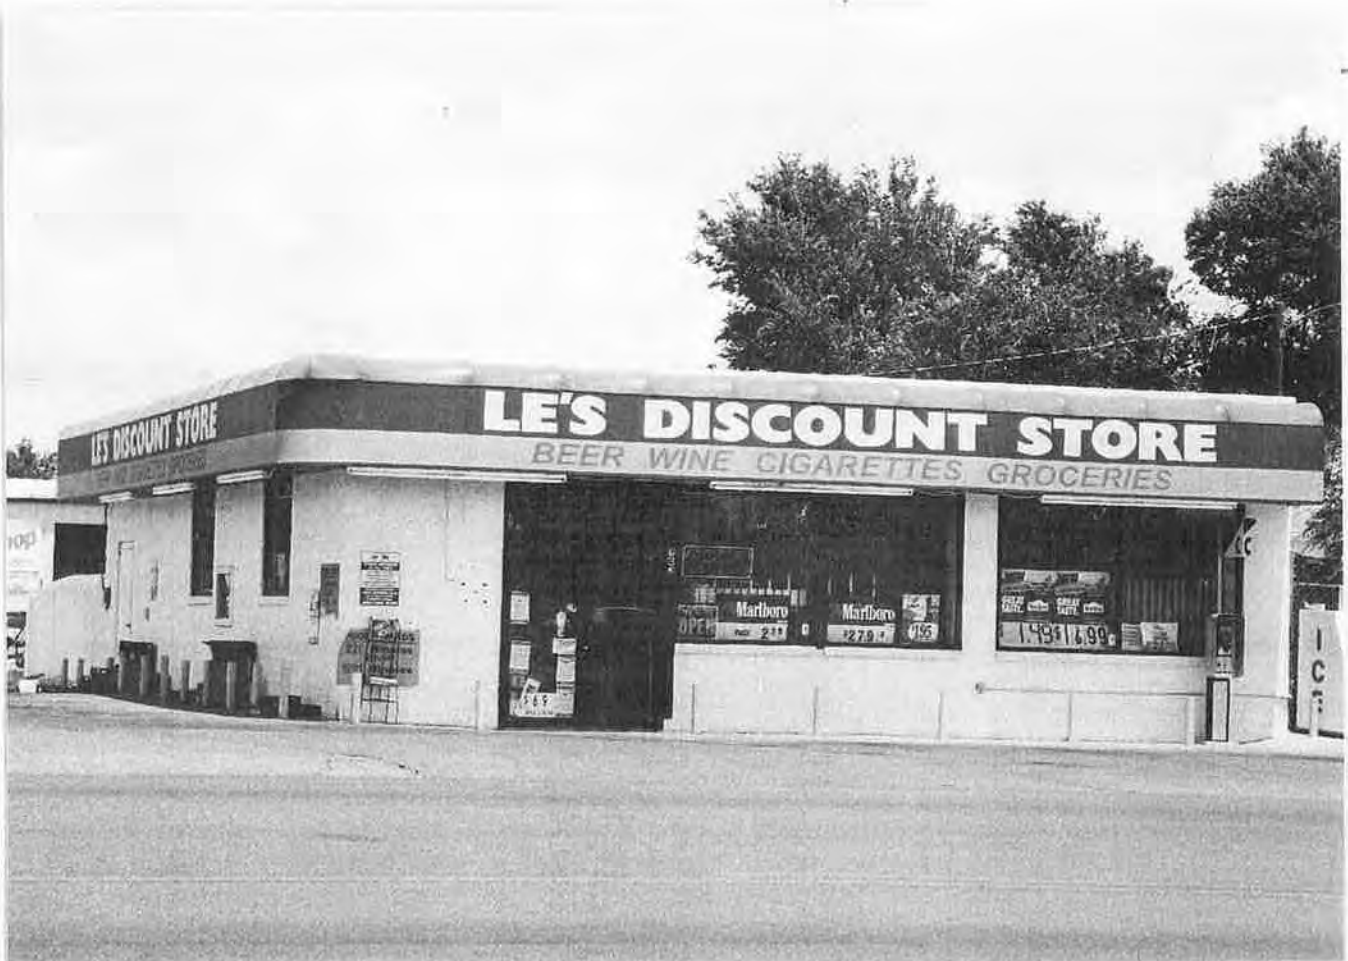
Roof type flat w/ MAOVE Materials _____

Wall facade brick Foundation _____

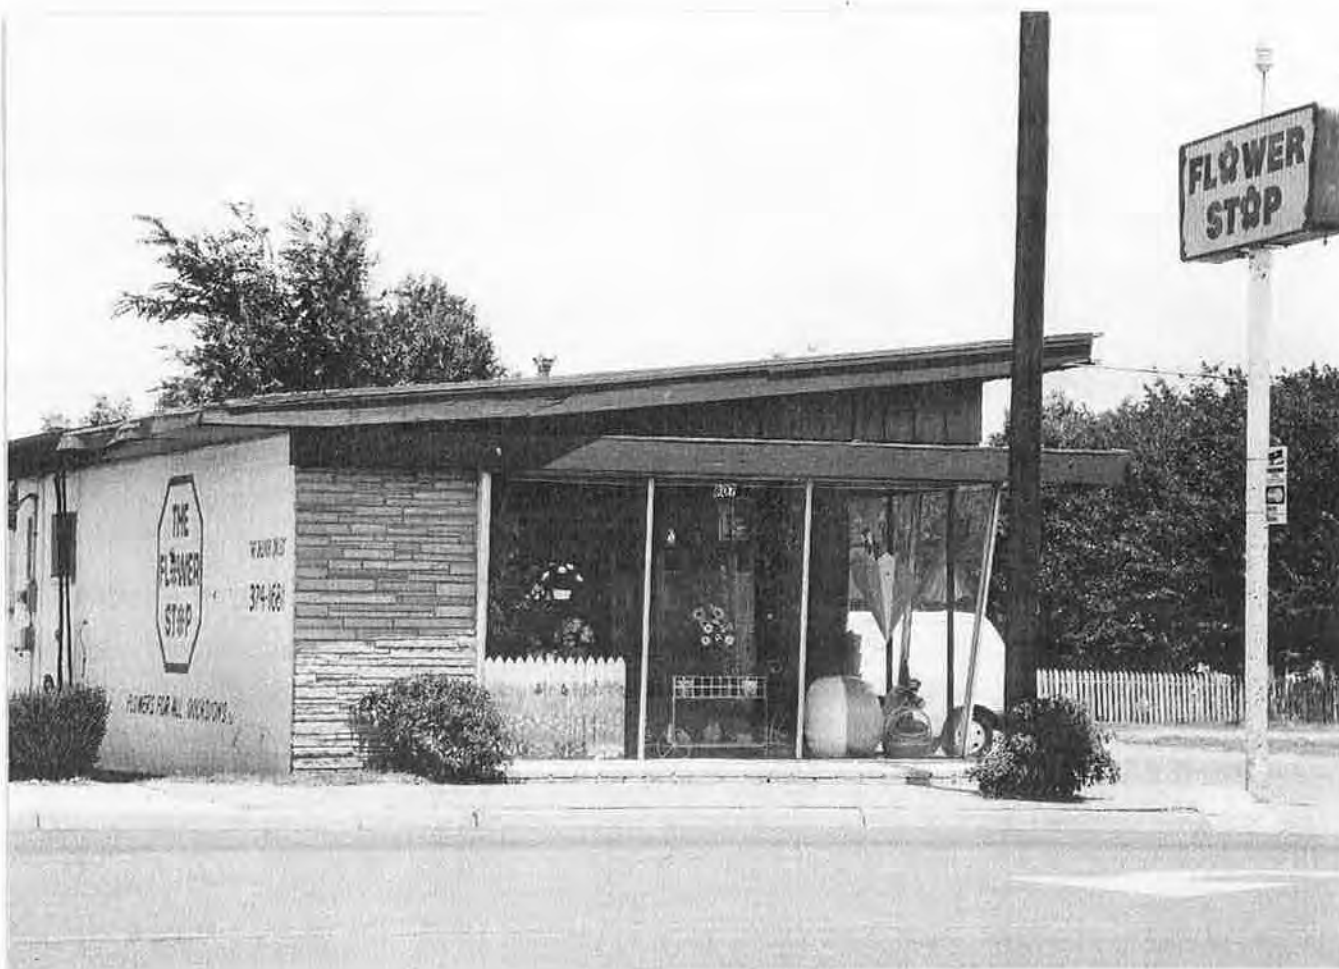
Roof type shed w/ exp joists Materials _____

Wall facade faux ashlar Foundation _____

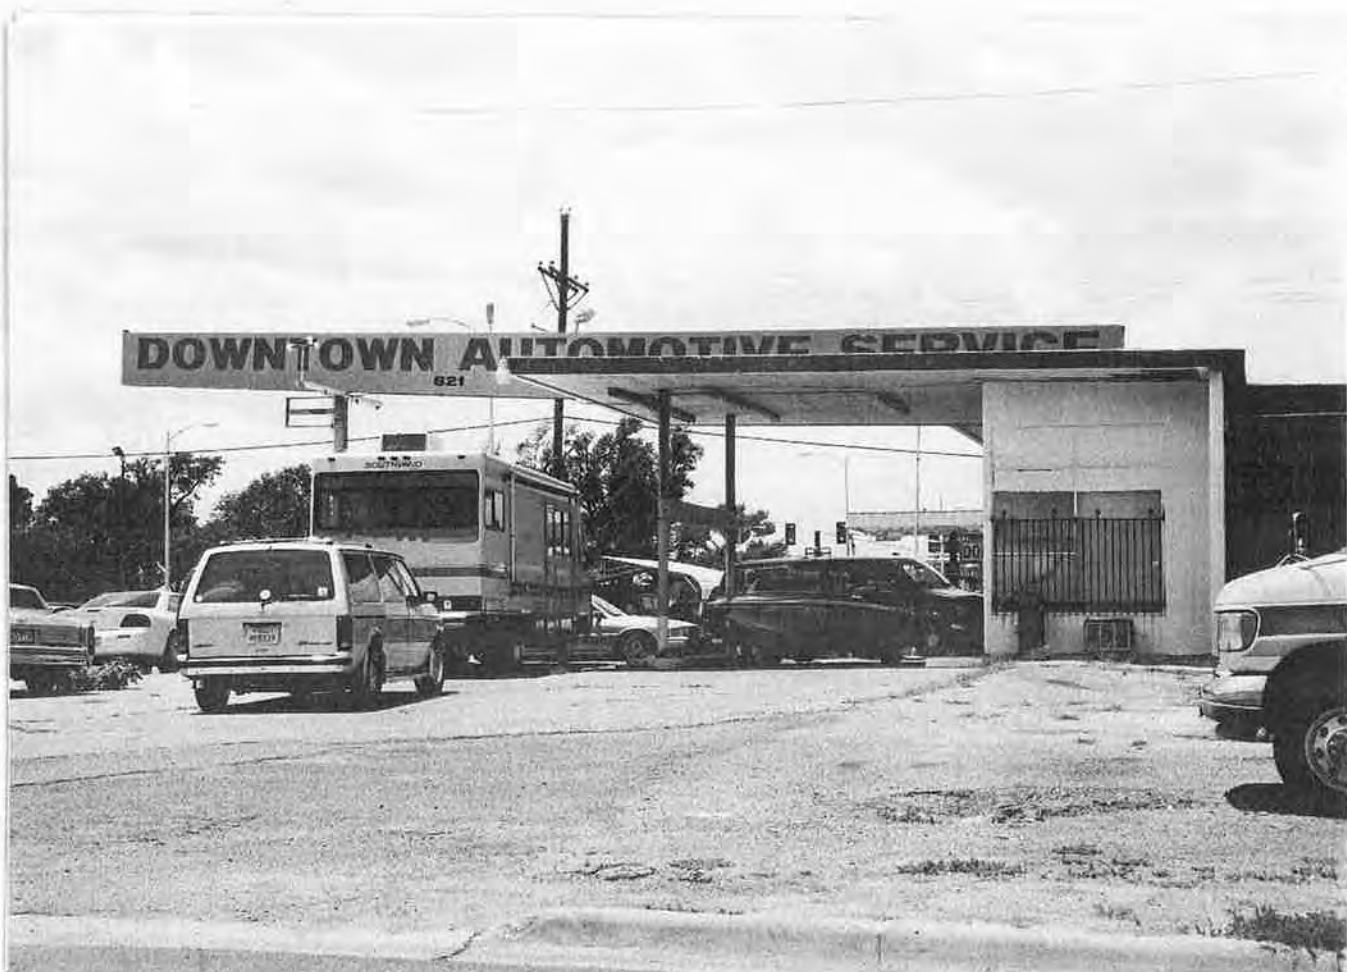
Roof type shed w/ upward projecting canopy Materials (profile stepped)

Wall facade slit, covered w/ metal? Foundation _____

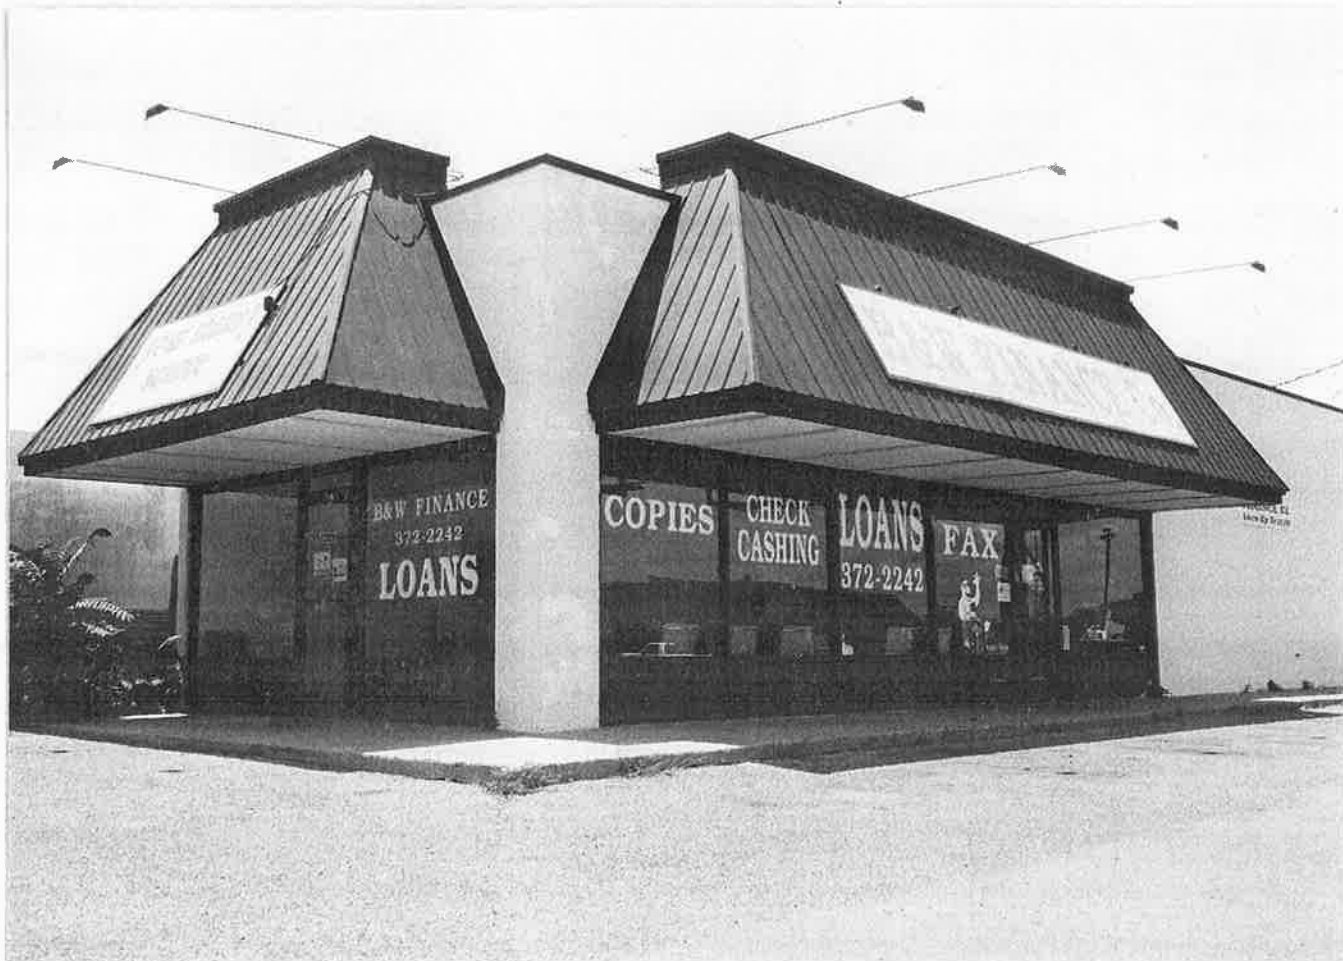
Stylistic Influence(s) _____
 Roof type flat w/ mansard style cornice / cornice Materials _____
 Wall facade Stucco Foundation _____
 Window type plate in metal (window well) Materials _____
 Door type fully glazed in metal Materials _____
 Porch type archway cornice Materials _____
 Number of Stories 1 Plan _____
 Chimney(s) _____

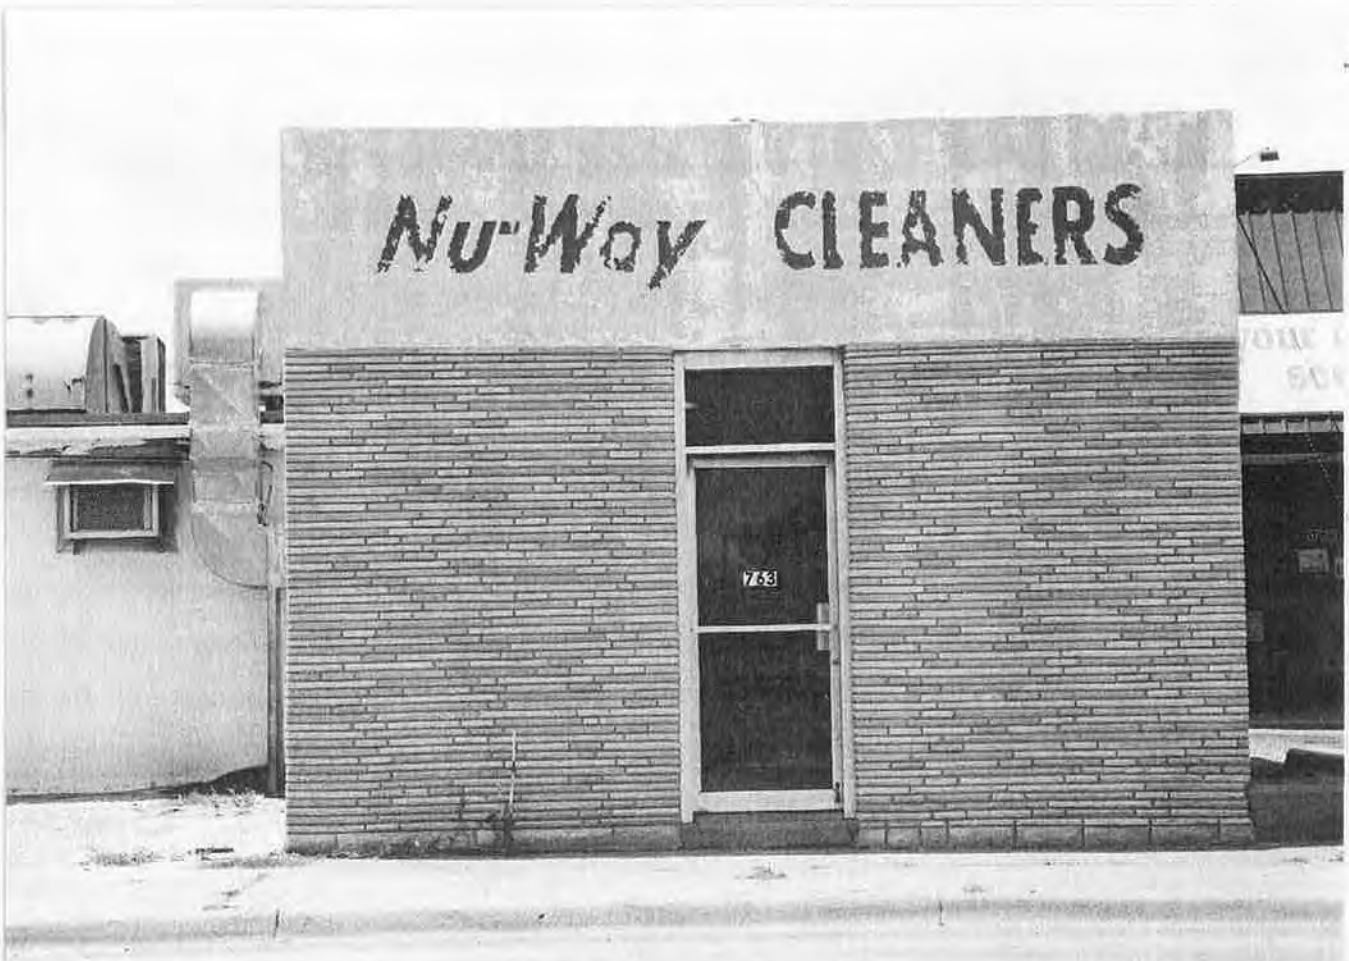
Roof type flat w/ parapet Materials _____

Wall facade stucco w/ faux ashler skirt (profile is stepped) Foundation TLH

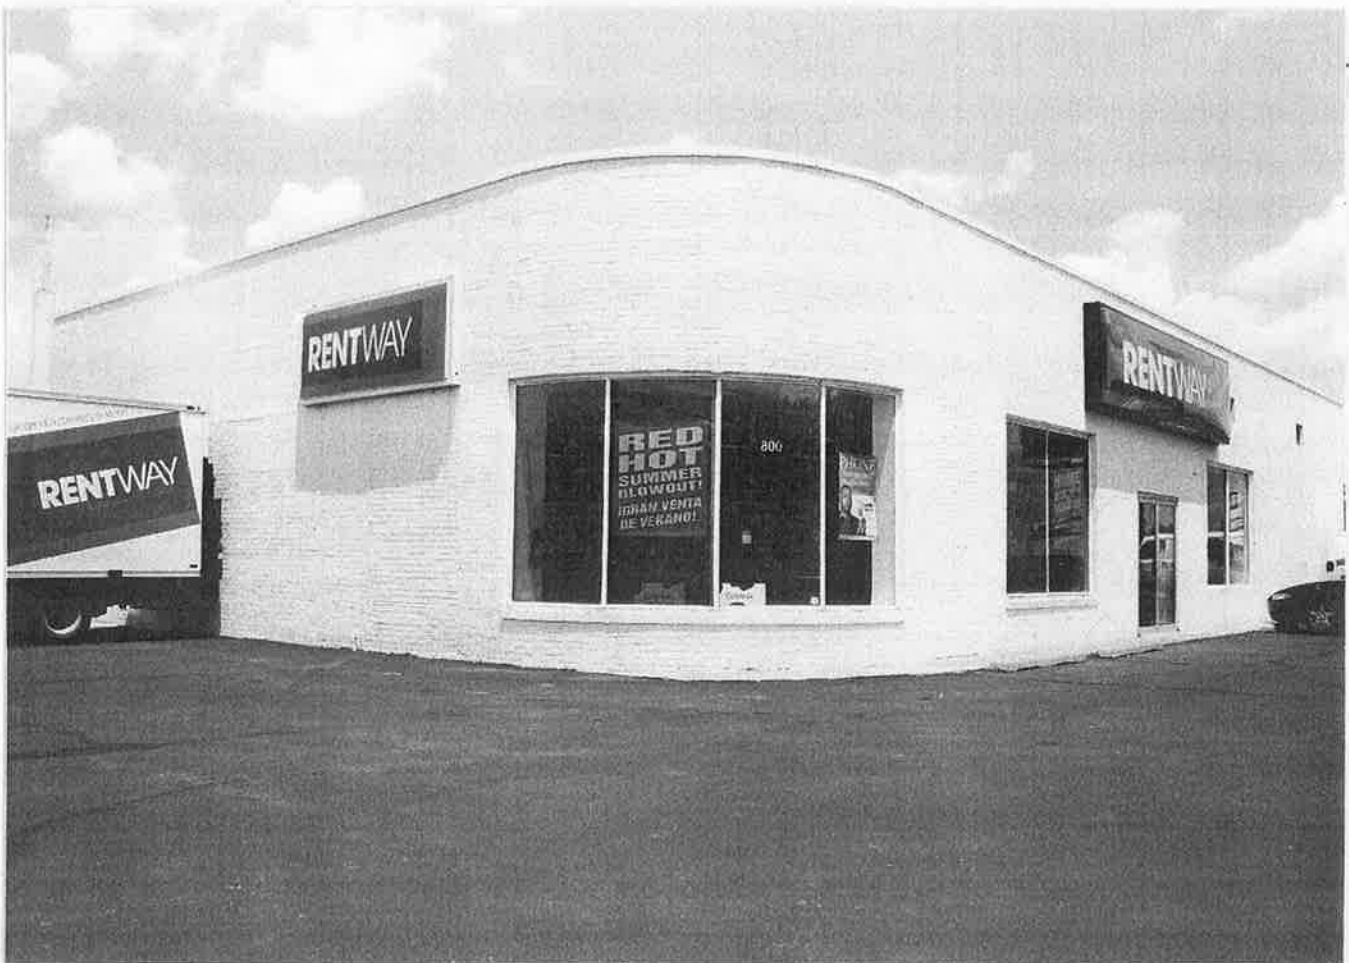
Roof type flat Materials _____

Wall facade brick / NW corner is curved Foundation _____

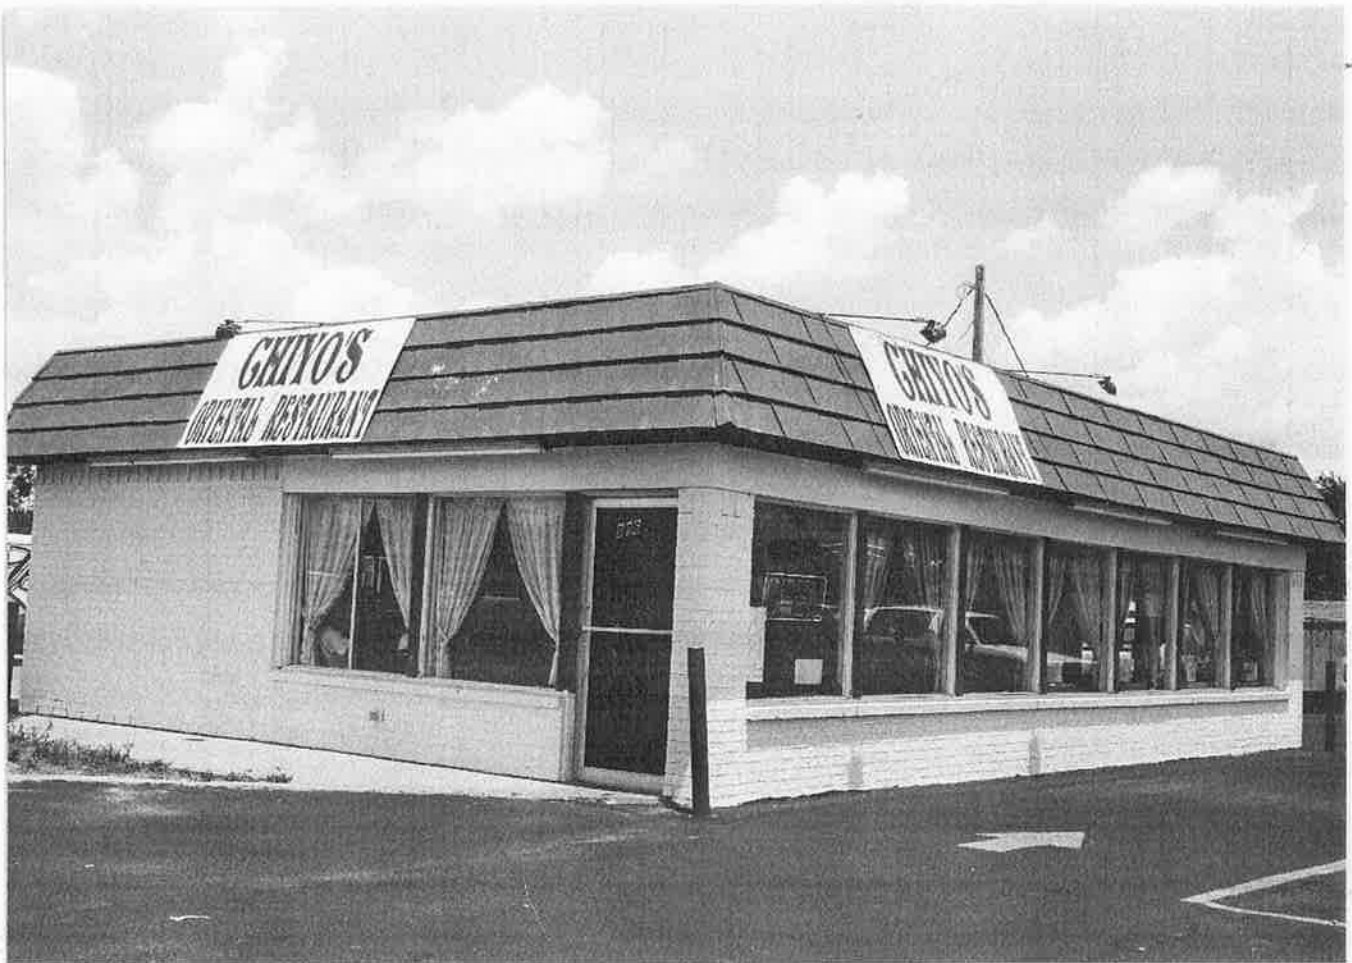
Roof type flat w/ mansard style cornice shingled in synth. (grooved) shingles.
 Materials _____

Wall facade plaster brick Foundation _____

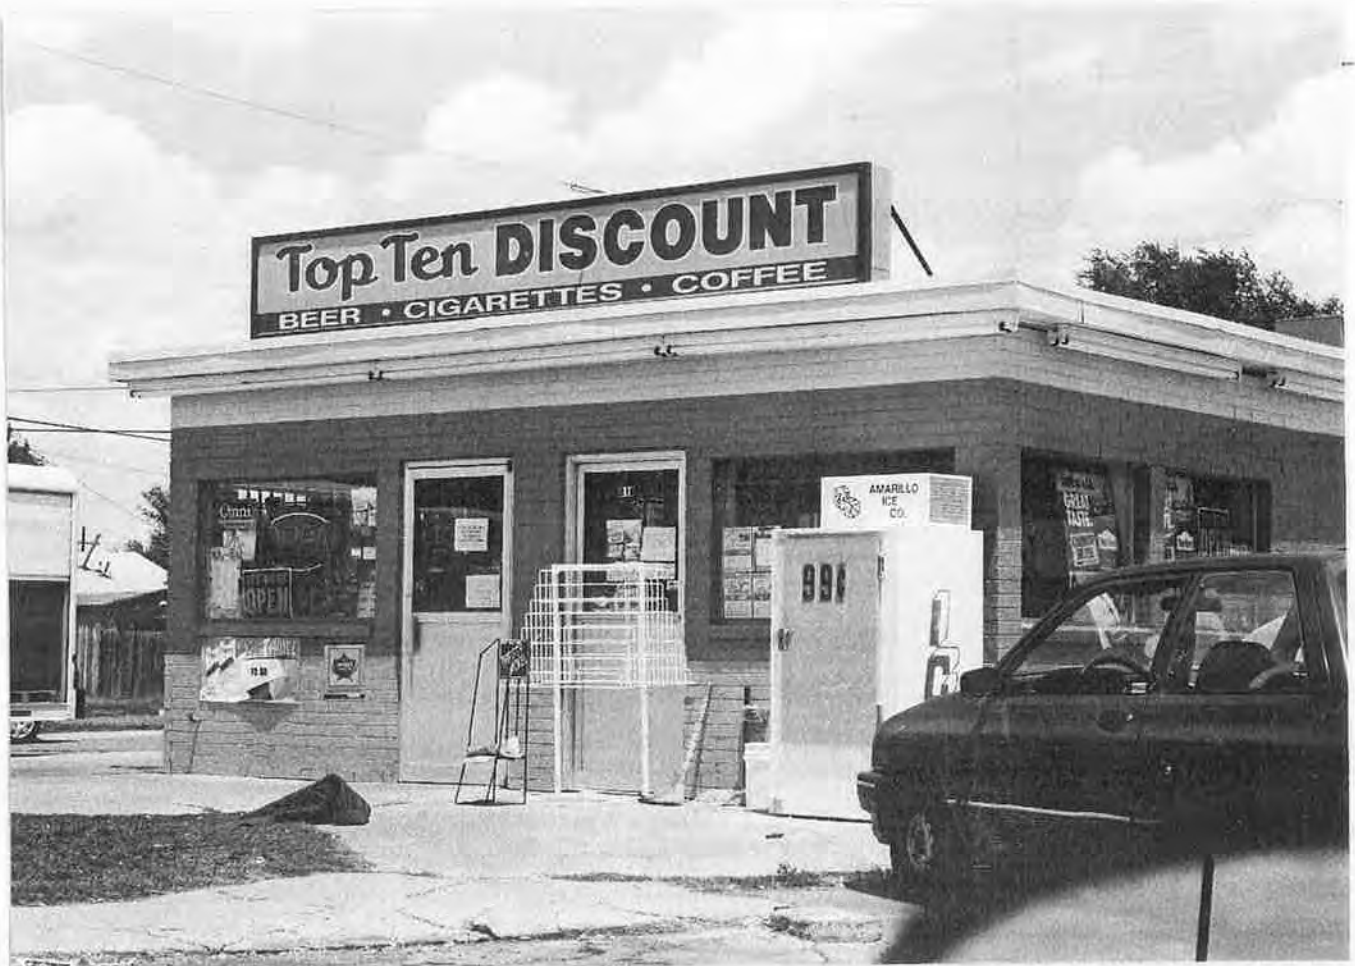
Stylistic Influence(s) _____
Roof type flat Materials _____
Wall facade brick Foundation _____
Window type plate in metal Materials _____
Door type fully glazed in metal Materials _____
Porch type _____ Materials _____
Number of Stories 1 Plan _____
Chimney(s) _____

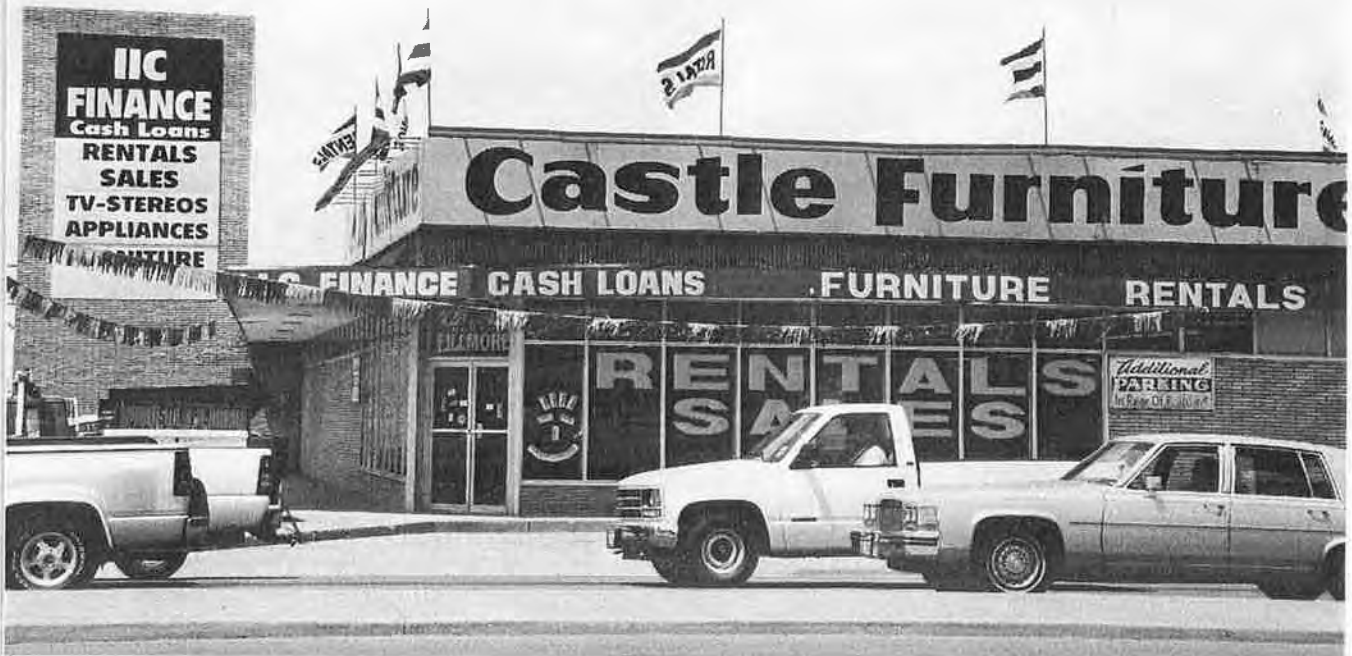
Roof type flat Materials _____

Wall facade Roman brick ; SW corner Foundation chamfered (3 glazed)

General Architectural Description windows run all along facade just below
awning lg rectangular pylon on W side (1 w/ facade)

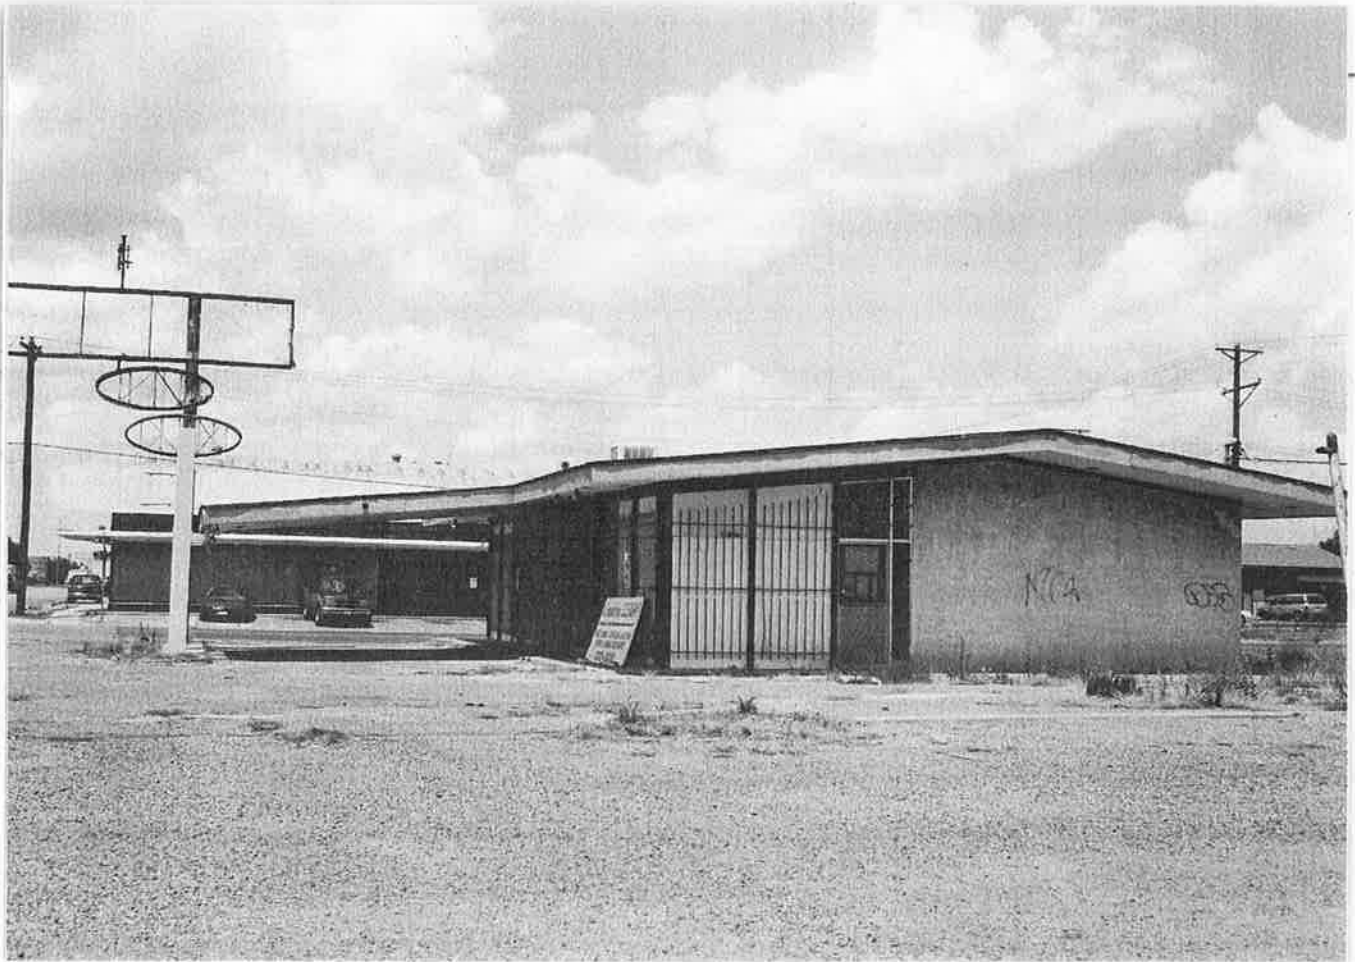
Roof type side gable w/ overhang eaves Materials _____

Wall facade stucco Foundation _____

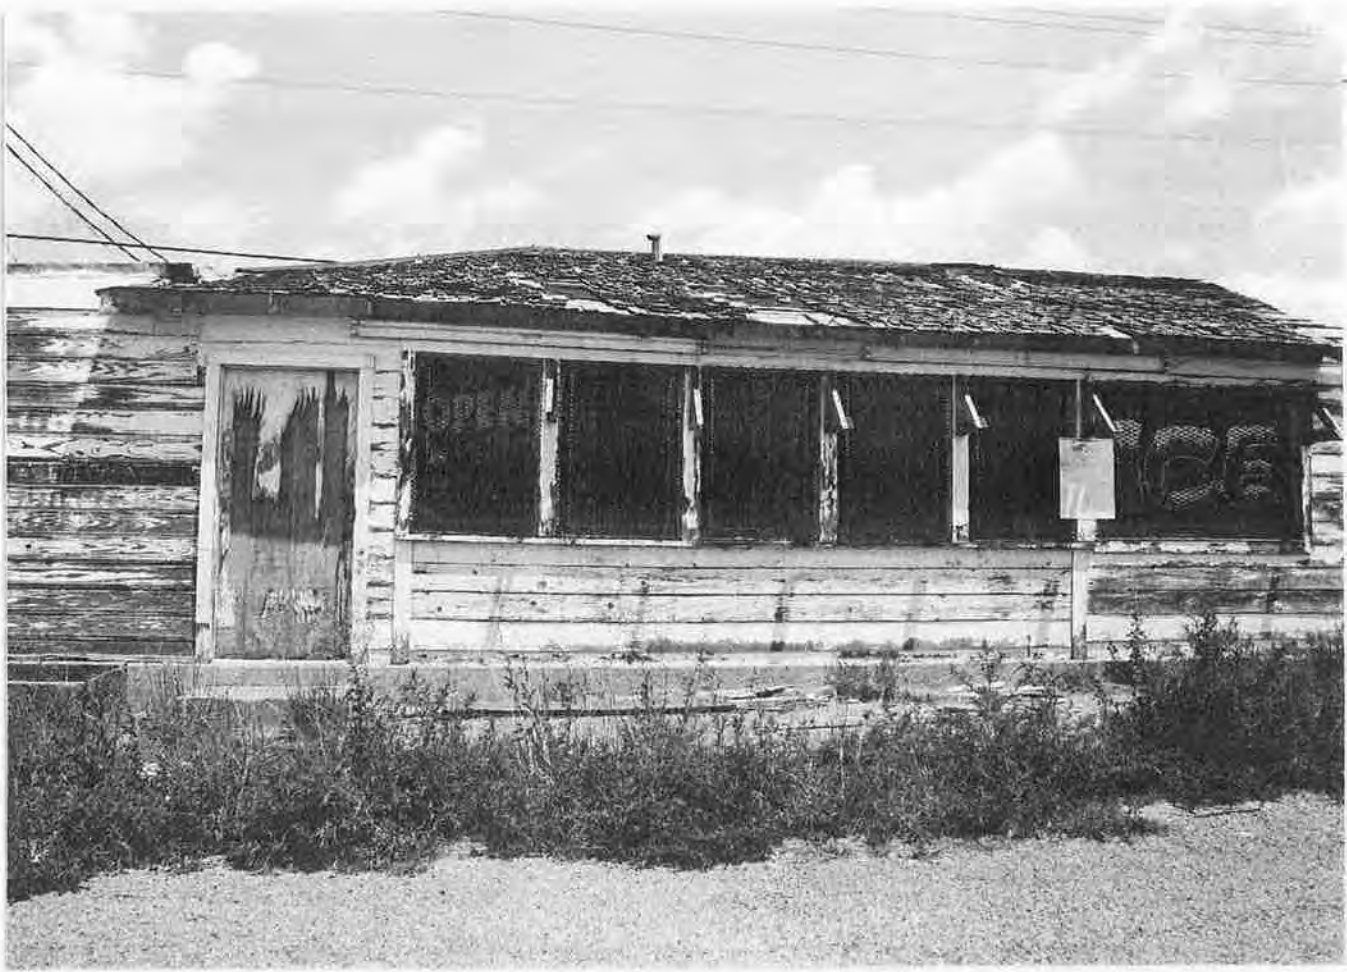
Roof type gabled gable w/ shed roof in rear Materials shingle

Wall facade horiz wood Foundation conc slab
