Historic Resources Inventory Form—Route 66

County POTTER City AMARILLO Inventory # 375-AM-NE
NOT INVENTORIED 844
 Historic Name PIGGY WIGGLY SIGN PHOTO CARD
 Current Name PIGGY WIGGLY SIGN
 Address AMA Blvd E side (behind/adj to County Motel)
 Lot(s): _____ Block: _____ Addition: _____
 Owners Address _____
 Resource type Building Structure Site Object District
 Landscape/Site Features _____
 Outbuildings _____
 Function: Current Use _____ Historic Use _____
 Construction Date: _____ Actual Estimated
 Architect _____ Builder _____
 Possible Threat(s) Demolition Development Neglect Alteration Vacant Utility Expansion
 Integrity Location Design Materials Workmanship Setting Feeling Association
 USGS Quad #: _____ Year: _____ UTM Zone: _____ Easting: _____ Northing: _____
 Priority High Medium Low Recorder Monica Penick Date(s) 7/16/2002

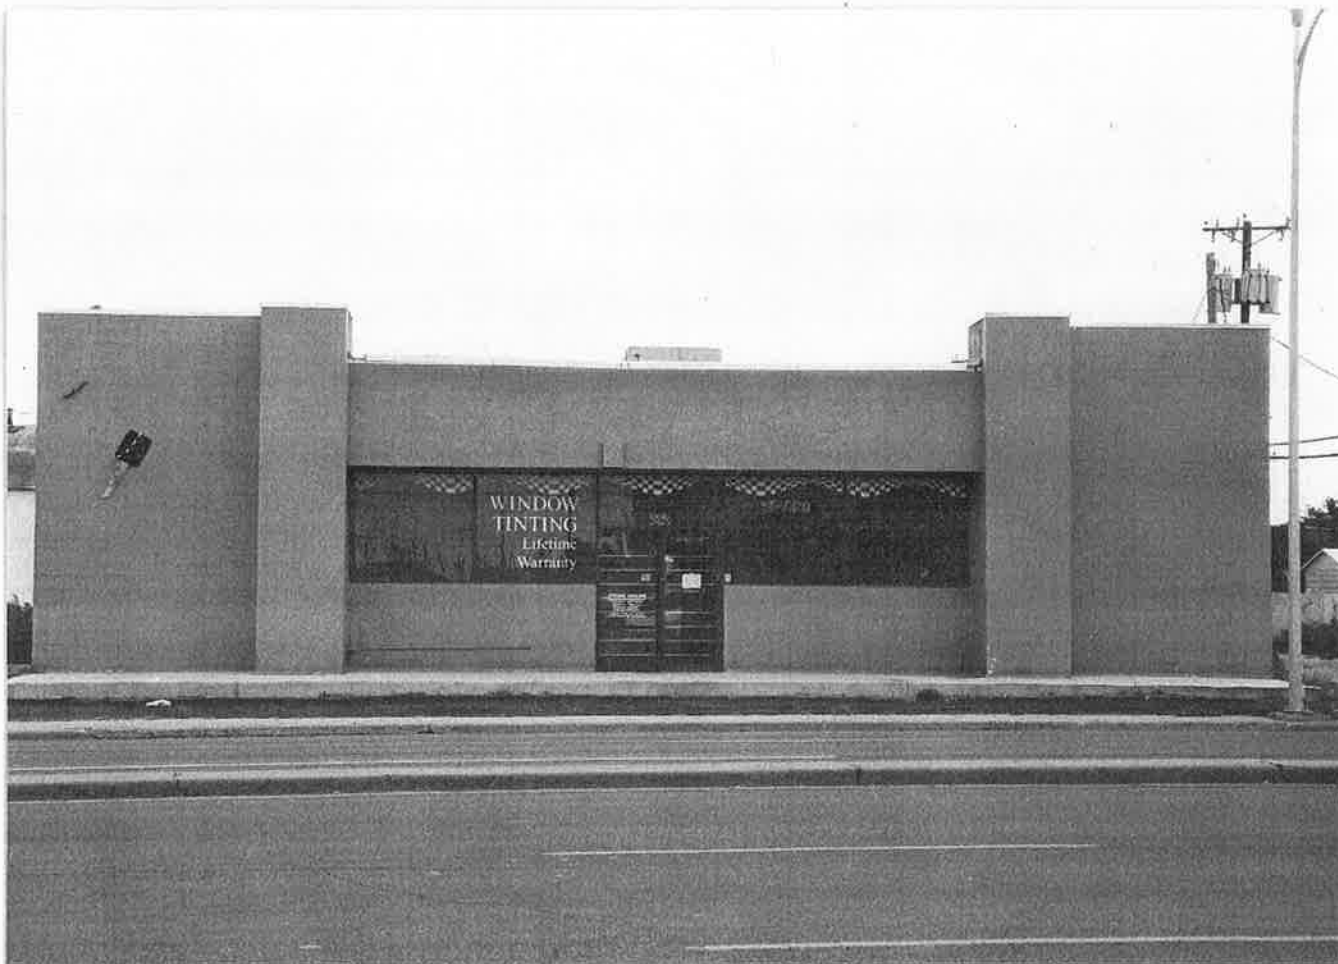
Roof type flat Materials _____

Wall facade conc block (center bay - stucco) Foundation _____
