Amarillo Part III

Historic Resources Inventory Form—Route 66

County Potter City Amargillo Inventory # 375-AM-209

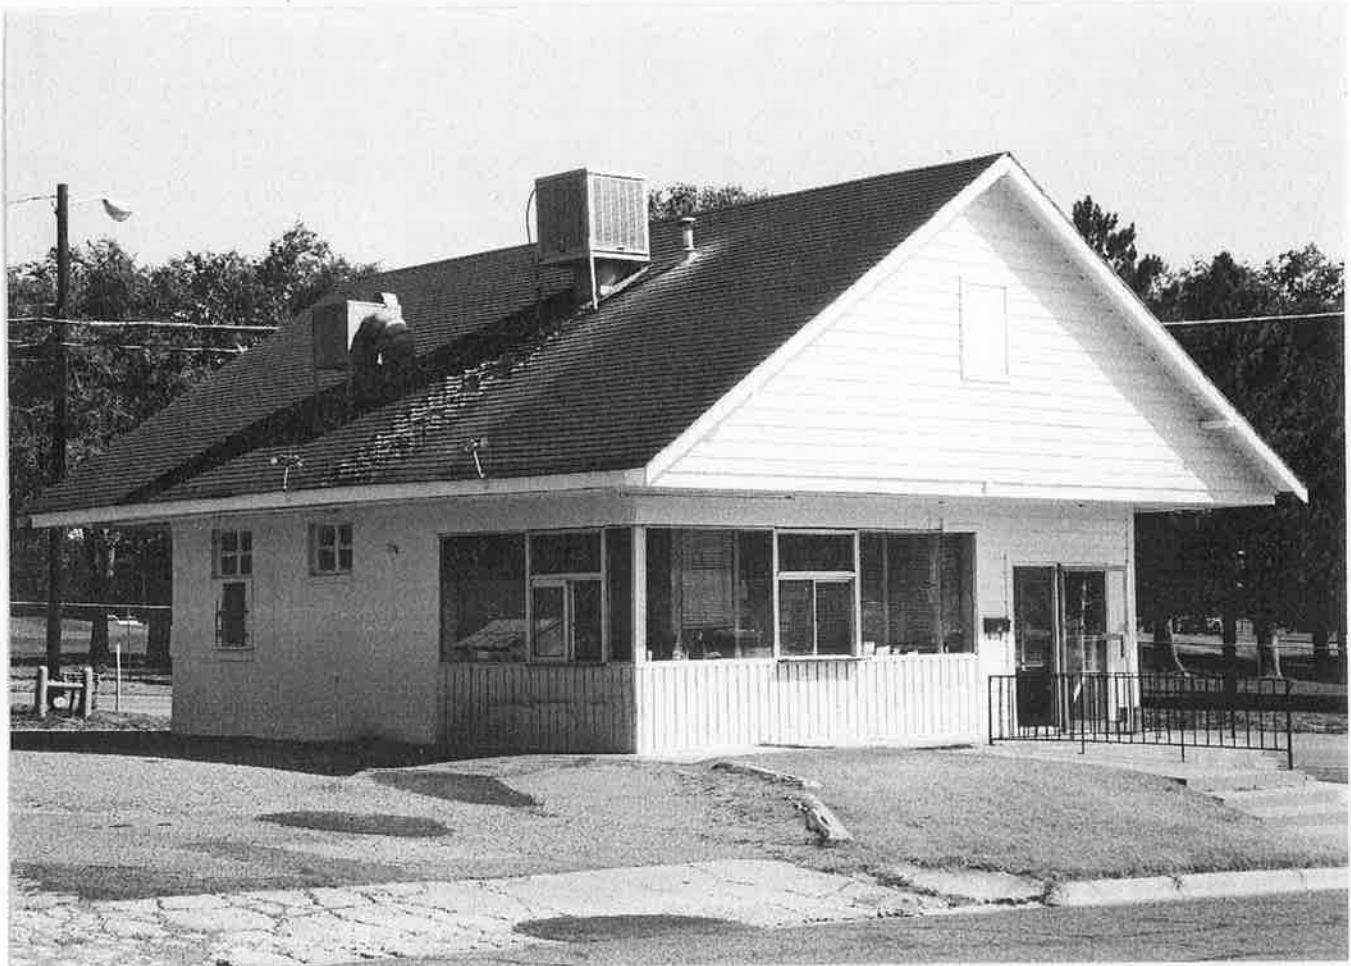
375-AM-209
30-3766-18
FACING NW

Roof type front gable (xassy. roof) Materials corr. shingle

Wall facade front: horiz wood siding rear: brick Foundation _____

Window type plate in metal w/ wood surround Materials vertical grooved metal siding

Door type fully glazed in metal w/ lg side Materials as siding

Porch type overhanging gable-type roof Materials _____

General Architectural Description horiz wood siding in gable end

drive-up windows on S & E elev.

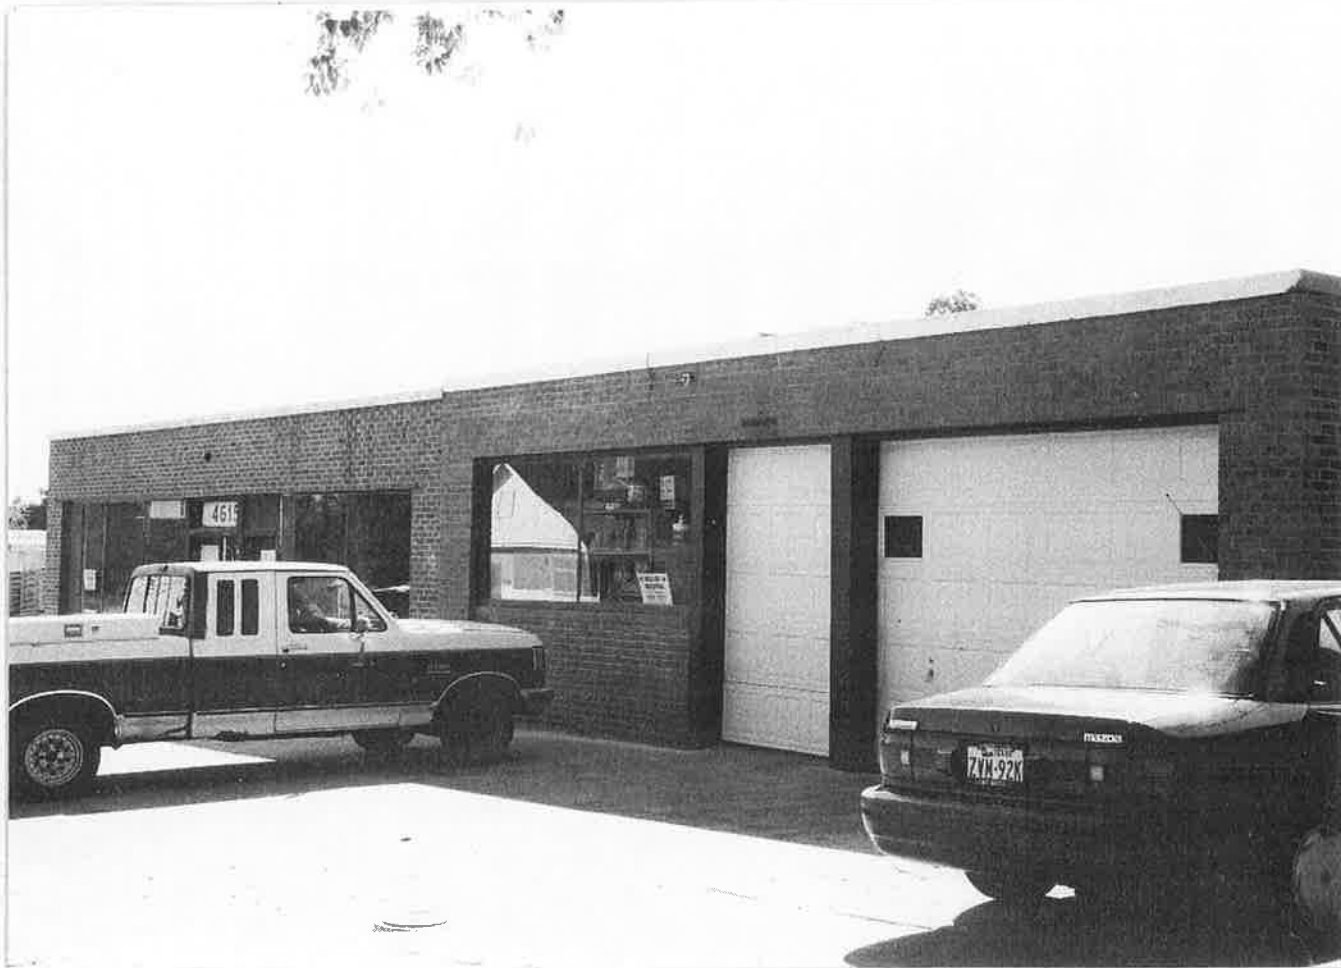
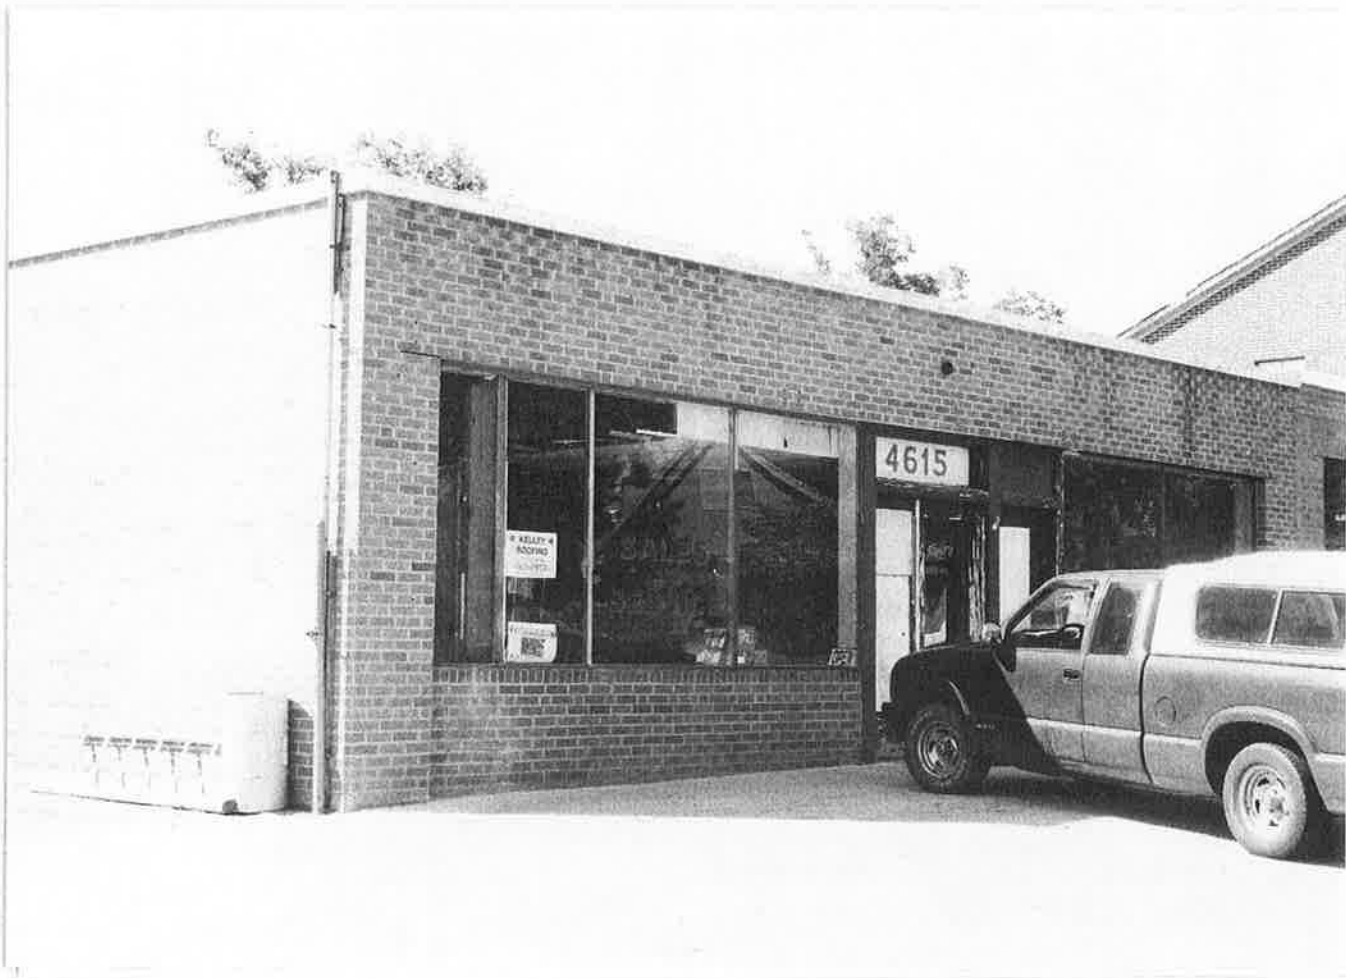
General Architectural Description 1 part commercial block; 2 separate bldgs

Ⓚ flat roof, red brick; plate in metal; 2 w's - both set in heavy wood framed - framed, glazed in wood w/ transom

Ⓛ flat, red brick; divided plate in metal w/ wood surround; 1 overhead bay w/ one multi-panel overhead door; main door ported has overhead-type door inserted

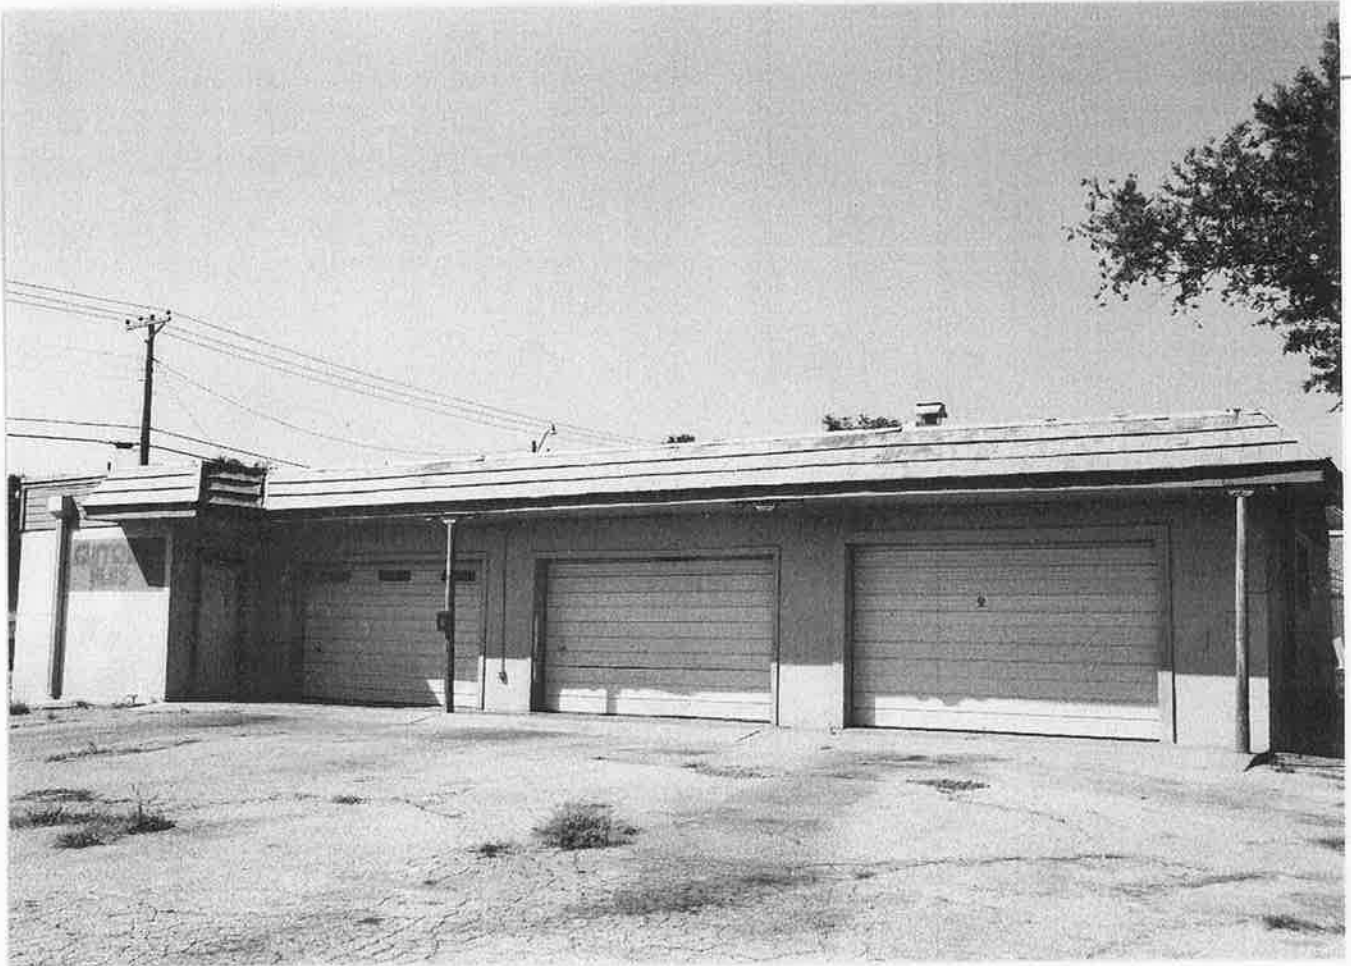
375-AM-211
30-3766-17
FACING SOUTH

Roof type flat w/ mansard style (shingled) Materials COANIC

Wall facade COANIC brick Foundation _____

Door type 1 wood door, ADA orig 6 panel metal Materials 3 over head bays w/ ADA orig metal doors

Porch type overhanging concrete on wood posts Materials _____

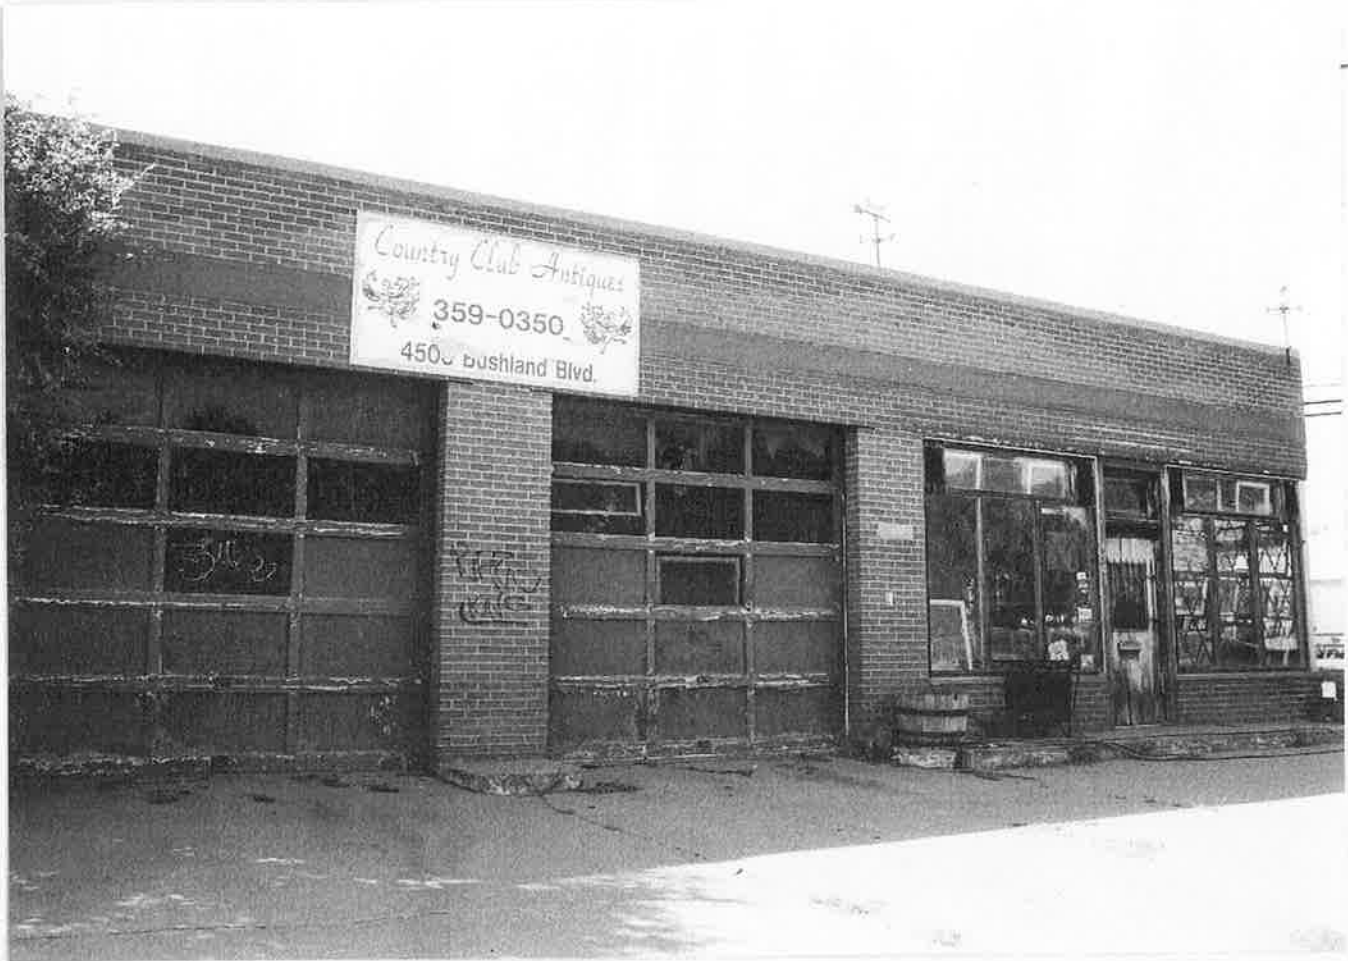
375-AM-212
30-3766-16
FACING SW

Roof type flat w/ parapet & conc cop Materials _____

Wall facade red brick Foundation _____

Window type 3 part plate in wood w/ transoms Materials _____

Door type 2 overhead bays, multipanel wood door; main door = framed glazed in wood w/ transom Materials _____

General Architectural Description transoms in rear on SW etc - solid doors in wood frame w/ transom

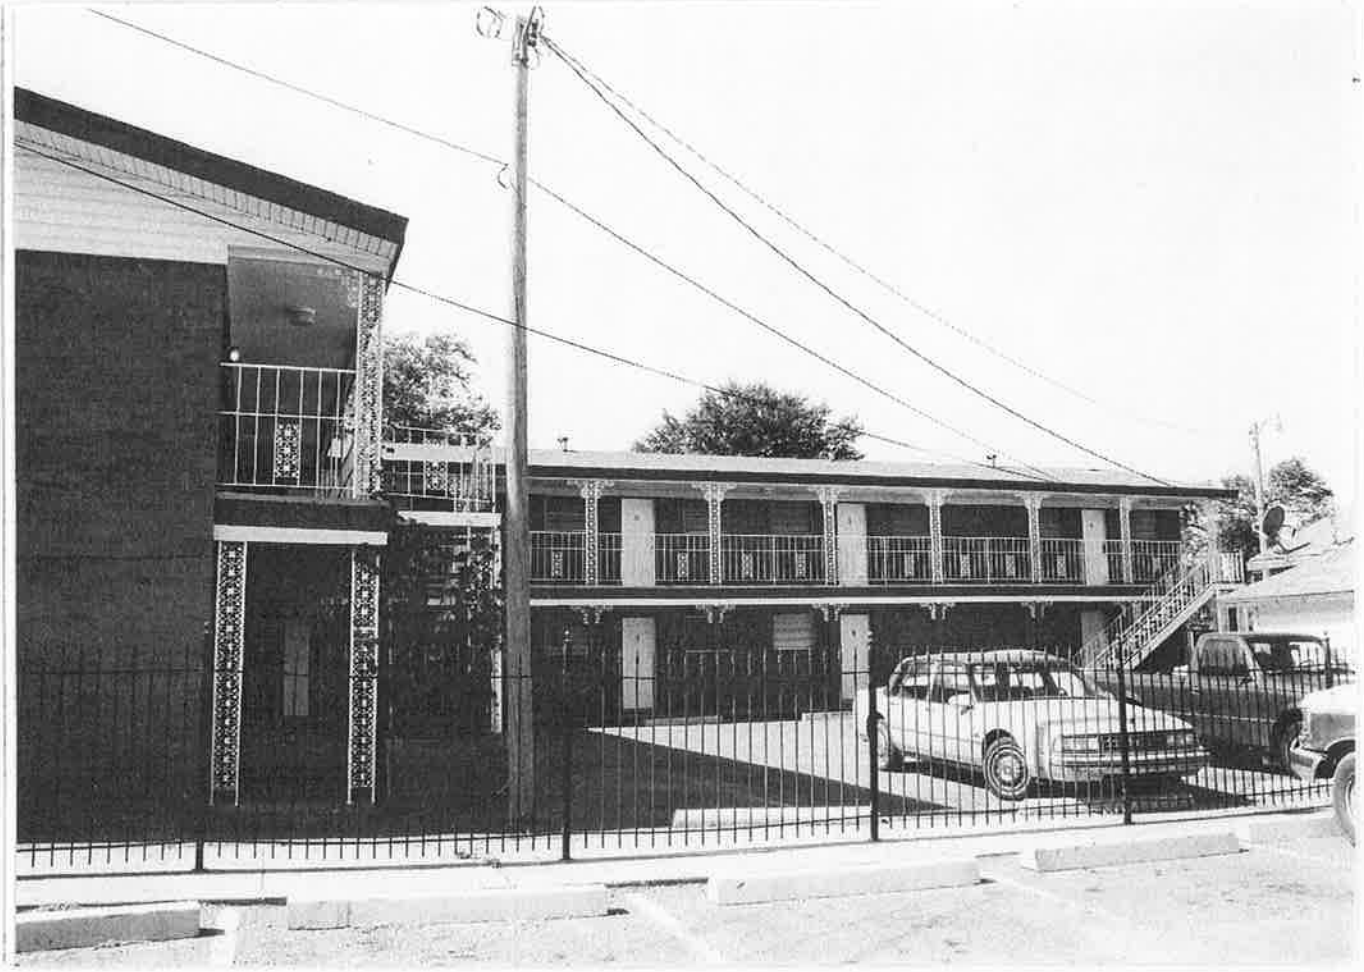
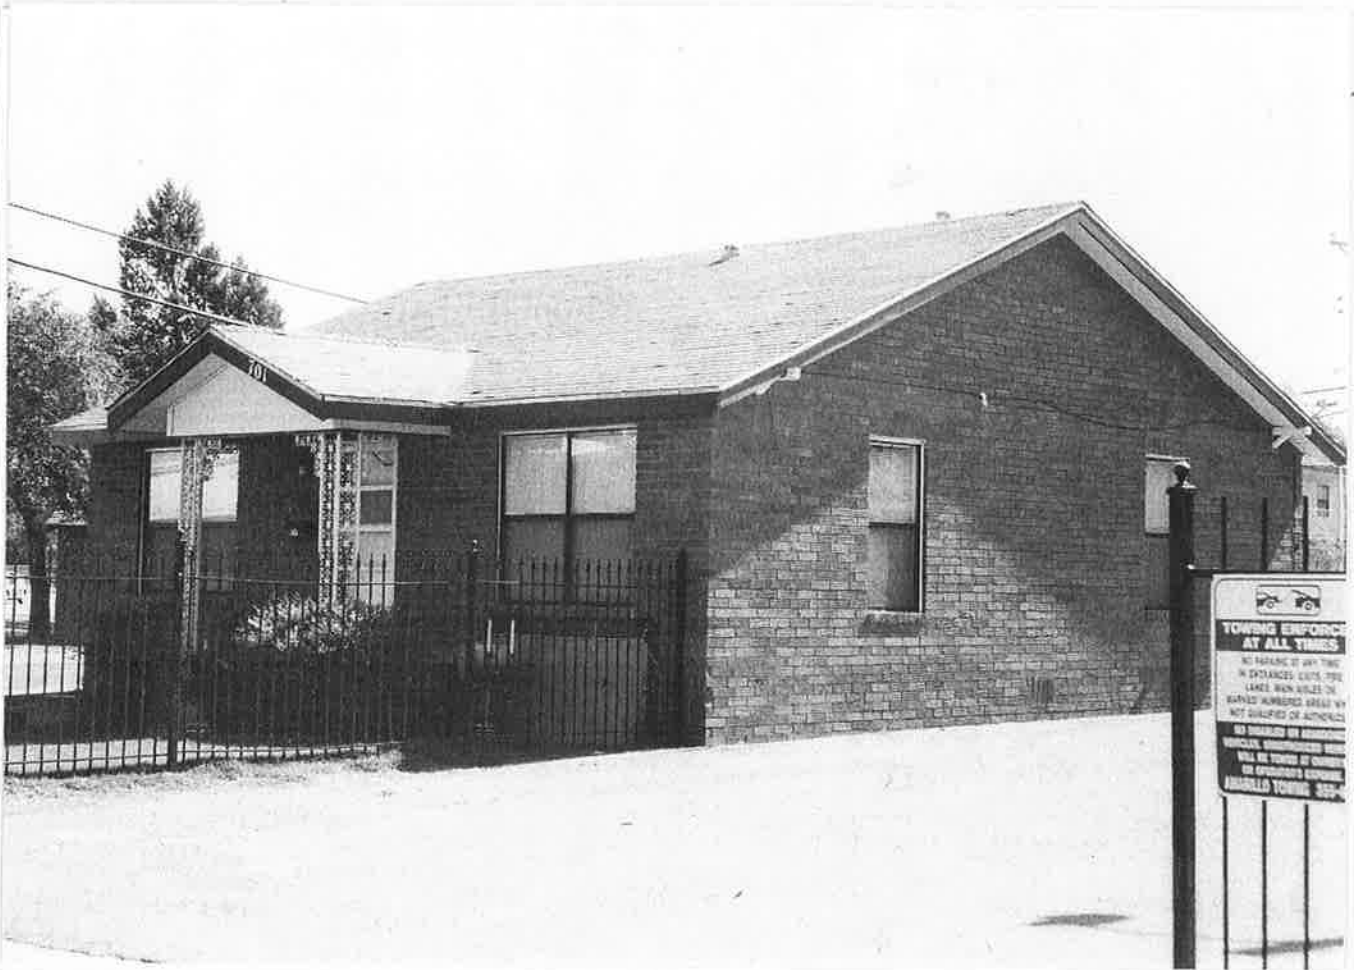
Roof type ① side gable ② side gable

Wall facade ① red brick ② red brick

Window type ① vinyl ② metal sash (1/1)

Door type ① obscured ② solid

Porch type ① front gable
low 2nd story porch

General Architectural Description 12 units office is sm house
or 14
