Historic Resources Inventory Form—Route 66

County POTTEL City AMARILLO Inventory # 375-AM-308
Historic Name _____
Current Name Thomas & Johnson, Attorney
Address 413 Fillmore
Lot(s): _____ Block: _____ Addition: _____
Owners Address _____
Resource type Building Structure Site Object District
Landscape/Site Features _____
Outbuildings _____
Function: Current Use office Historic Use car
Construction Date: 1927 Actual Estimated
Architect _____ Builder _____
Possible Threat(s) Demolition Development Neglect Alteration Vacant Utility Expansion
Integrity Location Design Materials Workmanship Setting Feeling Association
USGS Quad #: _____ Year: _____ UTM Zone: _____ Easting: _____ Northing: _____
Priority High Medium Low Recorder Monica Penick Date(s) 7/19/2002

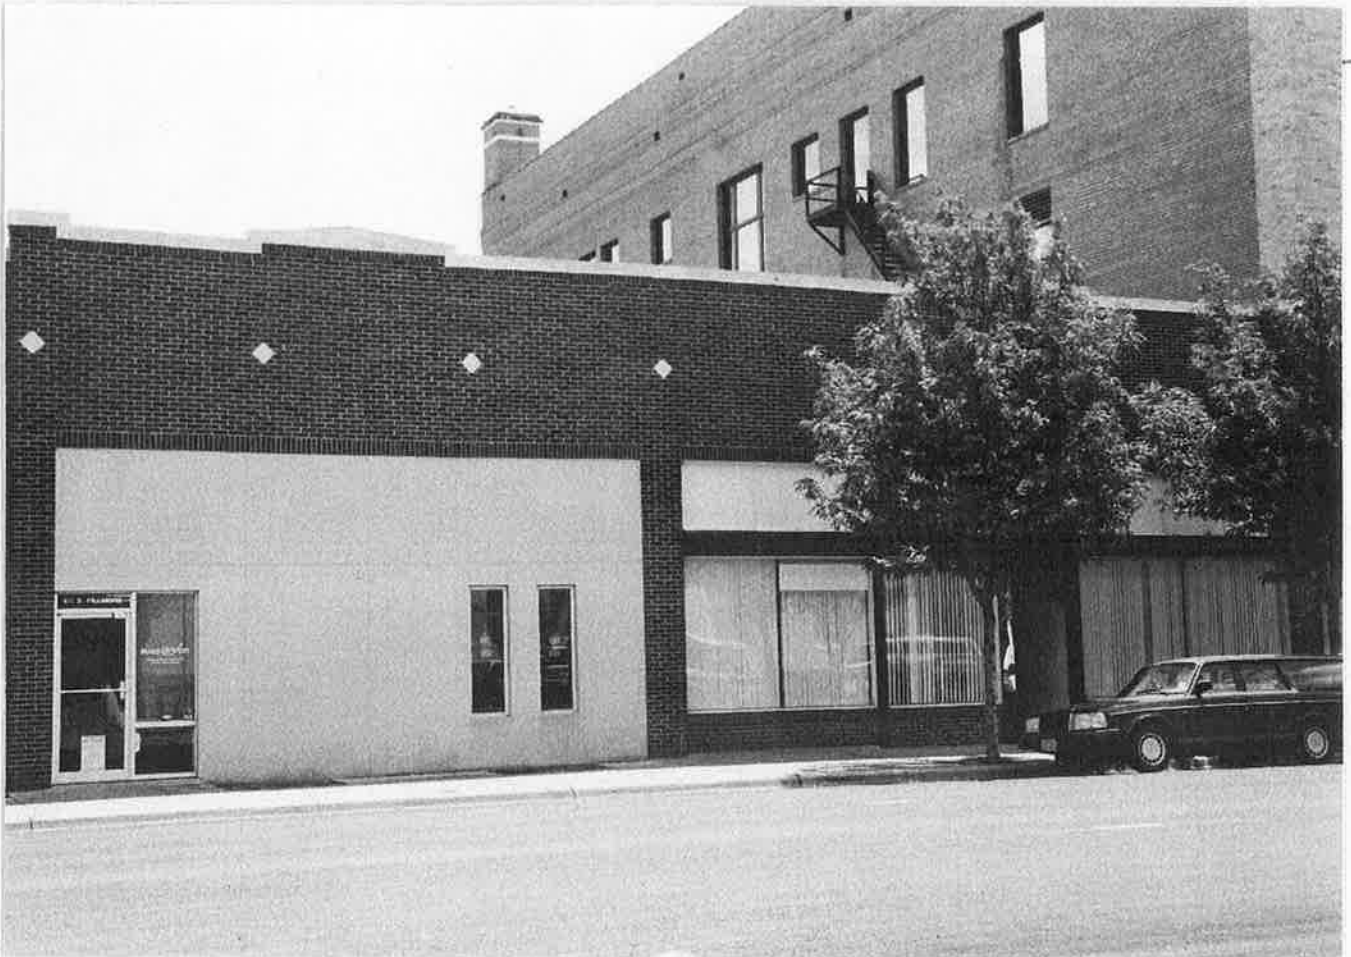
375-AM-307
35-3764-36
FACING SE

Roof type flat w/ pva flat Materials _____

Wall facade multicolored brick; stucco on N ^{bay} Foundation _____

Window type plate in metal w/ wood surround Materials _____

Door type non-orig fully glazed in metal w/ 1 side ^{cut} Materials glazed over transom

General Architectural Description 1 part common block div into 3 bays by brick piers (though the southern 2 bays have merged & pier is missing). N bay infilled w/ stucco 5 non-orig fully glazed metal w/ transom door installed

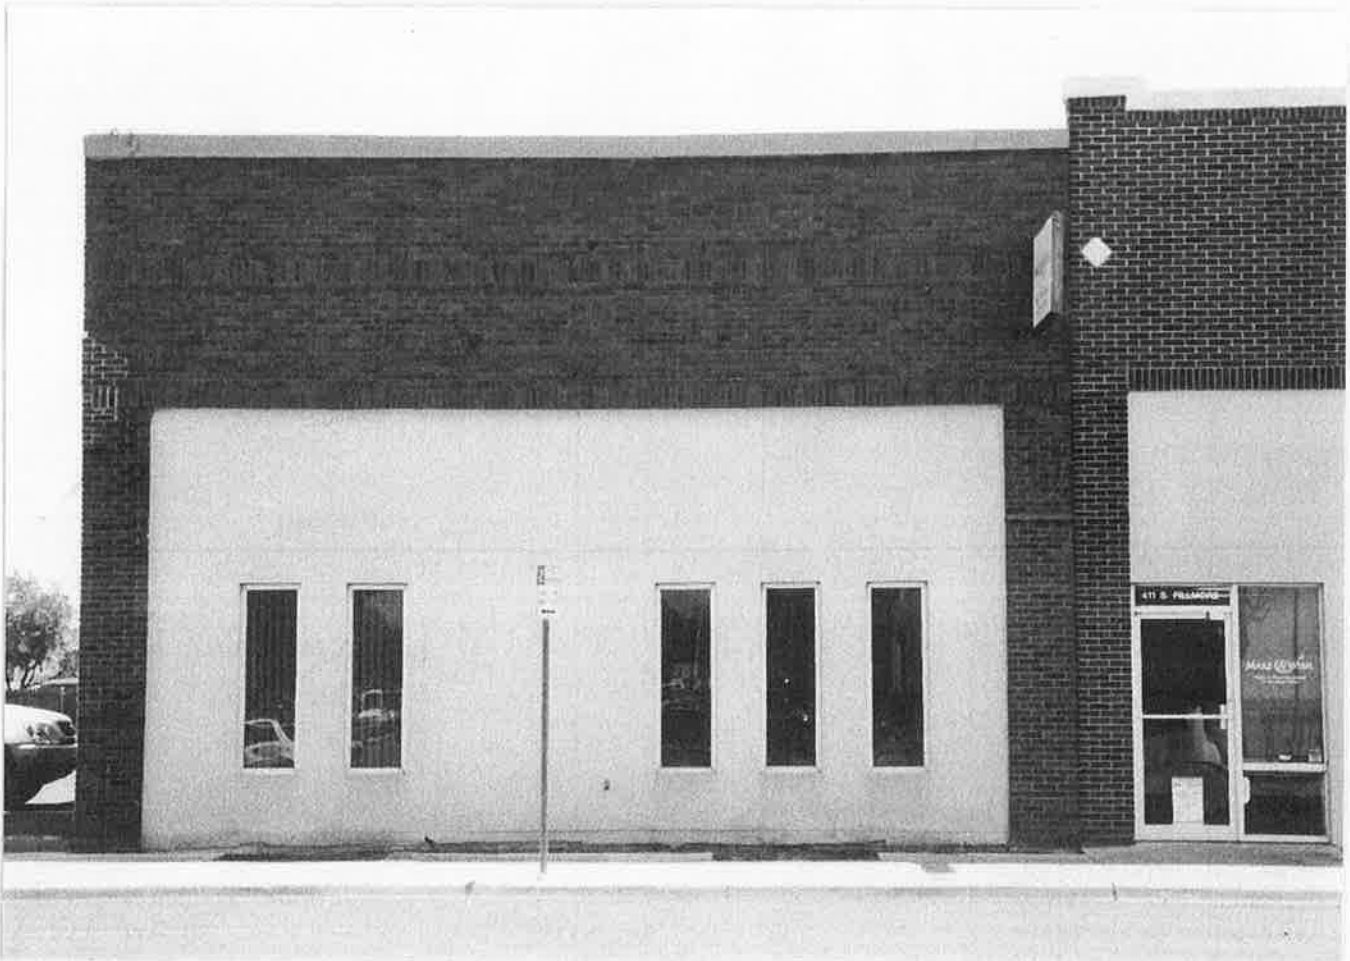
375-AM-308
35-3764-35
FACING EAST

Roof type flat w/ parapet & some of cork roofing Materials _____

Wall facade multicolored brick; scored stucco infill Foundation _____

Window type vertical slit windows - 6 pane in each Materials _____

General Architectural Description 1 part common block, 1 bay - store front
completely infilled & altered - no entry. Now is part
of N bay from #307 & entry to both is in #307

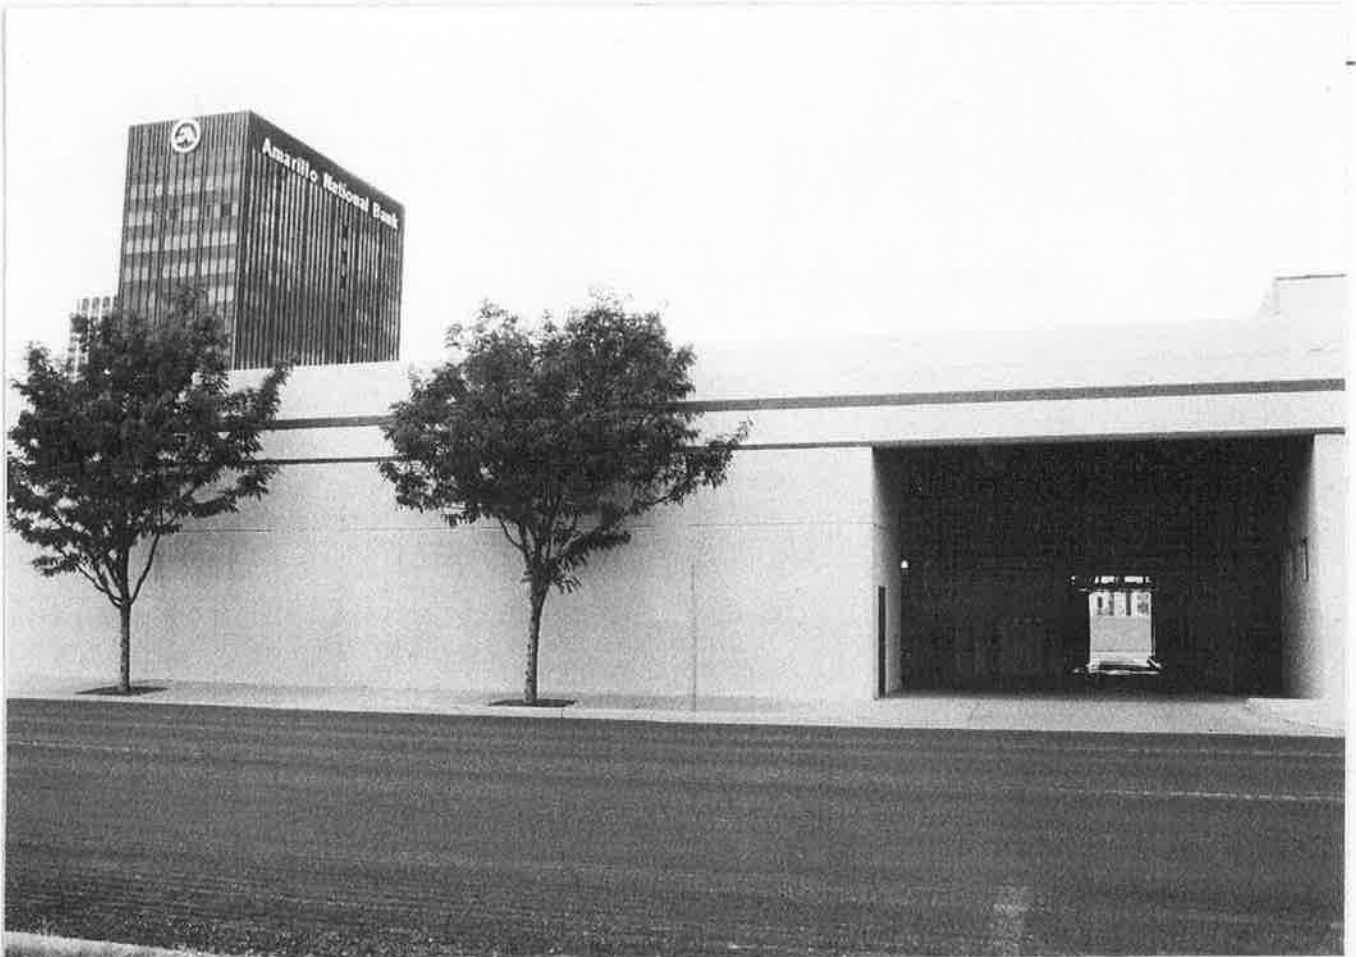
375-AM-309
85-3764-34
FACING WEST

General Architectural Description Bldg completely Altered though brick above
old stone fronts 3 Parapet details still apparent

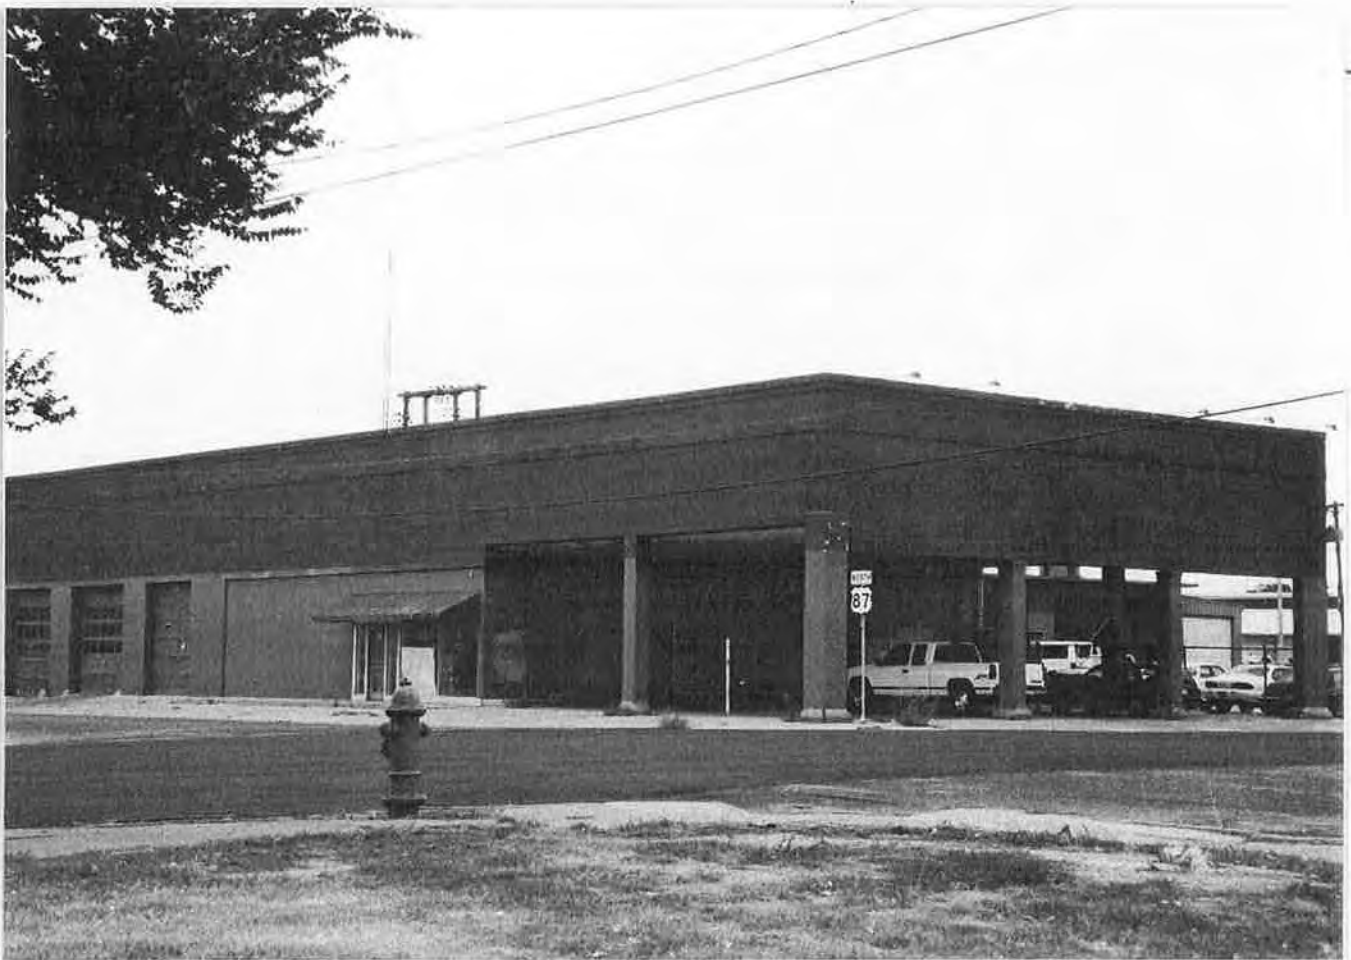
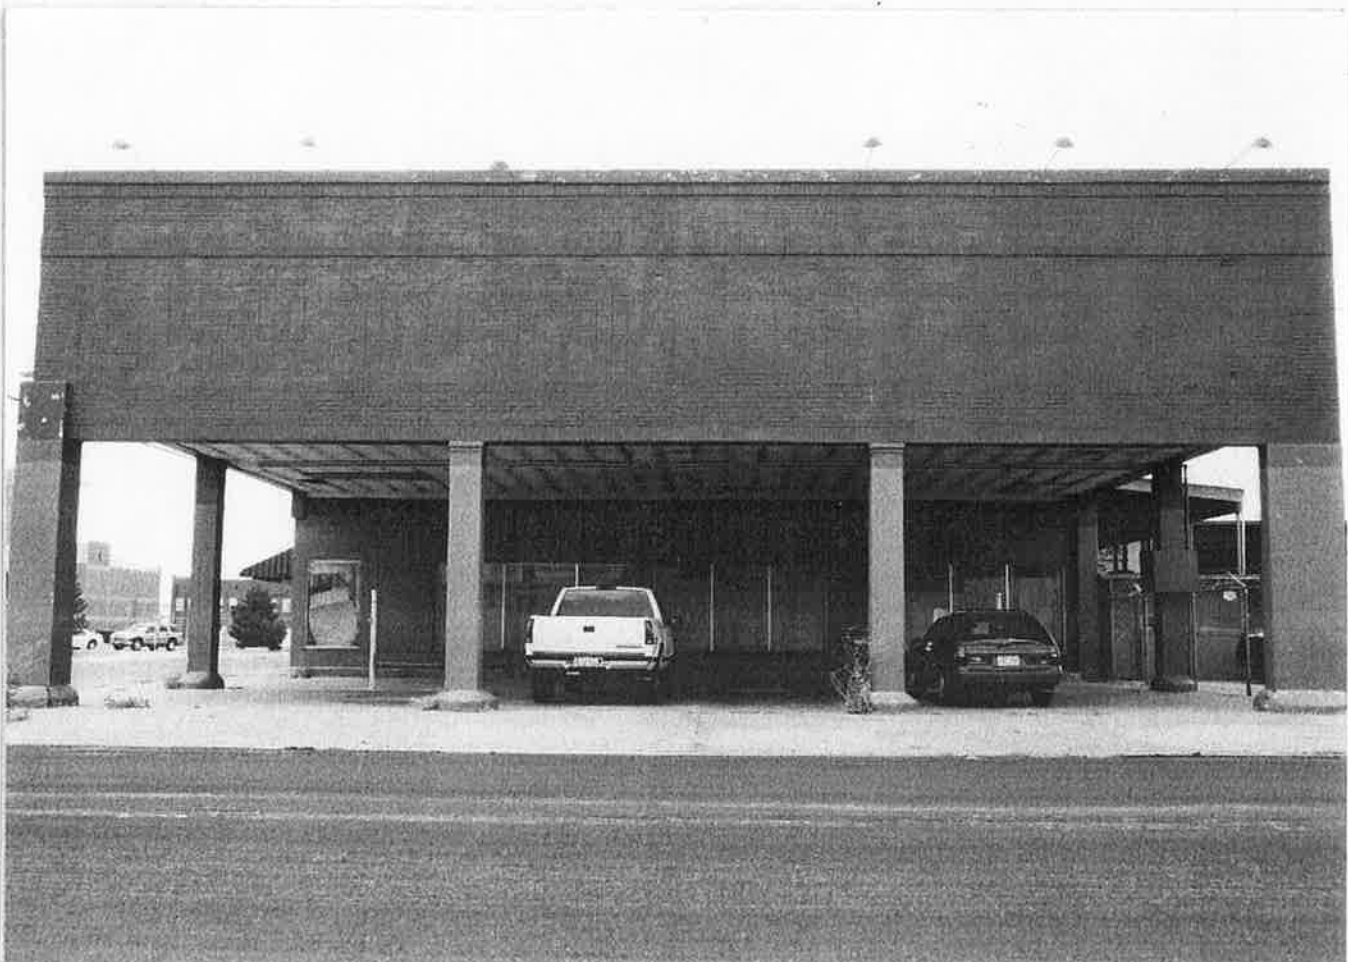
Photo Data: Roll 35 Frame _____ Feature 33 look NW

Roof type flat w/ parapet Materials _____

Wall facade Painted brick Foundation _____

Window type plate in metal Materials _____

Door type fully glazed in metal w/ side Materials overhead horizontal wood frame on S. side

Porch type polite cocher (exaggerated) on G Materials brick ~~cast~~ piers

General Architectural Description Street front inset under exaggerated p.c.

service bays set back front street front extends N.

5 bays w/ a sixth in a shed add to furthest N.

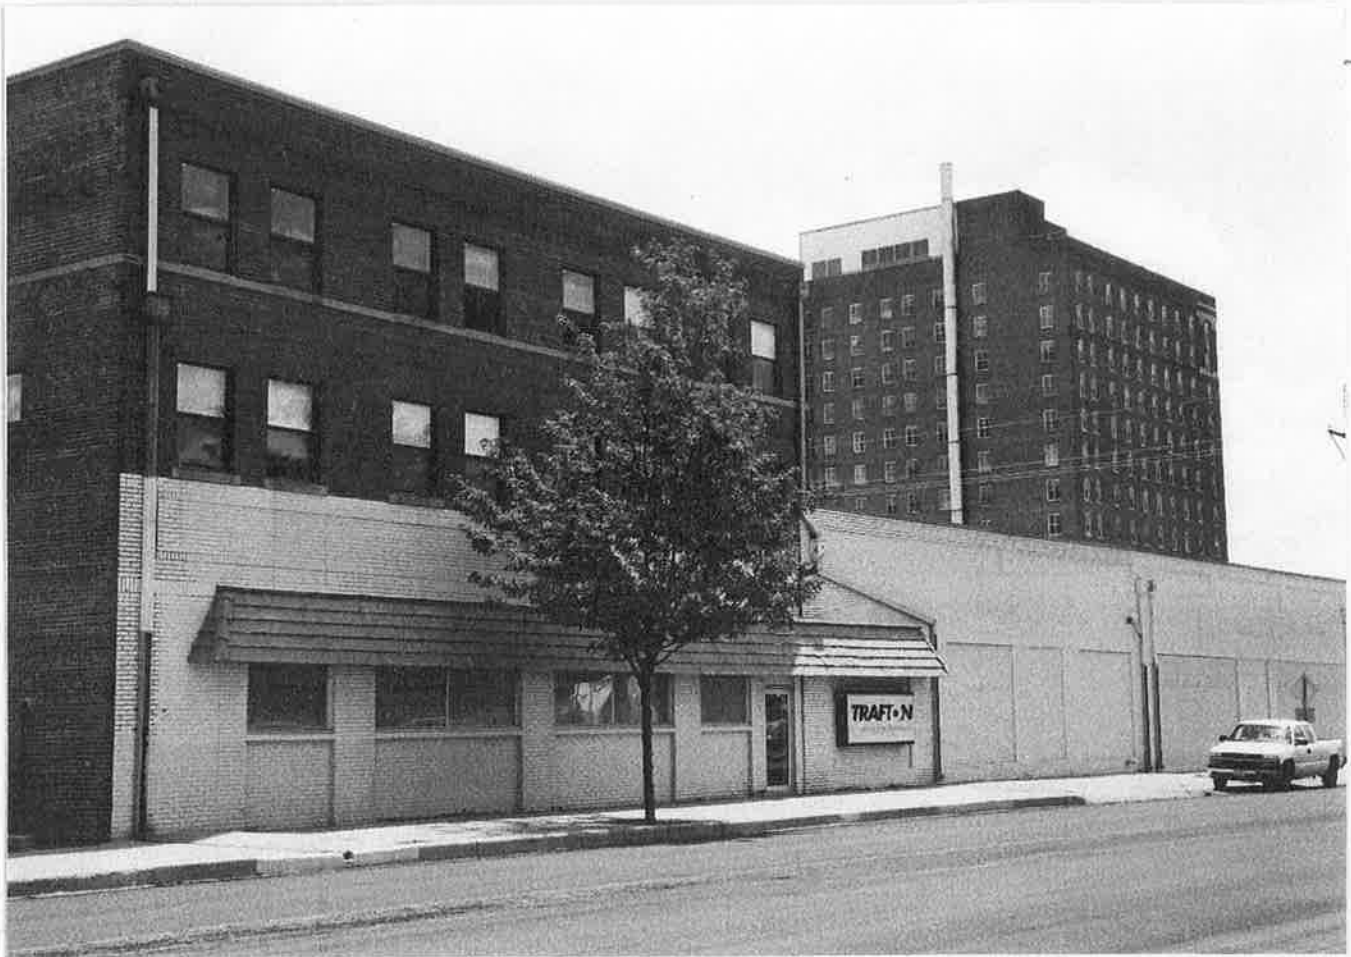
375-AM-311
35-3764-28
FACING SE

Roof type flat w/ parapet Materials _____

Wall facade painted brick Foundation _____

Window type All bricked in - was plate openings Materials _____

Door type All bricked in Materials _____

General Architectural Description 1 story 1 part common bldg divided into 2 bldgs - now completely altered. ~~has~~ inset panels @ parapet still evident.

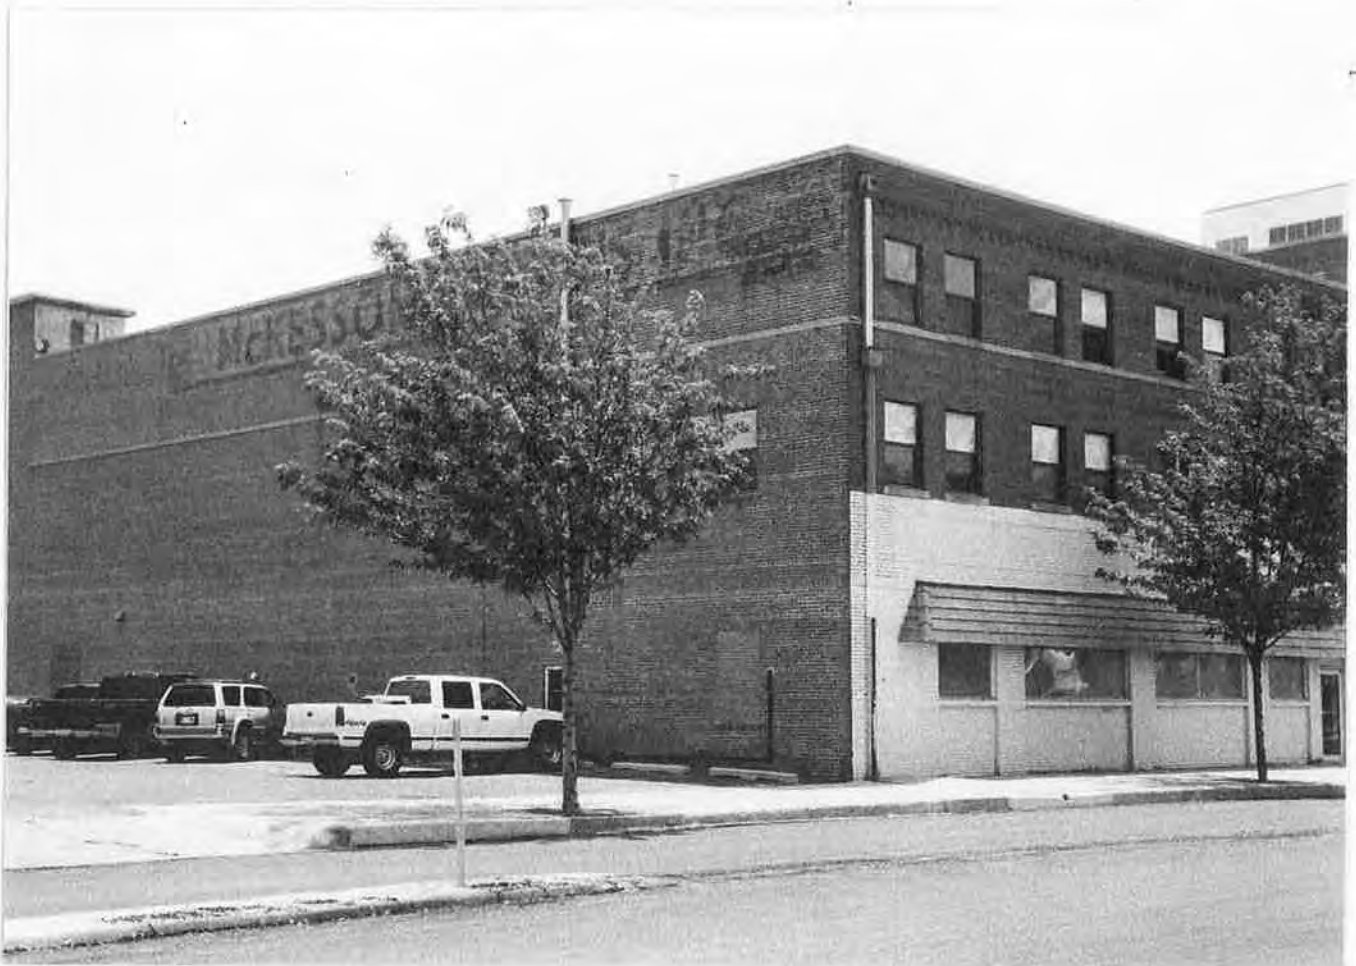
375-AM-312
35-3764-27
FACING SE

Wall facade paint brick on 1st level; red brick on top 2 levels Foundation _____

Window type plate in metal non-orig. / Materials 2 (tools have 1/2 metal sash

Door type fully glazed in metal, non-orig. Materials _____

Porch type pent roof turning above storefront Materials _____

General Architectural Description 3 part common block

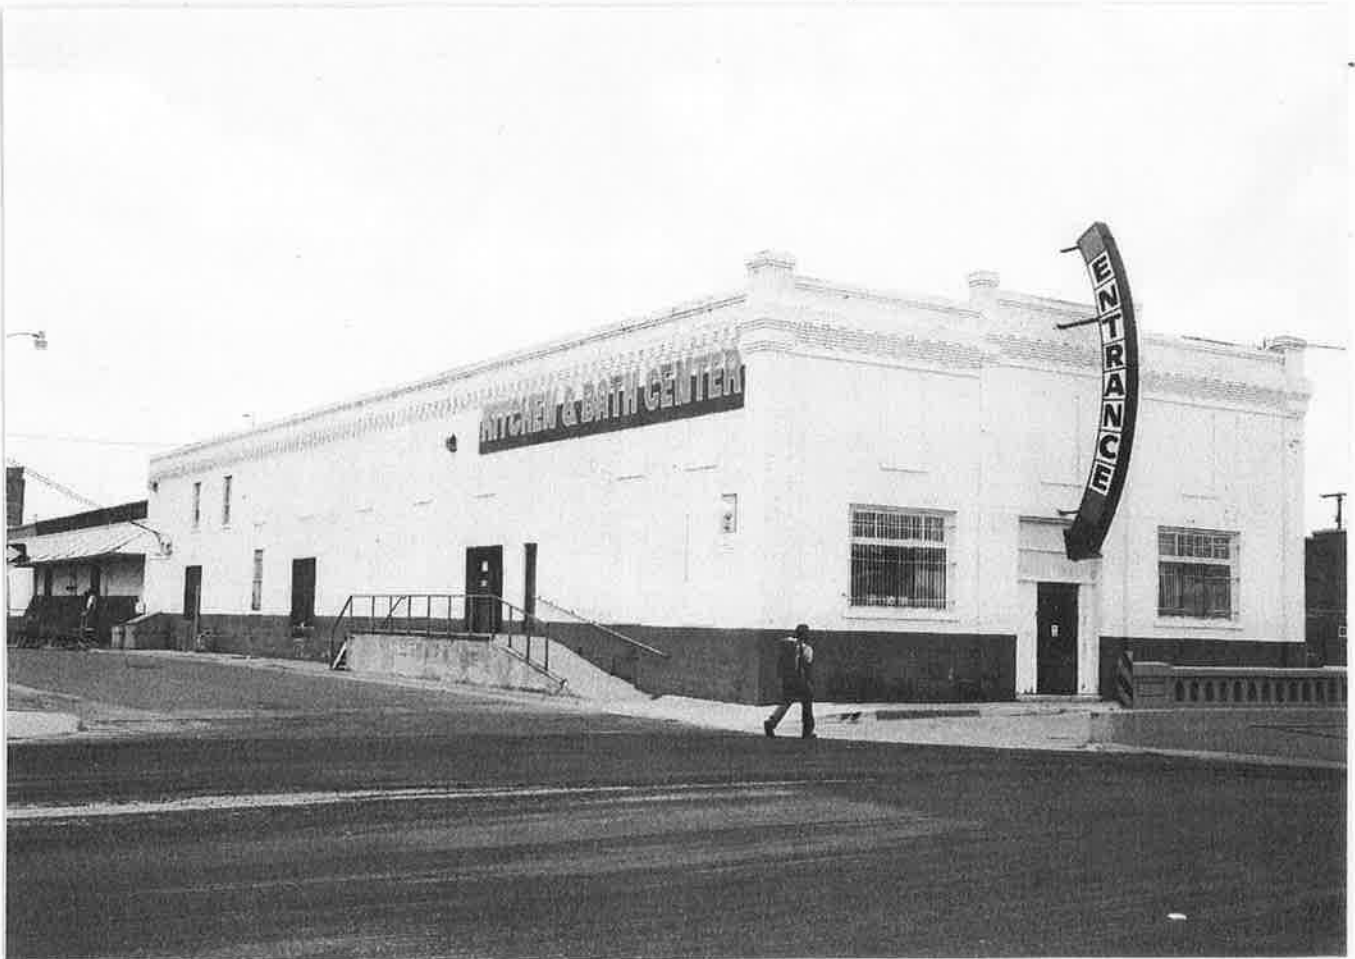
375-AM-313
35-3764-31
FACING NW

Stylistic Influence(s) Classical

Roof type flat w/ stepped parapet

Wall facade pinked brick

Window type flat front: multi light in wood - rest of windows

on 1st floor narrow openings

Door type front: central: non-orig fully glazed - w/ side

now bricked in indicate sash

General Architectural Description 2 part corr block div into 3 bays by brick pilasters. Detailing @ cornice includes corbelled

cornice line & corbelled capitals and projecting pilasters.

Corbelting continues along side elevations @ cornice, from distance appears as dentils. This is warehouse type & extends full block

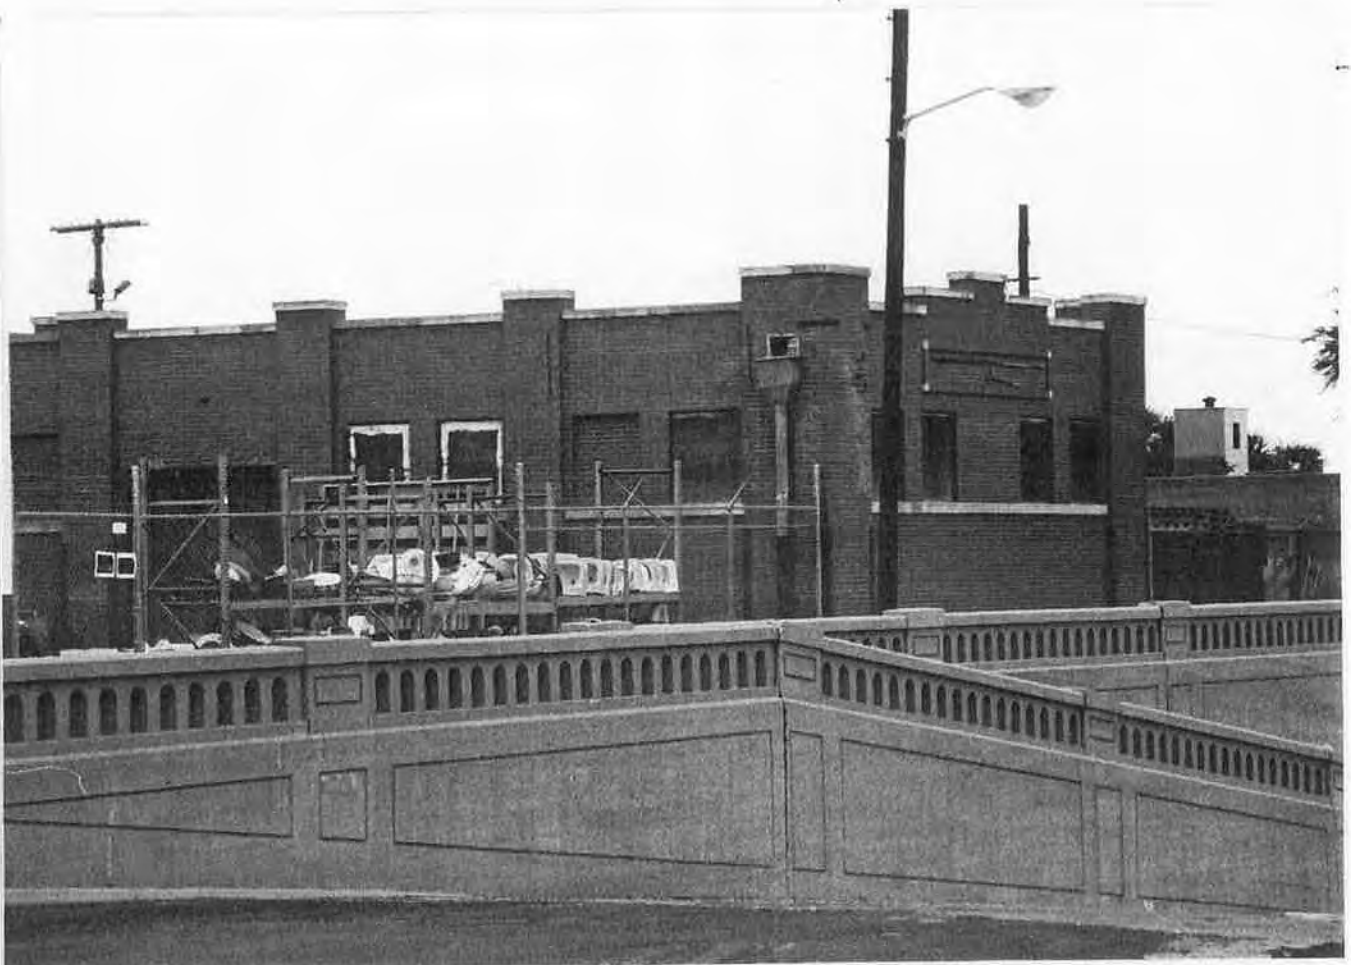
375-AM-314
 35 374-36
 FACING NW

Roof type flat w/ parapet Materials _____

Wall facade red brick Foundation _____

Window type blocked Materials _____

General Architectural Description 1 pt com block ~~stone~~ w/ only
6AC front bay - sides are div into bays by
brick piers that extend past parapet & are capped w/
conc & stone (to match coping). Unusual front parapet.
& band @ 1/2 height along facade (an extended
sill)

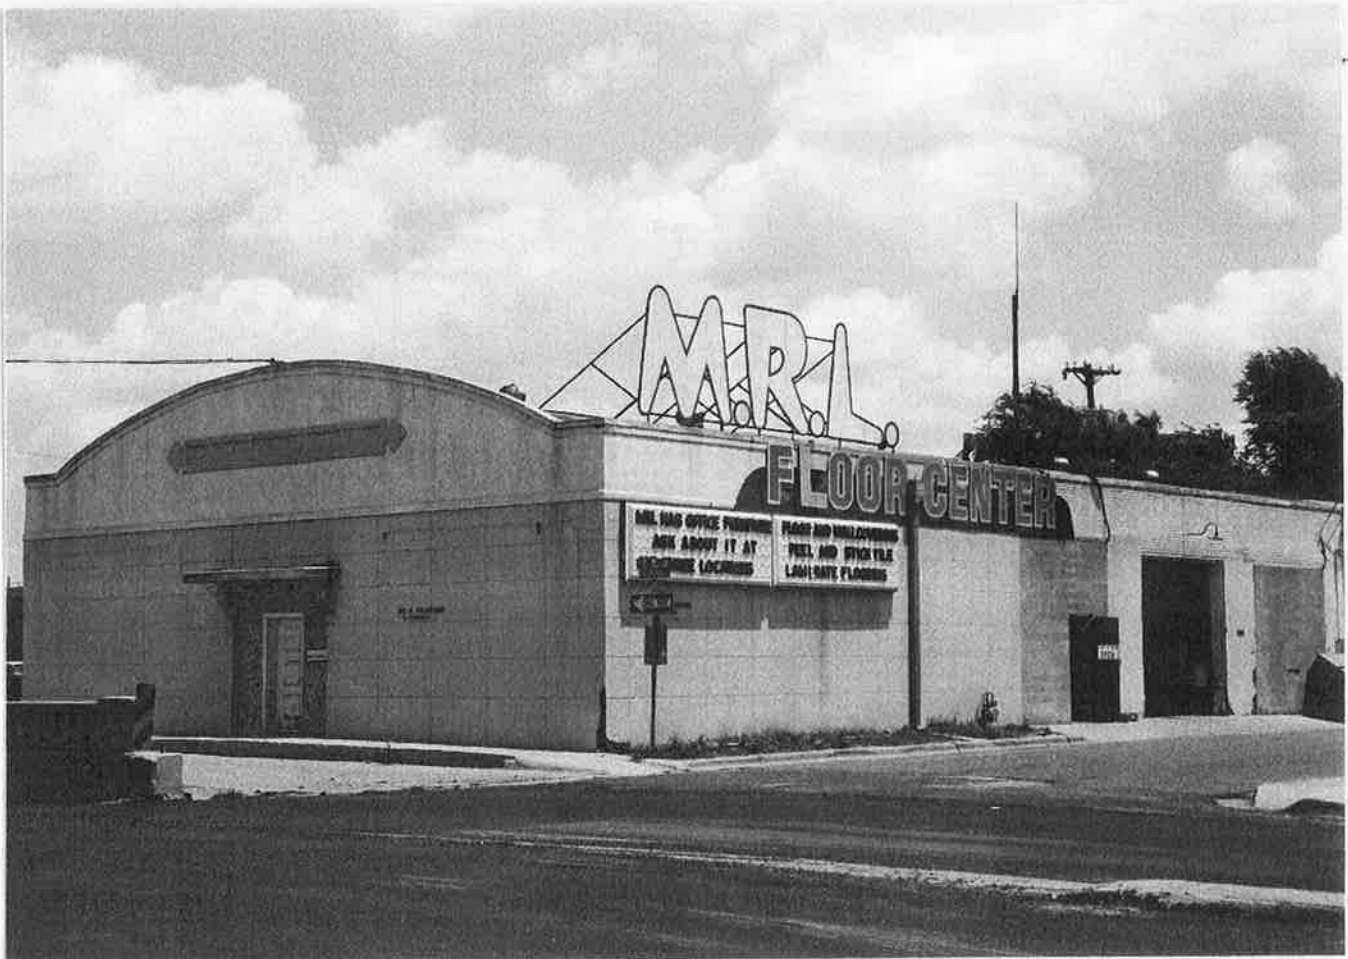
375-1M-315
35-3764-29
FACING NE

Roof type rounded w/ rounded parapet

Wall facade scored concrete panels; sides = brick

Door type central, wood panel w/ transom & sidelight

Porch type small, hood on knee brackets (metal)

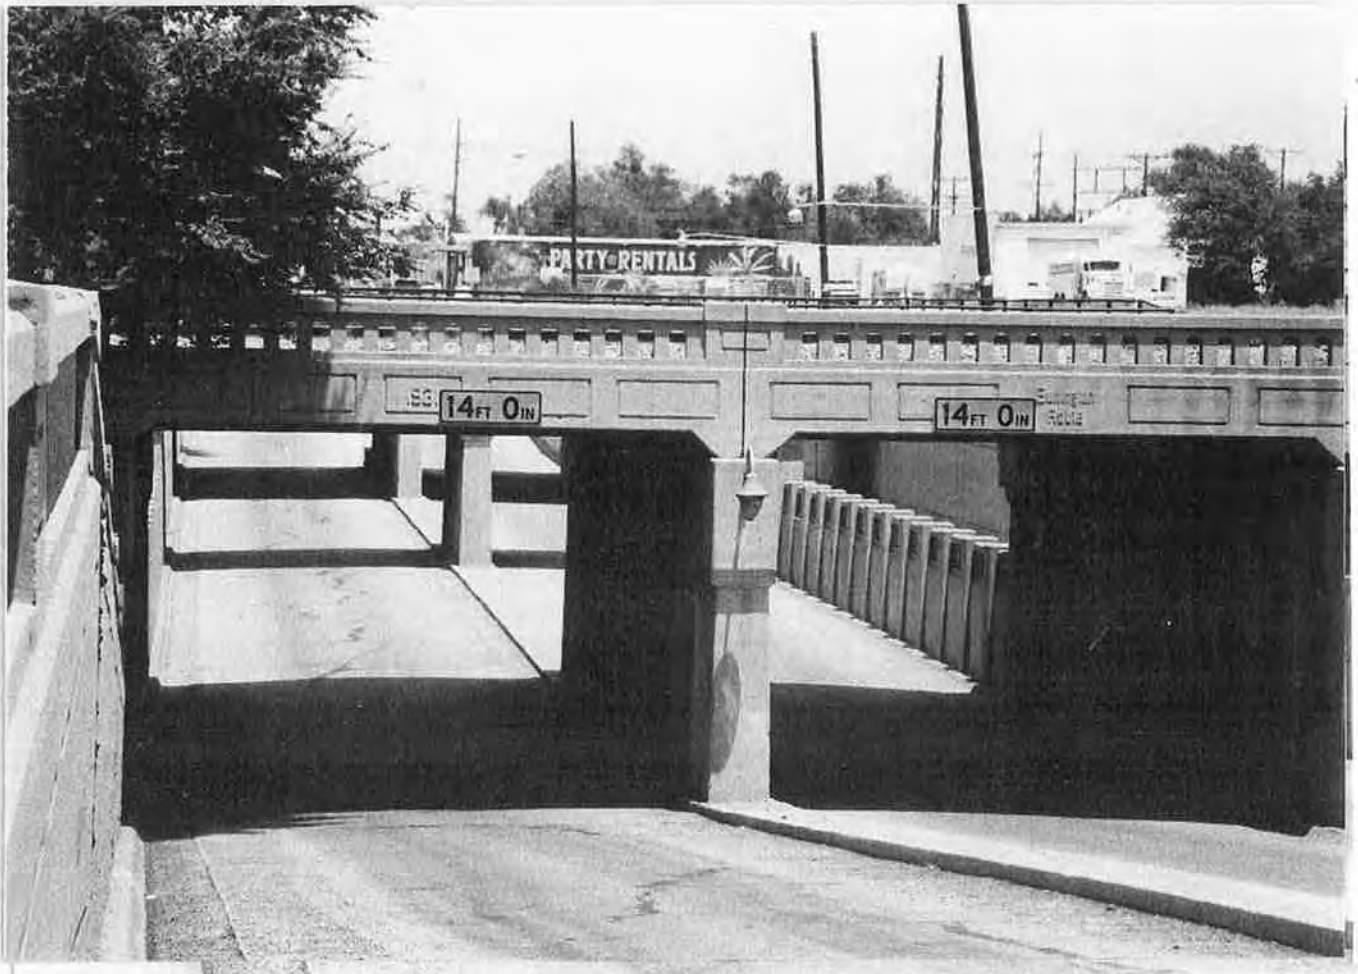
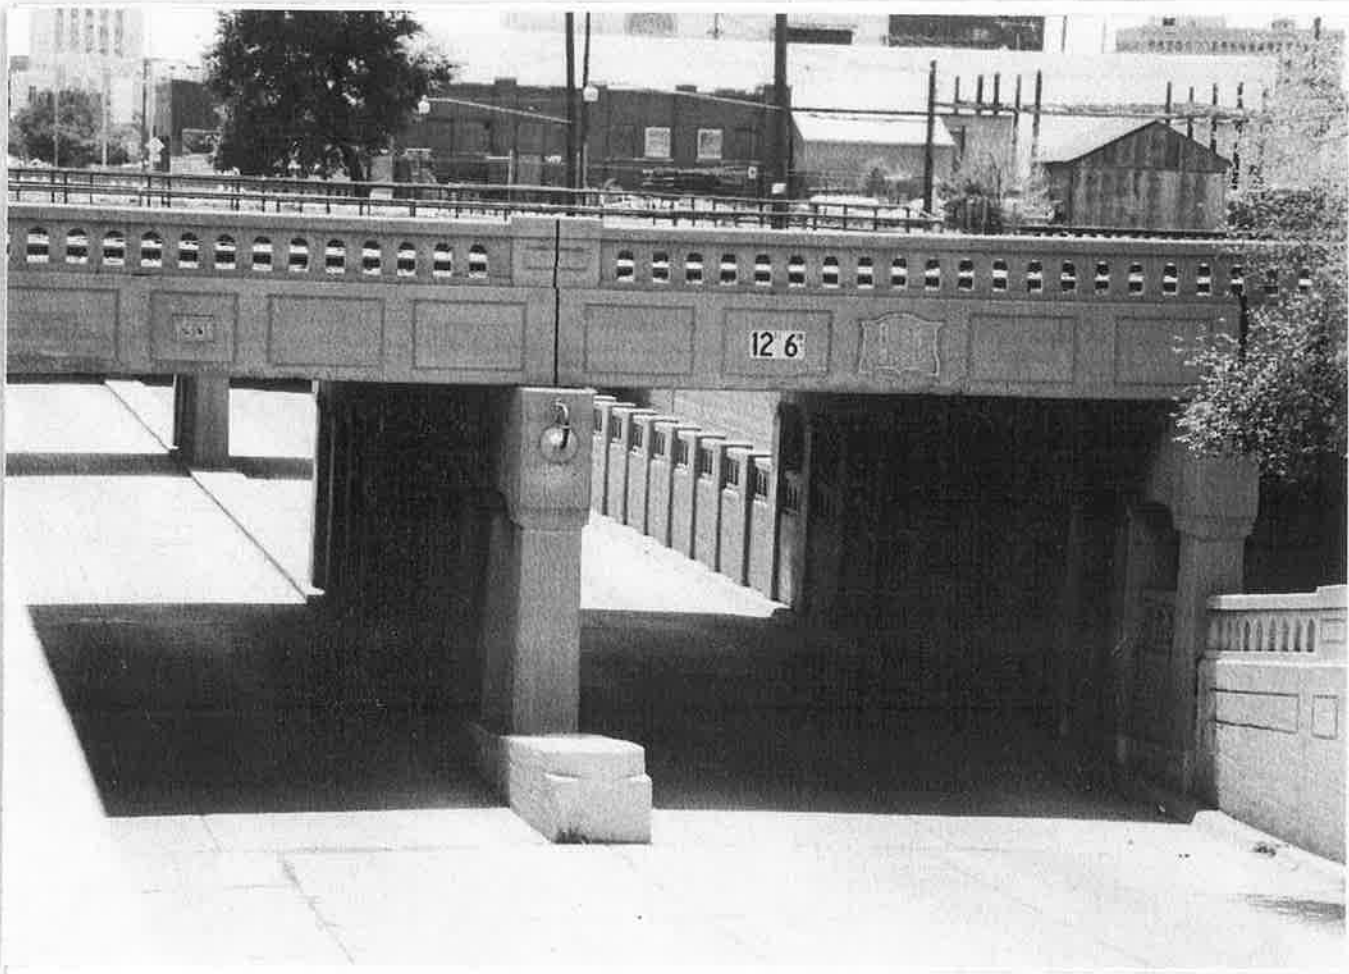
Photo Data: Roll 35 Frame _____ Feature 26 look N

* Excellent & Eligible

General Architectural Description 3 separate grade separation/bridges - all ident.
with 2 bay. Rein conc w decorative scofry

reinforced conc structure

ELIGIBLE

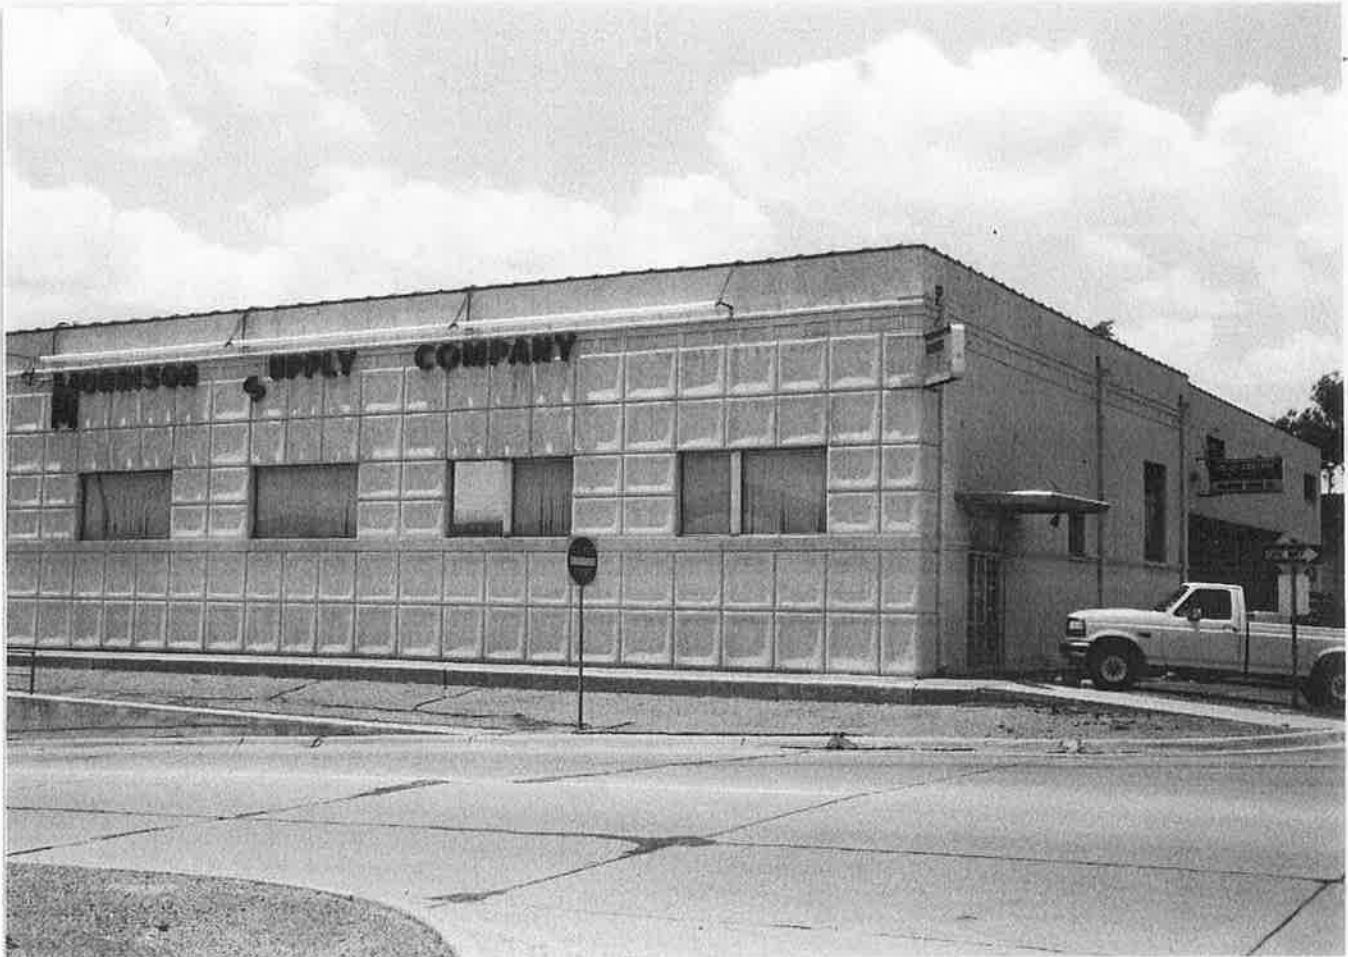
375-AM-37
35-3764-23
FACING SW

Roof type flat Materials corr metal

Window type plate in metal (unorig) Materials _____

Door type fully glazed in metal w/ transom & side lights Materials _____

Porch type horiz hood on metal rods over door Materials _____

General Architectural Description front faces NE 2ND - depart of front is
as follows: wall - brick side = scored conc/brick panels - decorative
brickwork @ cornice

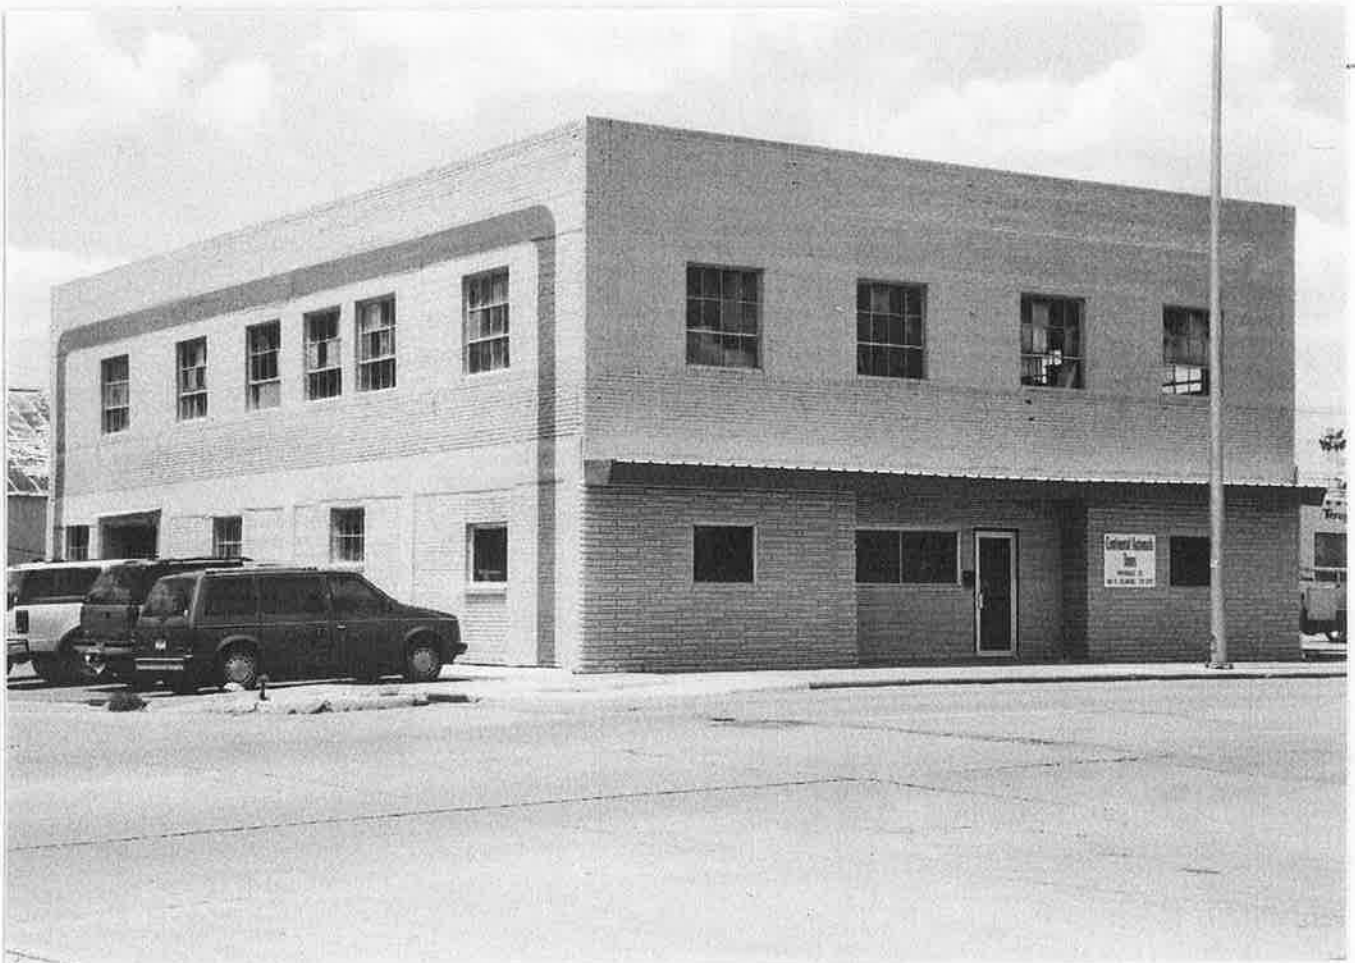
375-AM-318
35-374-22
FACING NE

Roof type flat Materials _____

Wall facade brick w/ faux Ashlar on Foundation 1st level

Window type 1st floor: plate in metal 2nd: 12 Materials metal casement

Door type fully glazed in metal Materials _____

Porch type running w/ roof metal deck Materials Full facade above storefront

General Architectural Description 2 yart com block w/ 3 bays -
center bay inset. store front altered

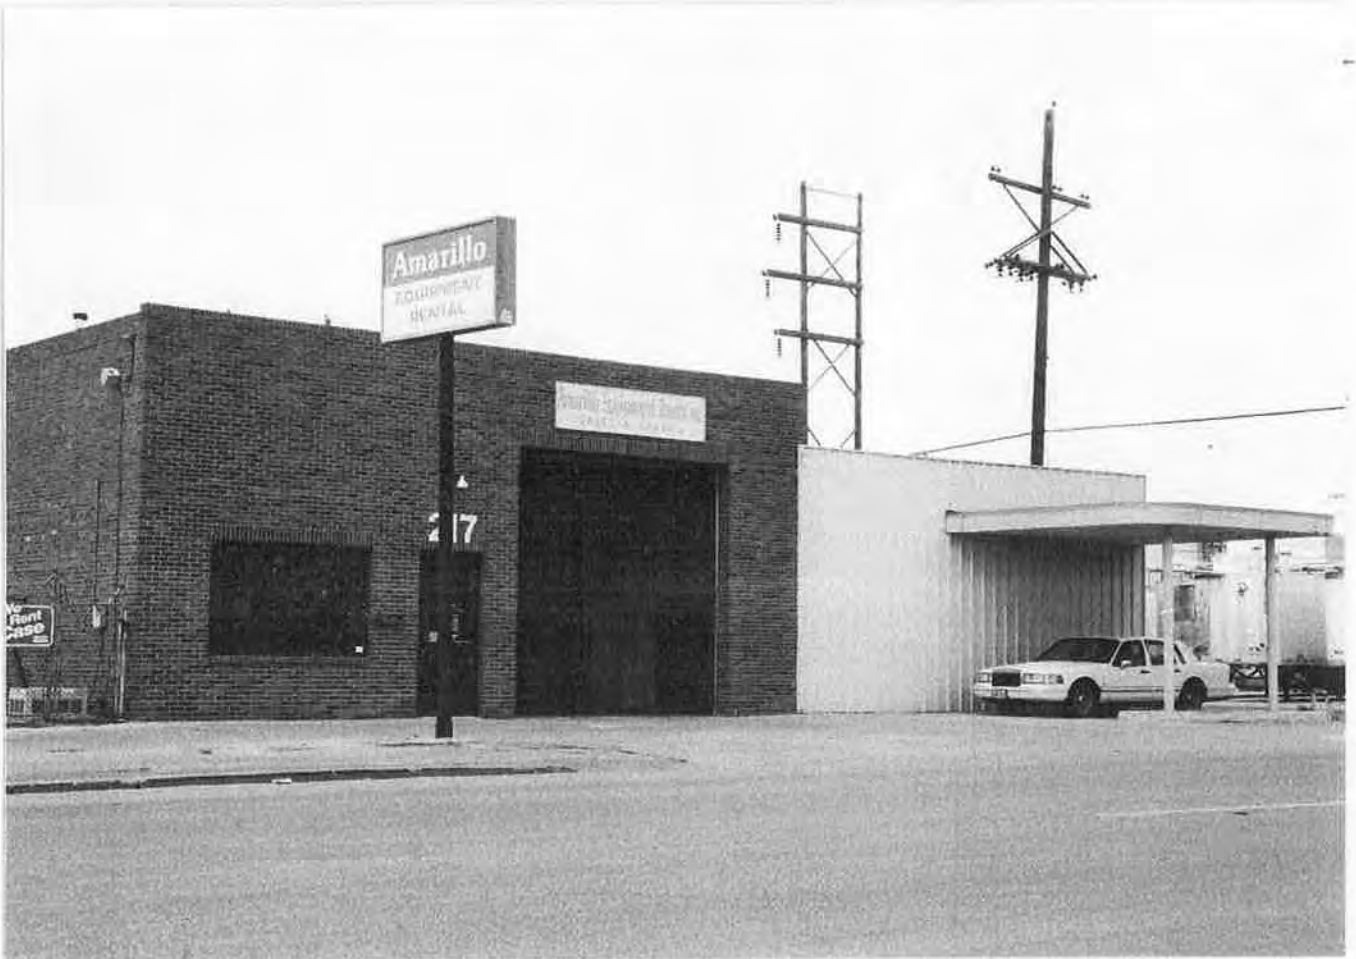
375-AM-319
 35-3764-20
 FACING NW

Stylistic Influence(s) _____
 Roof type flat Materials _____
 Wall facade red brick Foundation _____
 Window type plate in metal Materials _____
 Door type fully glazed in metal Materials overhead door - not vis.
 Porch type N/A Materials _____
 Number of Stories _____ Plan _____
 Chimney(s) _____

General Architectural Description 1 part cinder block, 1 bay.
Has corr metal add to north w/ porch part
rather on steel poles - corr metal covers
other brick bldg (evident on N etc)

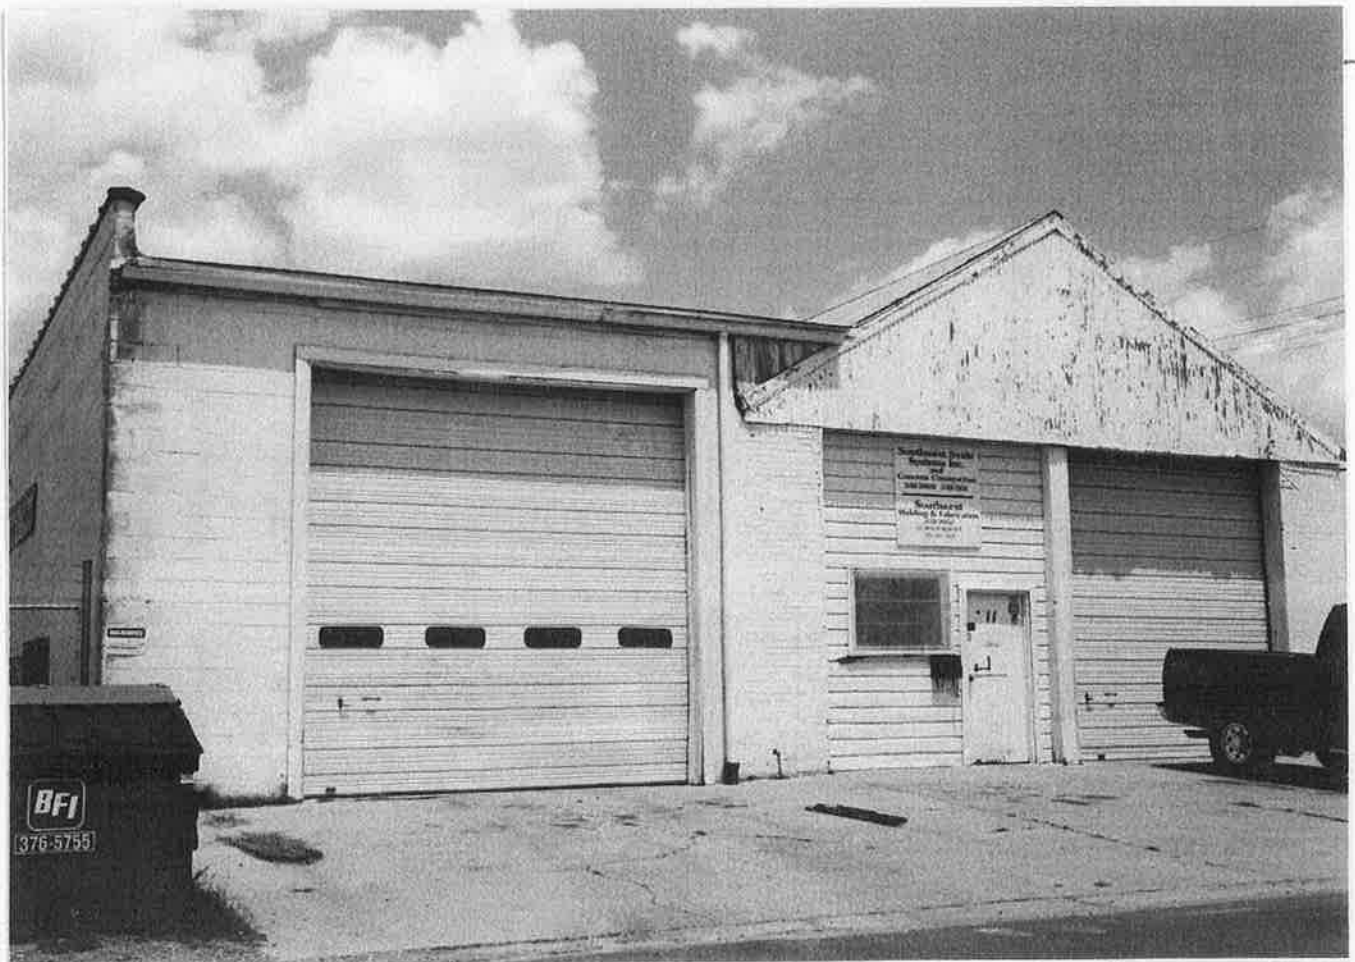
Photo Data: Roll 35 Frame _____ Feature 21 look N

Stylistic Influence(s) _____
 Roof type front gable / front w/ side wall parapet Materials concrete comp shing
 Wall facade conc block; brick Foundation _____
 Window type N/A Materials _____
 Door type 2 metal orched; 1 solid m.p. Materials _____
 Porch type N/A Materials _____
 Number of Stories 2 (warehouse) Plan _____
 Chimney(s) _____
