Historic Resources Inventory Form—Route 66

County POTTEL City AMARILLO Inventory # 375-AM-308
Historic Name _____
Current Name Thomas & Johnson, Attorney
Address 413 Fillmore
Lot(s): _____ Block: _____ Addition: _____
Owners Address _____
Resource type Building Structure Site Object District
Landscape/Site Features _____
Outbuildings _____
Function: Current Use office Historic Use car
Construction Date: 1927 Actual Estimated
Architect _____ Builder _____
Possible Threat(s) Demolition Development Neglect Alteration Vacant Utility Expansion
Integrity Location Design Materials Workmanship Setting Feeling Association
USGS Quad #: _____ Year: _____ UTM Zone: _____ Easting: _____ Northing: _____
Priority High Medium Low Recorder Monica Penick Date(s) 7/19/2002

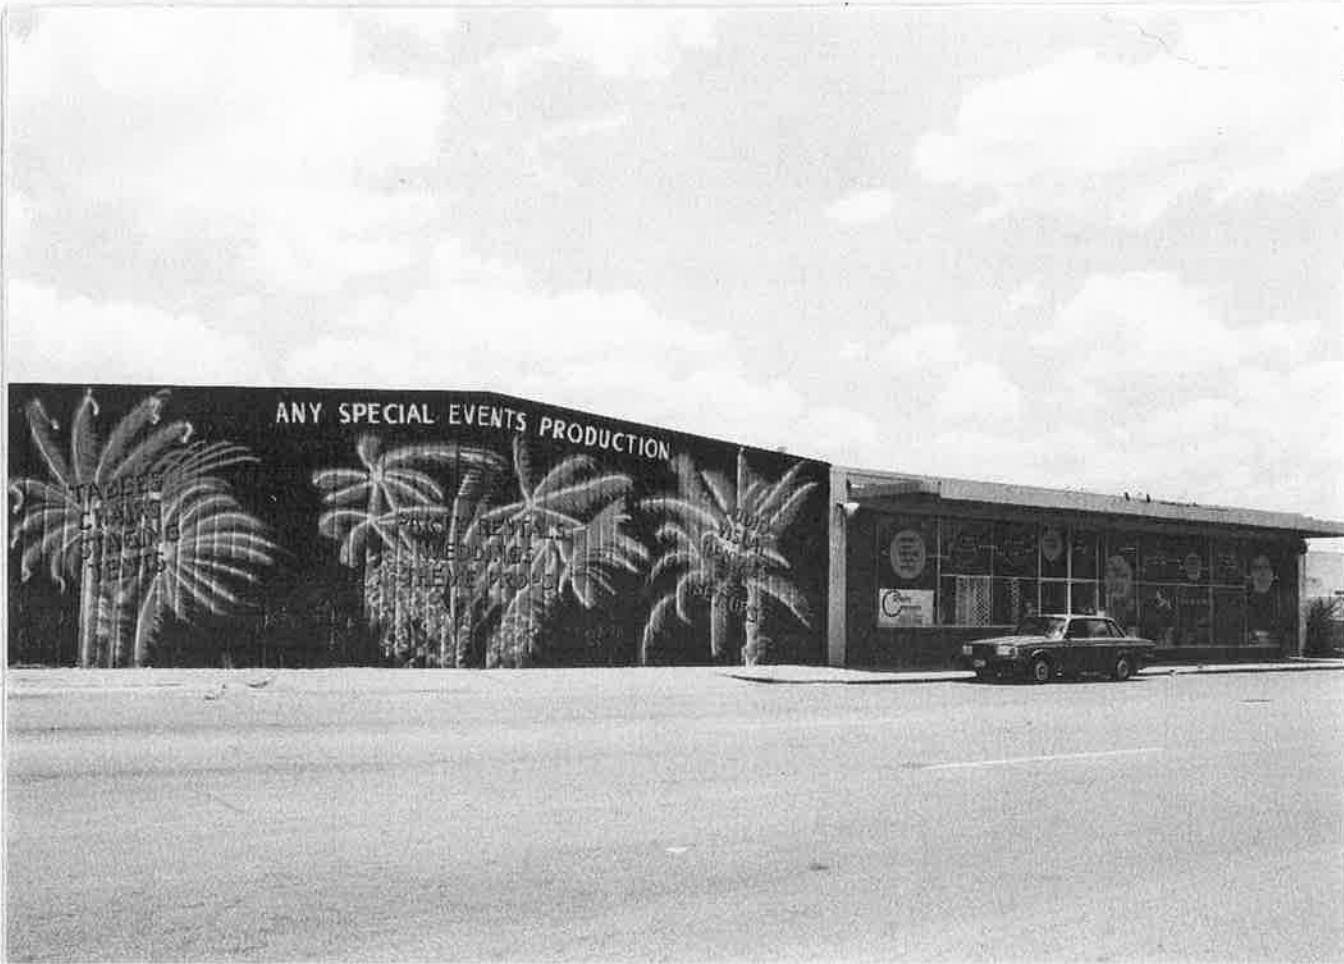
Roof type flat Materials _____

Wall facade red brick Foundation _____

Window type windows well; plate in metal Materials _____

Door type dbl fully glazed in metal w/ transom Materials _____

Porch type metal frame horiz Awning full facade above store front Materials _____

General Architectural Description w/ Butler bldg attached in N end

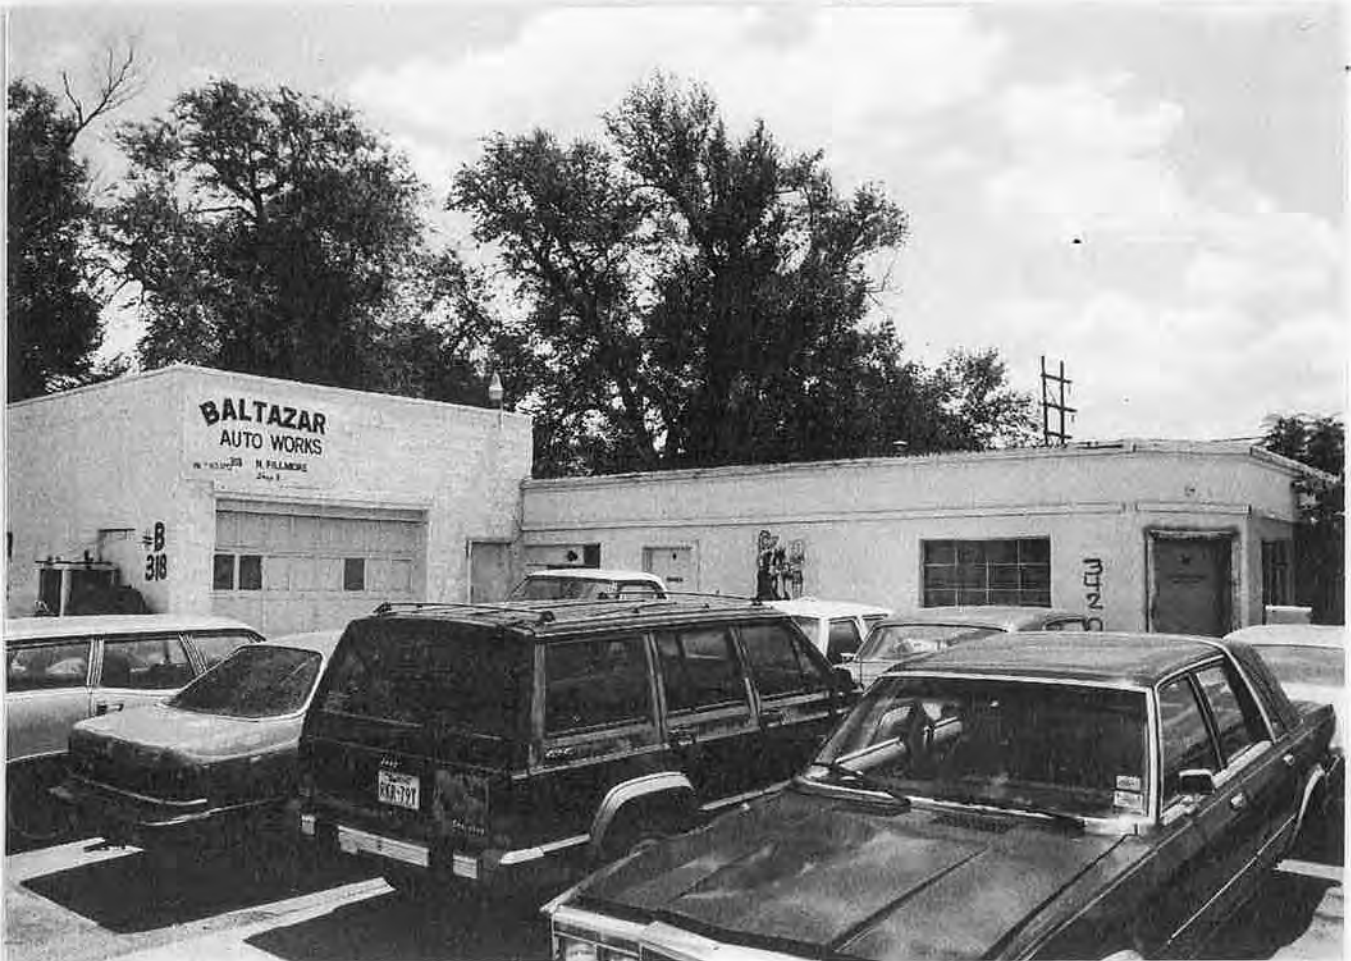
775-AM-322
35-3764-17
FACING SE

Roof type Flat _____ Materials _____

Wall facade conc. block _____ Foundation _____

Window type metal casement _____ Materials _____

Door type wd. solid overhead; multipanel _____ Materials wood _____

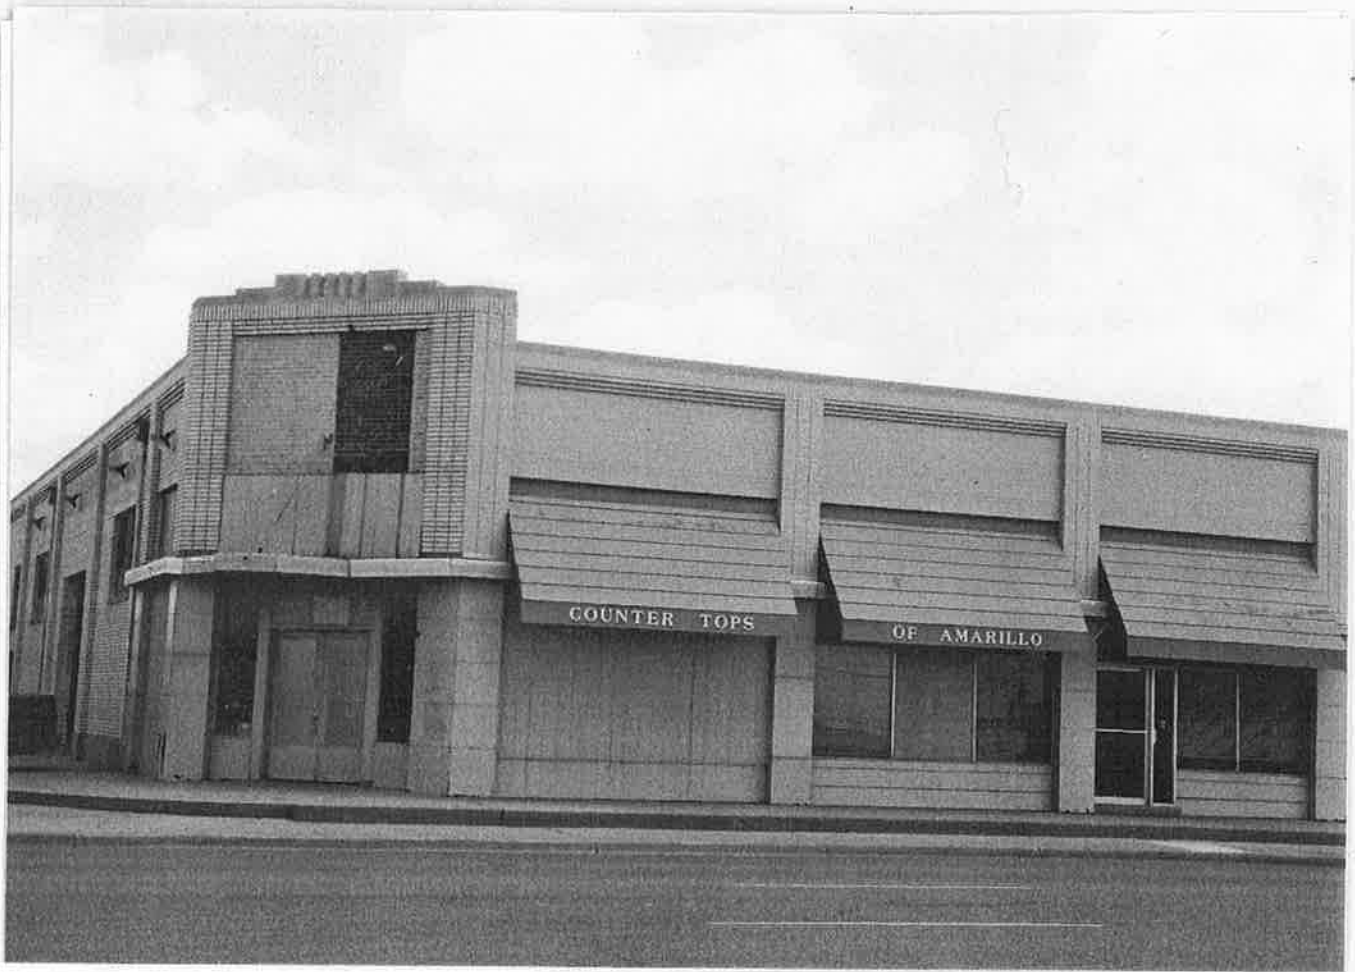
Photo Data: Roll 85 Frame _____ Feature 16 overall SE

Roof type flat w/ parapet Materials _____

Wall facade synth siding; painted brick above stone front
Foundation _____

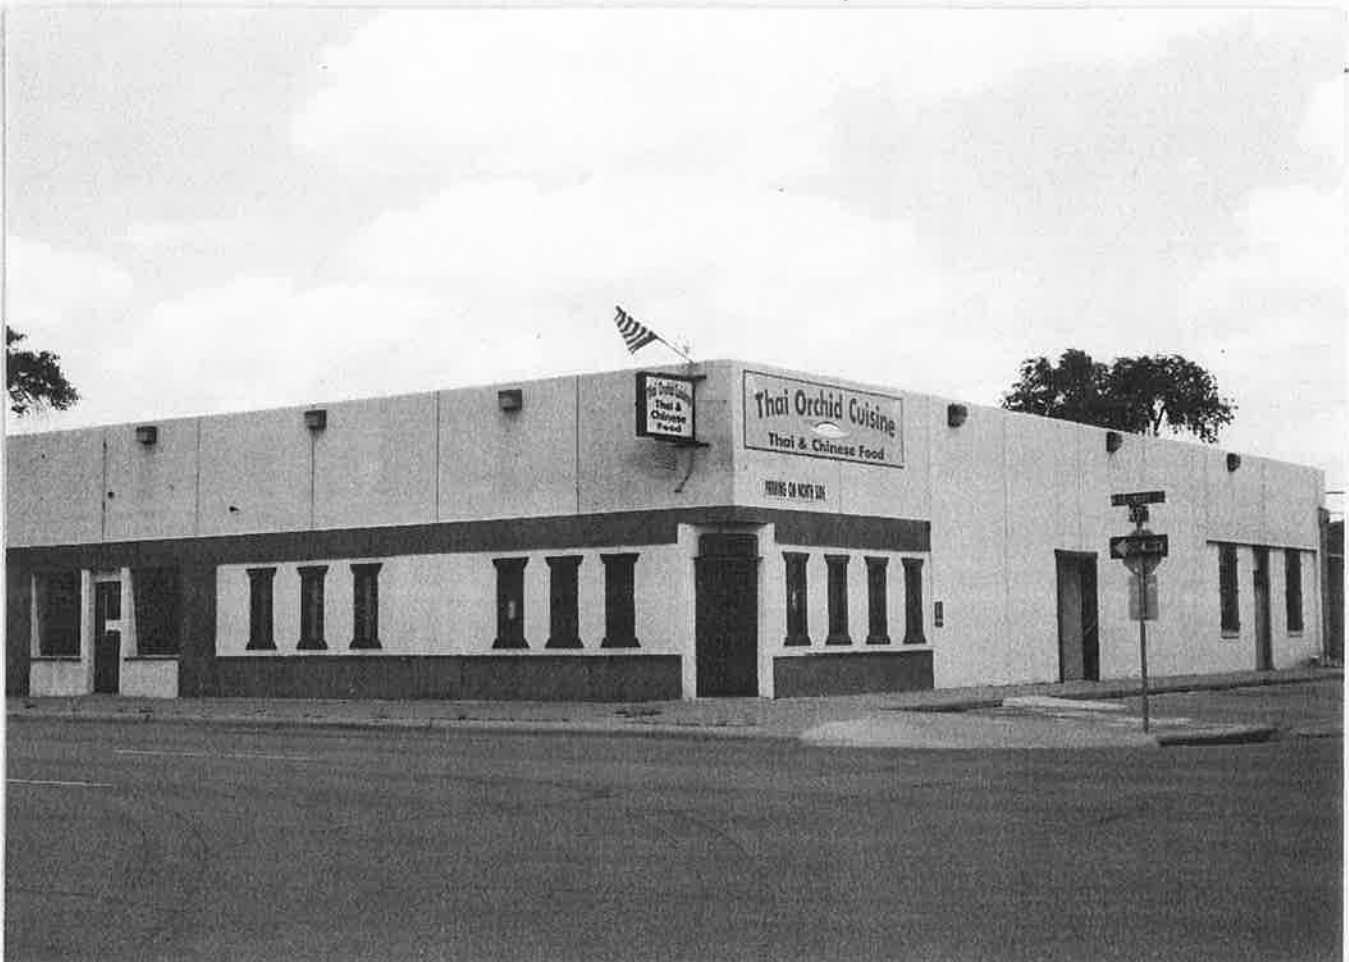
375 - AM - 324
35 - 3764 - 14
FACING NE

Roof type flat

Wall facade stucco

Window type plate w/ wood surround

Door type port, panel, 1/2 glass, 1/2 solid

General Architectural Description stucco front completely altered

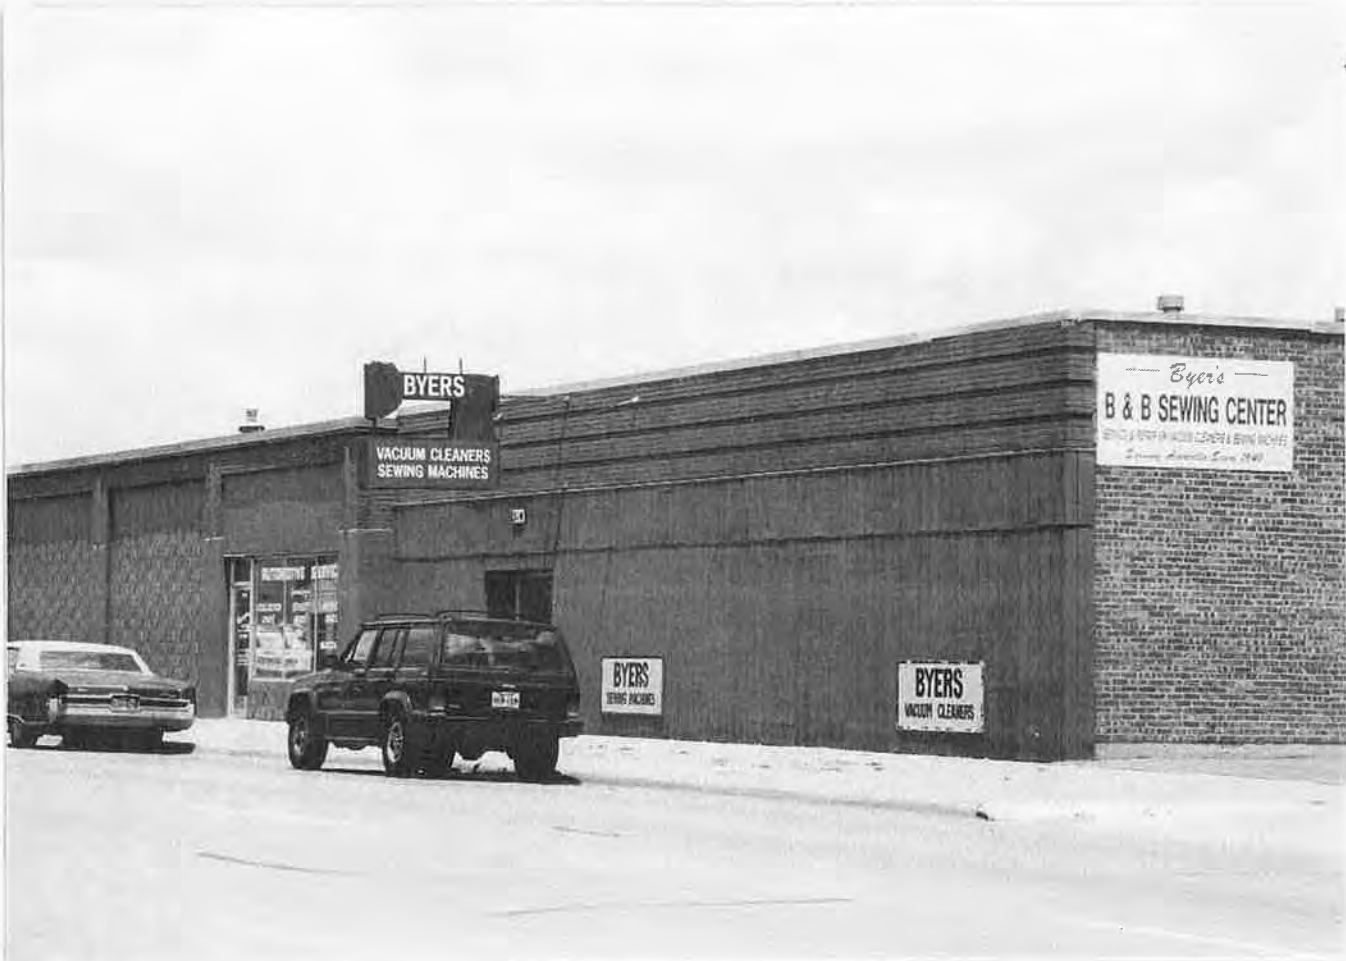
375-AM-325
35-3764-13
FACING NW

Roof type Flat Materials _____

Wall facade wood siding (vert), some painted brick Foundation sidewalls red brick

Window type plate in metal Materials _____

Door type fully glazed in metal Materials _____

General Architectural Description store front / facade completely altered & infilled. Some brick detailing still apparent - cornice & some w/ decorative conc. block

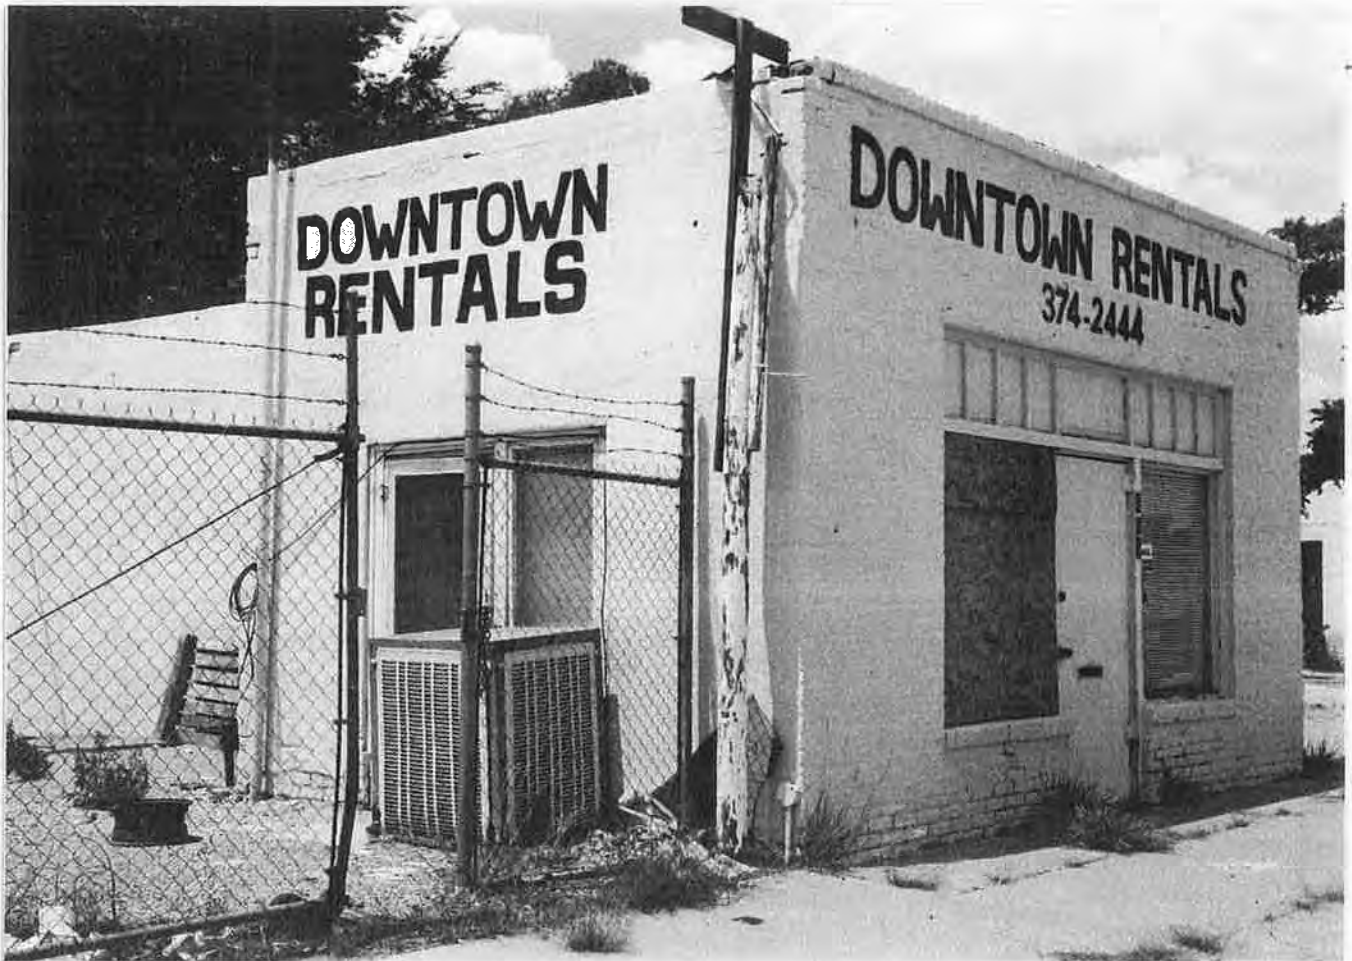
Roof type flat Materials _____

Wall facade paneled brick Foundation _____

Window type plate in wood w/ transom Materials _____

Door type non orig? sided Materials _____

General Architectural Description finy 1 unit bldg

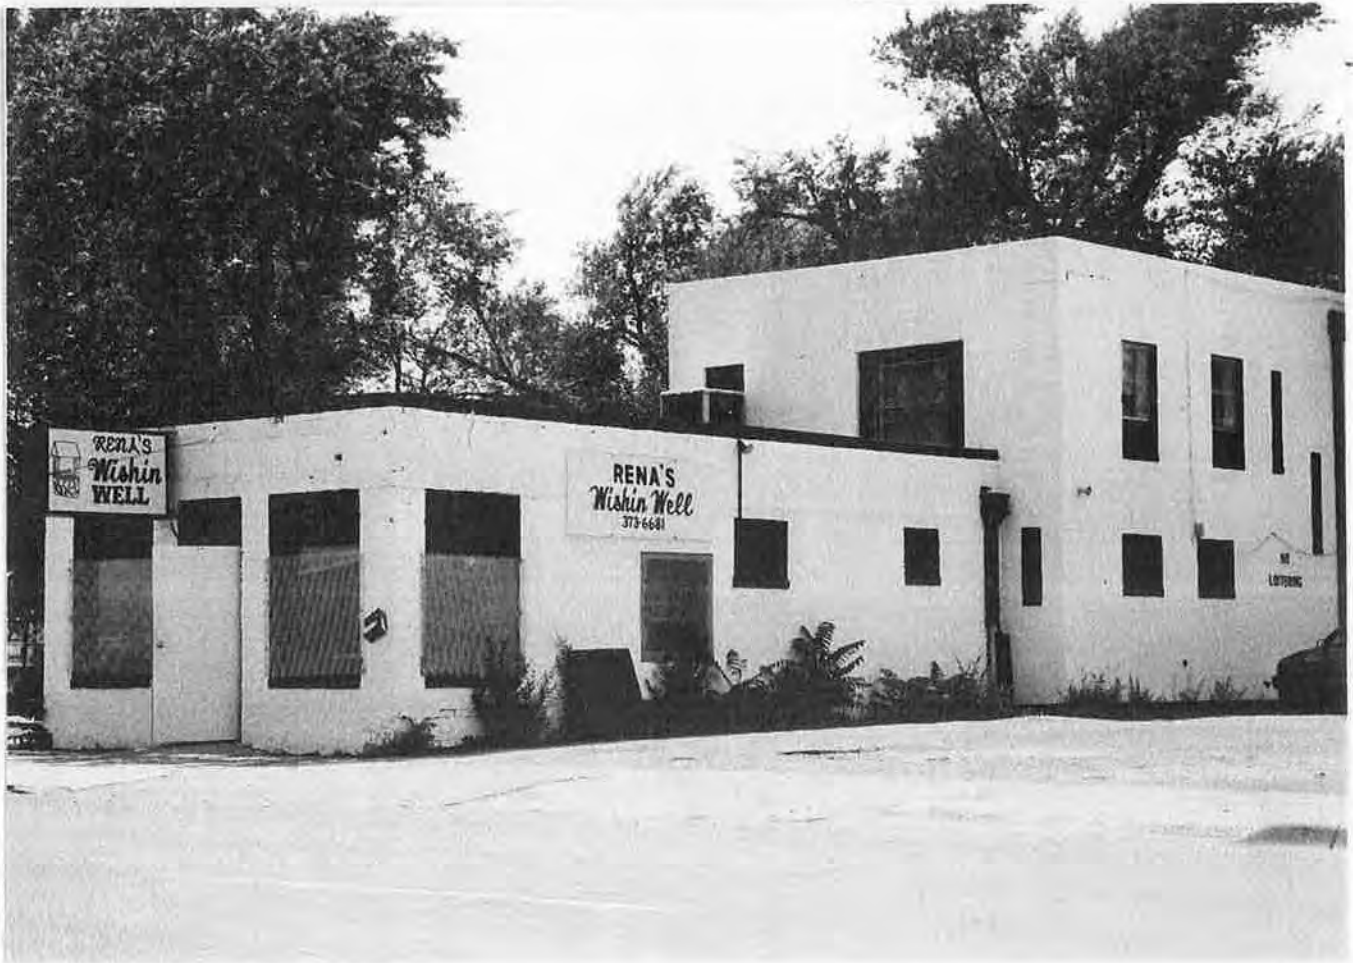
Roof type Flat Materials _____

Wall facade painted brick Foundation _____

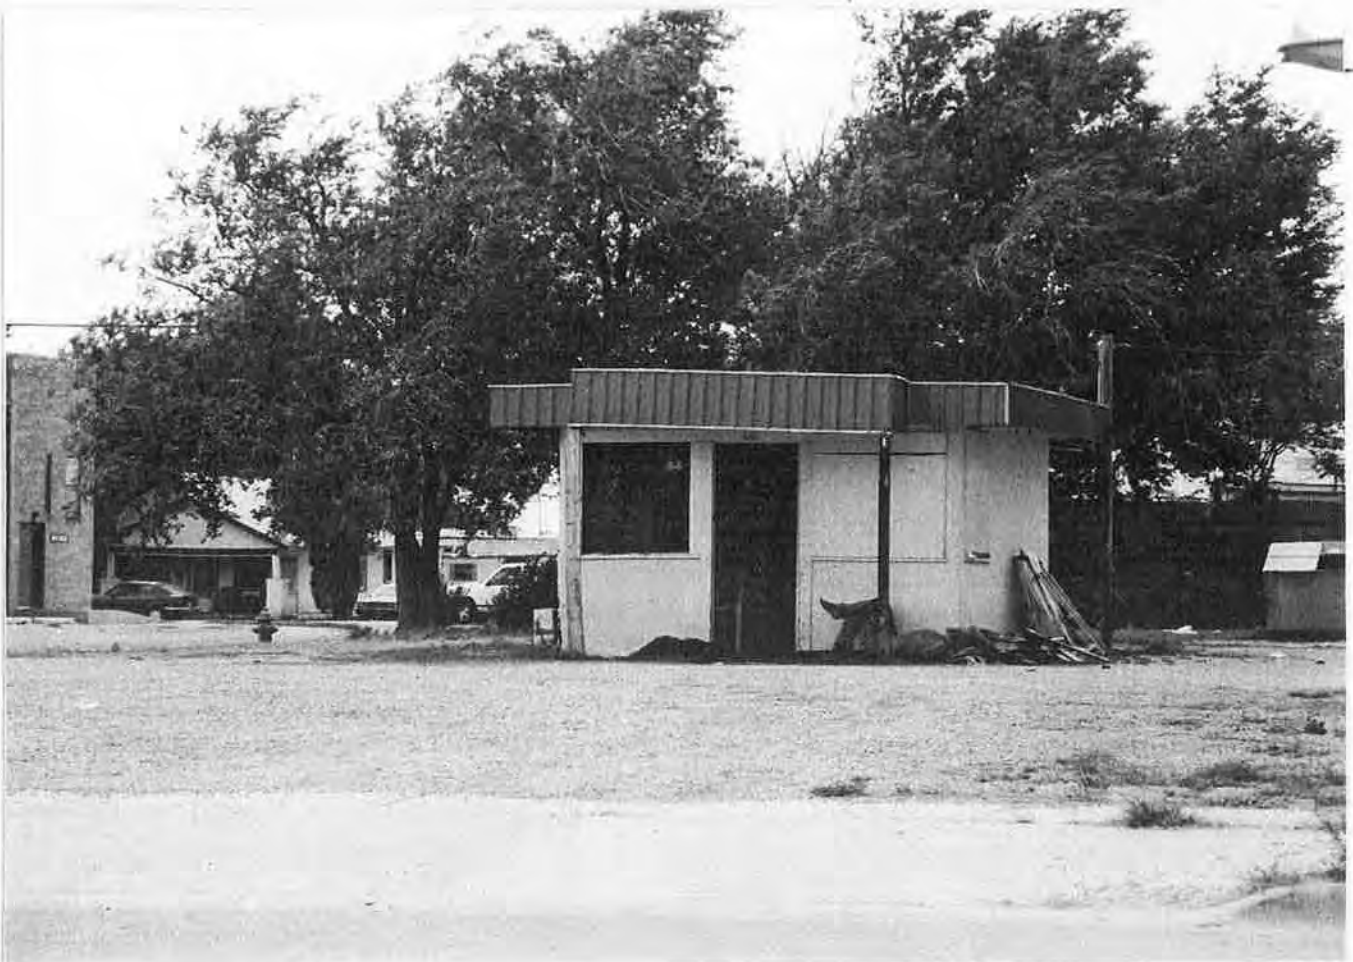
Roof type shed w corr metal COR-STEEL Materials _____

Wall facade stucco Foundation _____

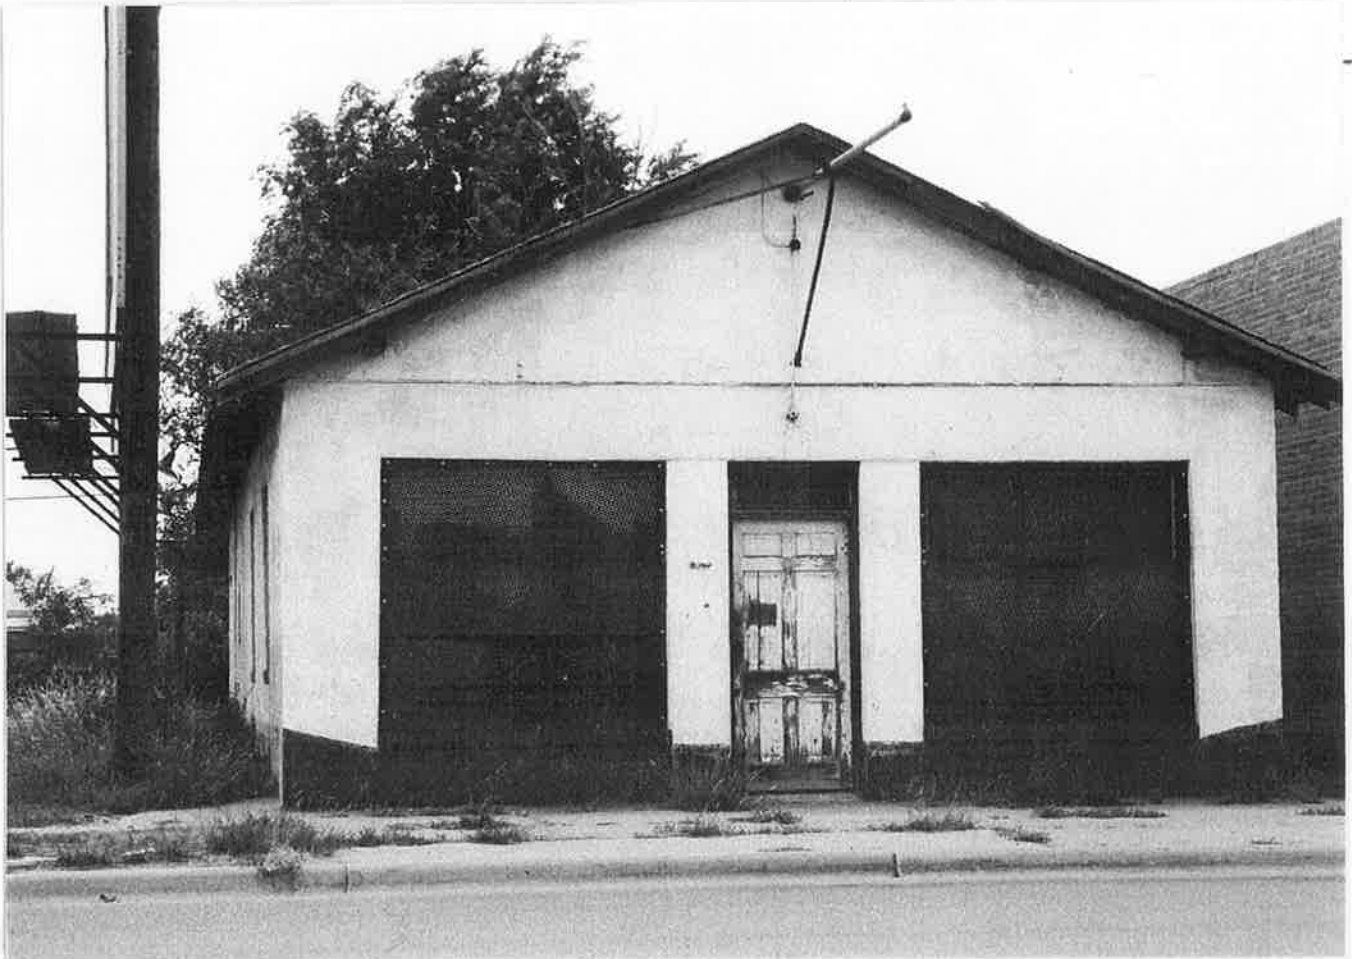
Stylistic Influence(s) _____
 Roof type front gable w/ ex RAFT eads Materials _____
 Wall facade stucco Foundation _____
 Window type plate in wood (mostly obscured) Materials _____
 Door type 6 panel wood w/ transom Materials _____
 Porch type _____ Materials _____
 Number of Stories 1 Plan _____
 Chimney(s) _____

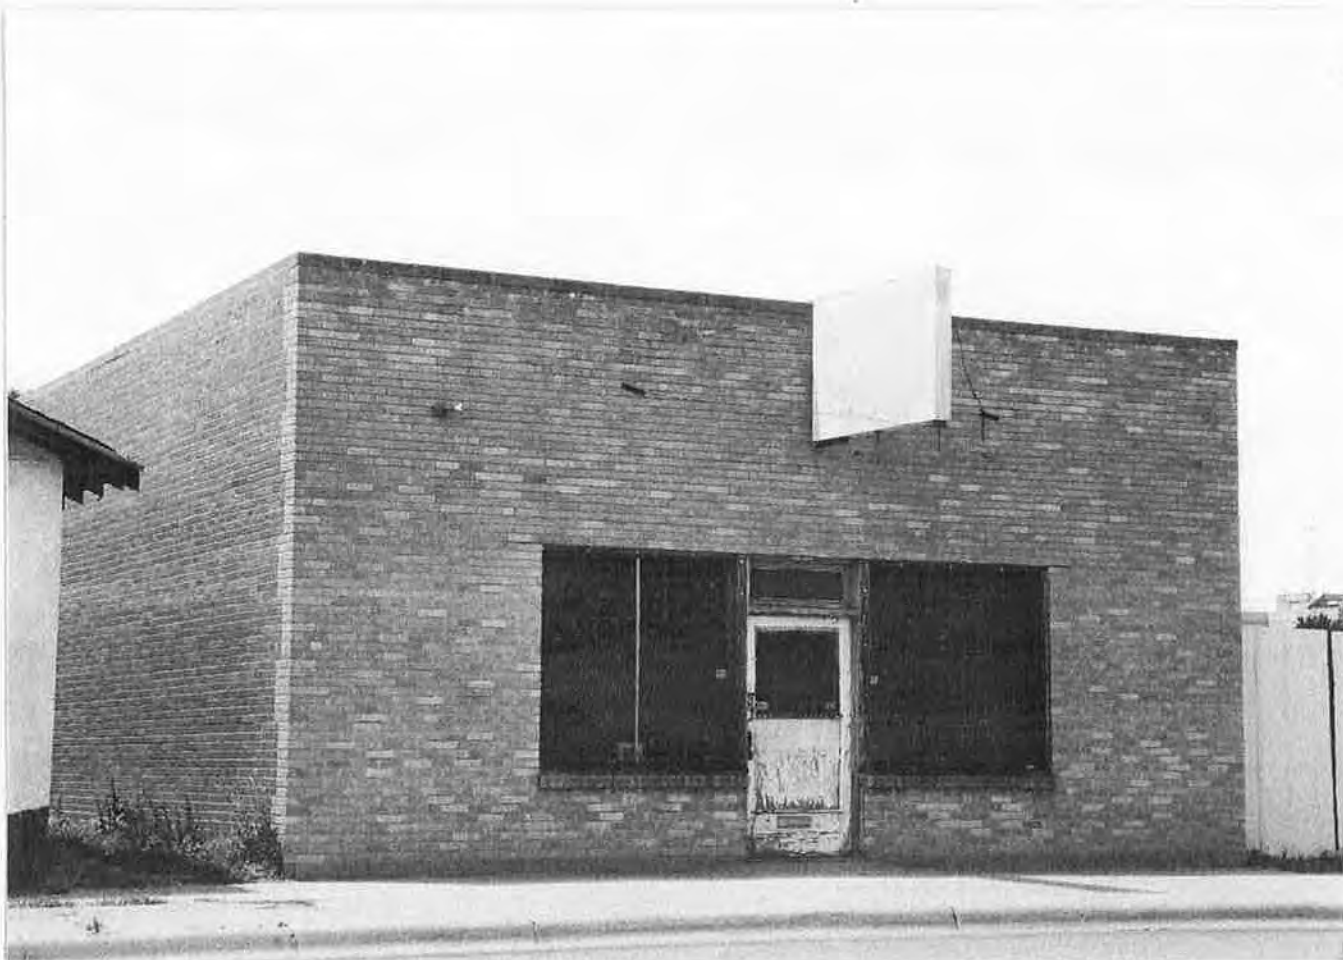
Stylistic Influence(s) _____
Roof type flat Materials _____
Wall facade buff brick Foundation _____
Window type plate, in wood Materials _____
Door type 1/2 glass 1/2 panel, wood w/ transom Materials _____
Porch type _____ Materials _____
Number of Stories _____ Plan _____
Chimney(s) _____
General Architectural Description _____

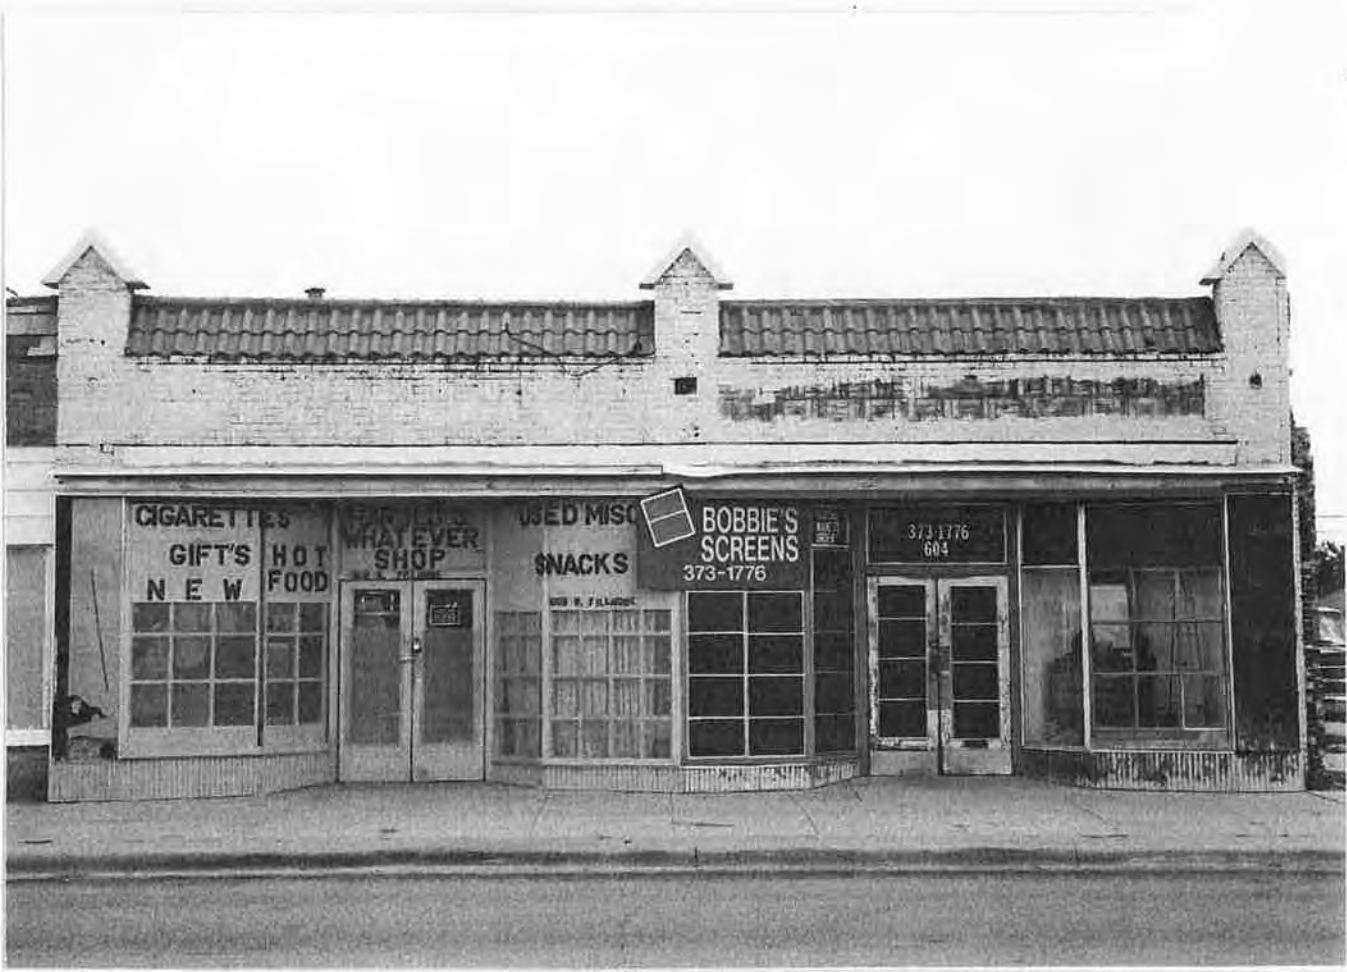
Roof type flat w/ parapet - pent roof detail Materials arrow shaped protrusions

Wall facade pinked brick / wood slip cover Foundation red Spanish Tile @ pent

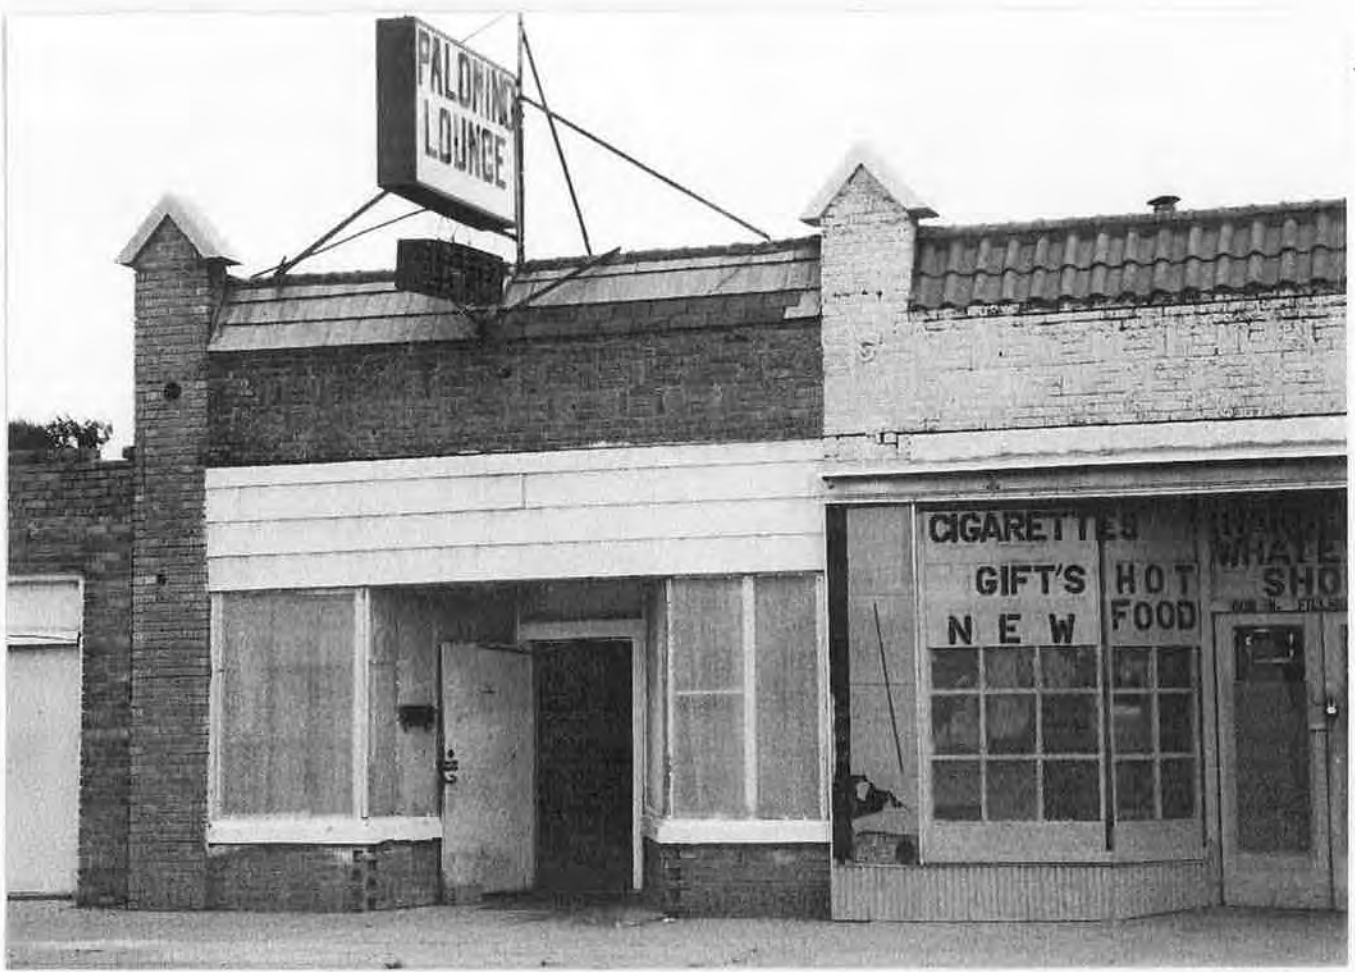
Stylistic Influence(s) _____
 Roof type Flat w/ pent roof @ parapet Materials _____
 Wall facade brick (on painted) Foundation _____
 Window type plate in wood Materials _____
 Door type inset in chamfered bay; non ^{orig} sol. d door Materials _____
 Porch type _____ Materials _____
 Number of Stories 1 Plan _____
 Chimney(s) _____

General Architectural Description 1 part corr block, 1 bay
orig part of # 331 now altered

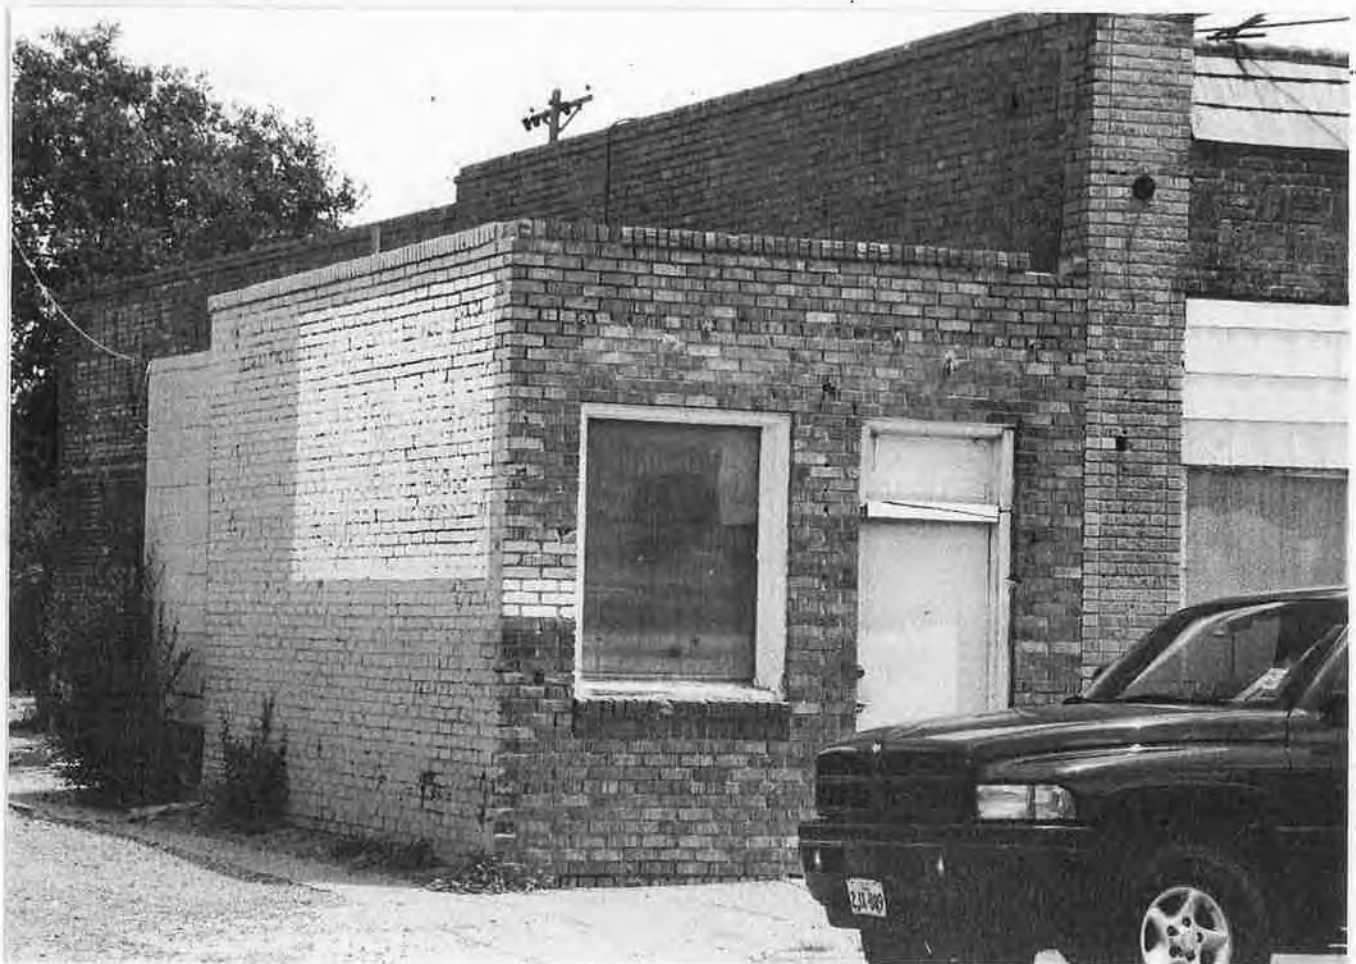
Roof type flat Materials _____

Wall facade red brick Foundation _____

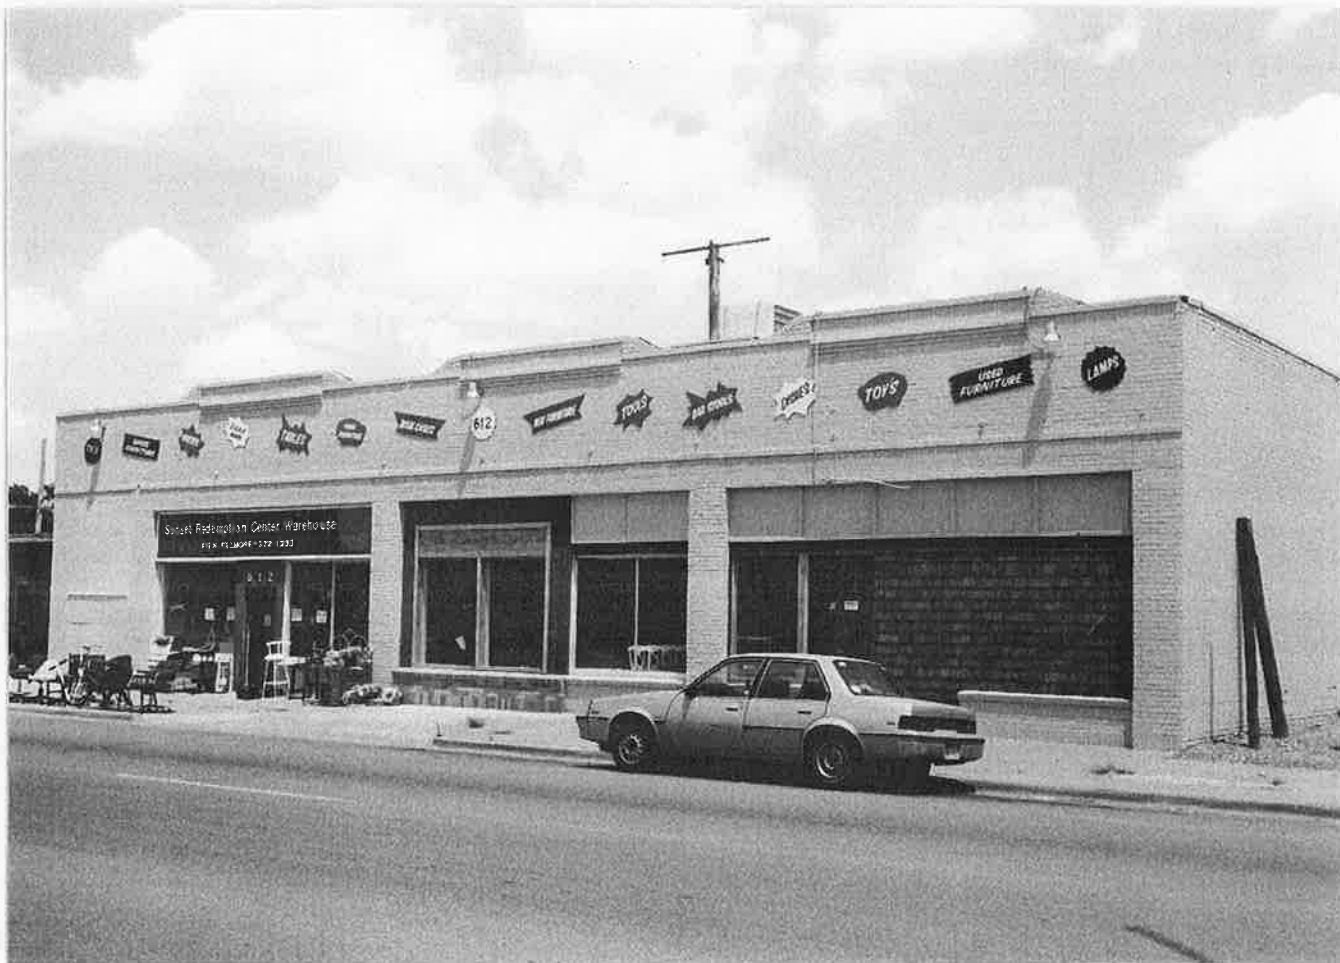
Roof type flat w/ 3 stepped parapet

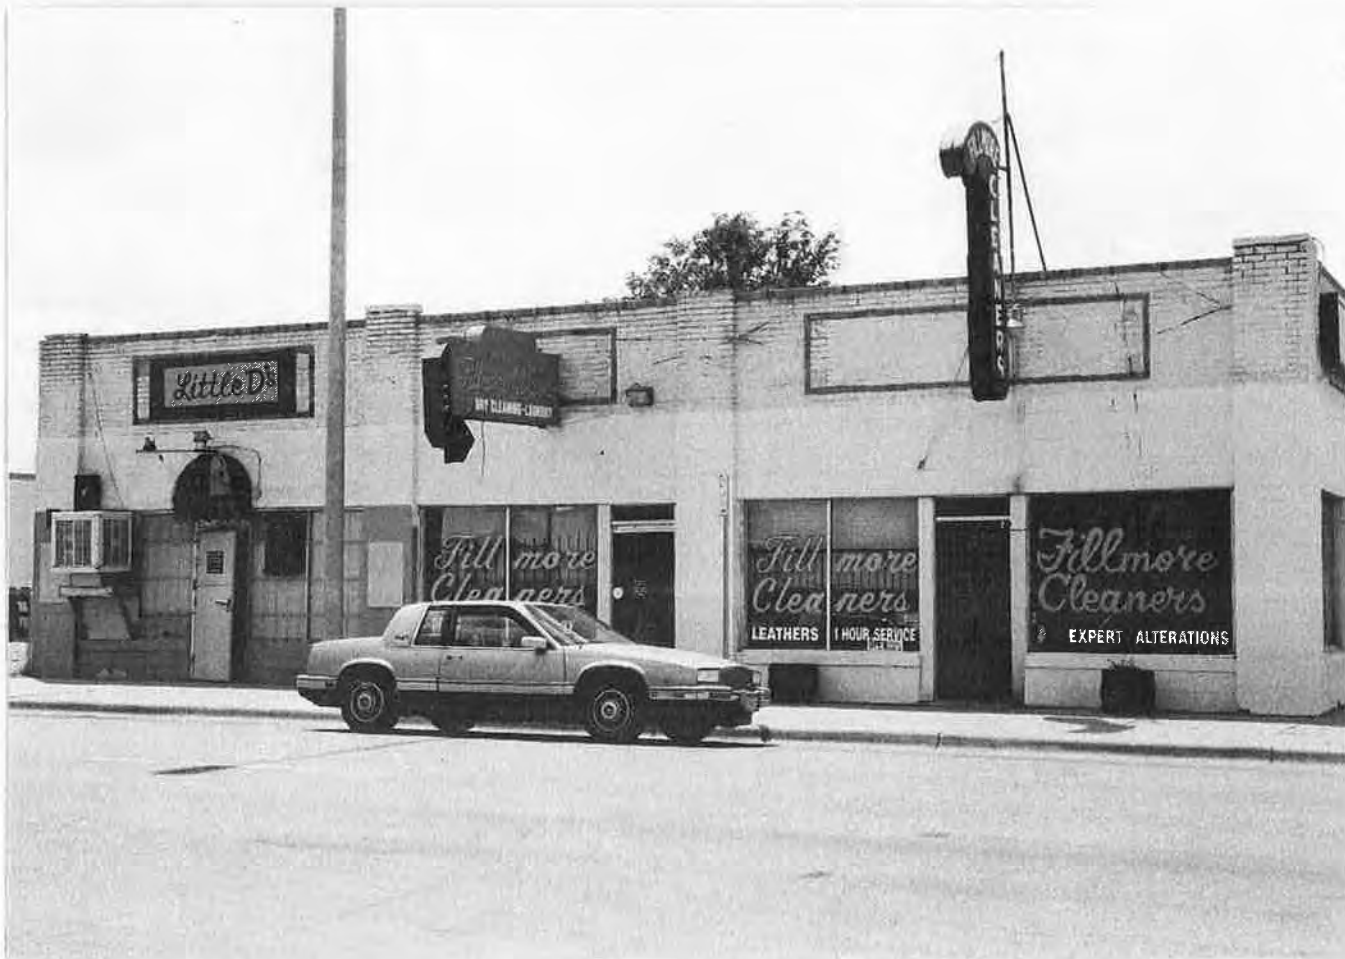
Stylistic Influence(s) _____
 Roof type Flat Materials _____
 Wall facade Painted brick Foundation _____
 Window type plate in metal Materials _____
 Door type fully glass in metal w/ transom Materials _____
 Porch type _____ Materials _____
 Number of Stories _____ Plan _____

Chimney(s) _____
 General Architectural Description 1 part corin block div into 3
ways by brick piers. Lower store front covered w/
score & stucco panels.
signs hang from facade.

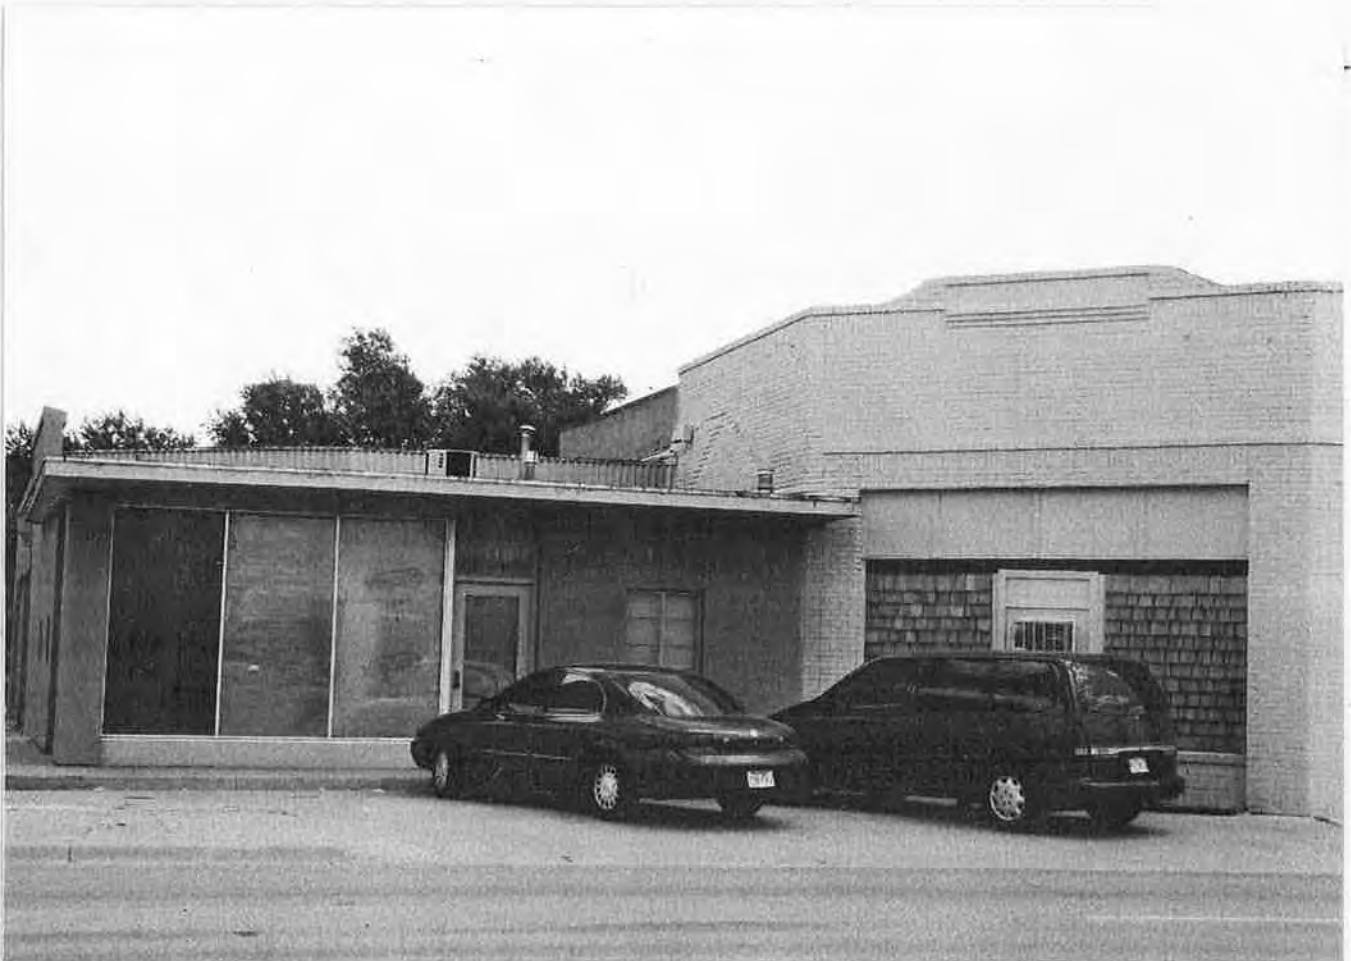
Roof type shed to flat in front Materials _____

Wall facade stucco Foundation _____
