Historic Resources Inventory Form—Route 66

County POTTEL City AMARILLO Inventory # 375-AM-308
Historic Name _____
Current Name Thomas & Johnson, Attorney
Address 413 Fillmore
Lot(s): _____ Block: _____ Addition: _____
Owners Address _____
Resource type Building Structure Site Object District
Landscape/Site Features _____
Outbuildings _____
Function: Current Use office Historic Use car
Construction Date: 1927 Actual Estimated
Architect _____ Builder _____
Possible Threat(s) Demolition Development Neglect Alteration Vacant Utility Expansion
Integrity Location Design Materials Workmanship Setting Feeling Association
USGS Quad #: _____ Year: _____ UTM Zone: _____ Easting: _____ Northing: _____
Priority High Medium Low Recorder Monica Penick Date(s) 7/19/2002

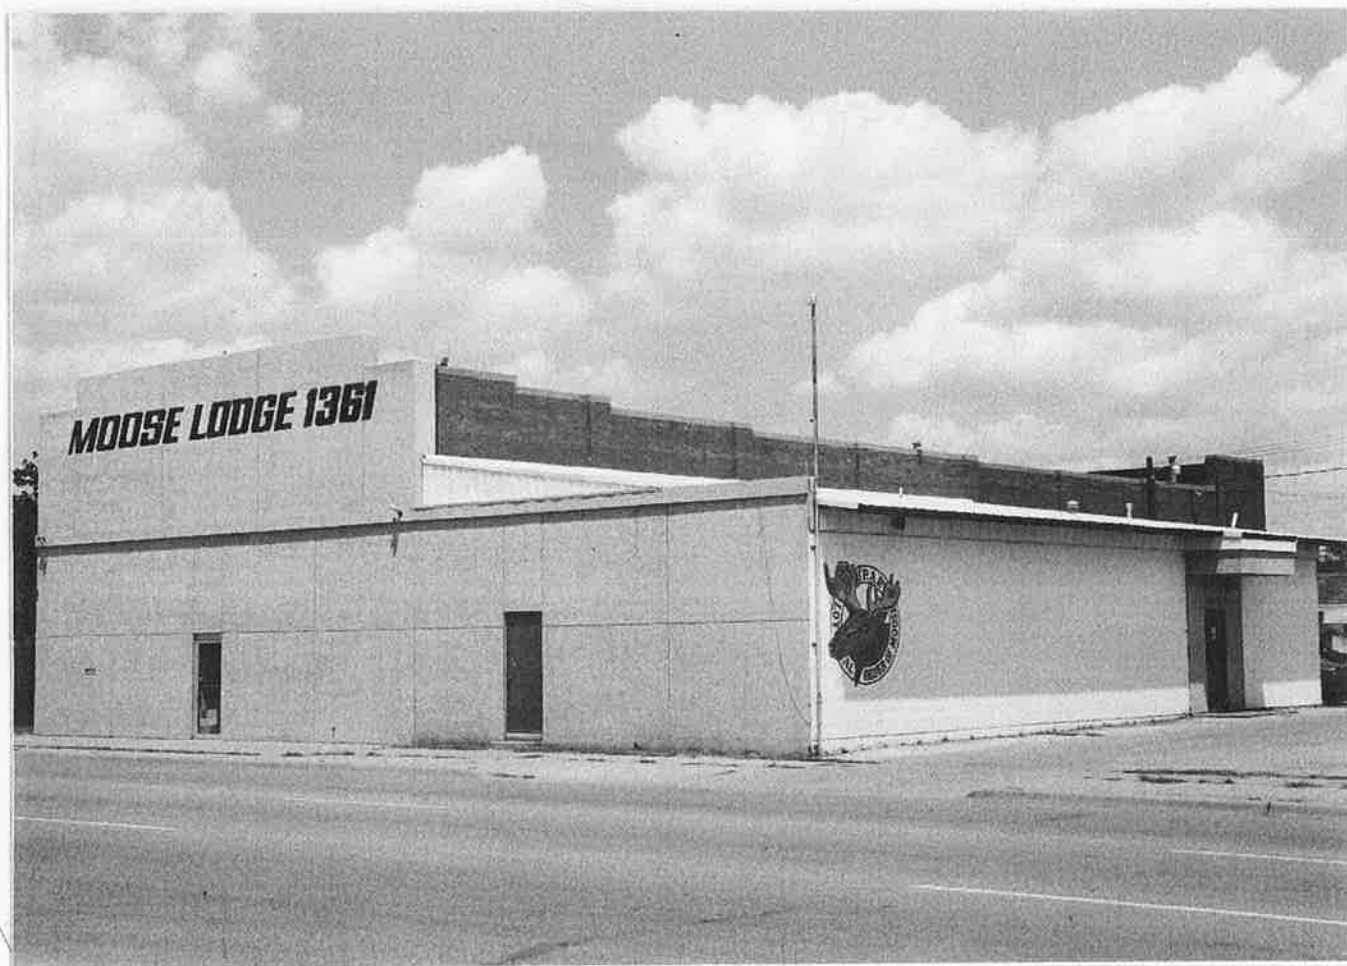
Roof type Flat w/ parapet to N, shed to S. Materials S.

Wall facade stucco Foundation _____
