Historic Resources Survey Route 66 through Texas

Survey Materials

Carson County

Groom

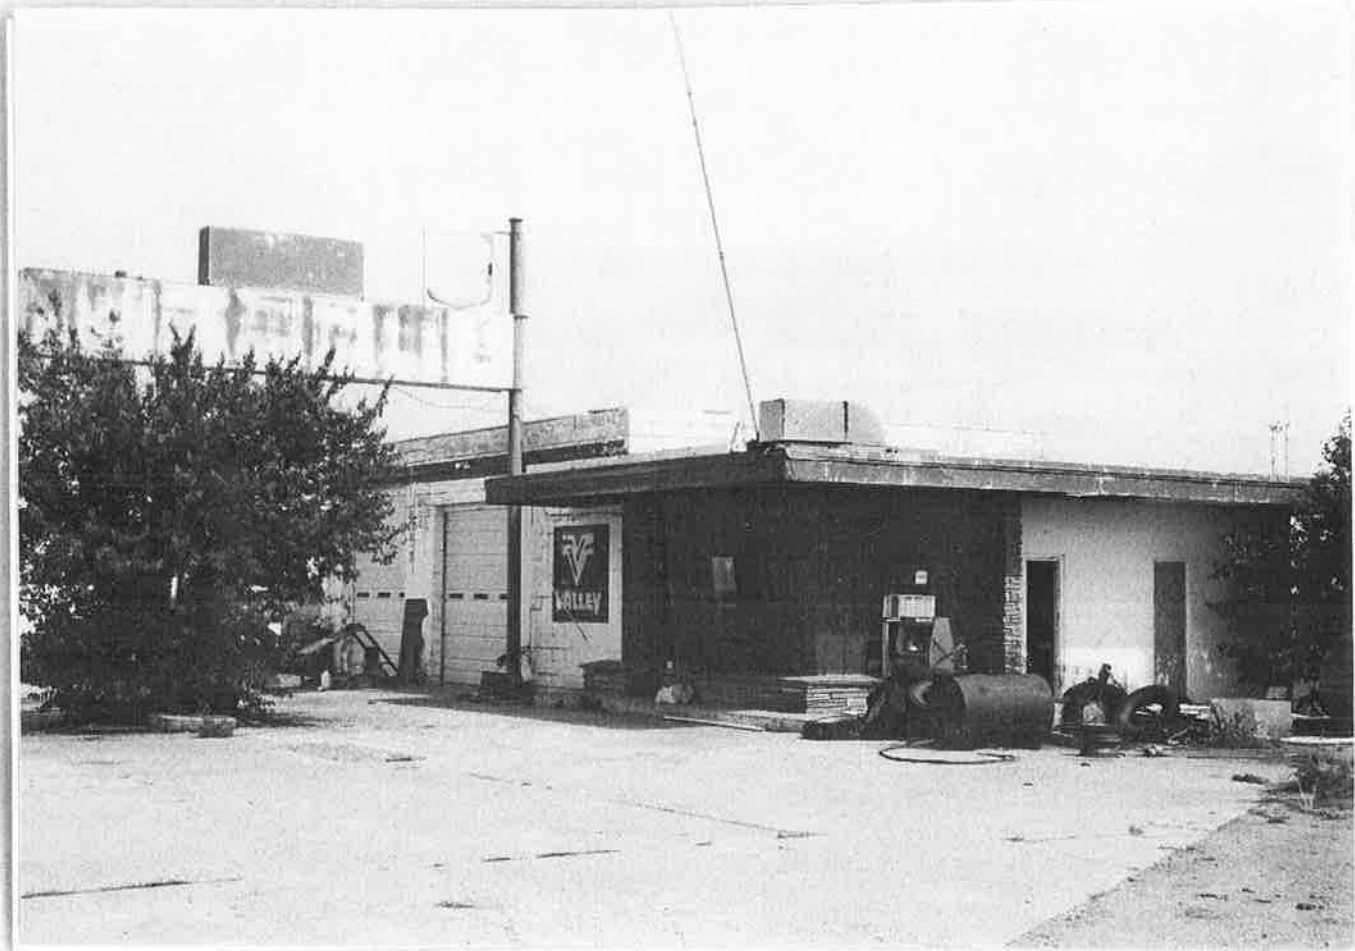
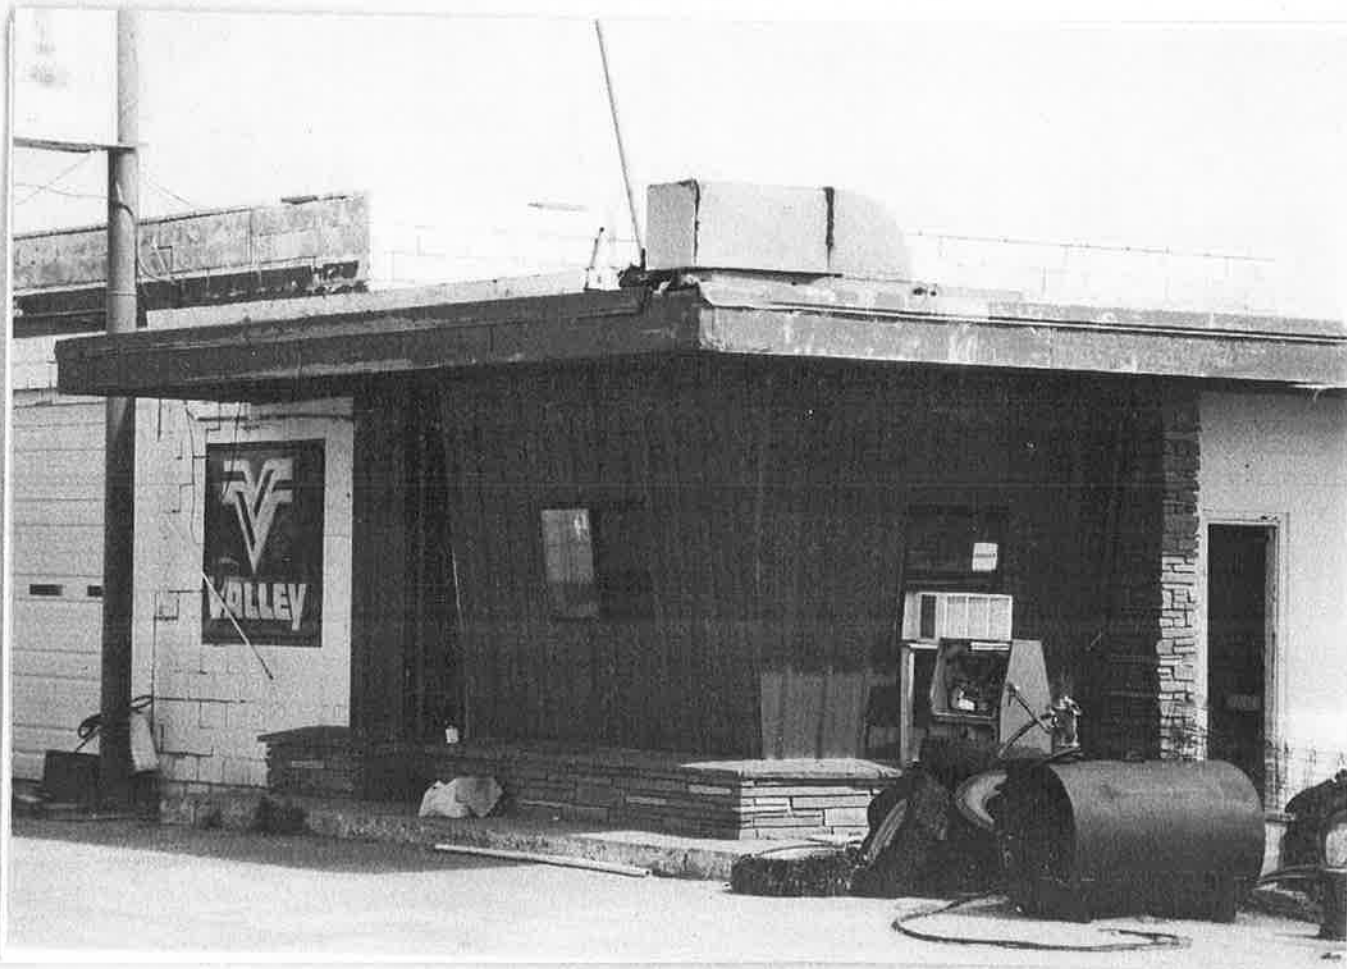
Photo Data: Roll 14 Frame 121¹¹ Feature look SE

Roof type flat: garage has parapet Materials _____

Wall façade garage: painted cnc block; cafe: cnc Foundation block, brick at base + rest of window bay

General Architectural Description garage is typical 2 bay config. Cafe has overhanging eaves & sloping window bay. Bay likely to have been glazed. Restrooms in rear

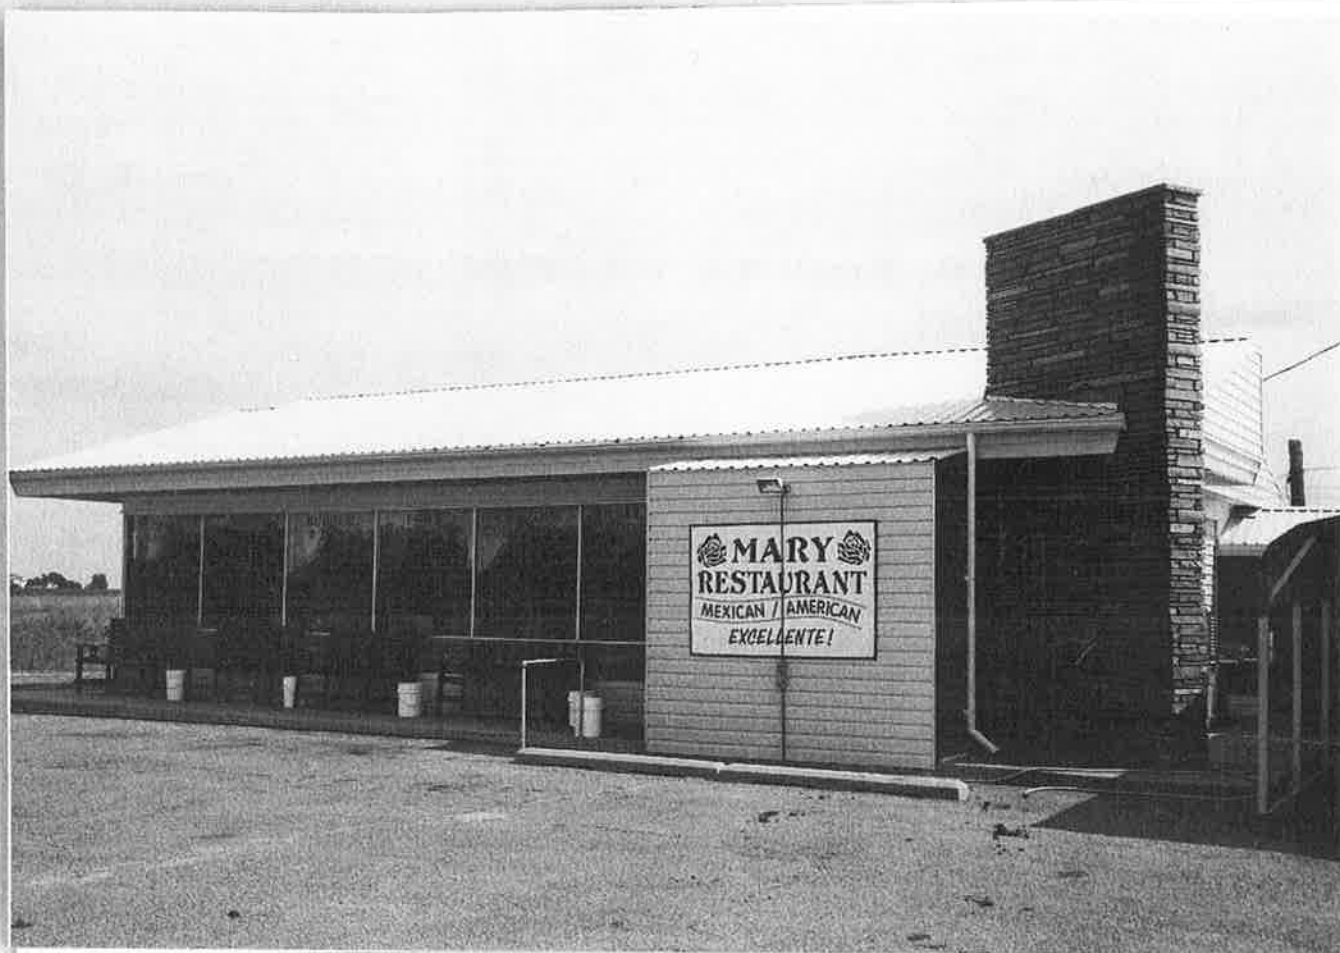
General Architectural Description Pylon is at angle to restaurant - this form suggests this is older bldg under new slipcover. Sign frame prob orig but remade.

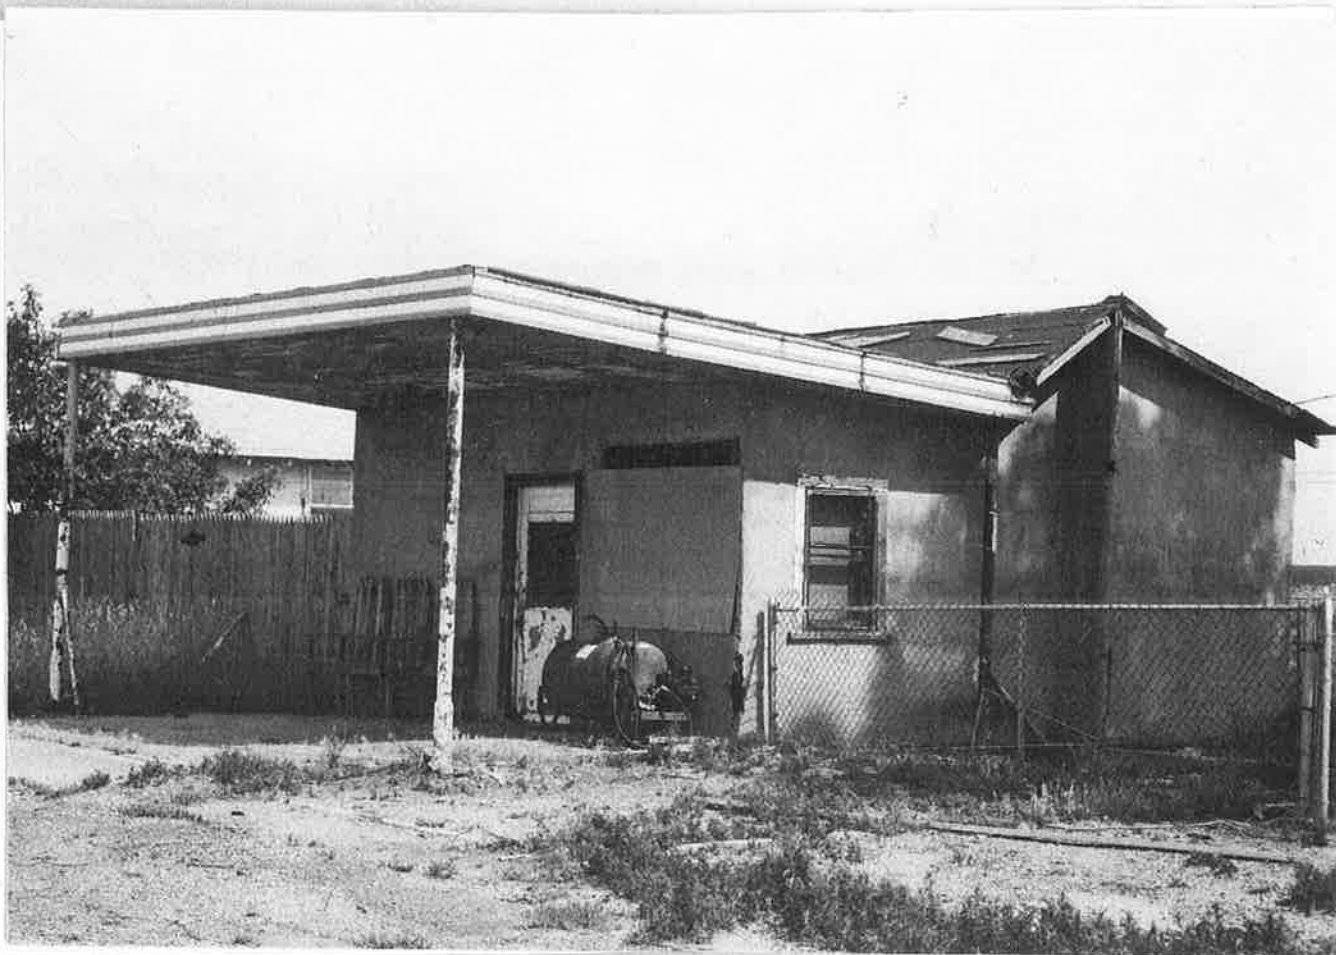
General Architectural Description small filling station. Unusual roofline. Profile:

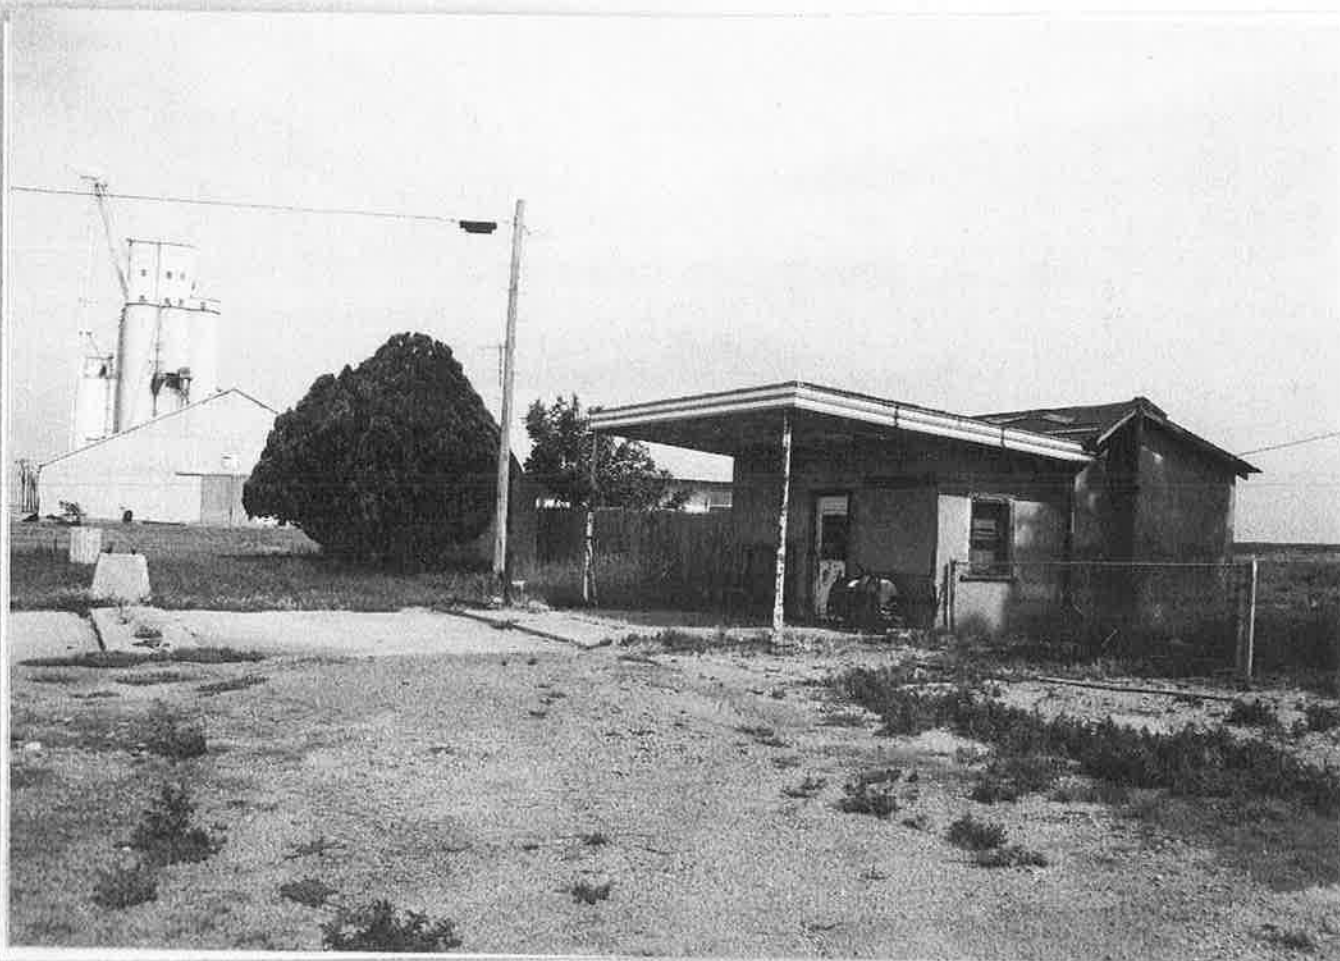
Photo Data: Roll 14 Frame _____ Feature B look SE

Roof type folded plate-type

Porch type metal canopy supported on steel poles Materials _____

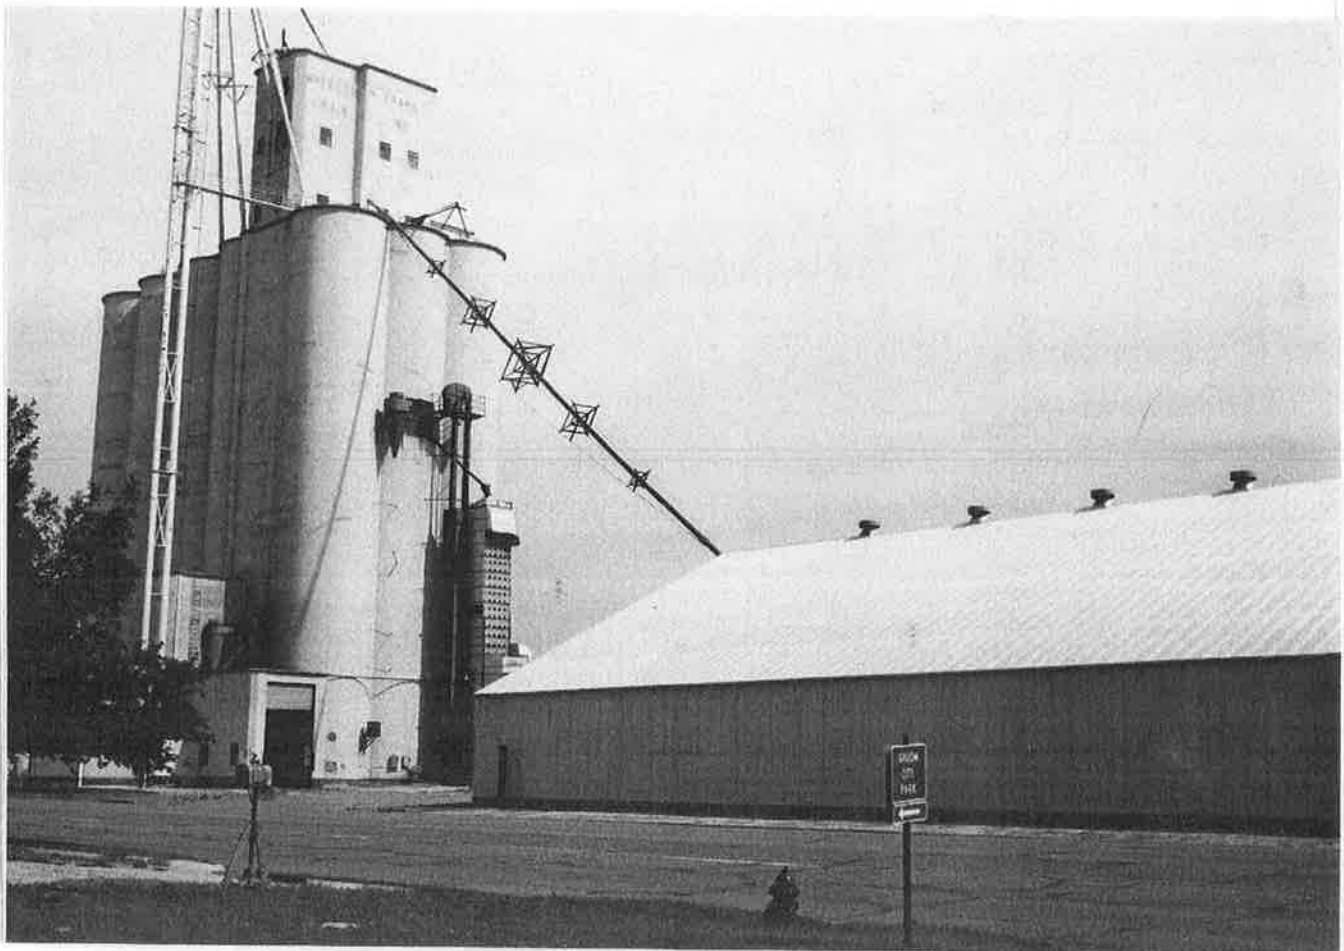
General Architectural Description typical grain convey w/ 15 connected silos

office is front gable w/ corr metal roof & walls. Has brick

inset on front facade - its elevated on conc slab

windows are plate glass in metal frame. 2 main doors 1/2 glazed over

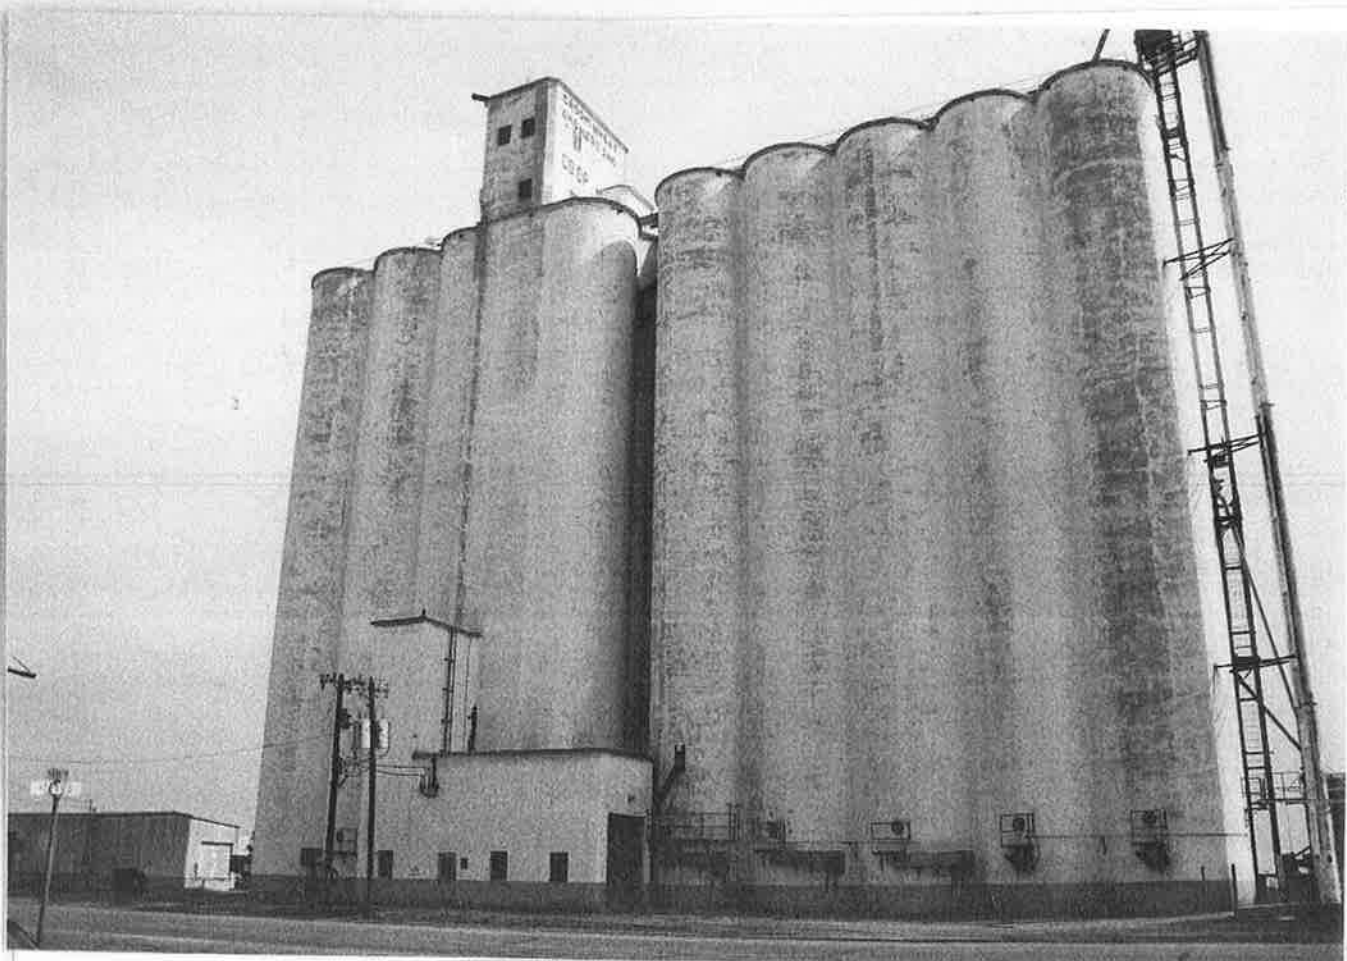
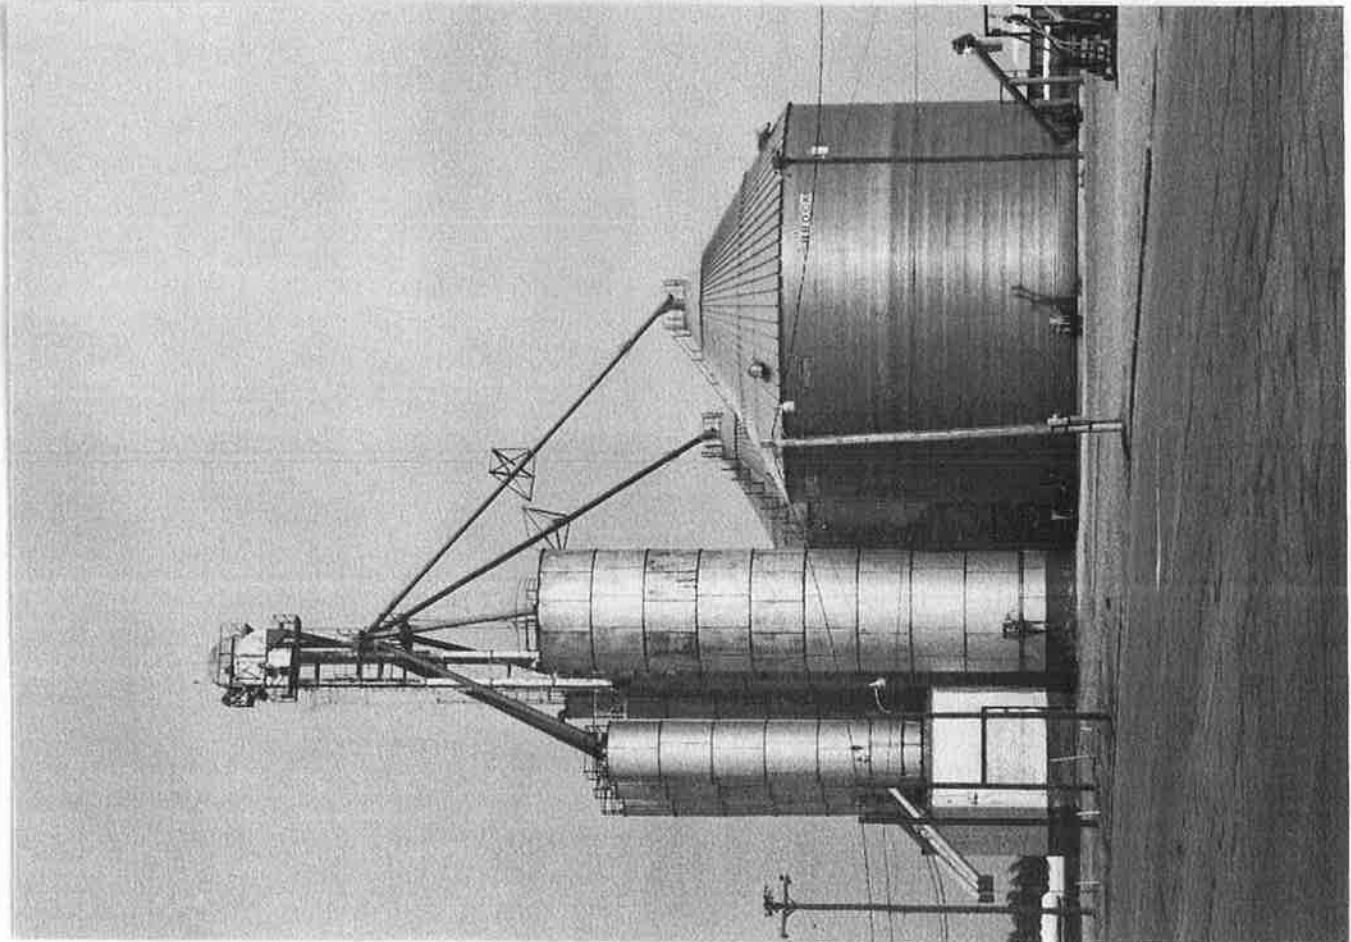
Photo Data: Roll 14 Frame _____ Feature 4 silos look S

General Architectural Description typical grain complex but w/ very large corr metal bldgs. has only small office & small storage wing

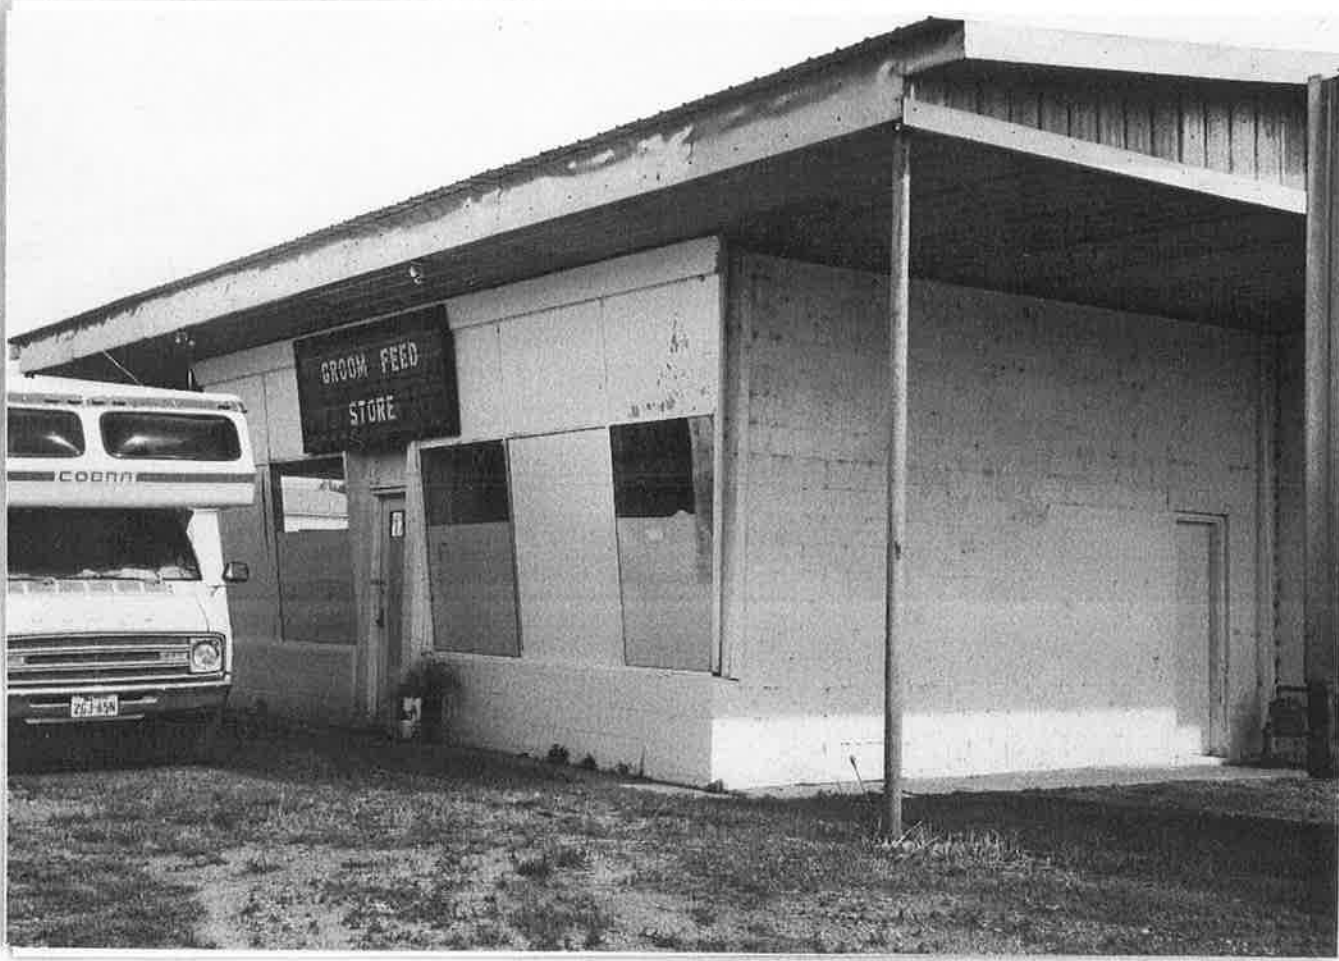
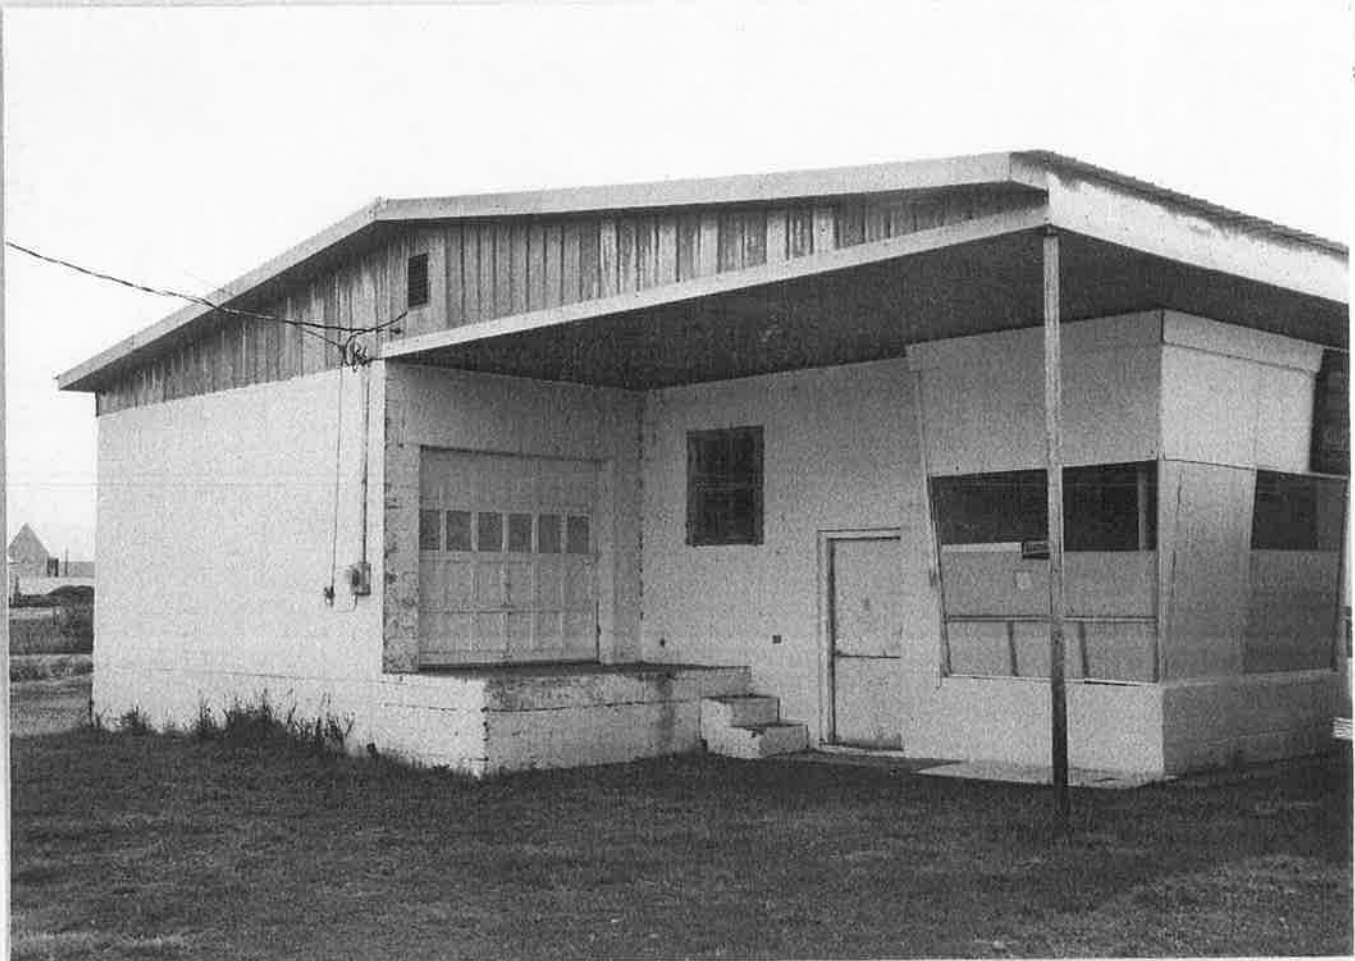
065-68-7
 PHOTO 14-3477-2
 PACING SOURCE

General Architectural Description shar metal panels grain silos w/ concrete storage
silos behind

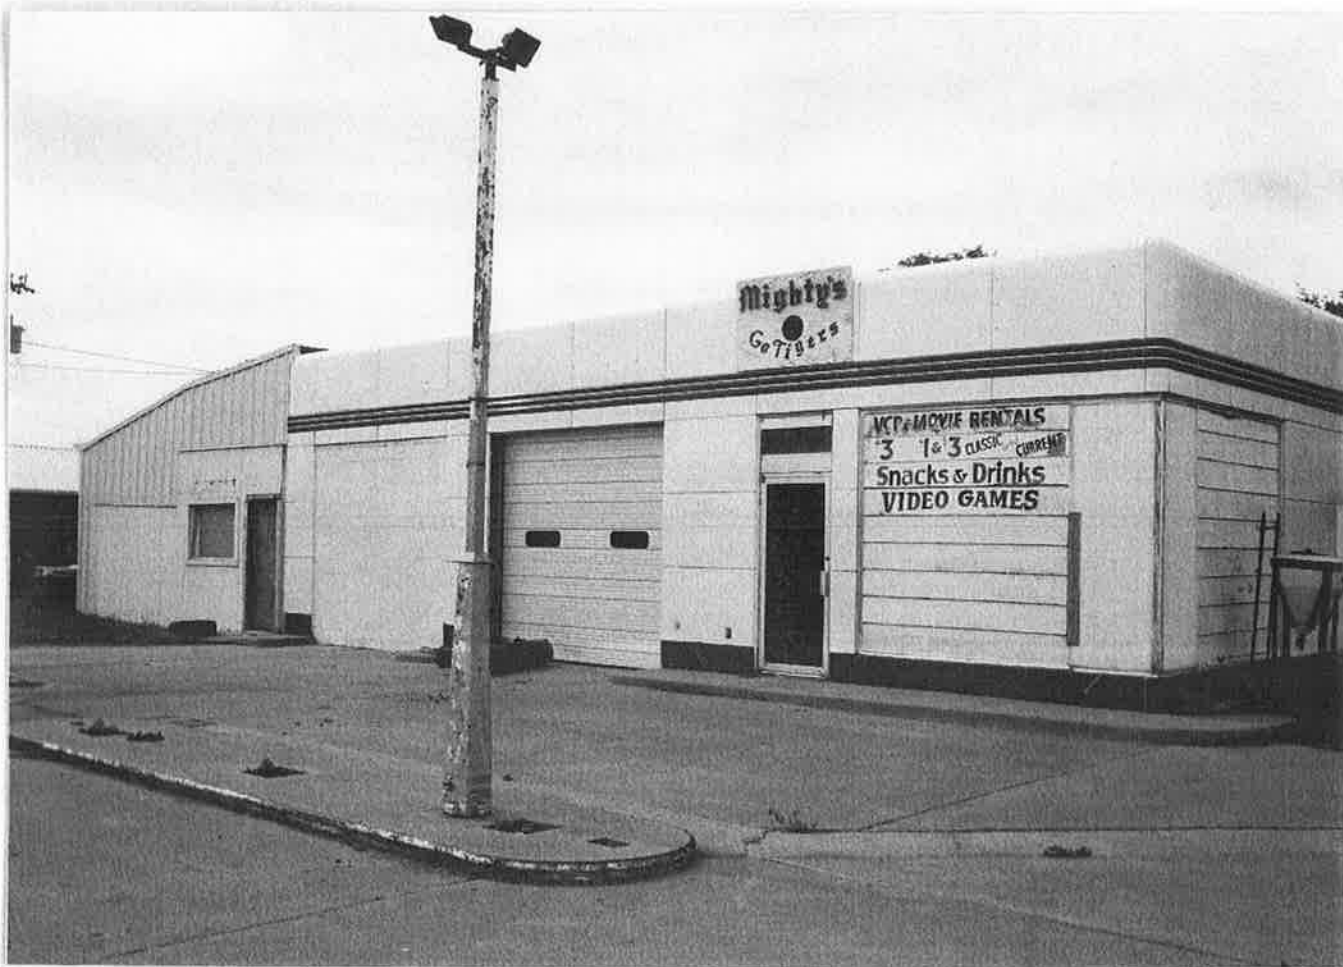
Stylistic Influence(s) _____
 Roof type flat Materials _____
 Wall façade porcelain w/ blue stripes Foundation _____
 Window type boarded Materials _____
 Door type fully glazed, metal frame; 2 overhead door bays - 1 blocked in Materials 1 metal door
 Porch type N/A Materials w/ 2 lights
 Number of Stories 1 Plan _____
 Chimney(s) N/A

General Architectural Description corr shed addition to west side.

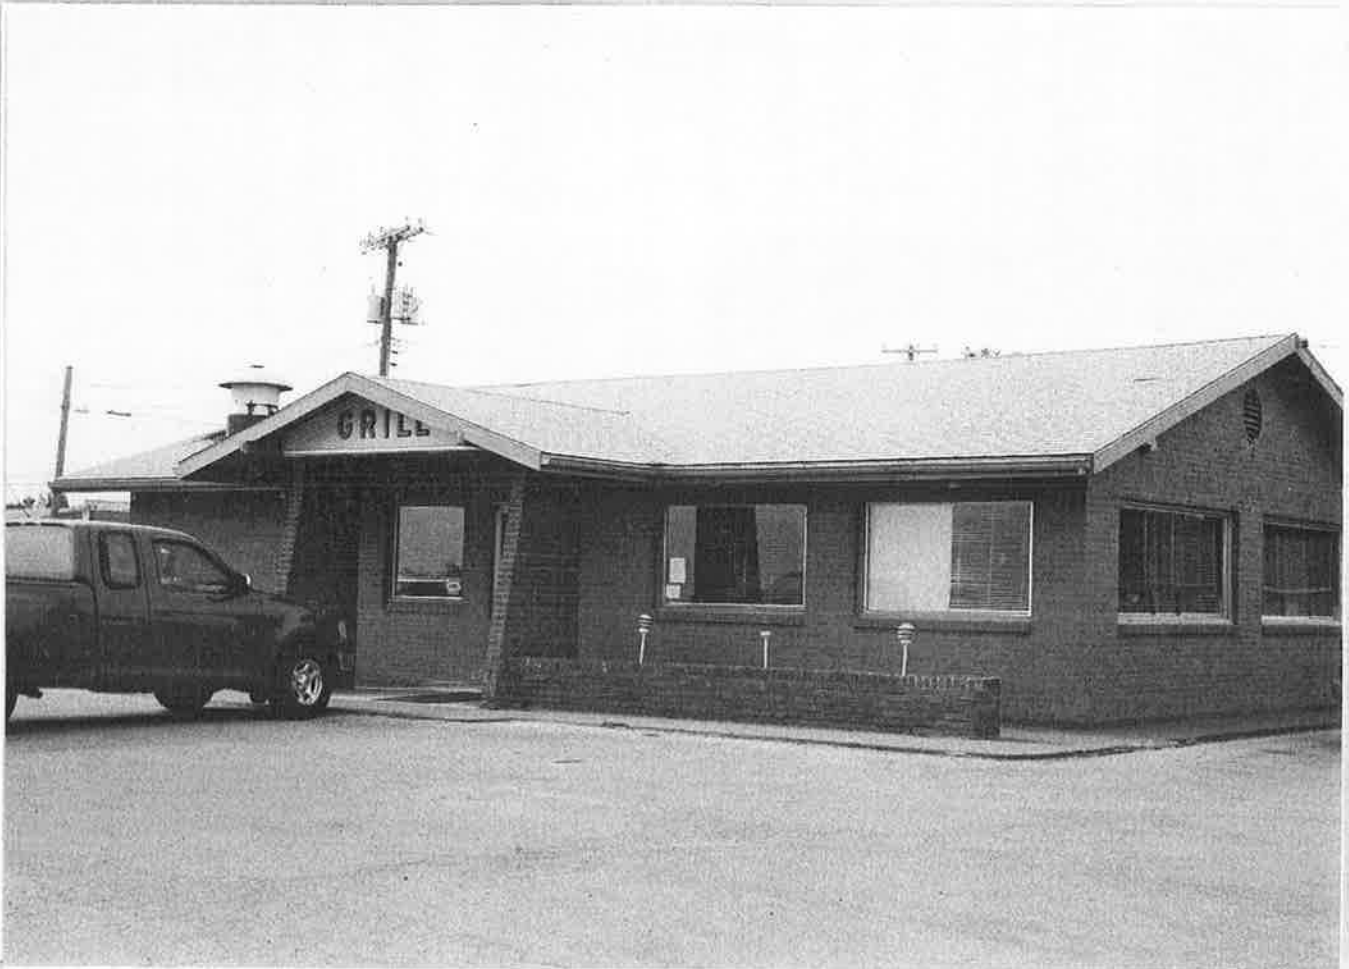
General Architectural Description sign intact - amazing feature - neon on
swiss-cheese like pier

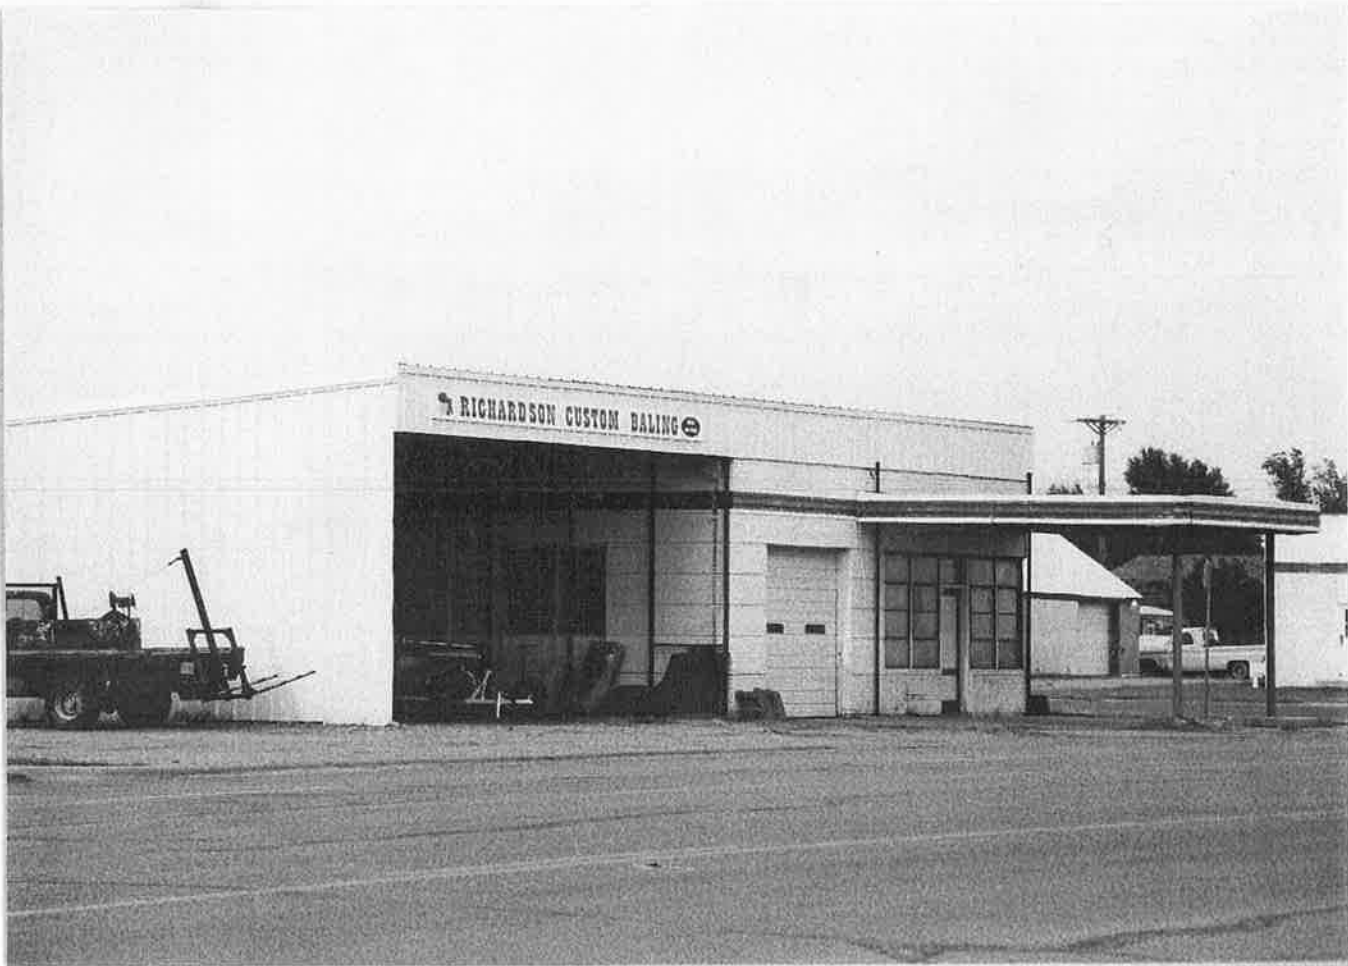
20 NE

Wall façade faired brick Foundation _____

Bay added to w. end Pump island is broken up.

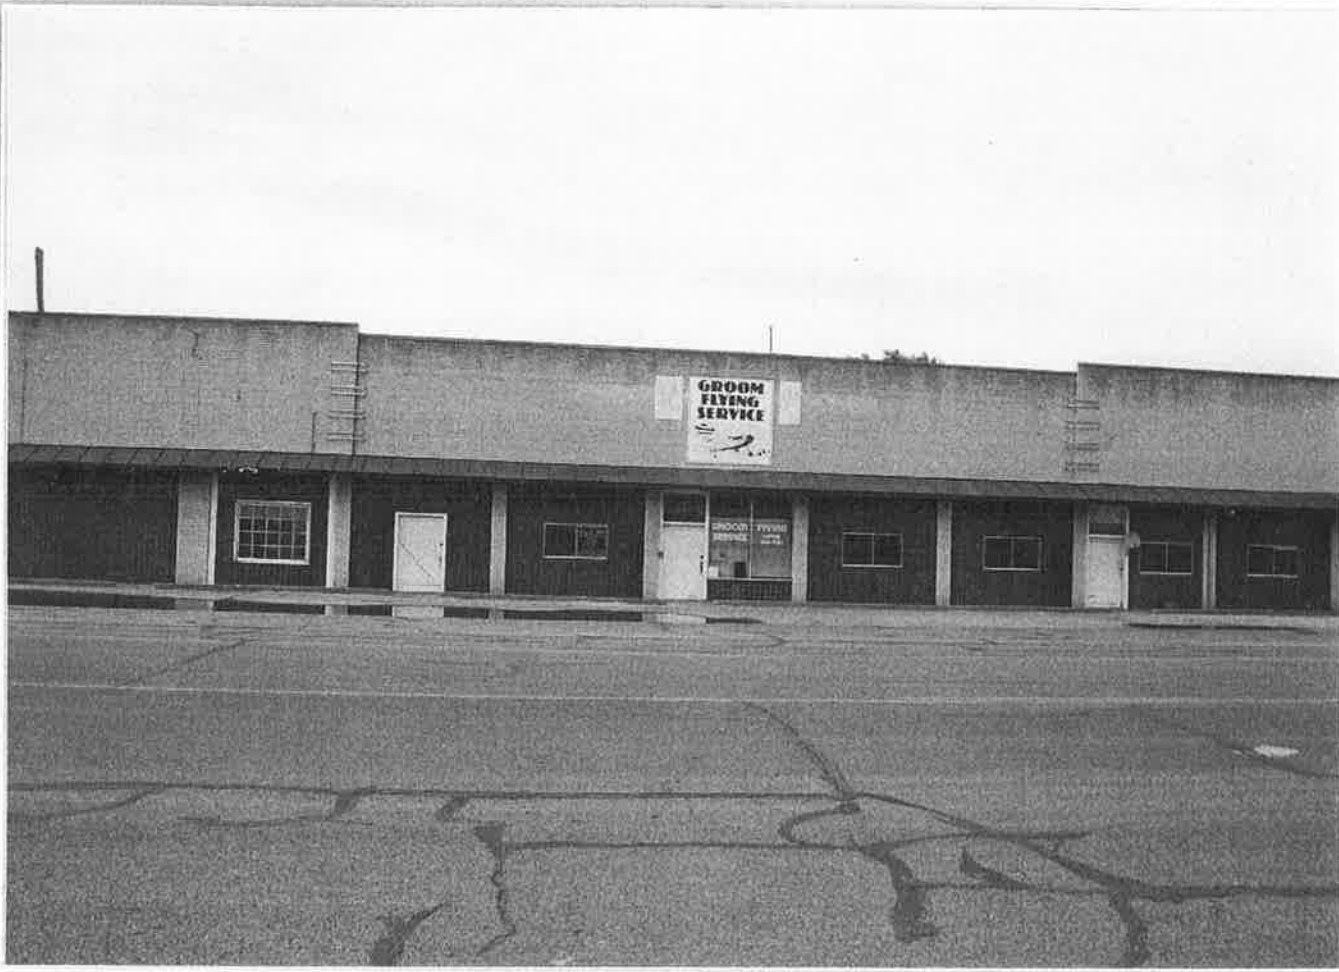
General Architectural Description commercial strip w/ 9 bays. Lower store front has been blocked in w/ corr metal siding. Metal sliding windows added. Center bay may be close to orig. mostly lit has glass ^{pane} panel wood door w/ transom above; 3 plate glass windows in metal frame though glass block added below. In Western bay (#3 if counting E to W) is metal casement — light. Trade awning, bldg is divided into 3 parts w/ ^{metal} bands accenting vertical joints. Bay #2 also has orig door w/ transom

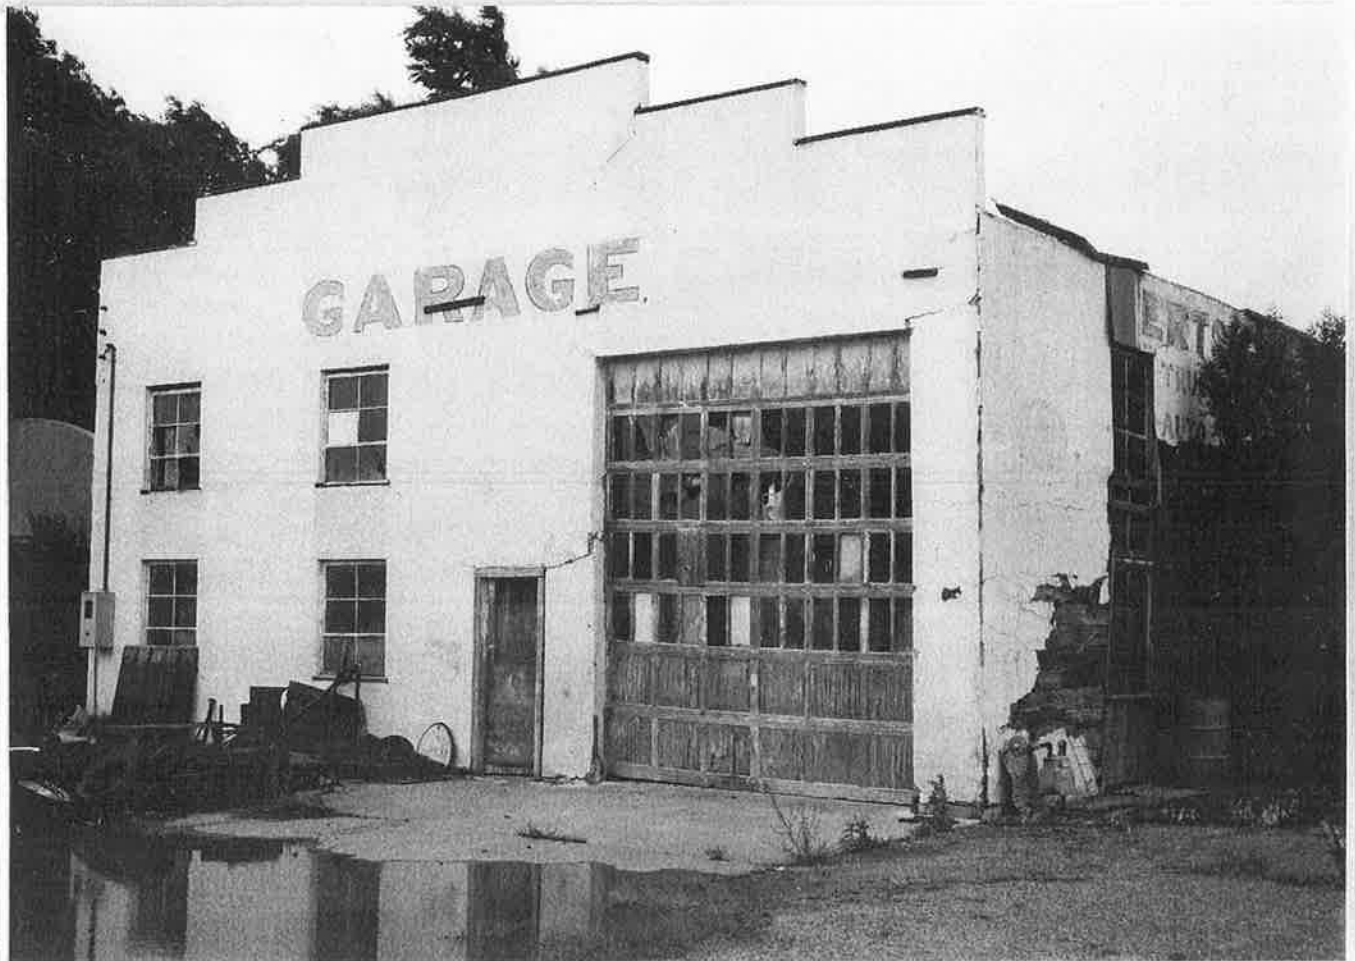
General Architectural Description lg garage w/ 2 story facade - behind gas station

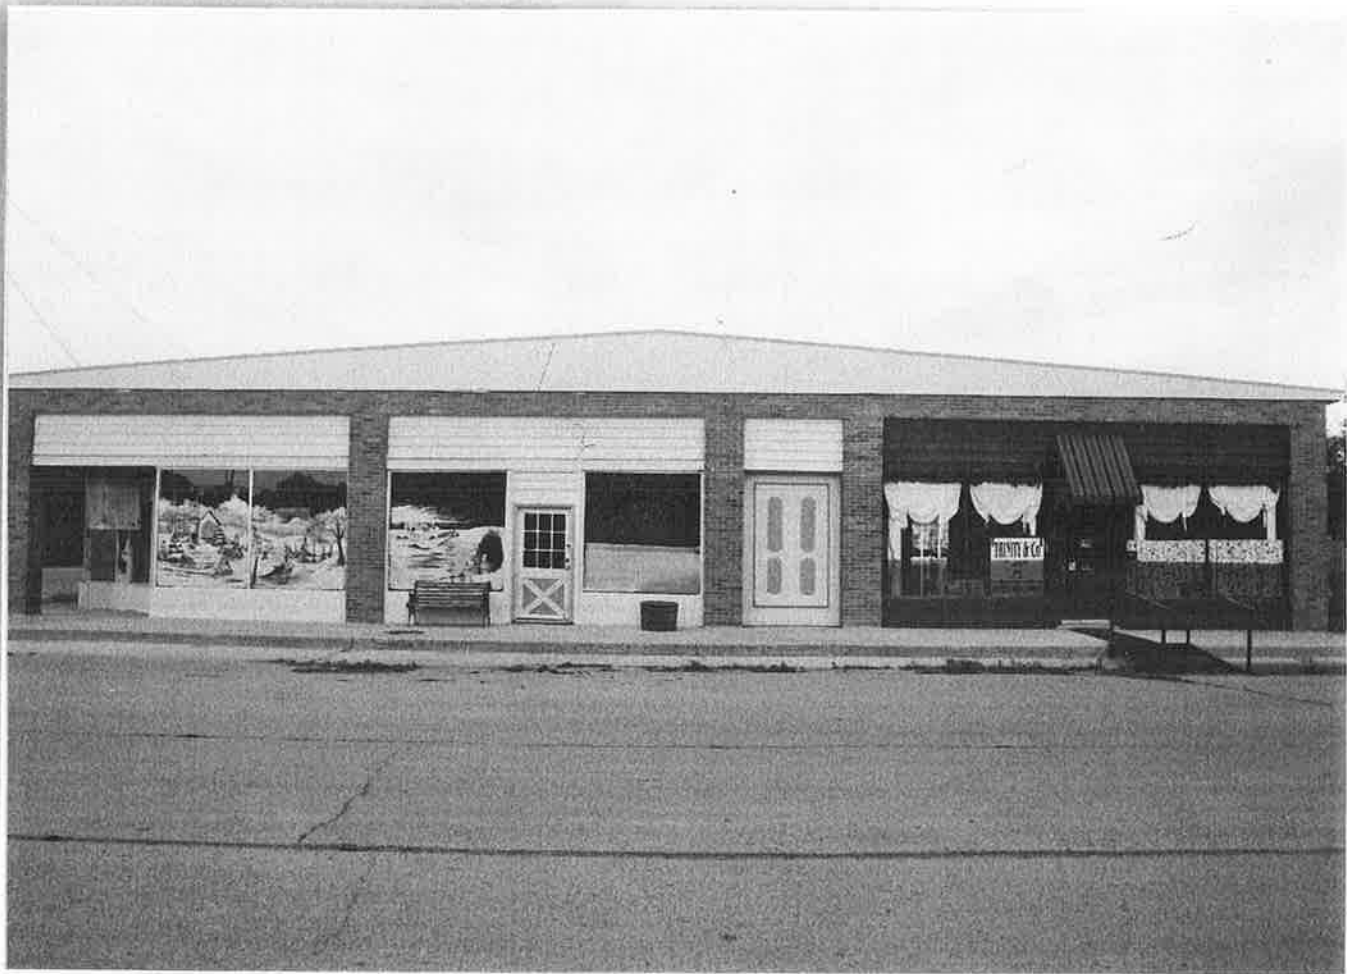
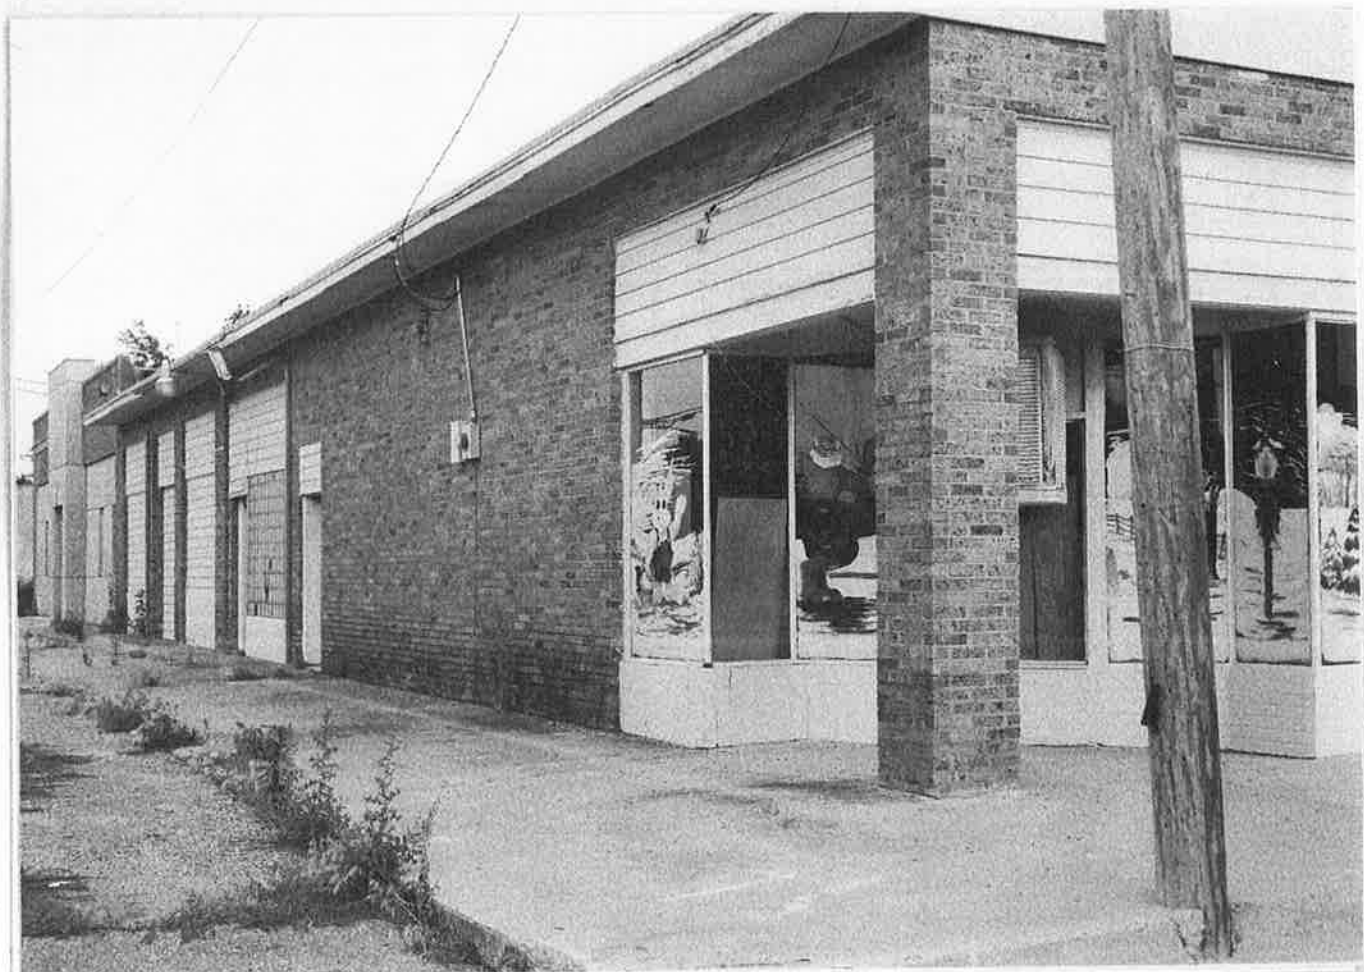
9 other look 5

Wall facade buff brick Foundation _____

General Architectural Description 4 bay facade - some store fronts have been replaced. NW corner is inset & chamfered w/ brick pize at corner. Looks like there was a door here. 4 large bays on N etc - either for cargo or overhead doors, now blocked. Attached to another building on this N etc.
