Historic Resources Survey Route 66 through Texas

Survey Materials

Carson County

Groom

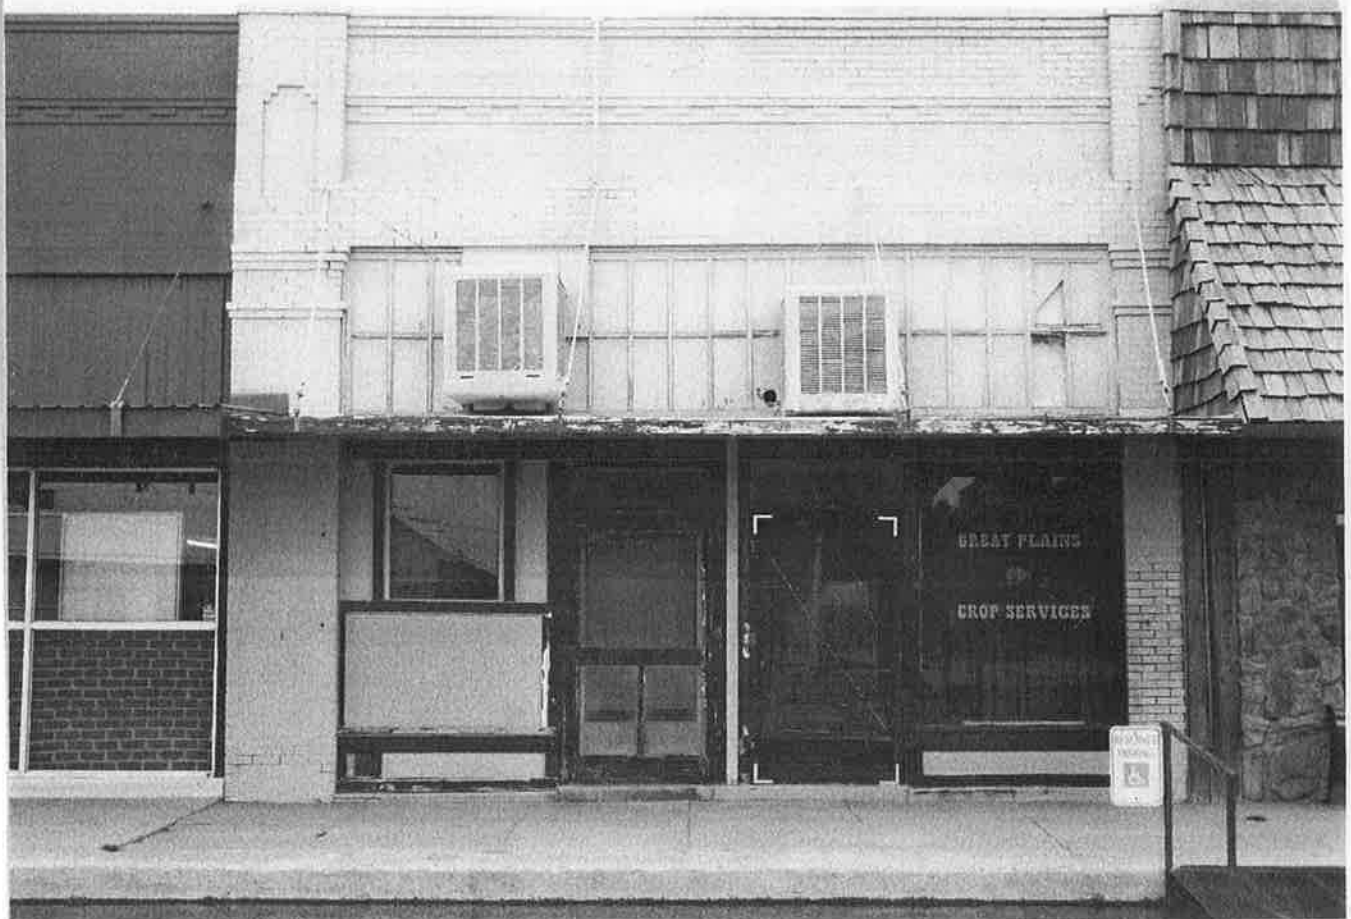
005-62-29
Photo 15-3769-5
Facing West

Wall facade Painted brick Foundation _____

Door type 2 doors side by side, obscured by Materials wood screens - looks like framed-glass, wood frame

Porch type flat awn. suspended on steel rods Materials w/ transom

General Architectural Description transoms above awning blocked in but opening is apparent. Decorative detail @ parapet including stripped-down cornice & dentils - A chevron-type detail is inset in pilasters

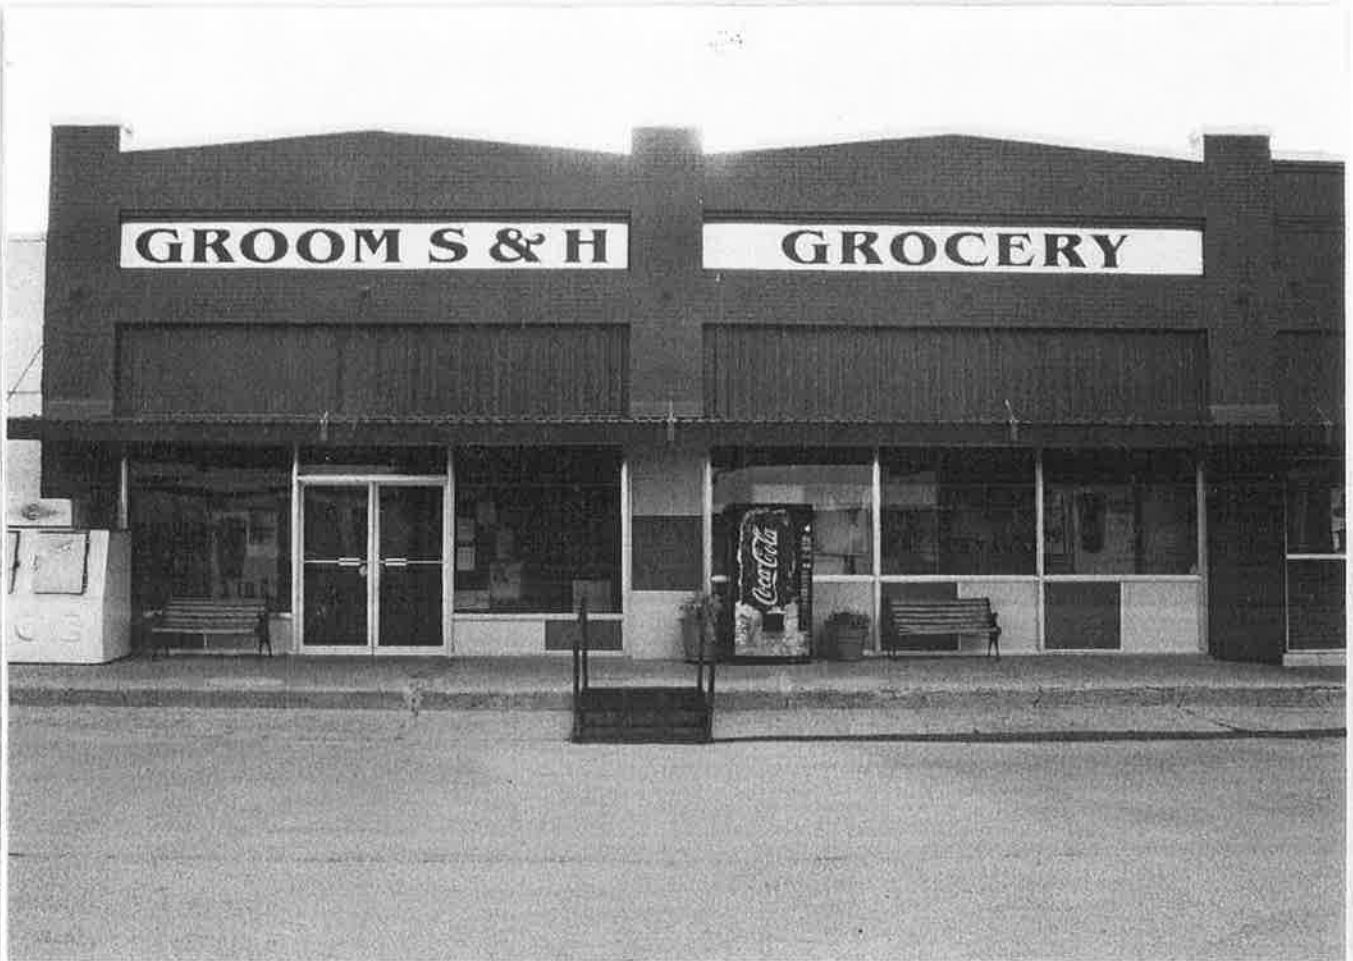
Photo Data: Roll 15 Frame _____ Feature 4 N Bay
3 2 South Bays

General Architectural Description 3 bays - North bay does not match other 2. It has flat parapet, stripped down classical cornice linear details. Transom above awning covered. Store front is metal cased painted like brick. Door blocked up. Southern 2 bays are of same bldg - ~~described above~~ flat roof w/ pitched parapet

painted brick facade; metal framed plate glass window & double doors (may glazed). Inset panel above transom on all 3 bays.

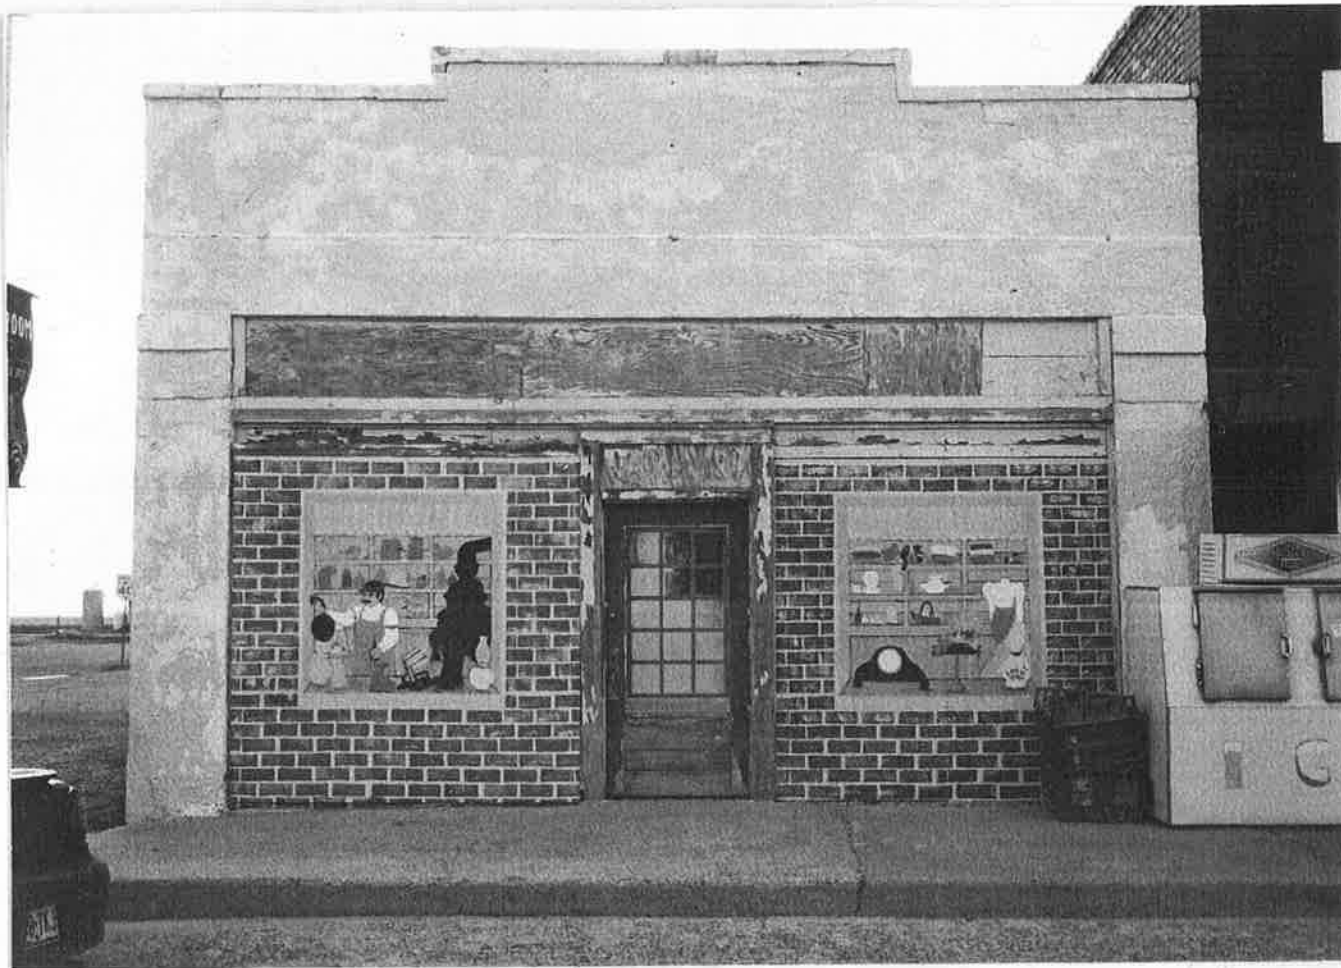
065-GR-31
 PHOTO 15-3769-2
 FACING WEST

Stylistic Influence(s) _____
 Roof type 1/2 striped parapet Materials _____
 Wall facade stucco, store front boarded w/ ply & painted to look like brick & door Foundation _____
 Window type boarded Materials _____
 Door type boarded Materials _____
 Porch type N/A Materials _____
 Number of Stories 1 Plan _____
 Chimney(s) _____

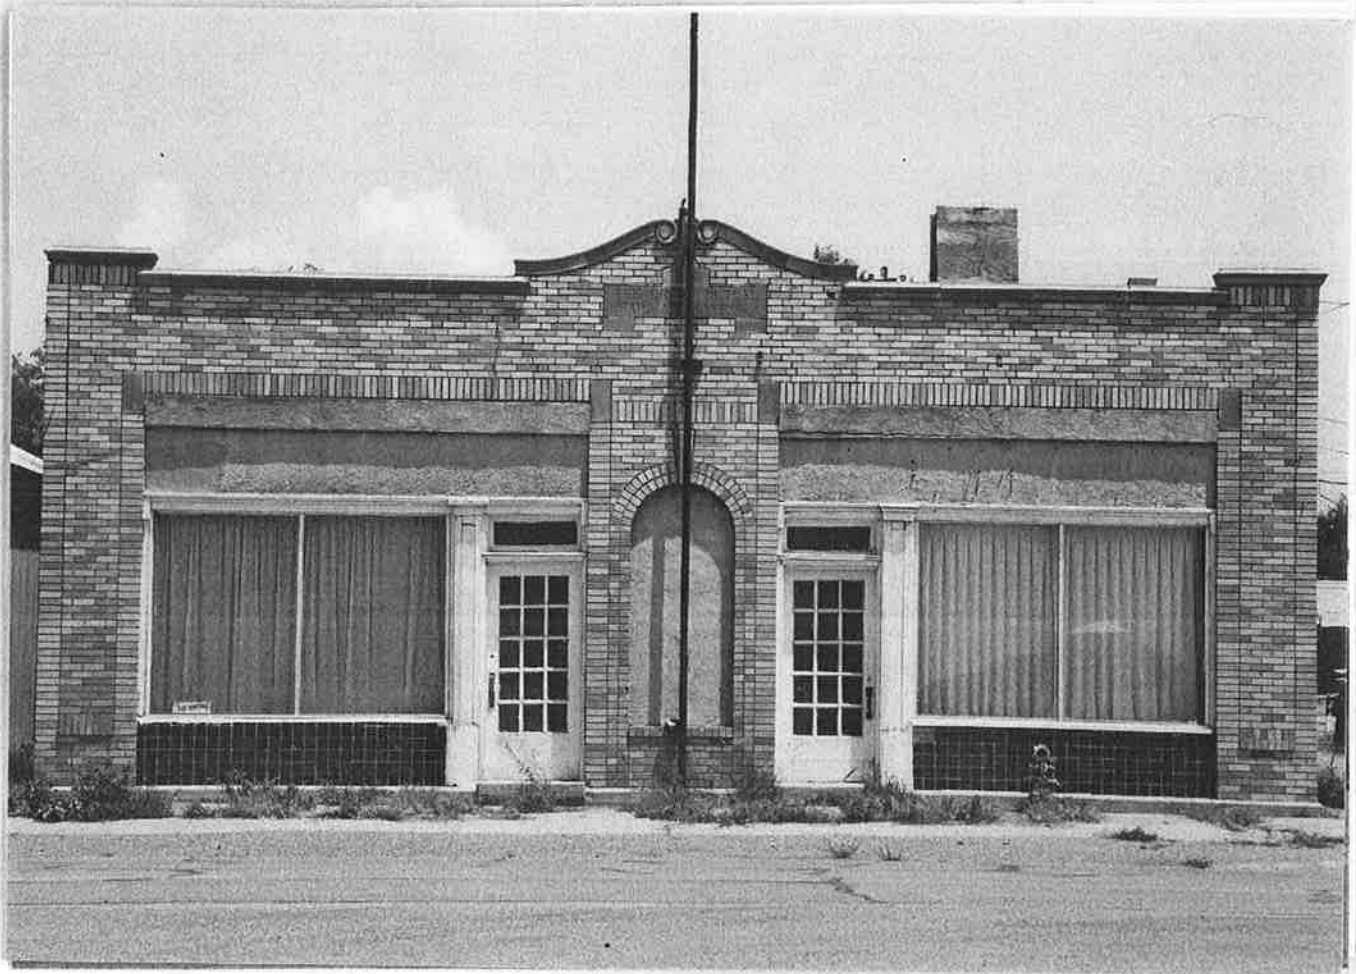
Photo Data: Roll 15 Frame 1 Feature _____

Roof type w/ scrolled parapet Materials _____

Wall facade buff brick / tile info below windows Foundation _____

Window type plate glass in wood frame Materials transoms above stuccoed over

General Architectural Description Beautiful detail (molding & scroll) at parapet. Arched non b/c 2 story fronts.

1 part cornice block div into 2 bays by brick pilasters.

MS&T CONC plaque @ granite base says 'Groom Mut of Hail Association'

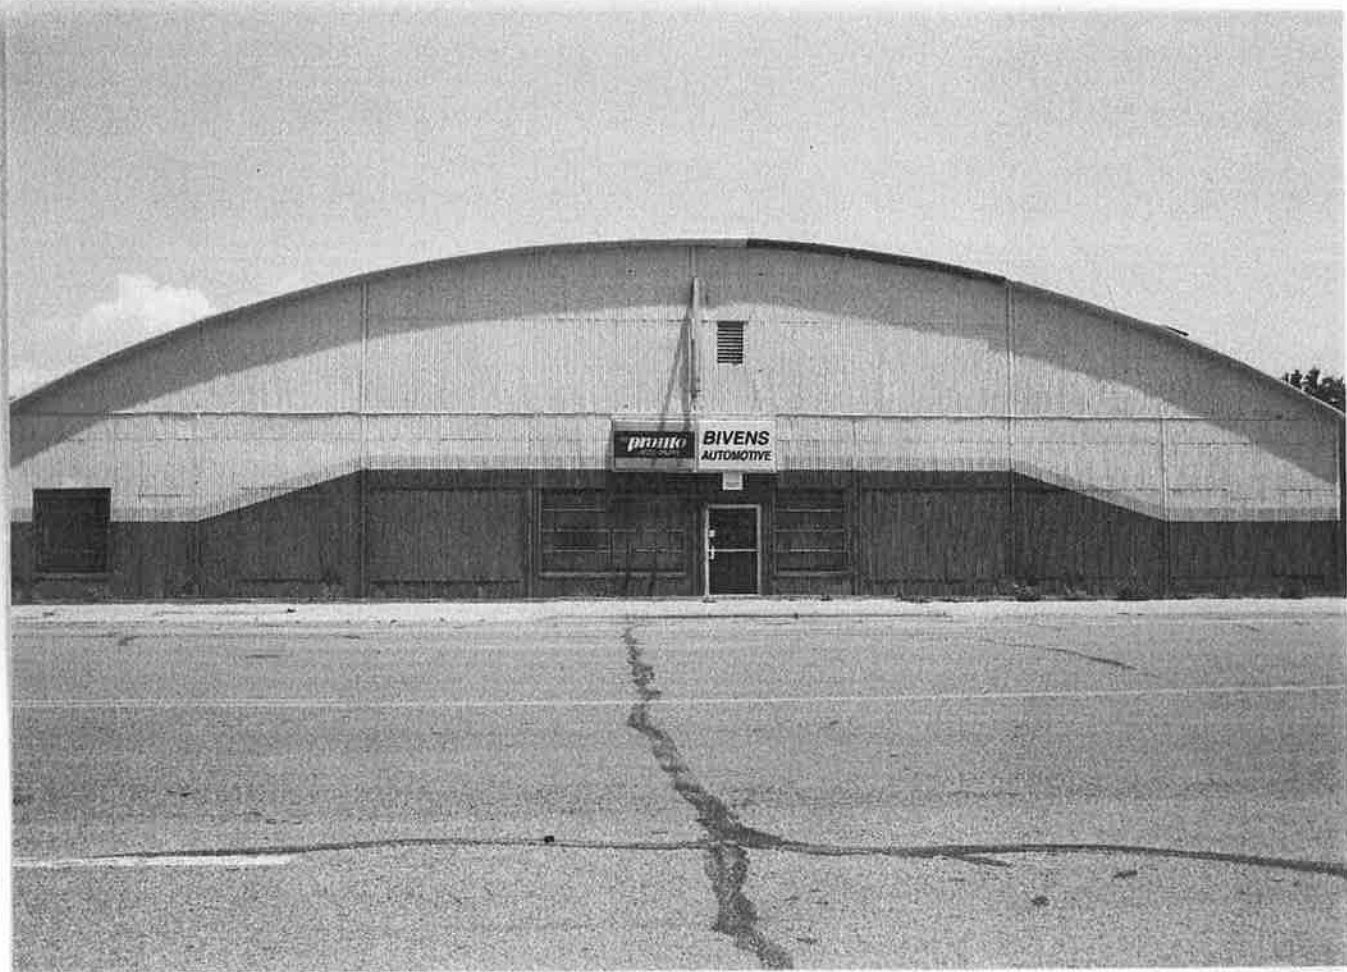
065-GR-33
PHOTO 16-3752-34
FACING NORTH

Window type 20 light metal casement Materials _____

Door type central; fully glazed in metal frame Materials _____

General Architectural Description corr metal quarter hut

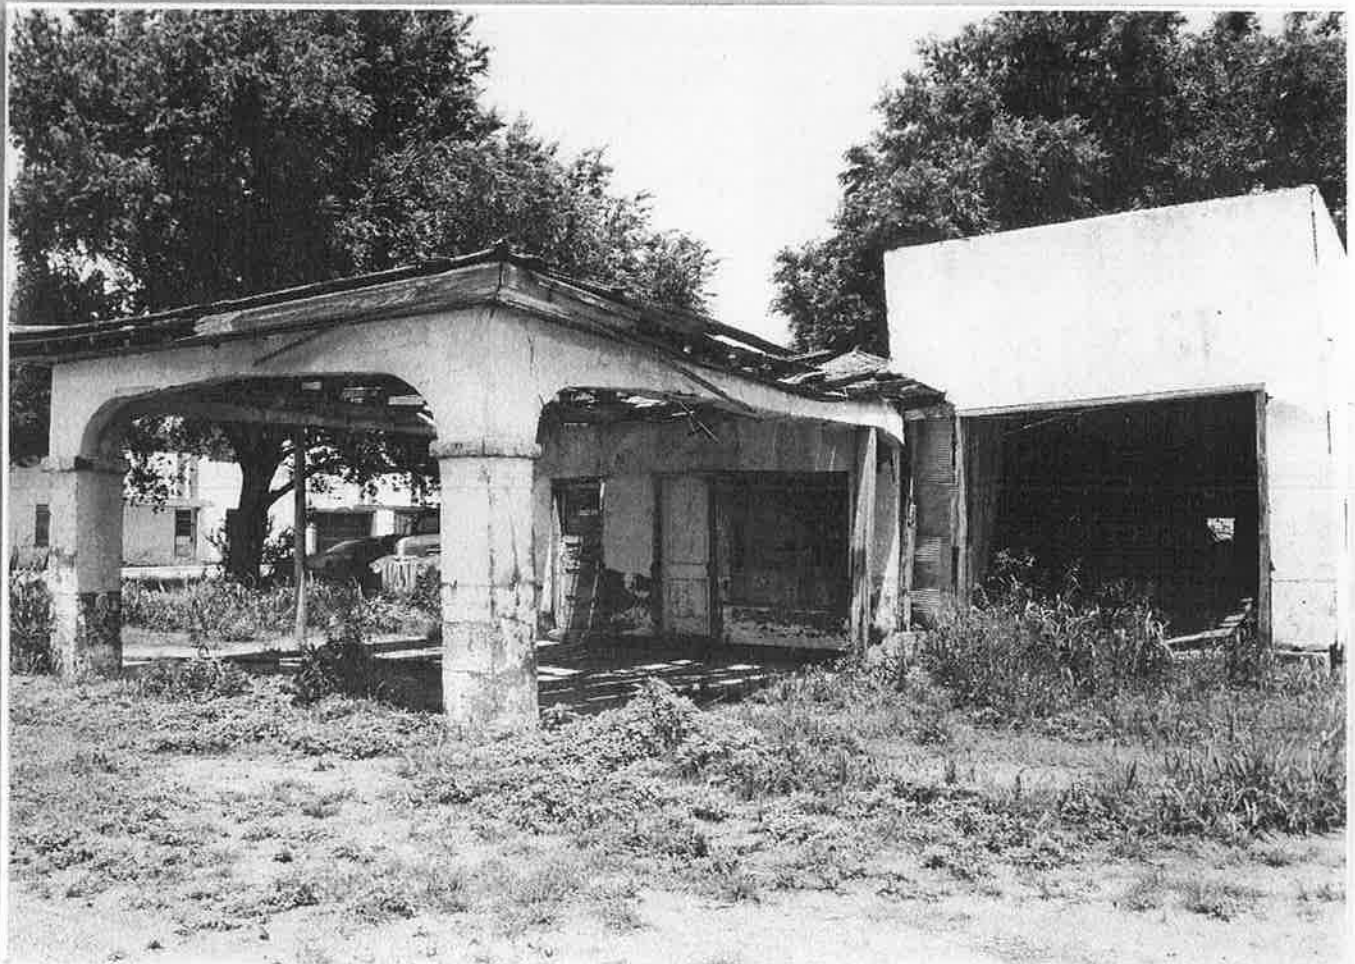
Photo Data: Roll 16 Frame _____ Feature 33 overall oblique look NE

Roof type flat w/ parapet Materials _____

Wall facade stucco Foundation _____

Window type wood frame - boarded up Materials _____

Door type 2 main doors, both wood panel in wood frame Materials overhead - data missing

Porch type canopy supported on stuccoed piers Materials wood frame, flat

General Architectural Description typical gas garage config; outline of pump island
v. side. though lot is overgrown. Details 5 paint match adjacent
66 Courts Motel - canopy piers have collar at 2/3 height
Canopy has rounded openings. In entry on W side - door in this
shed - rat entry portico

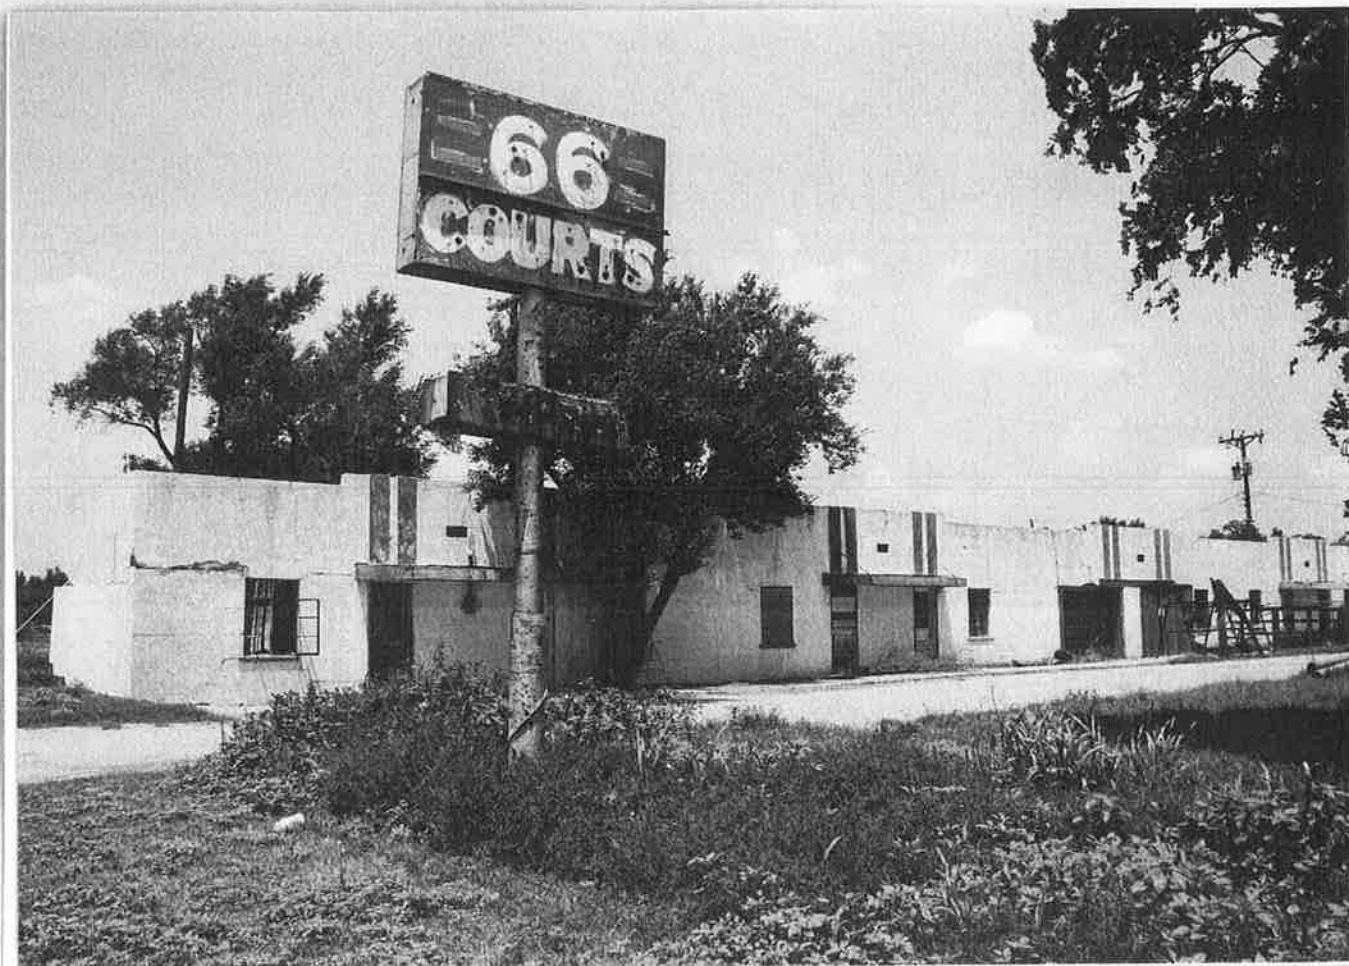
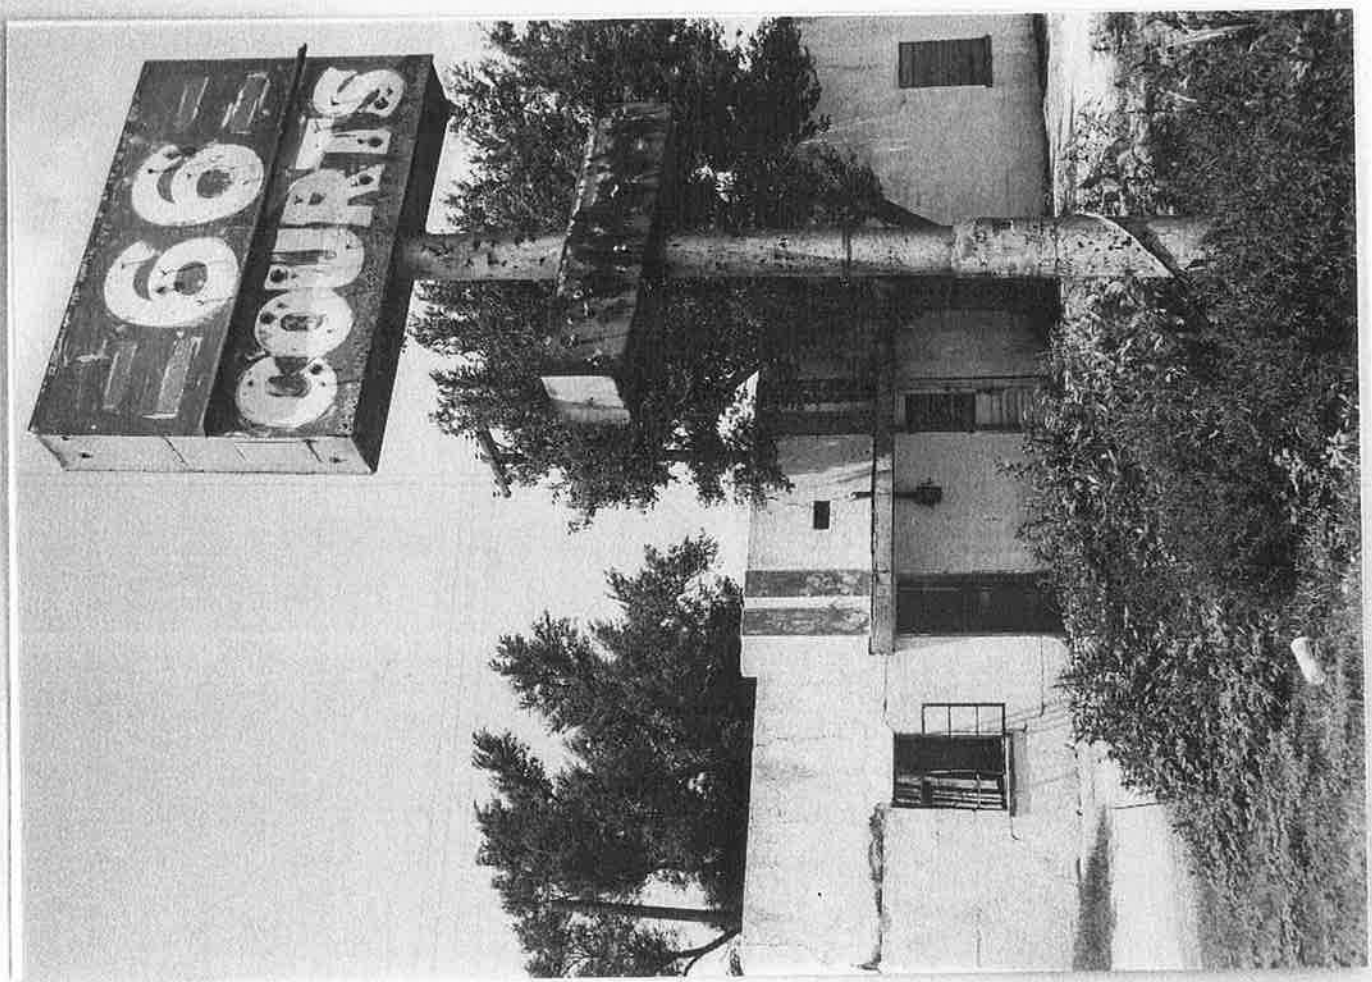
| Photo Data: Roll | Frame | Feature | |
|---|---|---|---|
| | | | <u>29 sign detail look <input checked="" type="checkbox"/></u> |

Stylistic Influence(s) _____
 Roof type shed w/ 1 step parapet over unit doors Materials _____
 Wall facade stucco Foundation _____
 Window type 8 light metal casement Materials _____
 Door type 3 horiz. l. st. over 3 wood panel, wood frame Materials 2 garage doors (wood panel) @ NW
 Porch type small hood over each set of doors (hood extends over) Materials 2 doors supported on metal rods. Has rounded corners
 Number of Stories _____ Plan linch
 Chimney(s) _____

General Architectural Description approx 6 units, possibly had 8 at one time but 2 now have garage door bays. Inlaid vertical wood planks provide detail above hood w/ for stepped parapet. No evidence of other units or office, though gas station adjacent may have been part of this complex. Poor condition, but great resource.

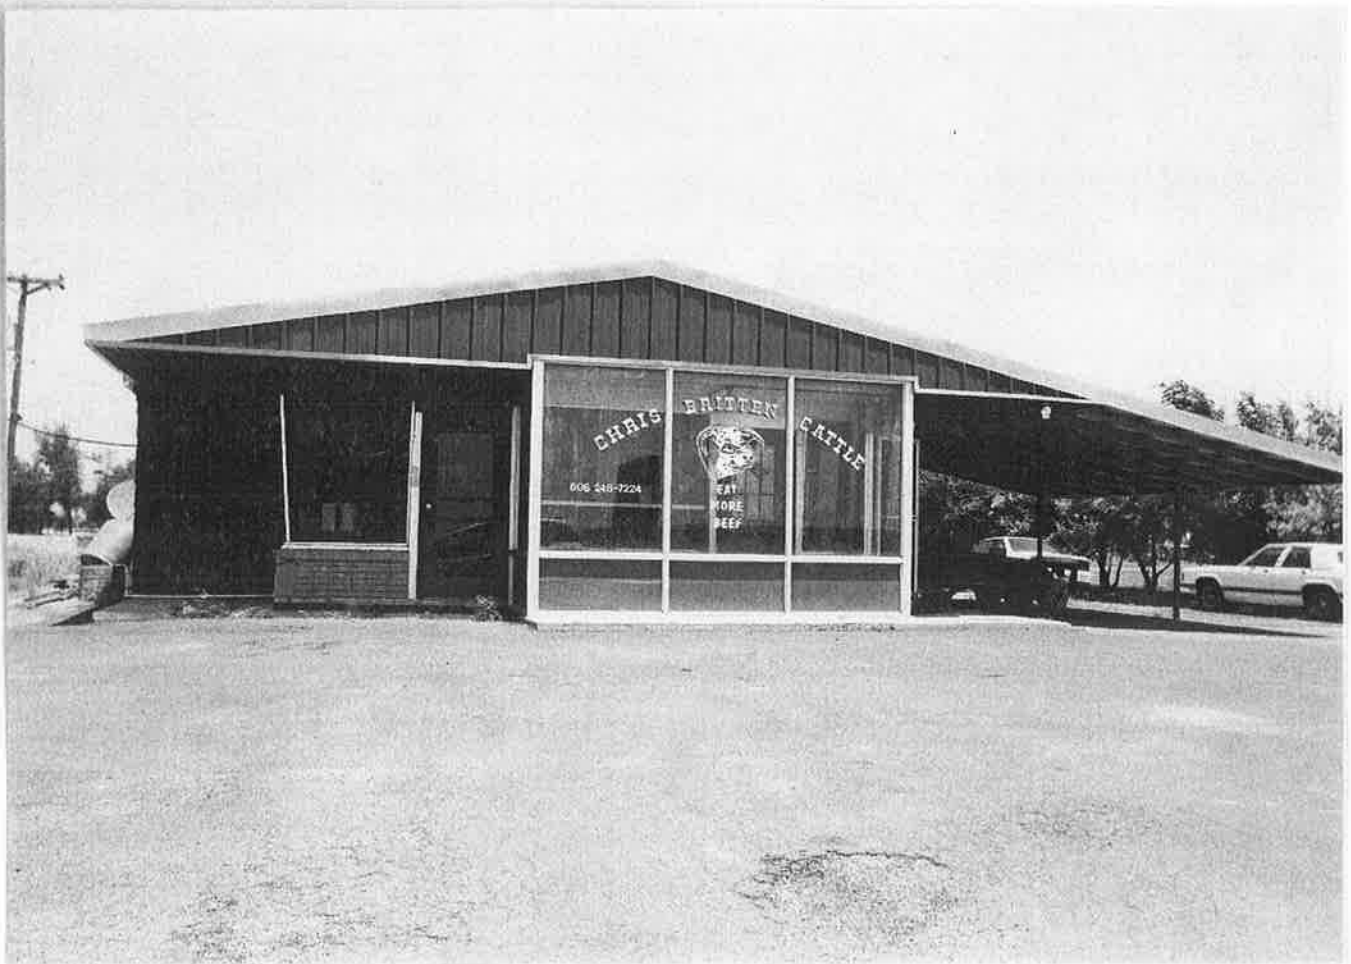
Photo Data: Roll 16 Frame _____ Feature 28 overall, look N

Stylistic Influence(s) drive-in restaurant

Roof type from gable; corr metal Materials _____

Wall facade horiz slip lap w/ plate glass on W; buff brick on E & rear Foundation _____

Window type metal frame plate glass - w/ Materials angled bays

Porch type extending eaves; carport added to Materials E side (supported on steel posts)

General Architectural Description Original bldg apparent although glass-encased entry has been added to front (S. side); roofline altered w/ carport added. But original window bays (tilted plate glass in metal frame w/ brick below) are still visible.

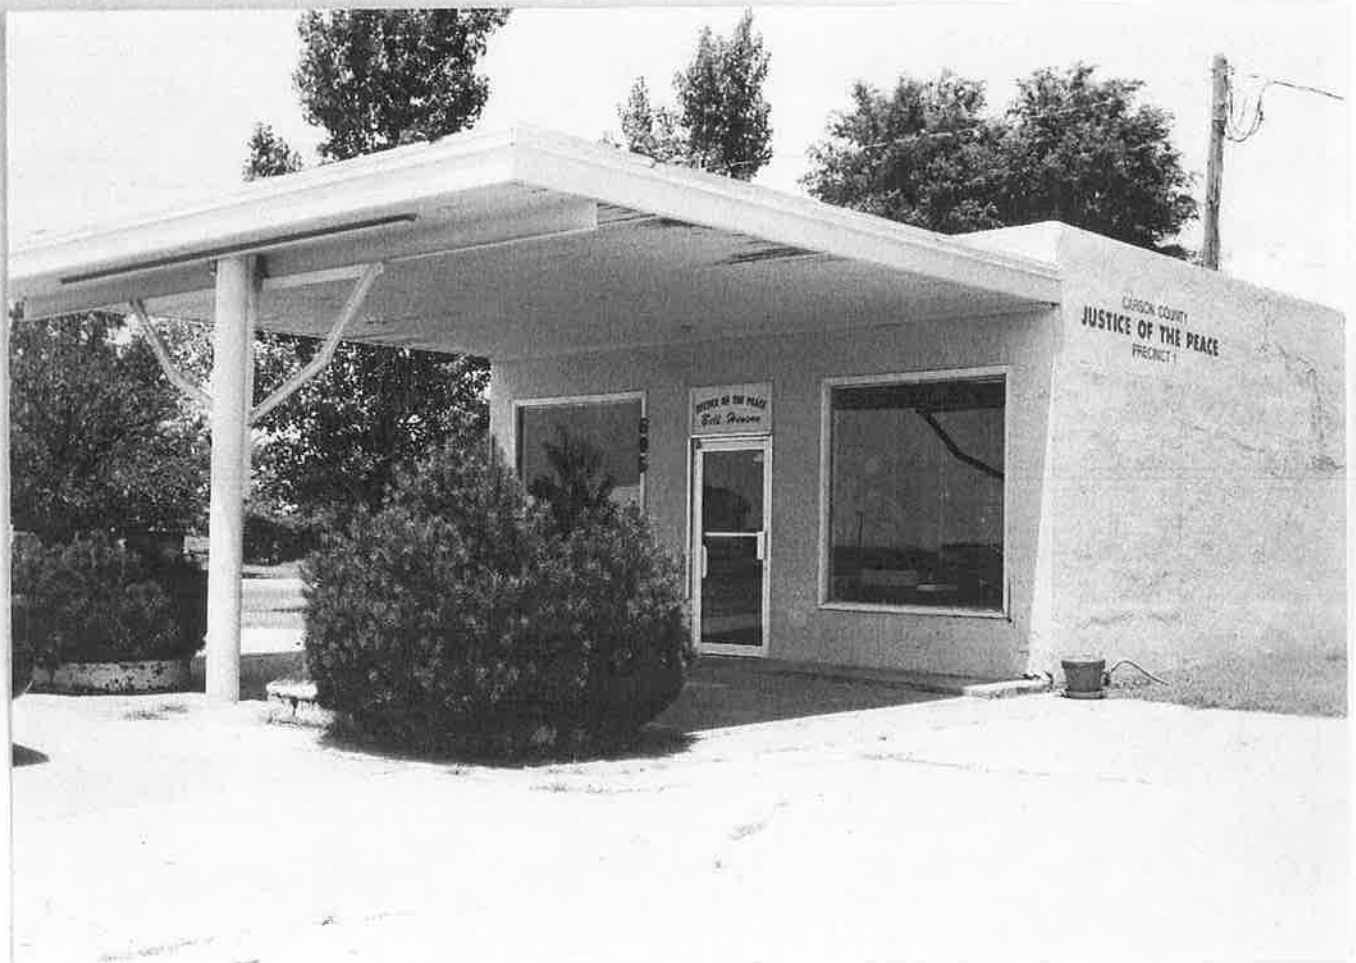
065-62-37
PHOTO 16-3752-27
FACING NW

Roof type flat w/ parapet Materials _____

Wall facade stucco Foundation _____

Porch type canopy supported on one steel column Materials has Y brackets attached to column

General Architectural Description small filling station w/ 2 pump islands.

Canopy has beaded board siding. Post column Y brackets prob. not original.

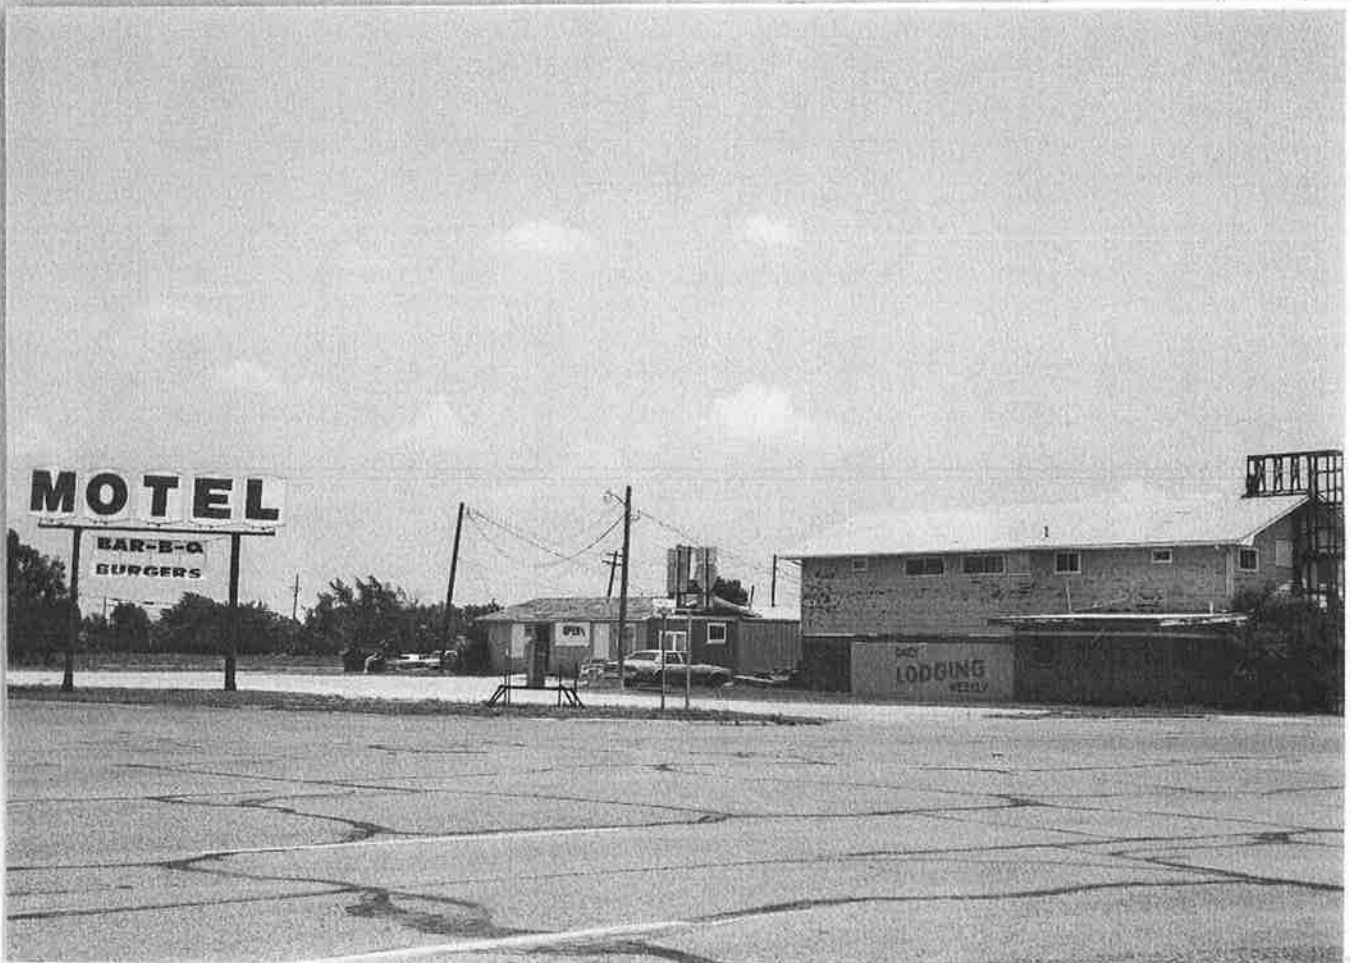
Photo Data: Roll 16 Frame _____ Feature 26 office look W

Roof type side gable, corr shingle - (both office & units) Materials _____

Wall facade red brick, 2nd story of offices has brick Foundation synth siding

Window type office: plate in metal frame - Units = pair of 2/2 meter sash Materials _____

Door type office - frame glass in cast frame; units Materials solid metal

Porch type porte cochere extends from office to the E Materials supported on concrete arrow picks

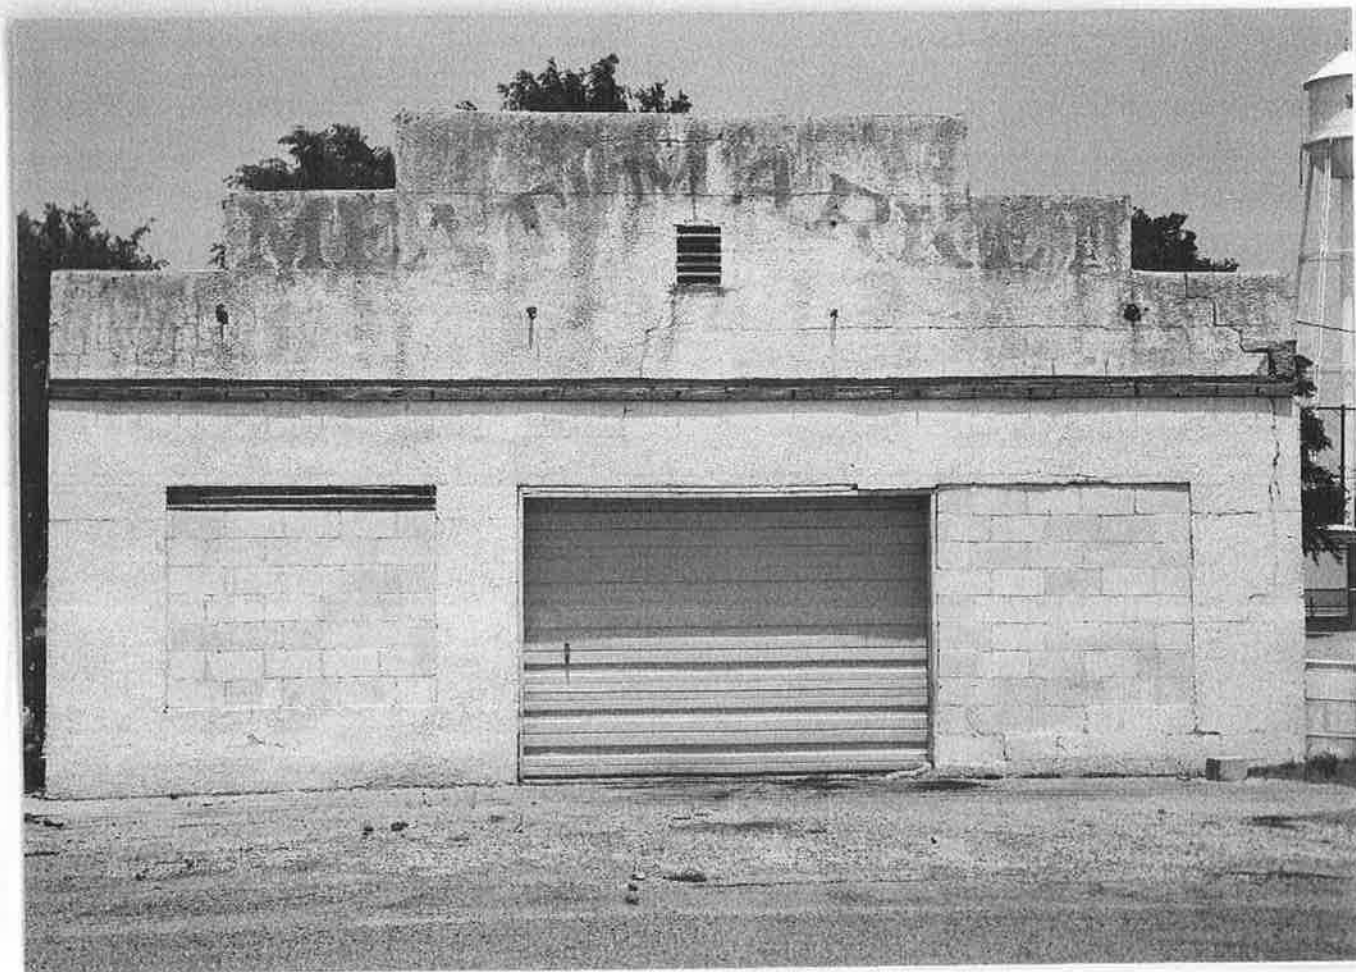
Roof type front gable w/ stepped parapet; corr metal

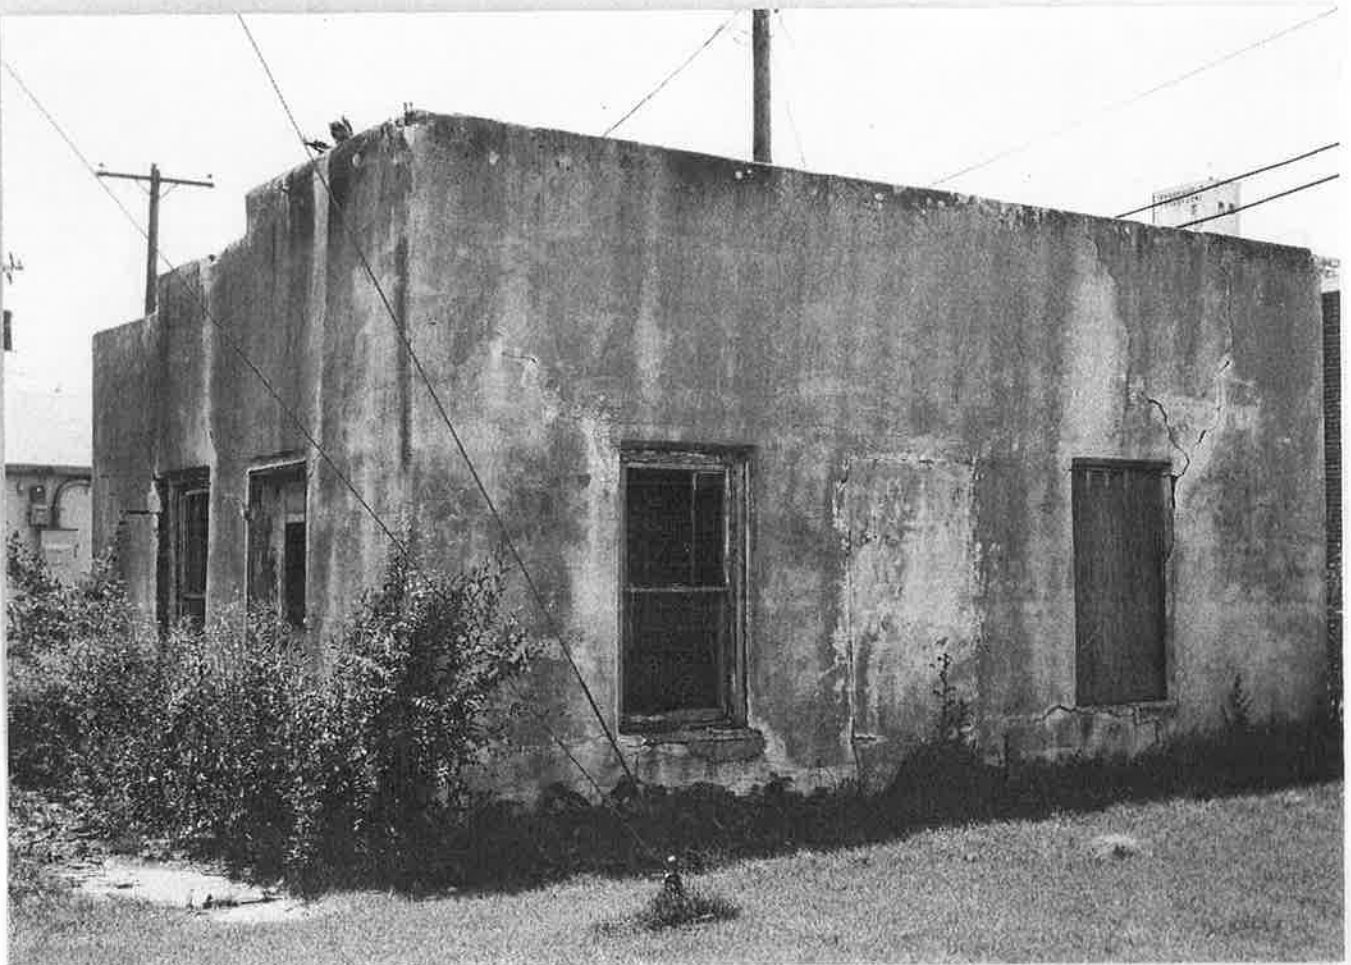
Roof type wt flat parapet Materials _____

Wall facade stucco (profile is stepped) Foundation _____

Window type wood frame / glass missing Materials _____

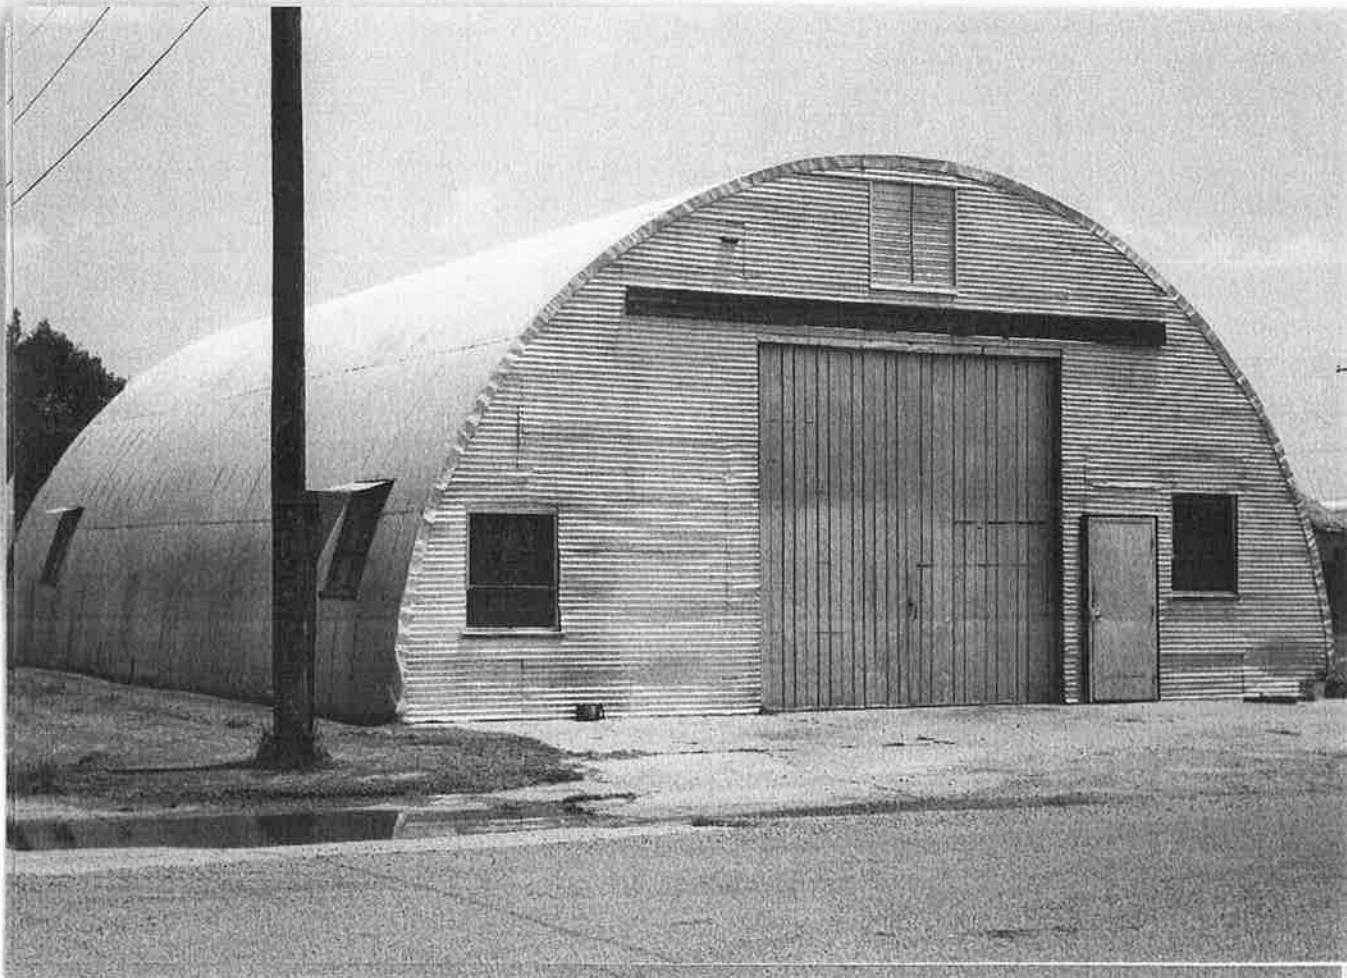
Roof type QUONSET Materials _____

Wall facade horiz corr metal Foundation _____

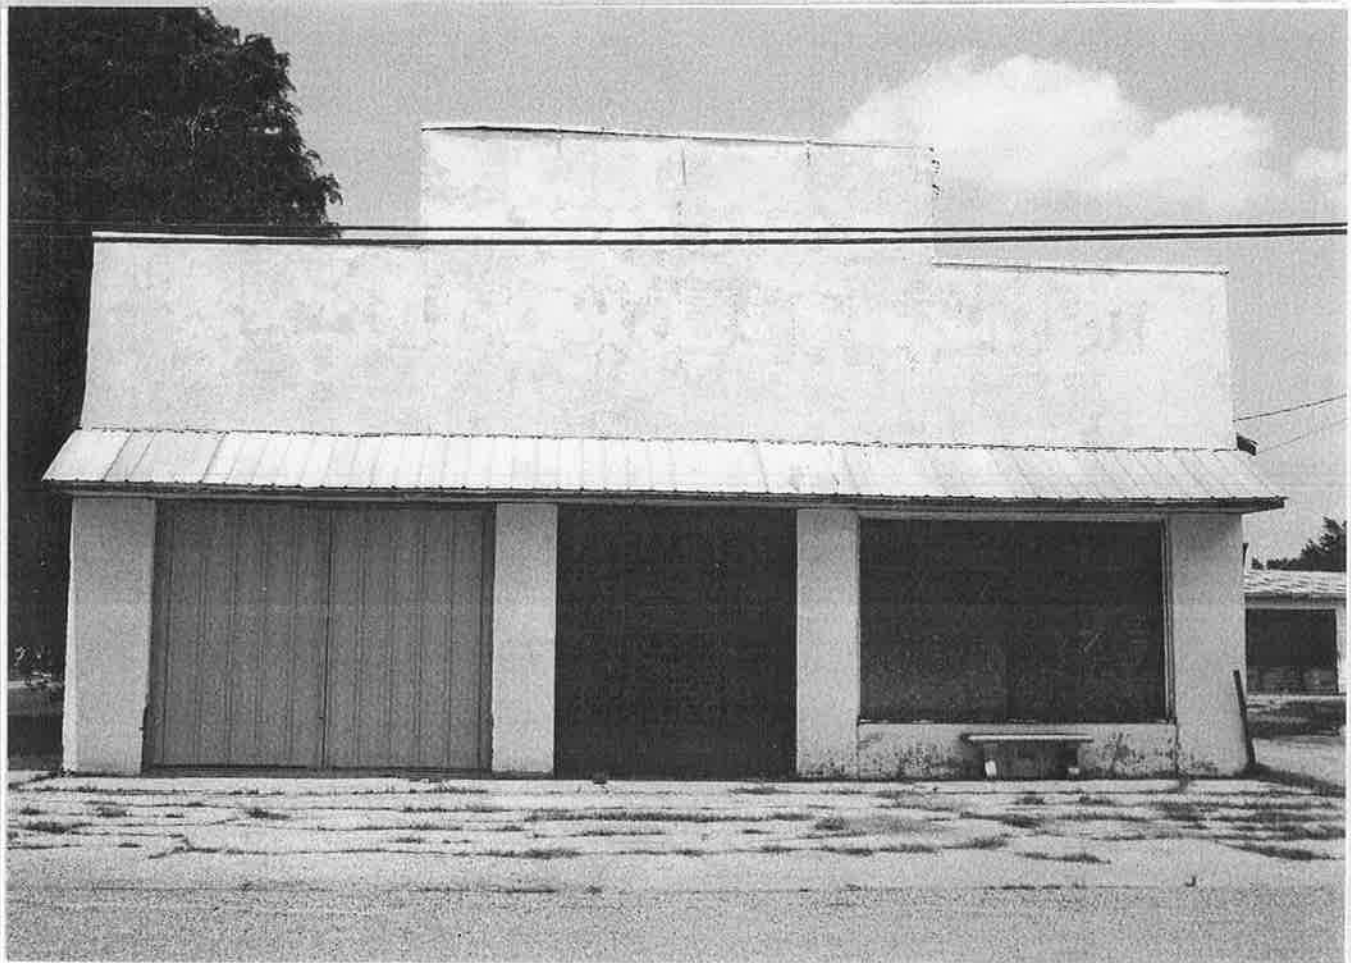
Photo Data: Roll 16 Frame _____ Feature 15 lot N
14 side bldgs, face W

Stylistic Influence(s) _____
 Roof type front gable w/ stepped parapet, corr. metal Materials _____
 Wall facade stucco Foundation _____
 Window type front boarded, sides have 4-light hoppers Materials _____
 Door type 3ly glazed over panel wood frame w/ transom Materials side lights; 1 over head bay, blocked
 Porch type shed awning, no supports, roofed w/ corr metal Materials _____
 Number of Stories _____ Plan _____
 Chimney(s) _____

General Architectural Description Some ghosting vaguely discernible of S. facade - can't read it. May have been lumber/hardware store. Main bldg is part of a U complex - wings are side gable w/ exposed rafter ends, shingles of comp wood shingles & some corr metal. Front of these wings face inward to a courtyard - are open w/ storage compartments (like a lumber yard). Rear faces 1st - stucco w/ 1 main door & 1 window.

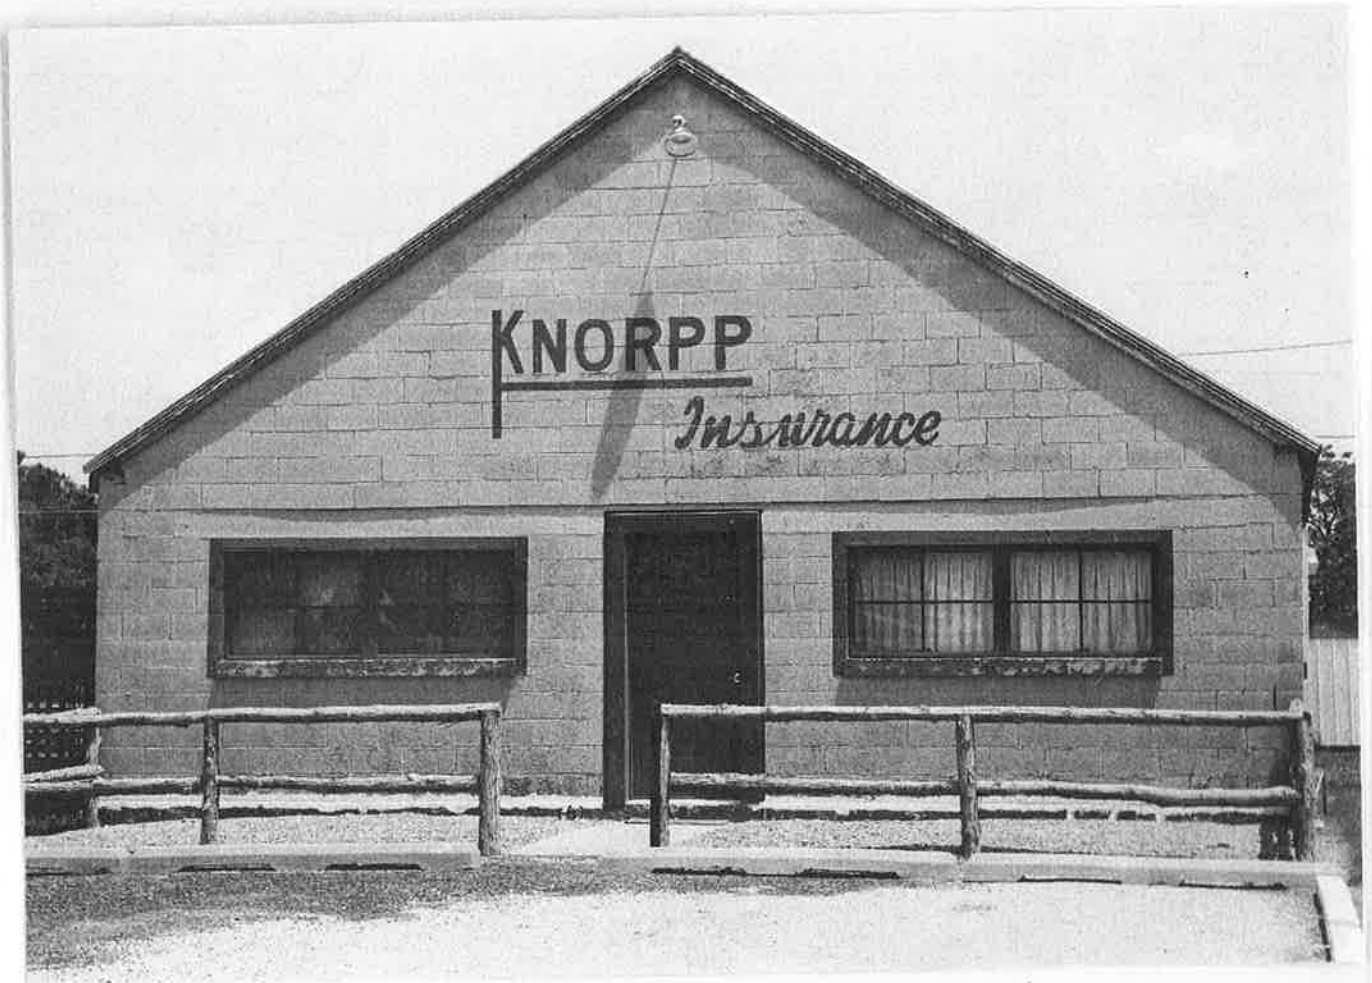
Stylistic Influence(s) _____
 Roof type front gable; corr metal Materials _____
 Wall facade painted conc block Foundation _____
 Window type pairs of divided-light (4 panes) in Materials wood frame - hopper style?
 Door type solid Materials _____
 Porch type N/A Materials _____
 Number of Stories 1 1/2 Plan _____
 Chimney(s) NA
