Historic Resources Survey Route 66 through Texas

Survey Materials

Carson County

Groom

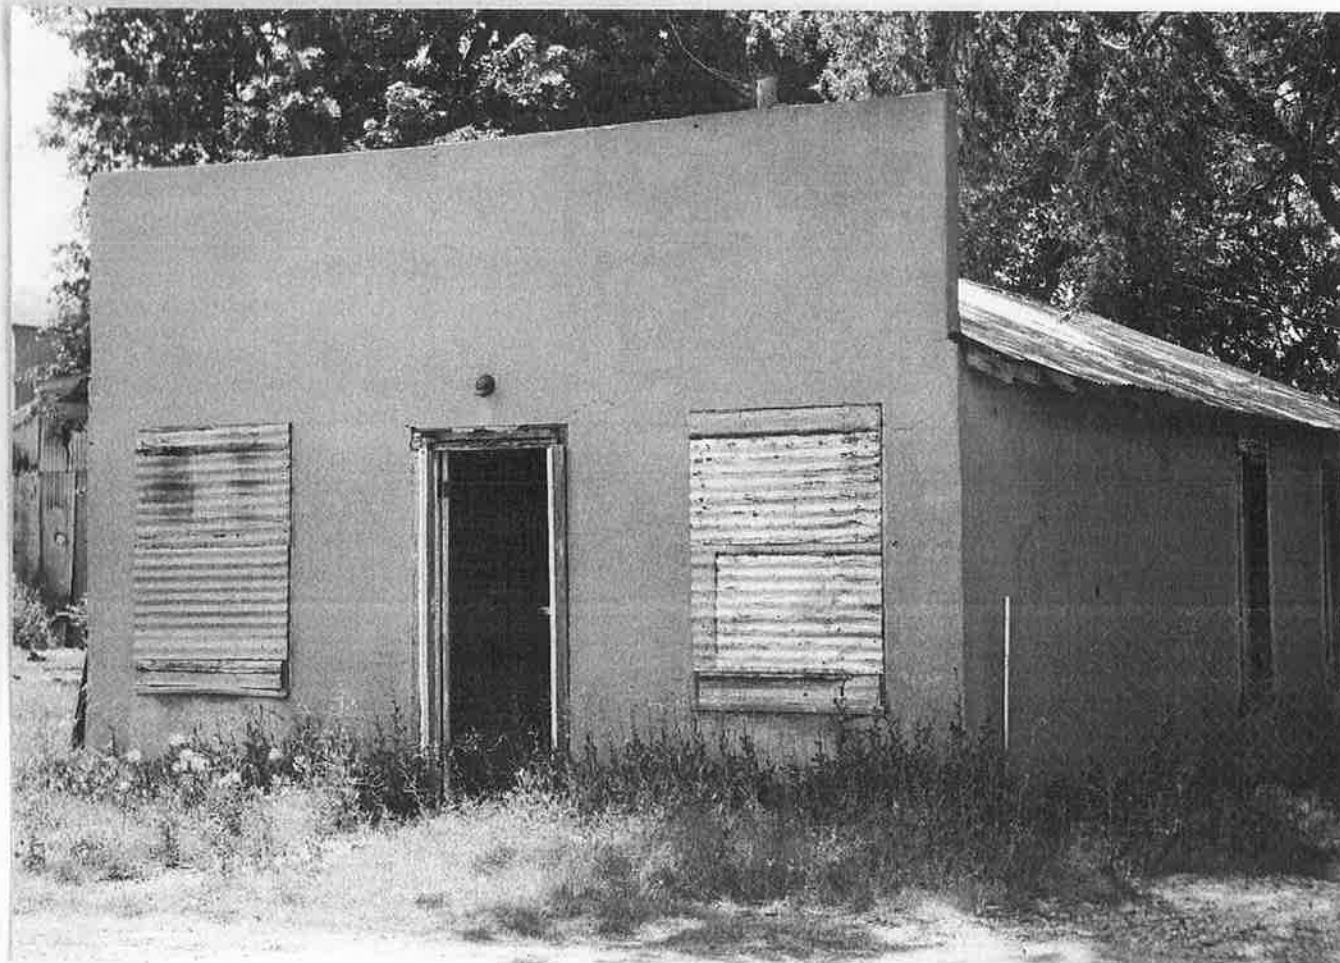
Stylistic Influence(s) afcd. front
 Roof type front gable w/ parapet; corr metal Materials _____
 Wall facade stucco Foundation _____
 Window type wood frame - though boarded Materials _____
 Door type wood panel Materials _____
 Porch type N/A Materials _____
 Number of Stories _____ Plan _____
 Chimney(s) _____

General Architectural Description commercial bldg; usage unclear.

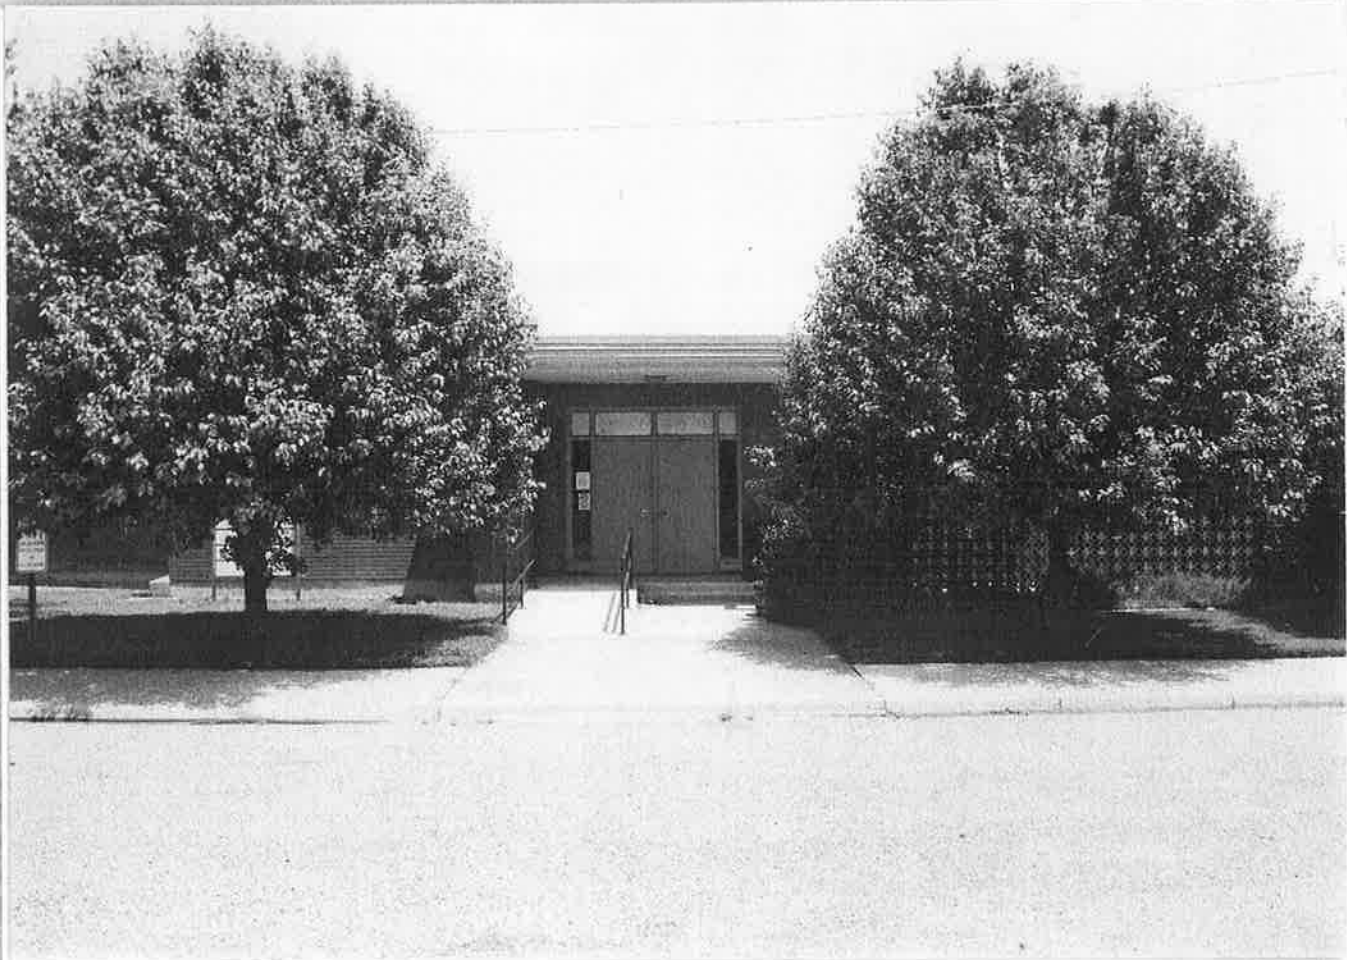
Photo Data: Roll 16 Frame _____ Feature 12 look E

Wall facade red brick Foundation _____

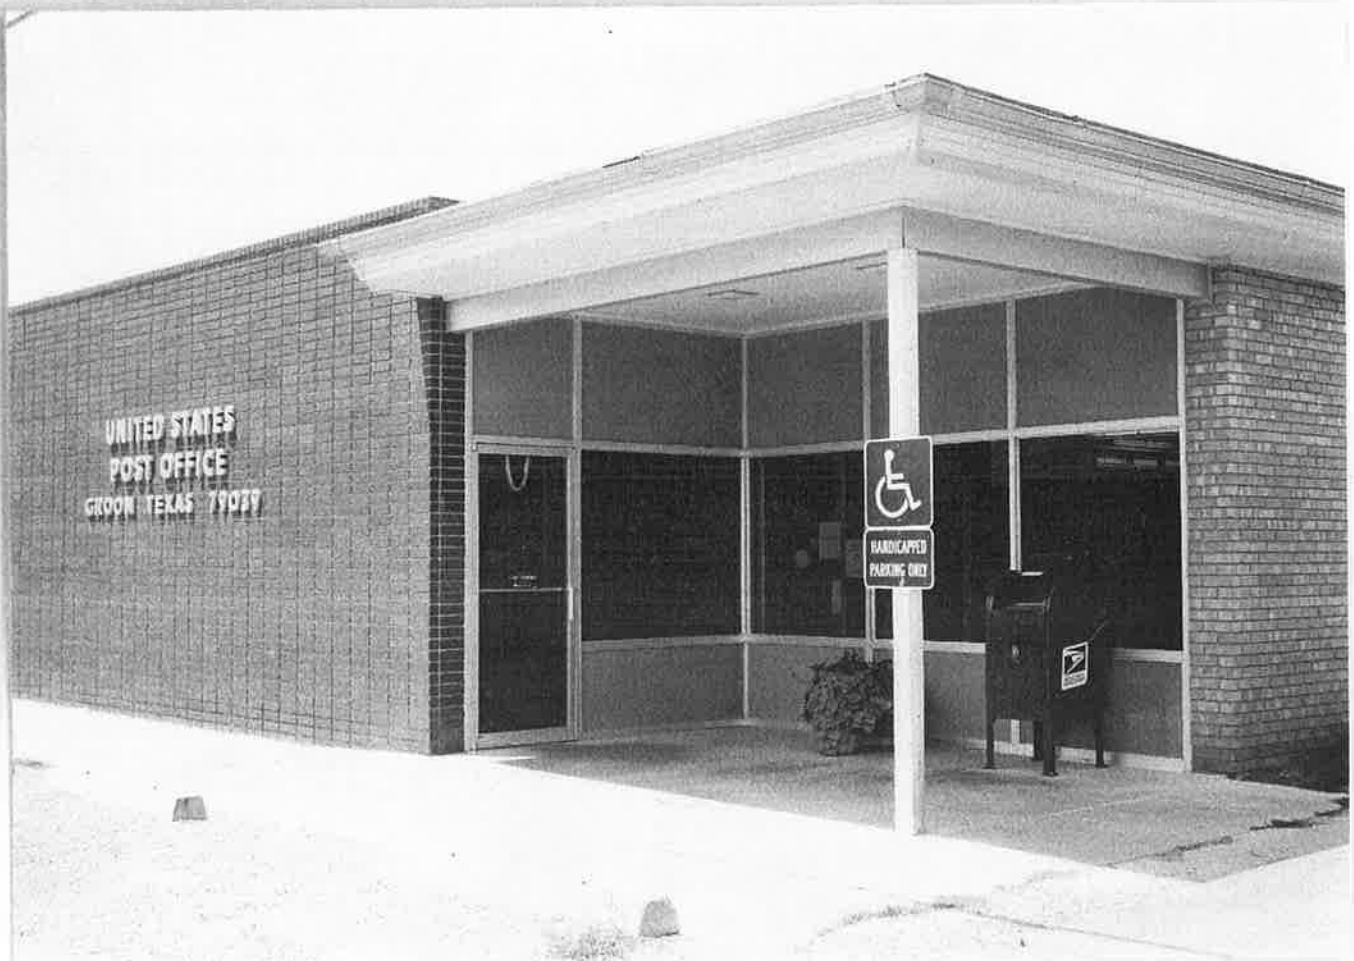
Roof type flat Materials _____

Wall facade front: brown brick & flat glass; sides - red brick Foundation _____
