Historic Resources Survey

Route 66 through Texas

Survey Materials

Wheeler County

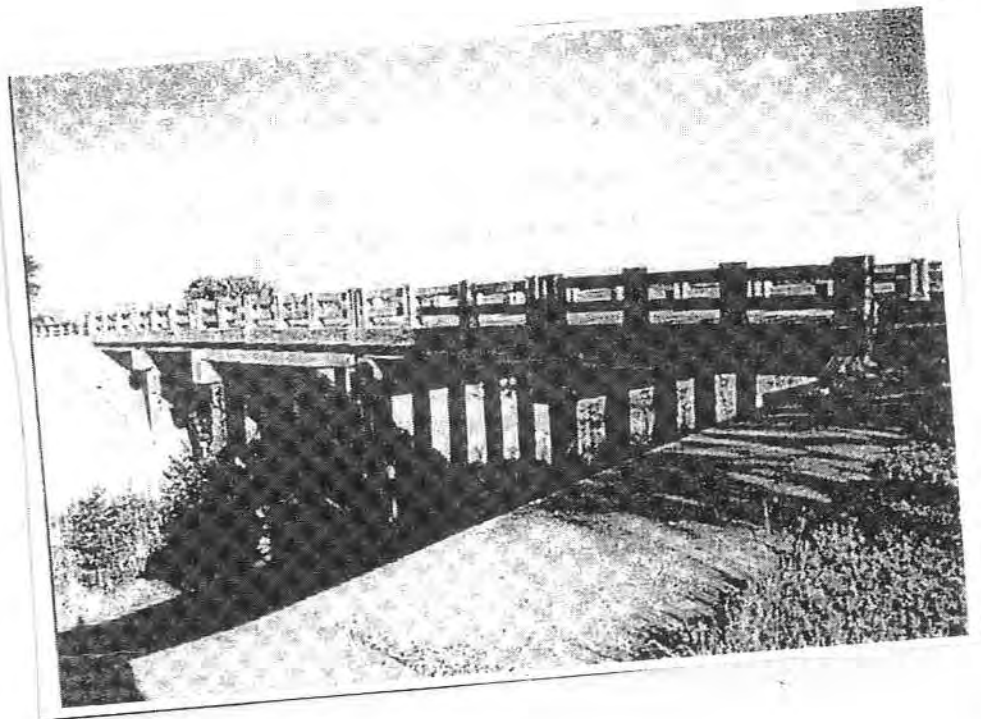
County Wheeler City RURAL Inventory # 483-RV-1

General Architectural Description conc frame bridge
See TX DOT files for more information

conc. encased steel I-beams; Steel beam structure.
126' in length, 5 spans

This five-span overpass is located on the original alignment of SH 75 and later US 66, in Wheeler County. The 128' long bridge features a main span composed of steel I-beams encased in concrete. The remaining spans are reinforced concrete girders units resting on reinforced concrete pile bents. The railing is a standard Type D, concrete post and double beam design. The superstructure carries a 24' wide concrete roadway over the abandoned roadbed of the former Chicago Rock Island and Gulf Railway railroads.

This overpass is significant for its type and railing. It is one of only a few known examples of a bridge in Texas with a concrete encased steel I-beam configuration and is noteworthy for its Type D railing. The bridge has retained its design, materials, workmanship, and location, and a sufficient degree of setting, feeling, and association to meet National Register eligibility under Criterion C, Engineering, at the state level of significance.

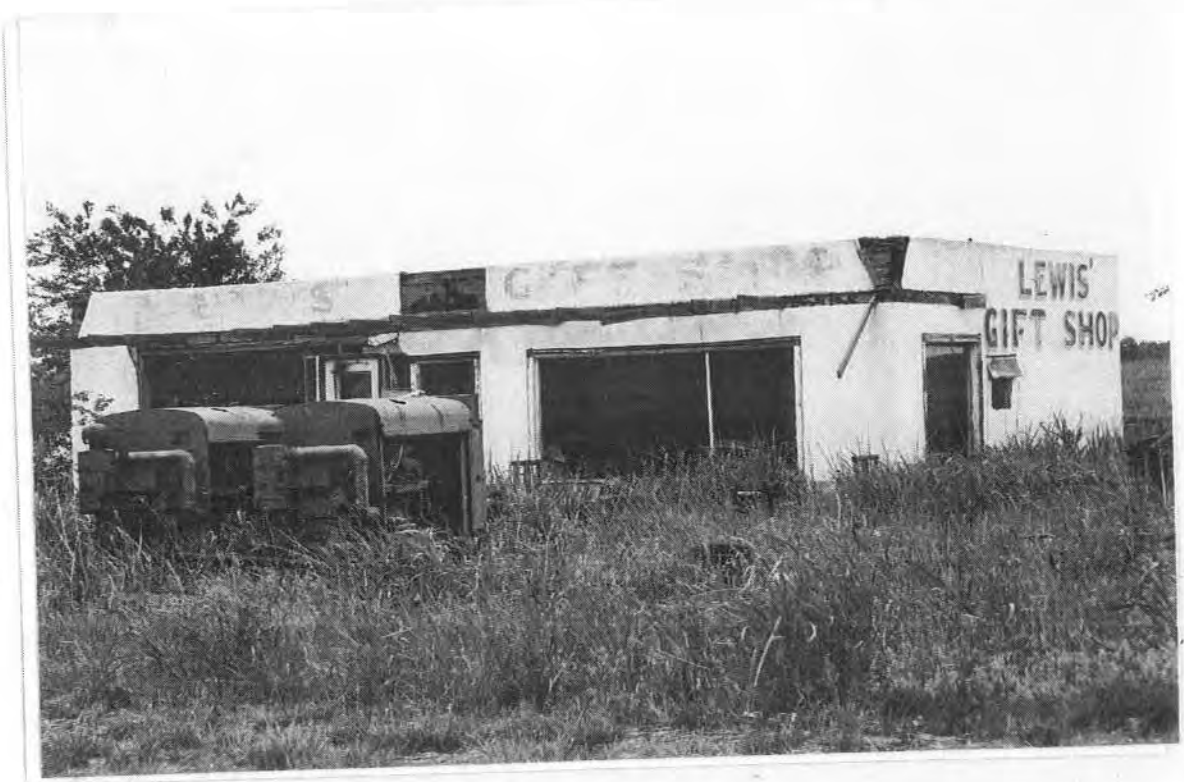
County Wheeler City Shawnee Inventory # 483-SH-1

Wall façade stucco (white, over wood?) Foundation _____

Window type plate glass? missing Materials _____

Porch type MISSING porch / awning Materials _____

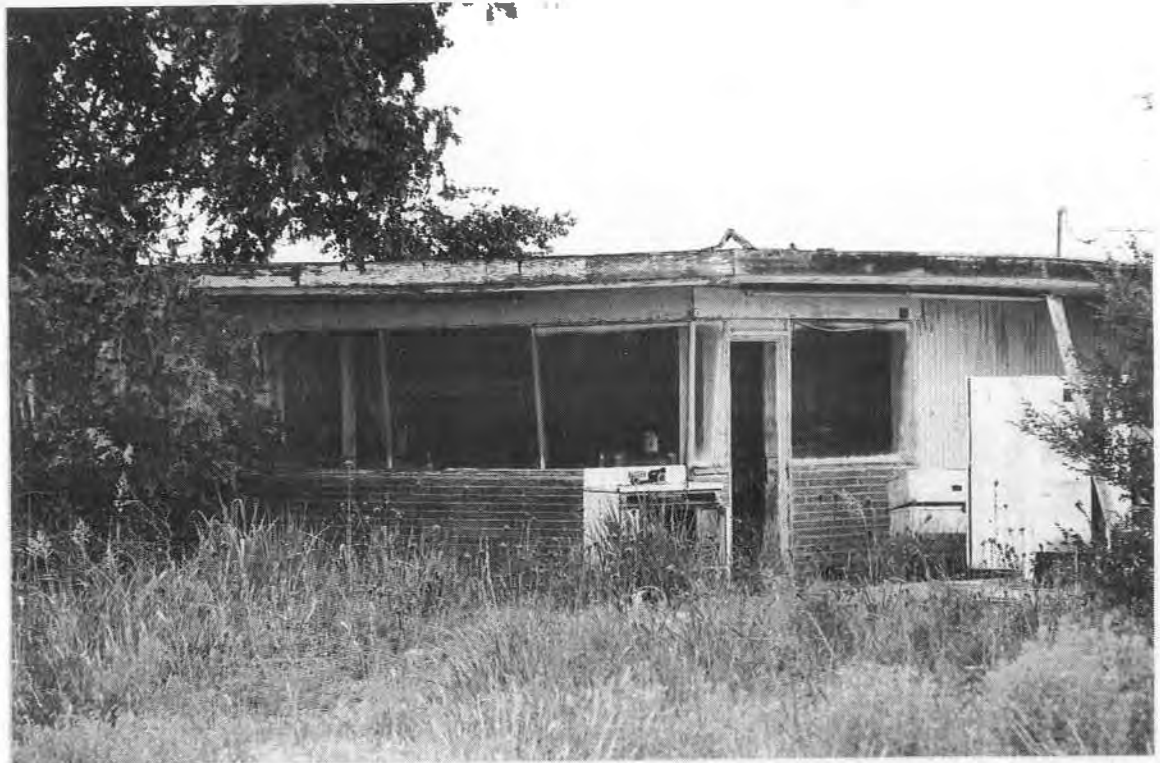
Roof type flat ^{or vertical planks} Materials _____

Wall façade plywood w/ brick veneer Foundation _____

Door type [MISSING] Materials _____

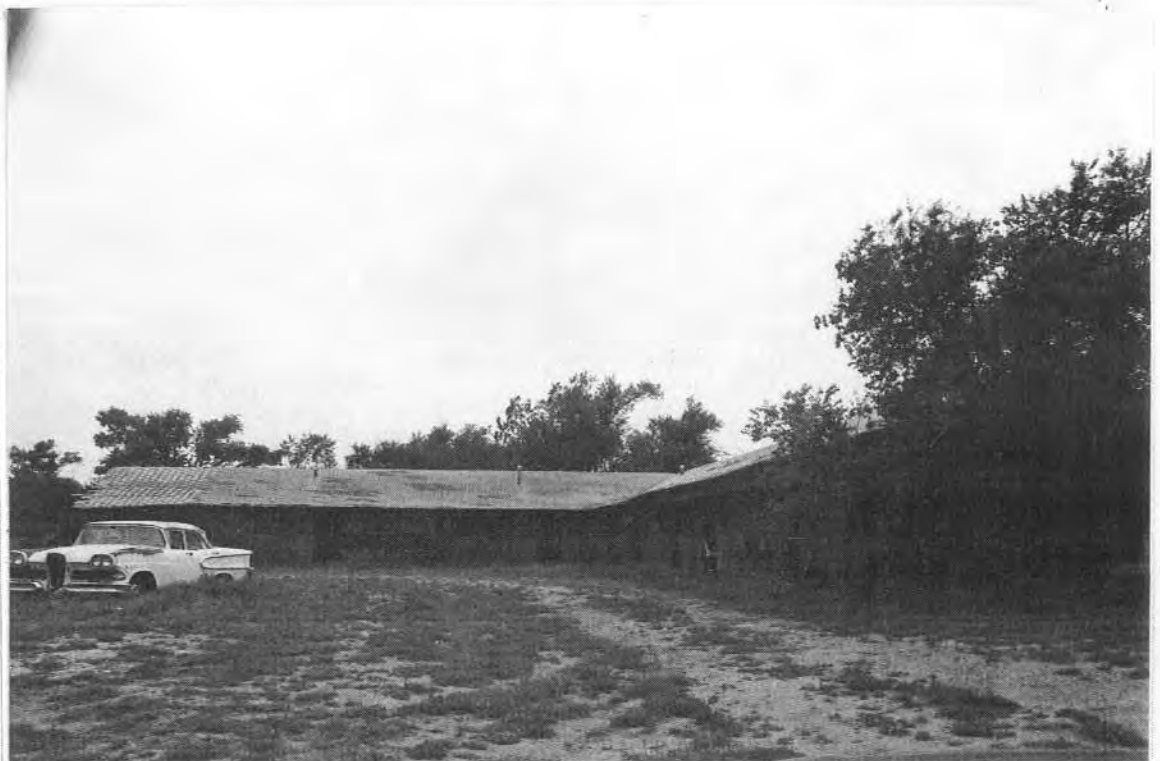
Roof type side gable / cross gable w/ ex. raft ends Materials comp shingle

Wall façade vertical plank on top; brick veneer on bottom Foundation _____

General Architectural Description L shape; metal oppers diff from W. neighbor. Had garage units which have been blocked in + windows added in their bay. Scattered woodwork (remnants) under eaves

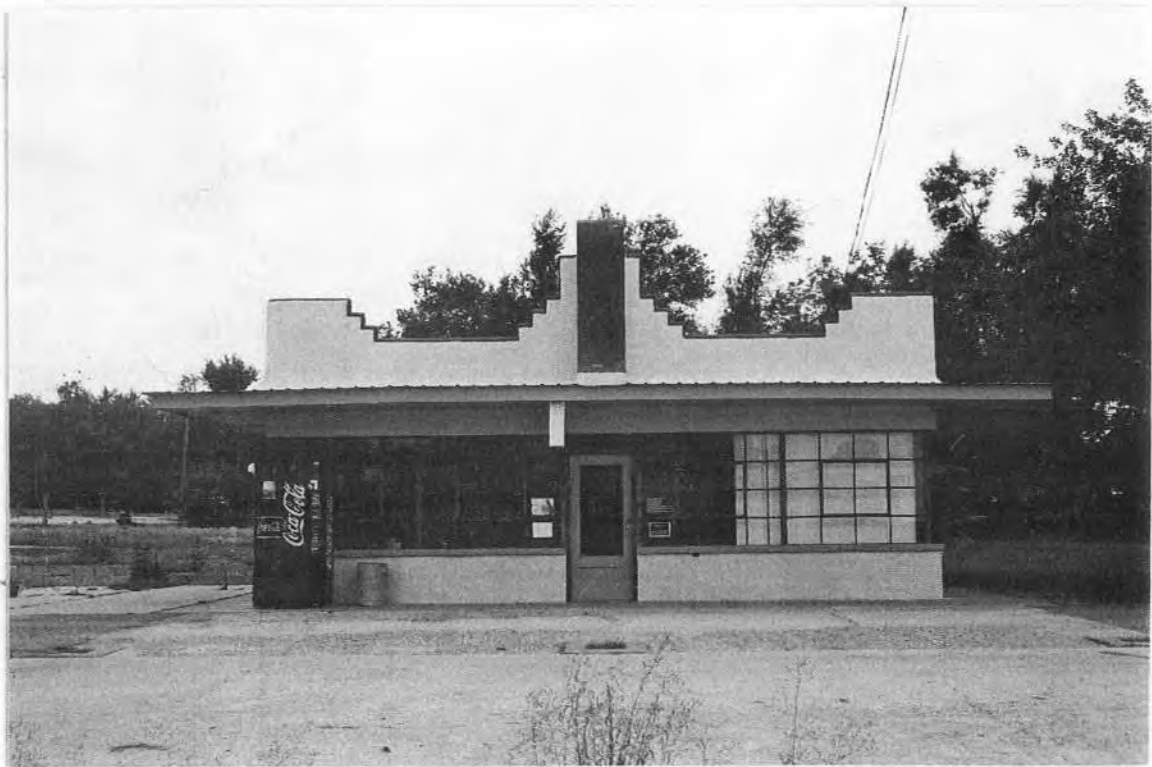
Stylistic Influence(s) _____
 Roof type flat w/ stepped parapet Materials cott. metal
 Wall façade stucco (tan) Foundation _____
 Window type fixed; multi-light Materials _____
 Door type central; 3/4 glazed over 1 panel Materials WOOD FRAME
 Porch type extended sm. canopy /awn Materials metal
 Number of Stories 1 Plan _____
 Chimney(s) _____

General Architectural Description small bldg 1 unit deep. Primary features incl. wrap-around fixed pane multi-light SSHT & parapet. Parapet has stepped corners w/ central projecting vertical element.

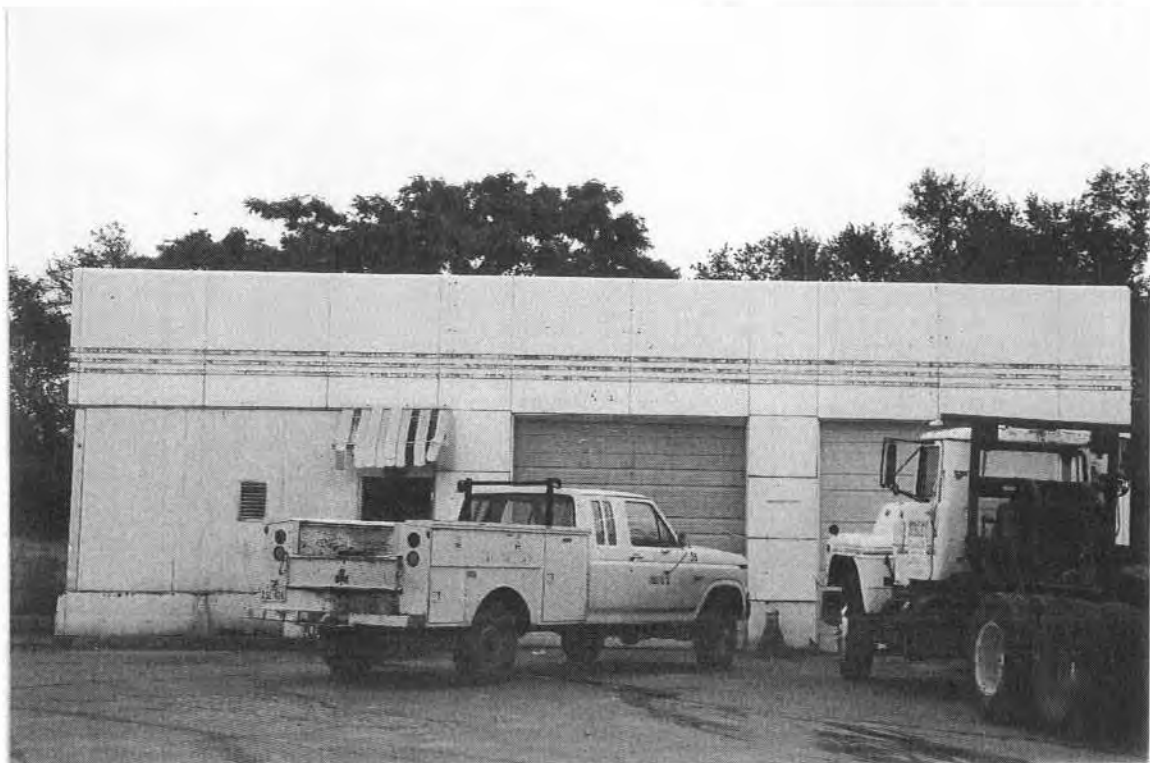
Roof type Flat Materials _____

Wall façade porcelain Foundation _____

Porch type missing canopy - has awning over man door Materials _____

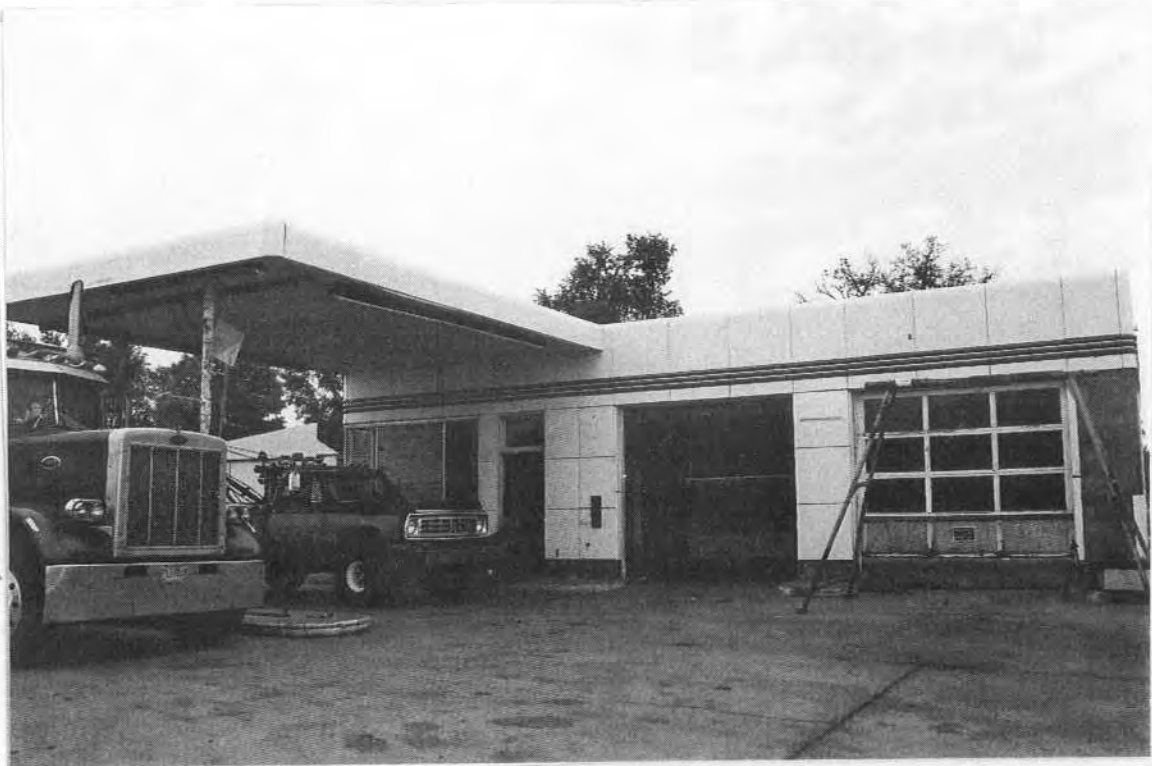
Roof type flat Materials _____

Wall façade porcelain Foundation _____

Evidence of gas pumps & island evident under canopy

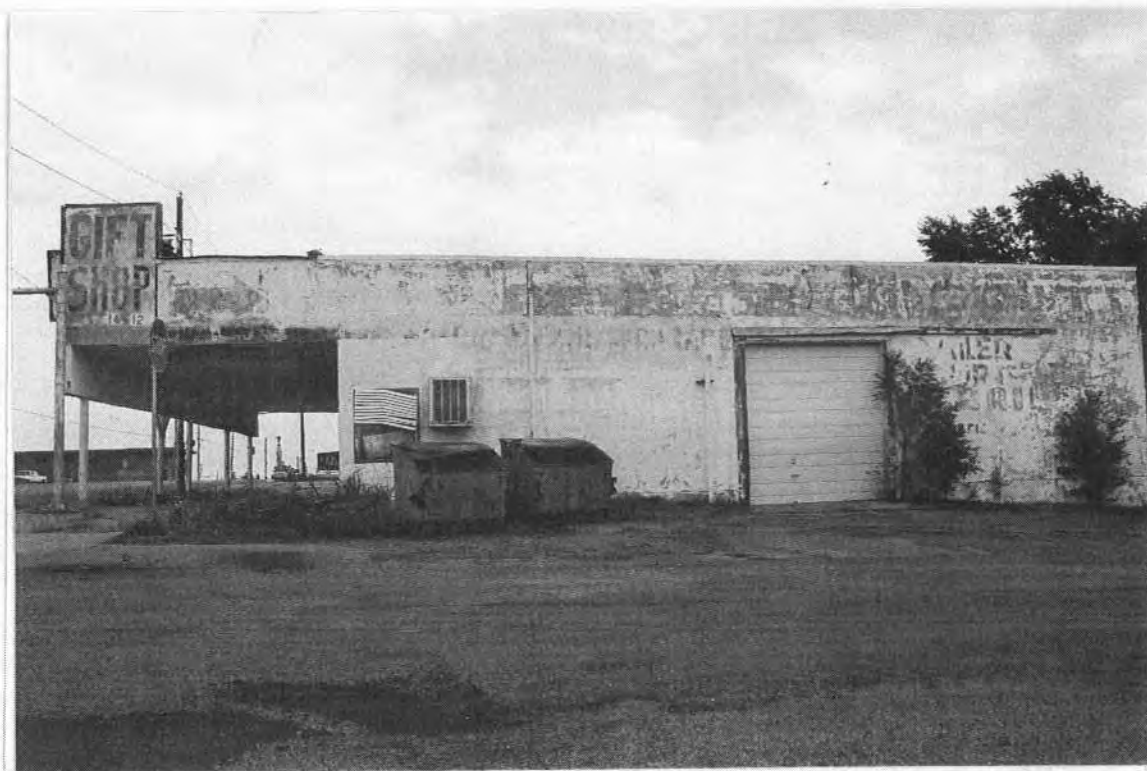
Roof type flat w/ parapet in front Materials _____

Wall façade stucco Foundation _____

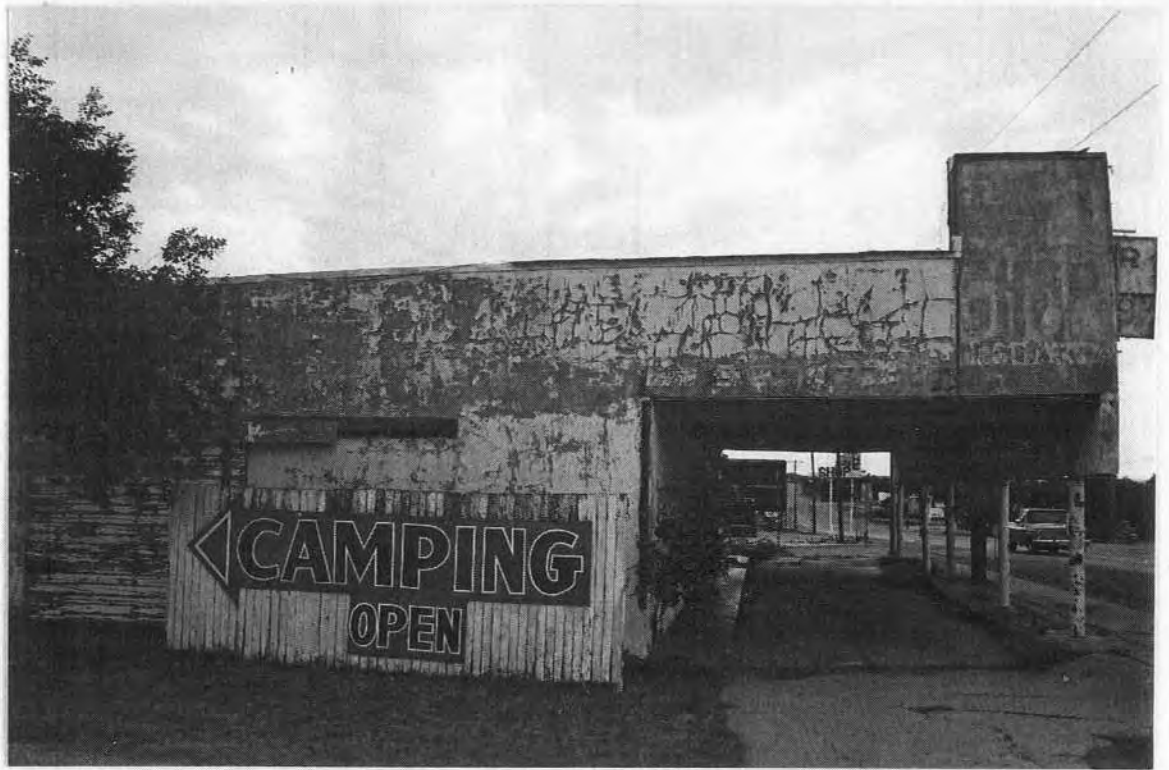
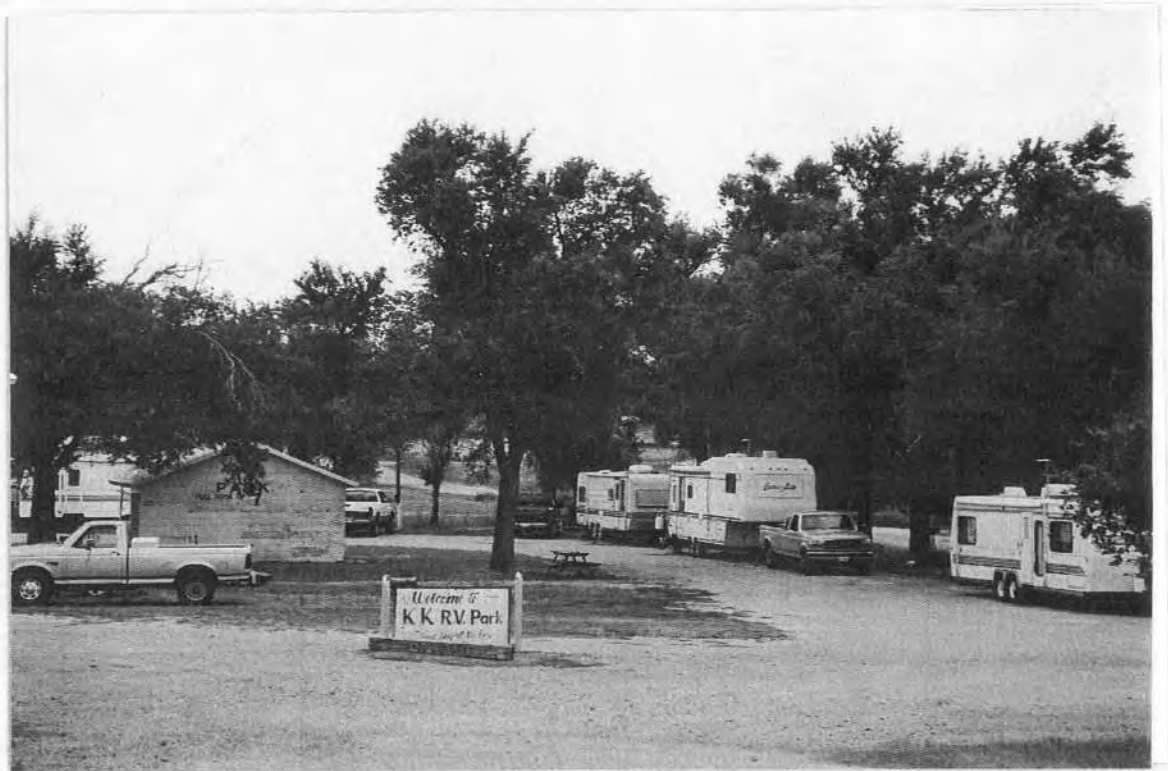
483-SH-9
PHOTO 4 (3235)-1
FACING WEST

S-24 RV bathroom facility

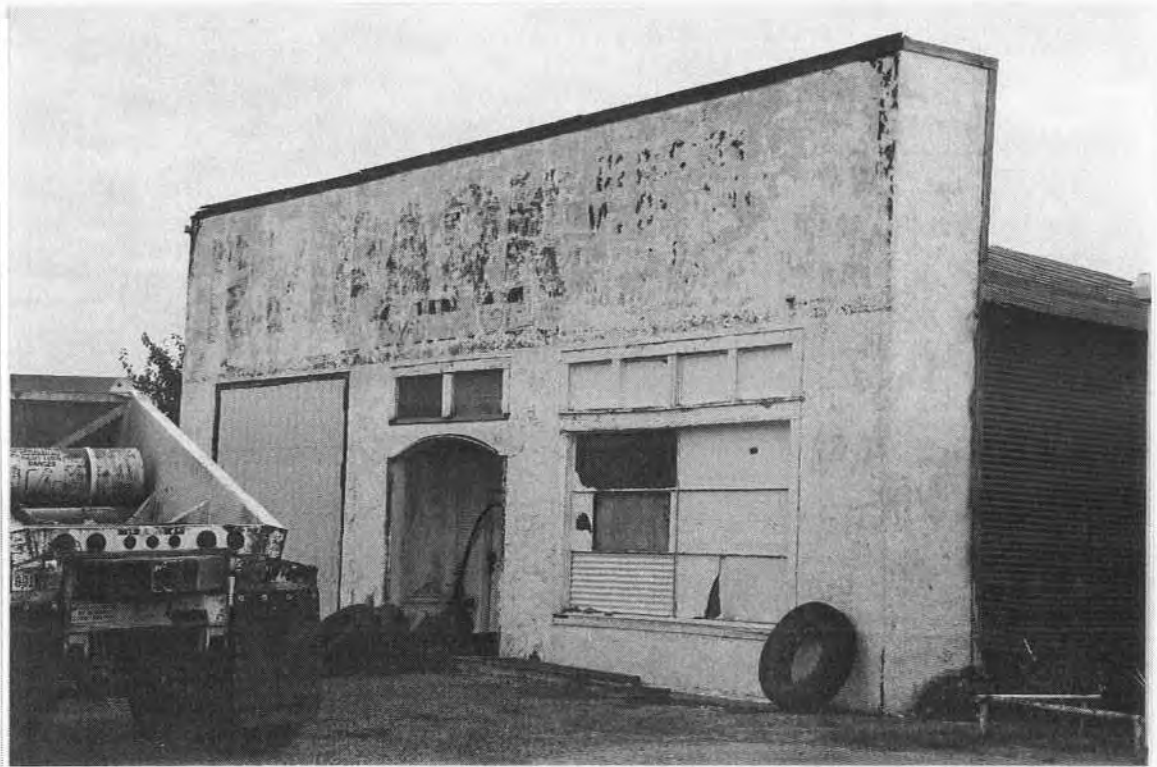
Roof type front gable w/ false front parapet Materials metal (on pitched roof)

Wall façade front = white stucco, sides = corrugated metal Foundation _____

General Architectural Description entry man door inset under arched entry - transoms above. Chamfered entry w/ windows flanking door

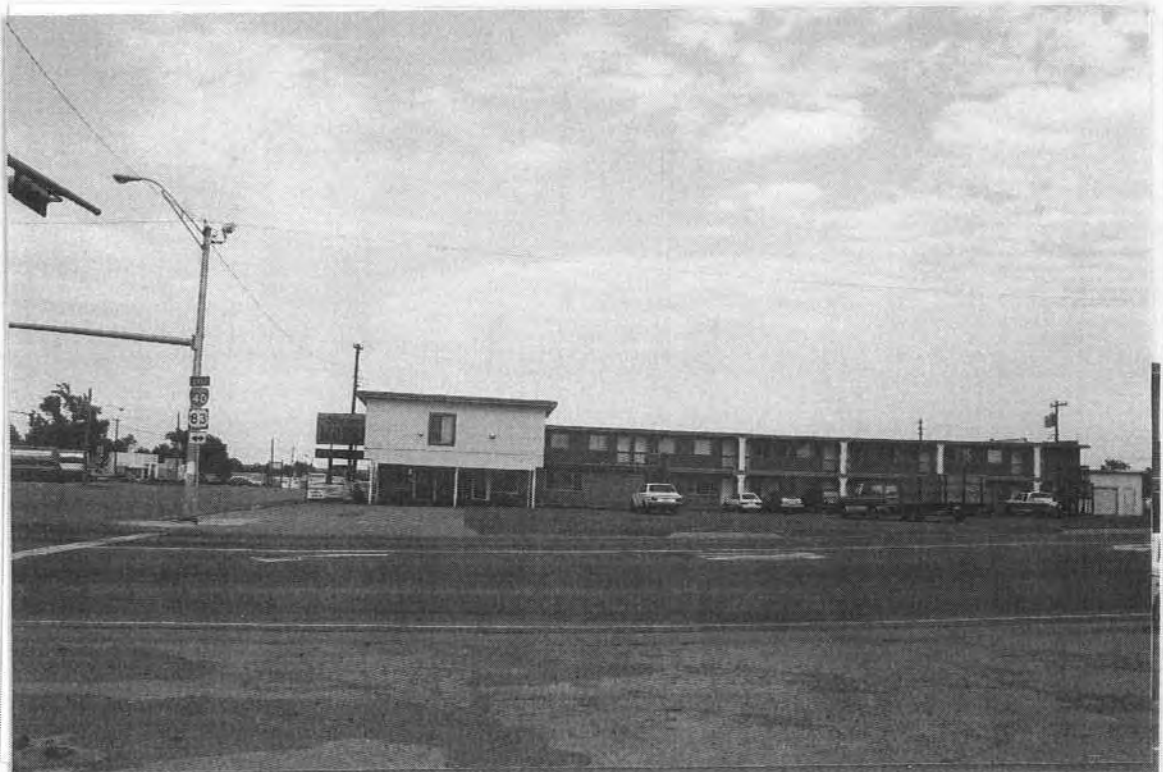
Roof type [ⓐ] inverted gable or double pitch [ⓑ] flat Materials _____

Wall façade brick veneer (cantilever facade - stucco) Foundation _____

currently sculpted ^{metal} in an X pattern & painted ^{black} (see sketch)

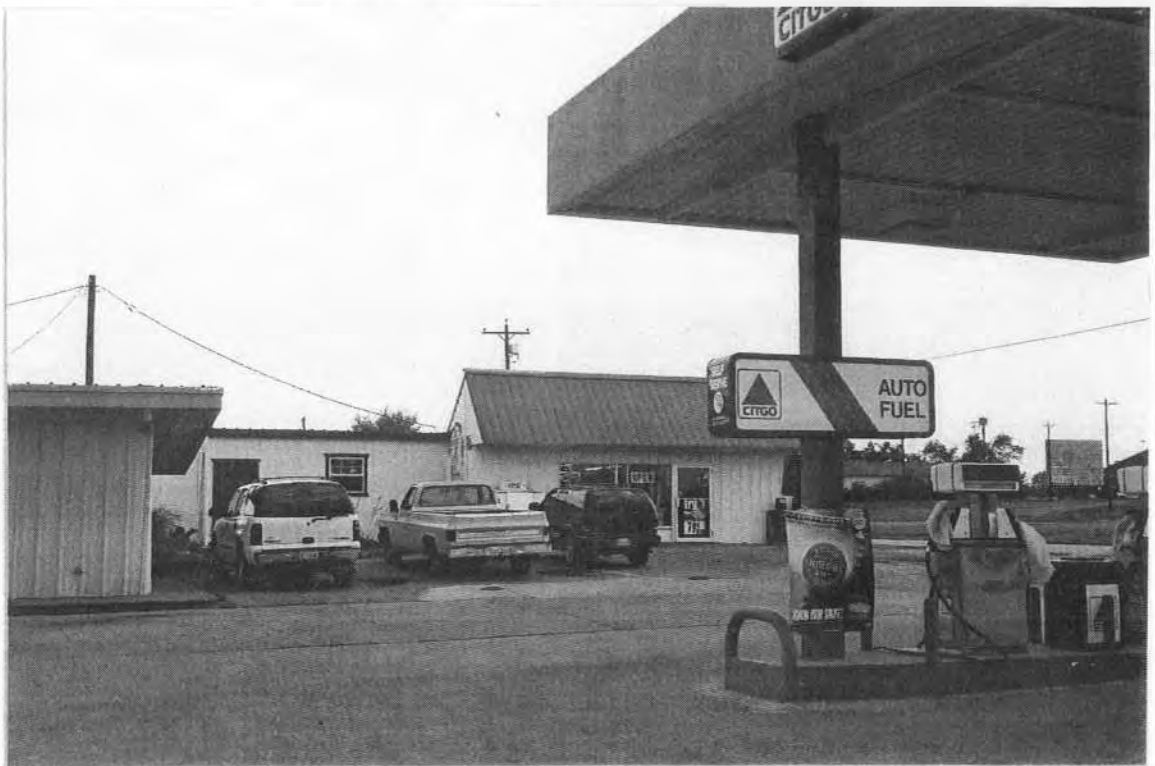
Old station - metal (corrugated) shed roof sloping to S. 4 exposed rafters (corrugated metal siding (not original). Appears to have had 1x fixed pane glass window adj. to man-door. Door = framed glazing [A] w/ transom above. Sidewall all around. Evidence of gas pumps remain on conc (door & 2 closer to street) Restrooms were in rear (S side)

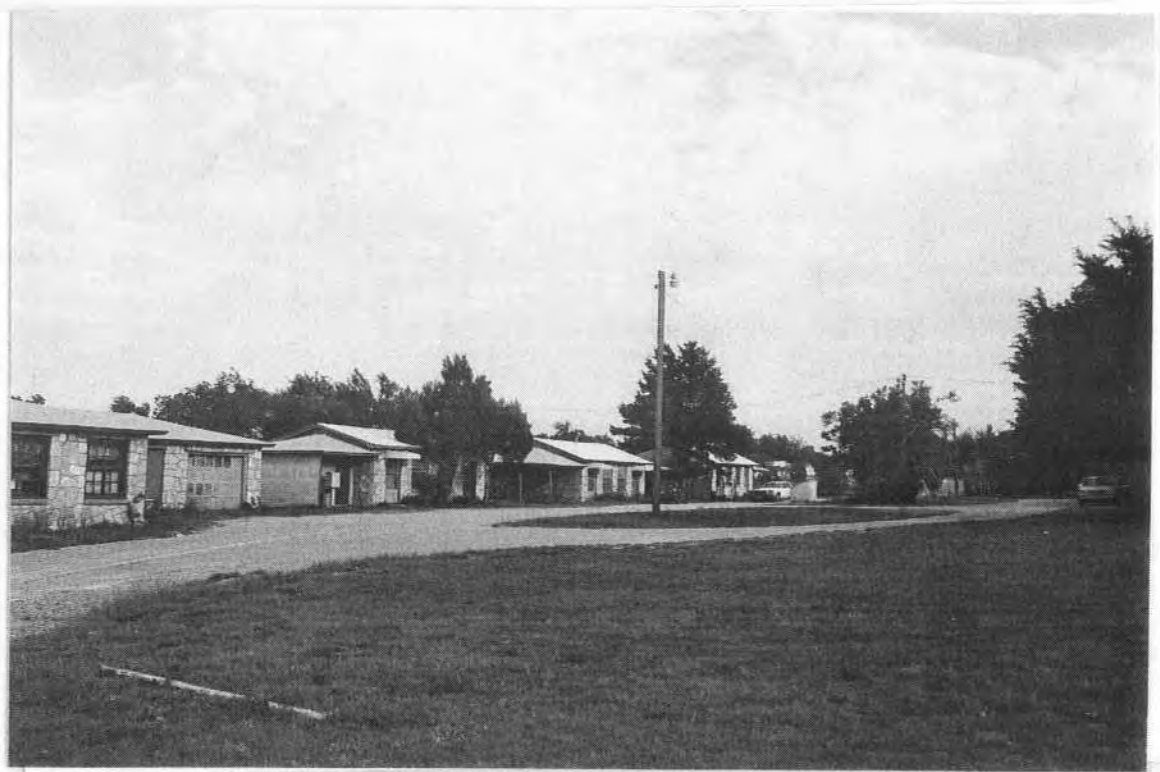
Roof type office hipped units side gable ^{w/hipped carport} Materials office: comp shingle units: corr metal

Wall façade random course uncut stone w/ raised mortar joints Foundation _____

One cabin (NW unit) has been resided w/ plywood & carports are missing. All other units have carports but some are filled in. ^{carport w/ baffles - on rear & S side, front & near mostly}

This complex had 8 cabins in 1931 & 13 cabins in 1945; office present continually

Photo Data: Roll 5 Frame _____ Feature 16, 15, 14, 13, 12 16 office
15 streetscape (entire E side of complex)
14 typical unit, east side
13 close up of same unit
12 rear of West units. (look E)

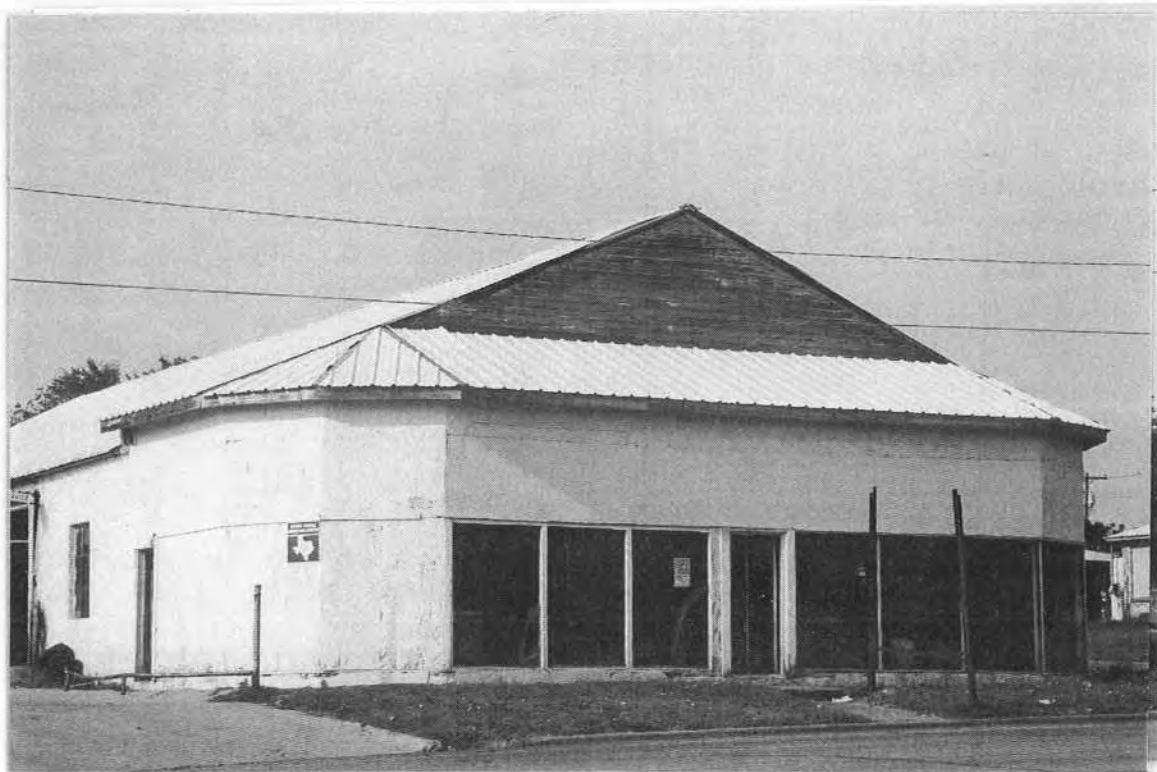
Roof type front gable w/ shed add on front (for display) Materials corrugated metal

Wall façade stucco in front; some metal in back Foundation _____

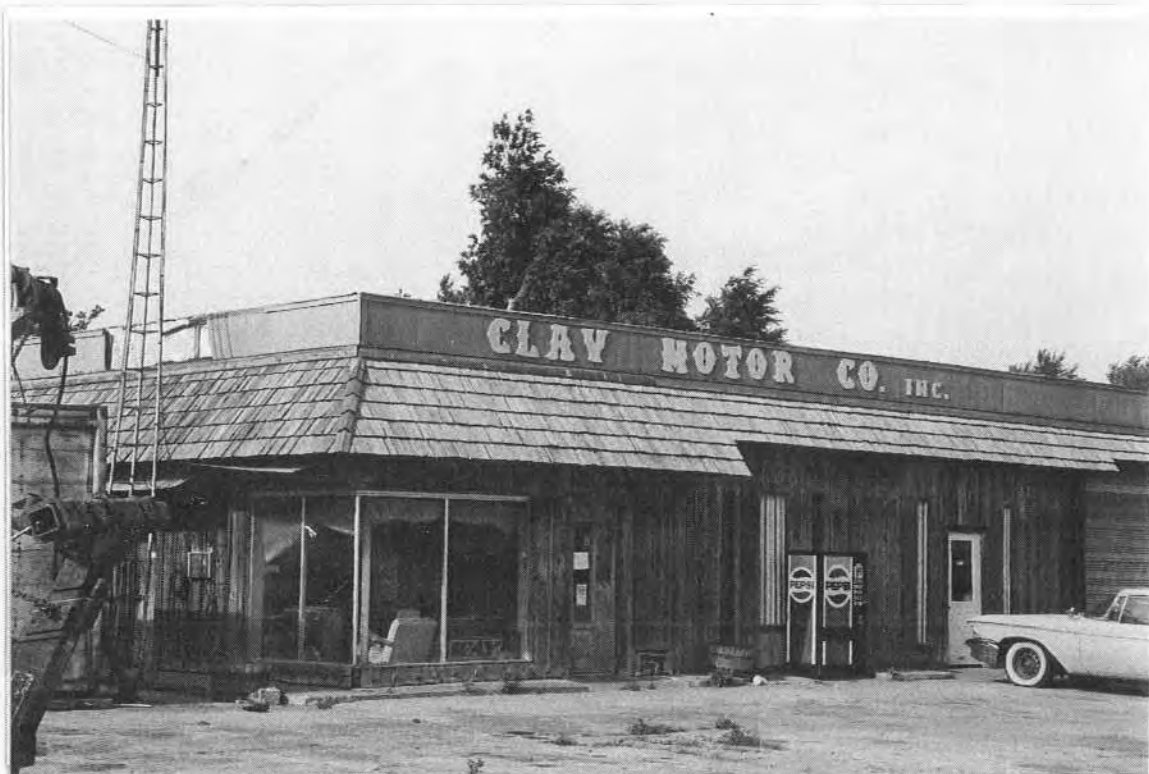
Photo Data: Roll 5 Frame 9, 8, 7 Feature 9 = both Clay Bldgs

Roof type flat w/ structural parapet. Shingled shed overhang (almost mansard) Materials _____

Wall façade front - vertical plank & batten, sides conc block (painted yellow). Rear side has stepped parapet Foundation _____

Window type on front @ NE corner - plate in metal frame. Had narrow vertical fixed pane slits across facade Materials _____

Door type 2 main doors both framed glazed. 2 metal overhead doors on W end. Materials _____

General Architectural Description Buildg is now part of Clay complex. Front facade has been altered w/ what looks like projecting addition - this has been sided w/ plank & batten & capped w/ shingled shed overhang. Obviously an older block bldg underneath. In rear, a small bay projects back & has another overhead metal door & 1 fixed pane multi lighted casement (capped). Also has windows @ rear (S. side)

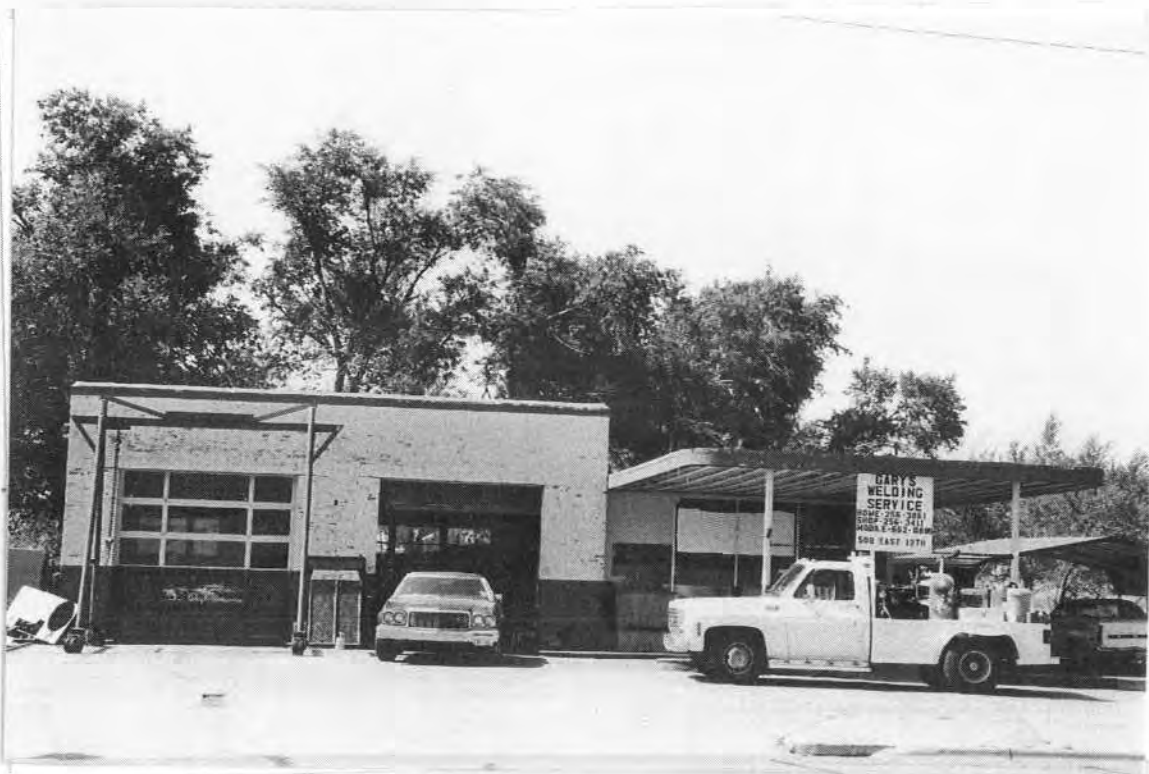
Photo Data: Roll 6 Frame 24, 23 Feature _____

Roof type flat - no visible parapet Materials _____

Wall façade office - glazed & stucco garage - conc block Foundation packed (tar) brown in bottom & tan on top w/ bands of dark brown @ red line

General Architectural Description typical gas & garage combo. Unusual features are intact canopy & pump island (no pumps) & chamfered entrance into office. Canopy has rounded edges. Canopy is wood decking (visible from underneath)

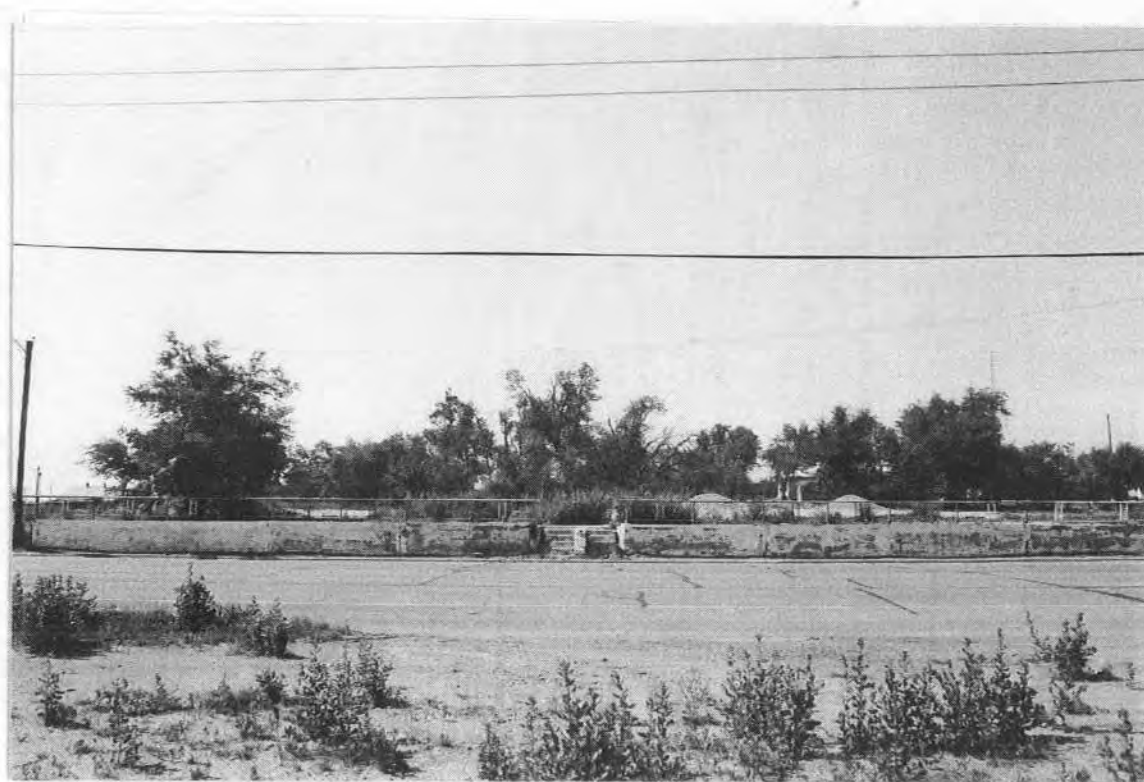
Photo Data: Roll 6 Frame 22, 21 Feature _____

Remnants are retaining wall w/ metal railing & centrally located stairs -
retaining wall & terrace slope back to road grade on E & West ends

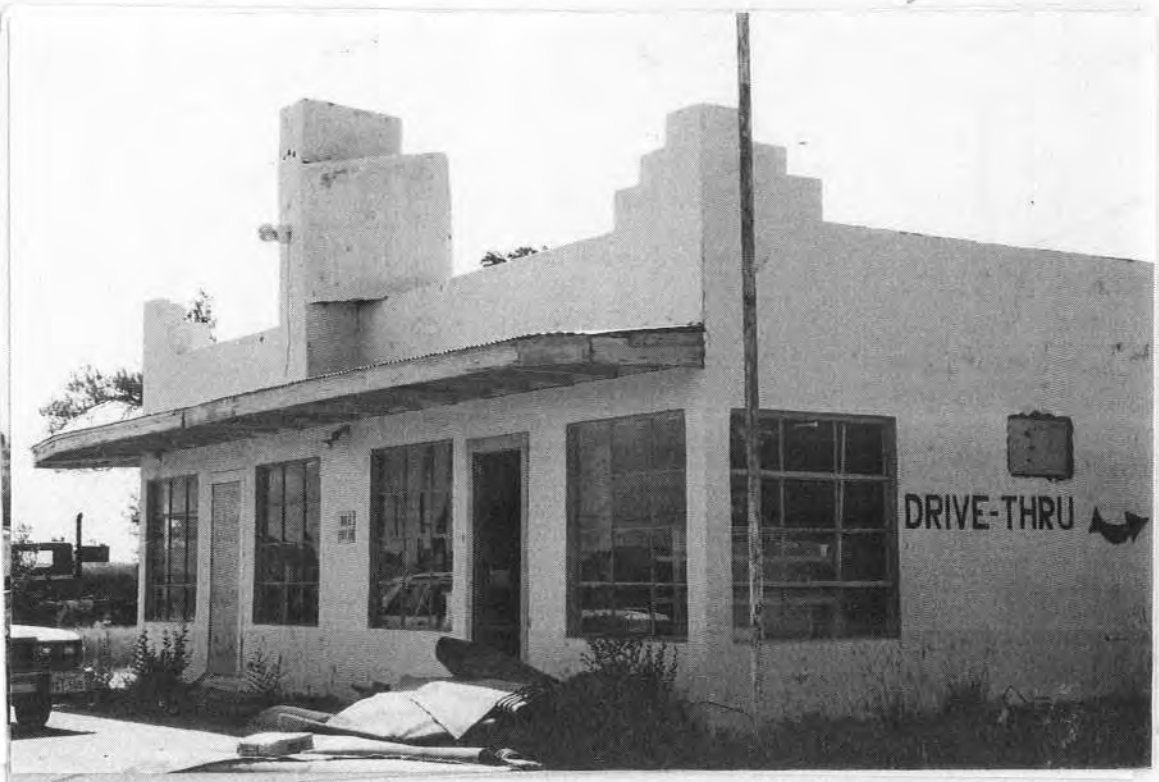
Roof type shed w/ parapet - step parapet @ corners ^{extruding vertical element} Materials shed = corrugated

Wall façade stucco (white), blue trim around windows Foundation 3 at fascia

General Architectural Description Excellent architectural details @ parapet. Stepped parapet @ corners is similar to other Shantou examples - center vertical element is unusual - W side has a small drive thru sign painted on 7 sm. boarded window. Eviden of gas pump island in front (broken conc).

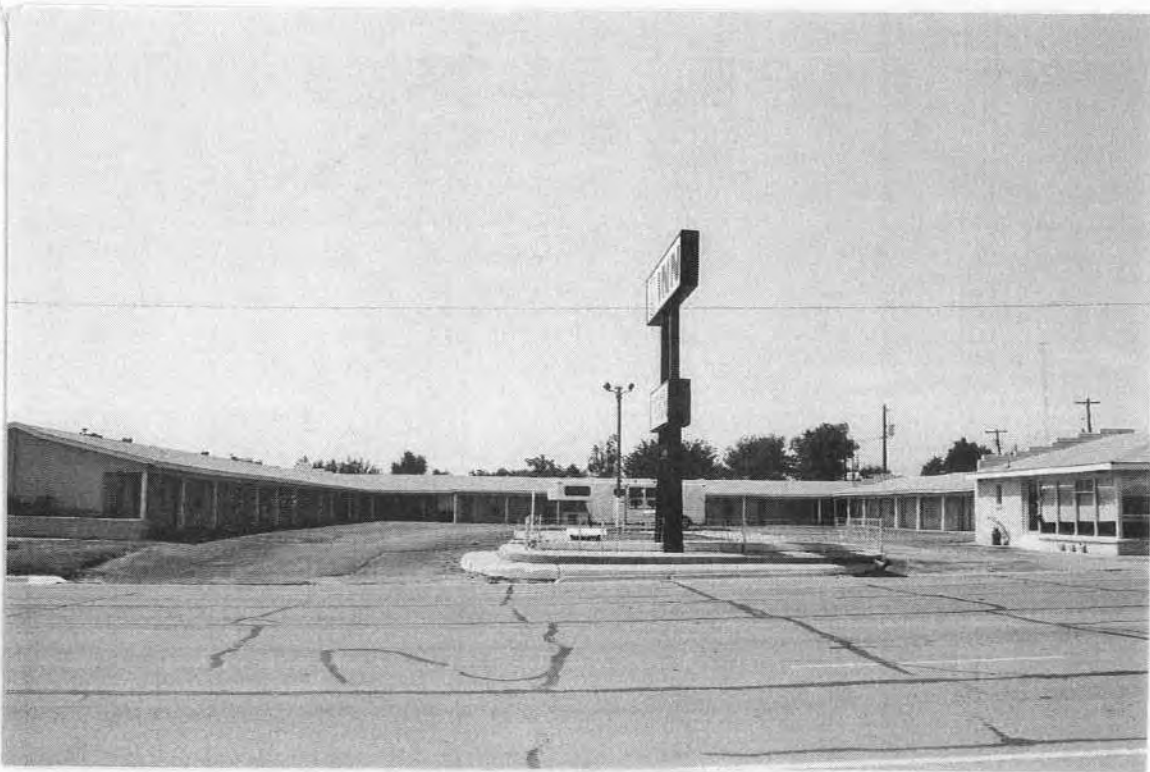
Roof type office - hipped, restaurant add: gabled units: side gable & salt box? All comp single. HAS projecting
 Wall façade brick (running course) painted buff - has hor. grooves in each brick Materials _____
 Window type office - CORNE has vertically divided fixed SASH (11) UITS - 12 light metal casement - operable Foundation _____
 Door type office - fully glazed UITS. - panel, metal? Materials _____
 Porch type slight overhang & eaves supported by carved wooden posts Materials _____
 Number of Stories 1 Plan U w office projecting
 Chimney(s) N/A

General Architectural Description typical motel plan & type. Restaurant appears to be added to W side - has planning in gable end above fixed pane windows. Unusual features incl. conc block parapets place at right angle w/ run of plan, carved posts & decorative detail in pool rail (squares & diamonds). The two end units (on E & W vests) have horizontal flush siding above the brick; rest of complex has brick from found to roof windows are typical casings like top row is fixed & bottom 9 lights are operable

Photo Data: Roll 6 Frame 17, 16, 15 Feature see photo
rear of bldg has unpainted brick - use both the regular sized rough face & the narrower (almost roman) brick used on public facades. Rear also has exposed rafters.

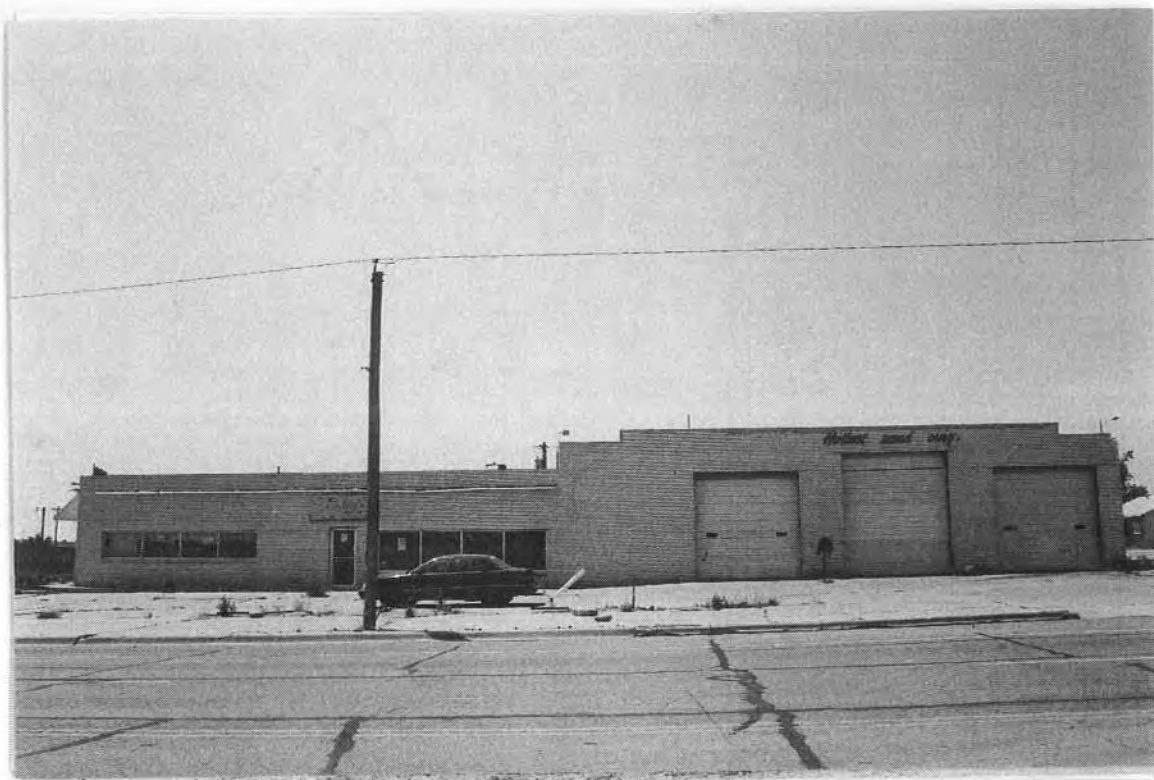
Photo Data: Roll 6 Frame 12, 11, 10 Feature _____

Roof type flat w/ parapet

Foundation corrugated metal on sides & rear

General Architectural Description East half was apparently truck stop / restaurant w/ entrance on E wall [glass door w/ sidelight] & north (front) facade. This portion is brick on all sides, regular coursing. E side has slightly projecting canopy over sidewalk - roofed w/ corr. metal.

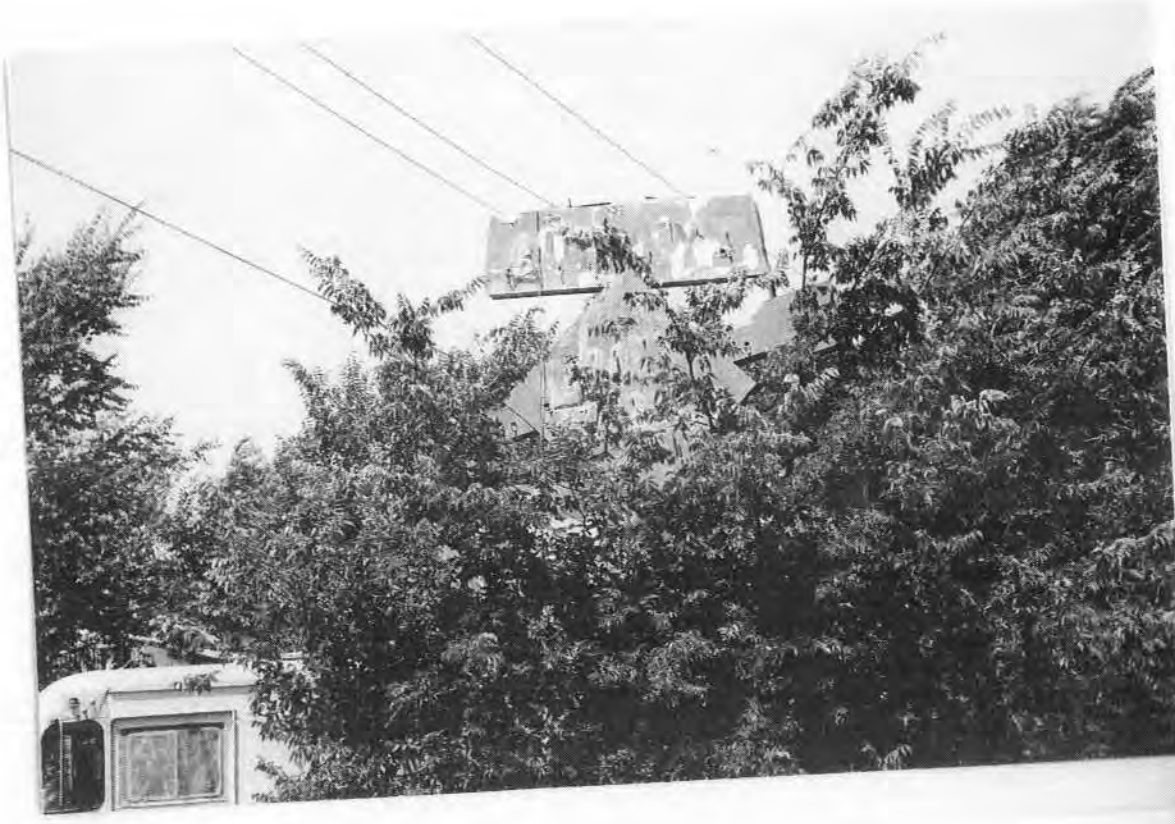
483-SH-22
PHOTO 6(3240)-8
FACING WEST

General Architectural Description CANNOT see - overgrown w/ trees & surrounded
by junk & old cars. Sign barely visible.

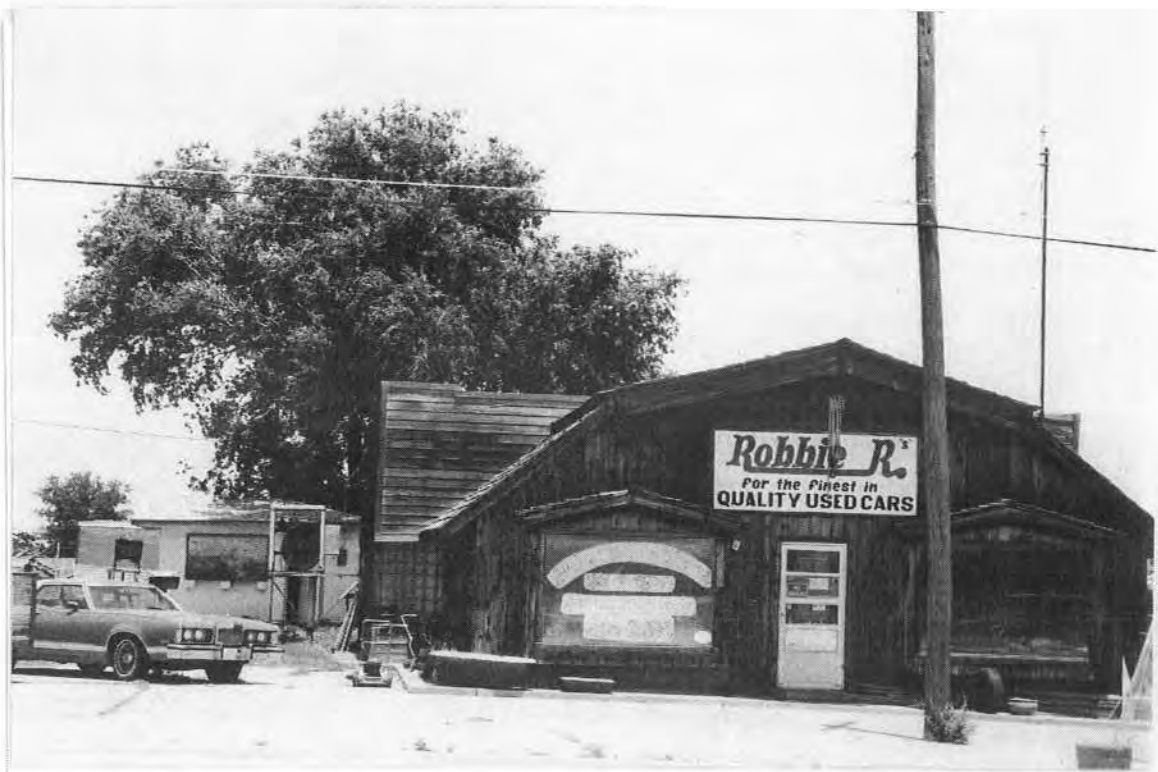
Photo Data: Roll 6 Frame 5, 4 Feature _____

Roof type old: gable flat, w/ porch NEW: gambrel w/ ^{decorative} peak, wood shingled Materials _____

Wall façade old: horiz ^{wood} plank siding (covers something else) NEW: horiz plank on sides, vertical wood plank on front Foundation _____

General Architectural Description New addition w/ gambrel roof has doubled size of orig square-plan garage. Garage had glass block at corners, rest of details are covered.
