Historic Resources Survey

Route 66 through Texas

Survey Materials

Wheeler County

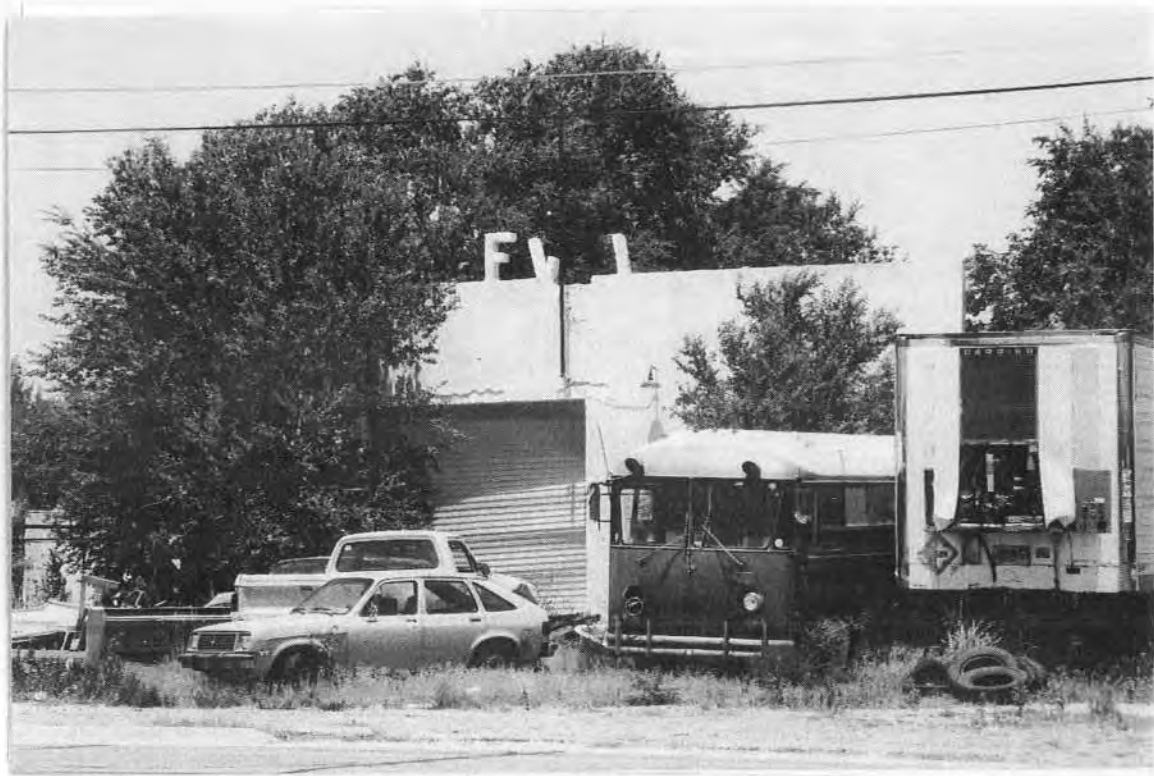
Photo Data: Roll 6 Frame 3, 2 Feature _____

Roof type w/ parapet Materials _____

Wall façade white stucco Foundation _____

Window type windows missing Materials _____

sign - 3D letters - on top of parapet. Can see EV 1. Constable said it was
Frenchy Le Blancs garage.

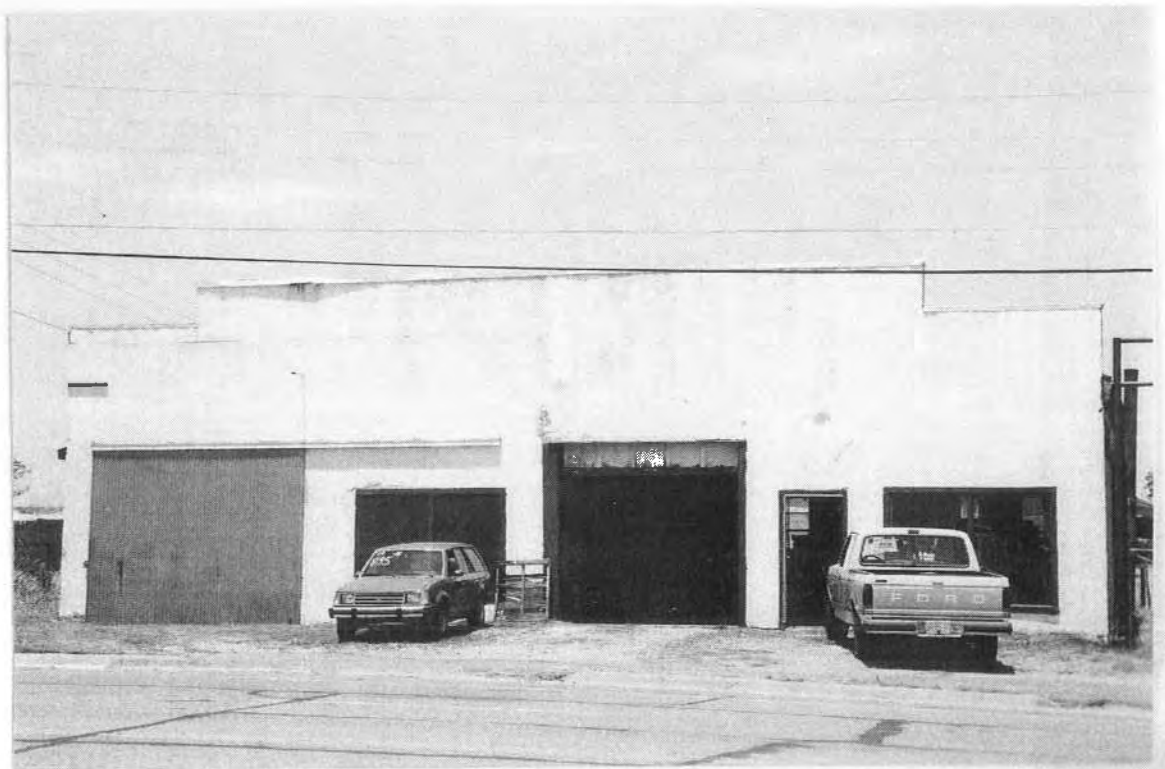
483 SH-26
 Photo 6 (3240)-1
 FACING NORTH

Stylistic Influence(s) (false front)

Roof type front gable w/ 3 part parapet Materials corr metal

Wall façade stucco (white), stucco tan on side Foundation _____

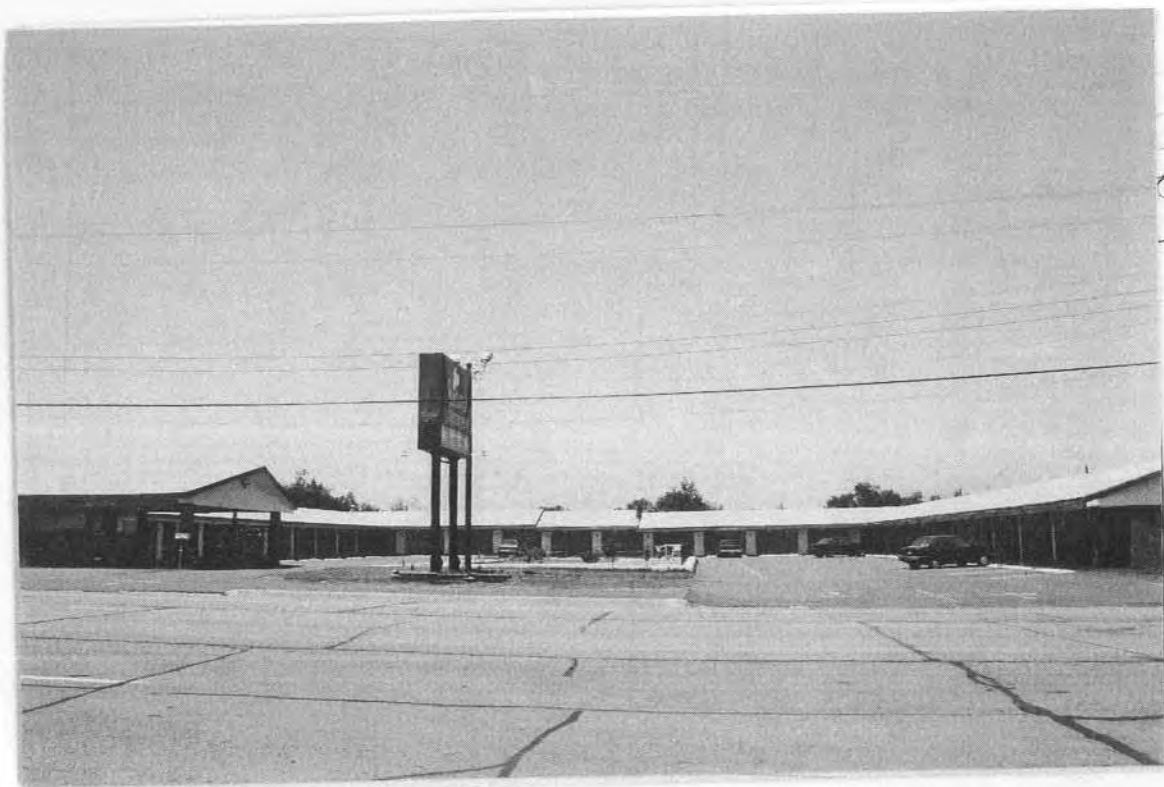
Photo Data: Roll	<u>7</u>	Frame	<u>21</u>	Feature	<u>21</u>	<u>overall look S</u>
					<u>20</u>	<u>office look W</u>
					<u>19</u>	<u>type unit look E</u>

Roof type office: front gable w/ porte cochere ^{units} ^{side} ^{gable/porch} ^{gable} Materials All comp shingle

Wall façade split faced brick, unpainted (red) Foundation _____

General Architectural Description typical U motel plan, typical type. Windows smaller than max. Directly N of sign, has projecting parapet @ 90° w/ roof line, like Shamrock Inn. Approx 30 units

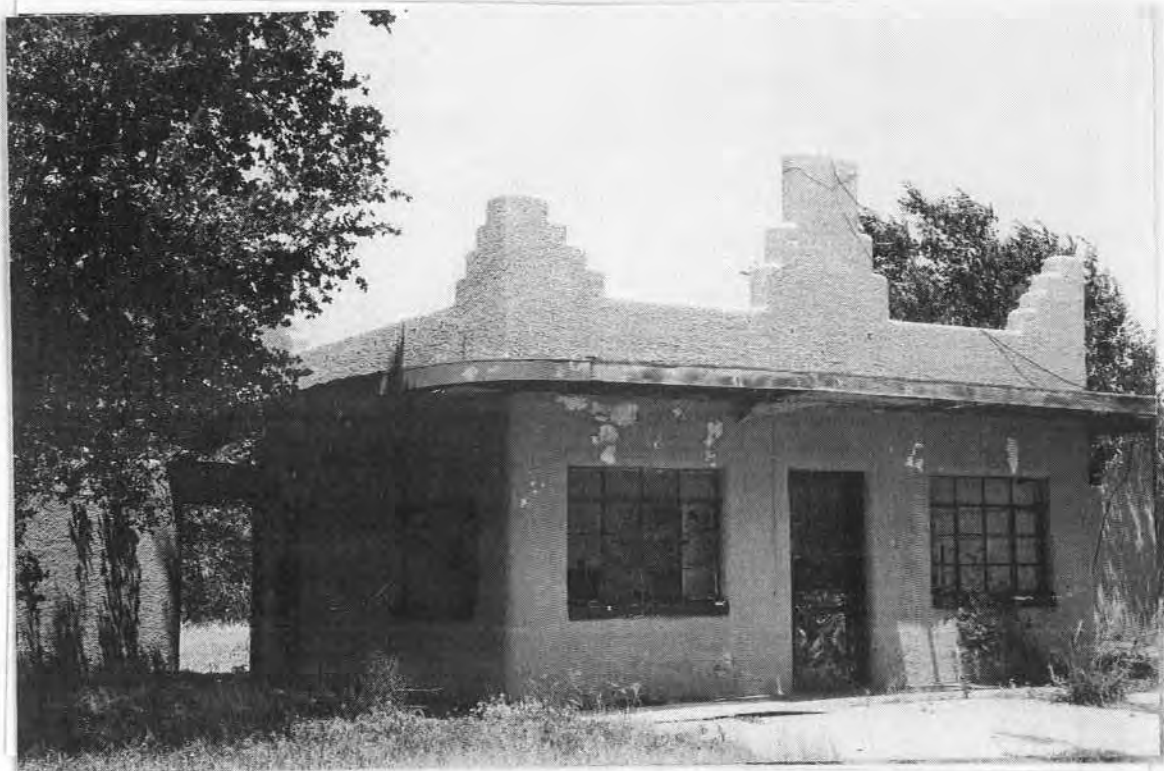
Photo Data: Roll 7 Frame 10, 17, 16 Feature _____

Roof type flat w/ ^{stepped} parapet Materials _____

Wall façade stucco (brown) Foundation _____

General Architectural Description One room in front w/ restrooms at either side in the rear. Details included ~~stepped~~ parapet [w/ protrusions @ corners & in center; repeated on extension walls]. Walls (w/ doorway thru) suggest rear courtyard / picnic / camp area

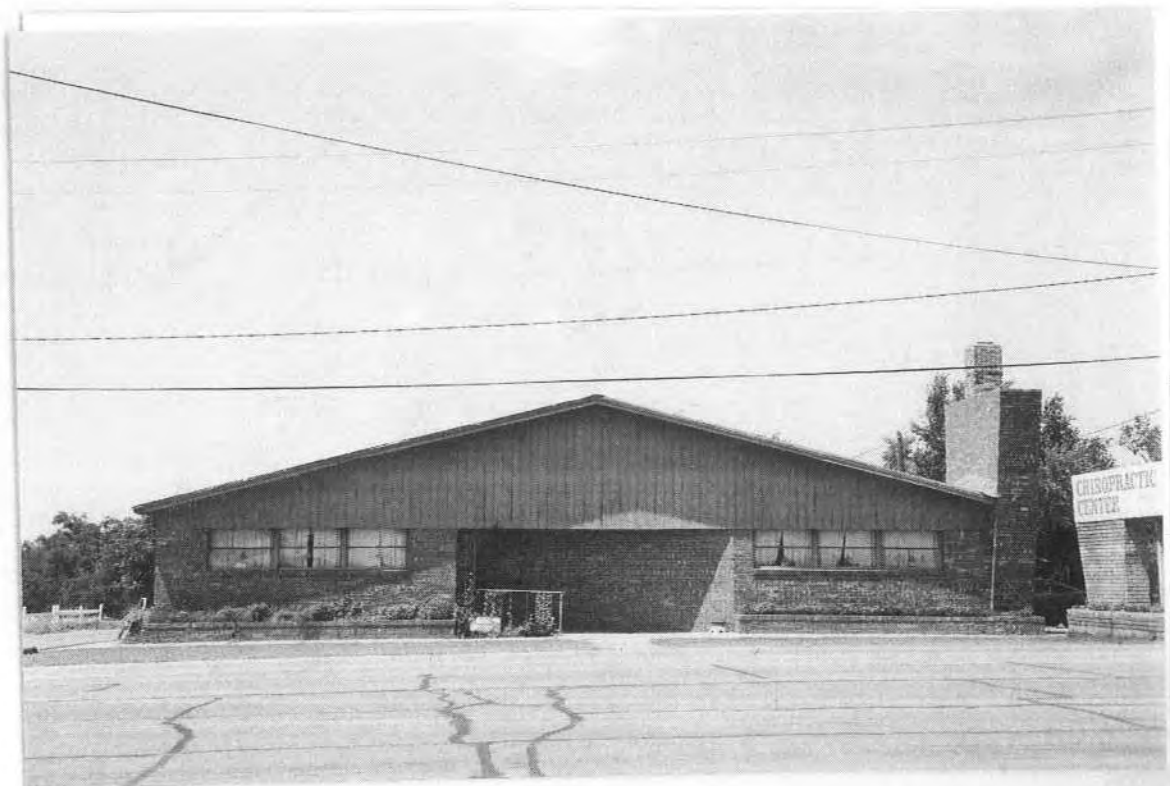
Wall façade red brick • wood plank @ gable end; Wood plank - horiz under eaves (2 planes high) Foundation _____

General Architectural Description front facade has interesting arch detail - vertical downward tapering ^{PYLLON} triangle element at E terminus of bldg. has decorative iron railings & brick planters in front. Sign base repeats ∇ element though original sign top is replaced.

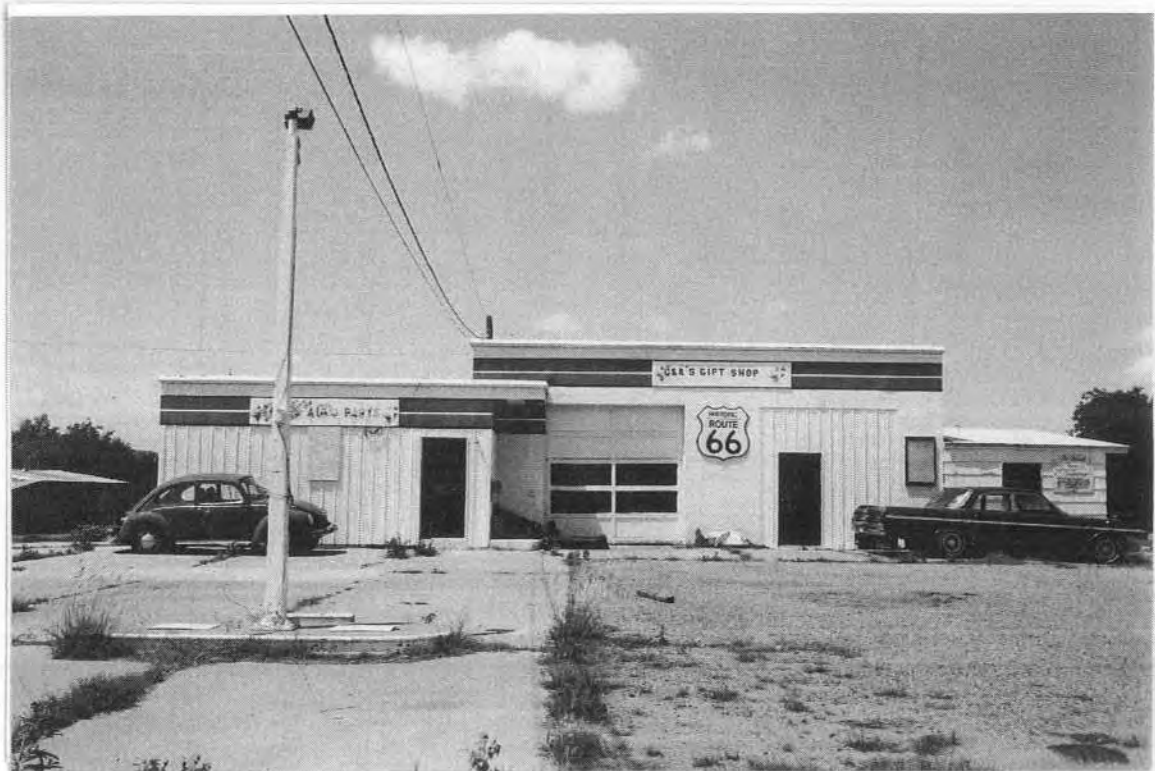
General Architectural Description typical gas station at corc though 1/2 height
additions added on W & E sides. Orig sign frame remains w/ new
sign inside

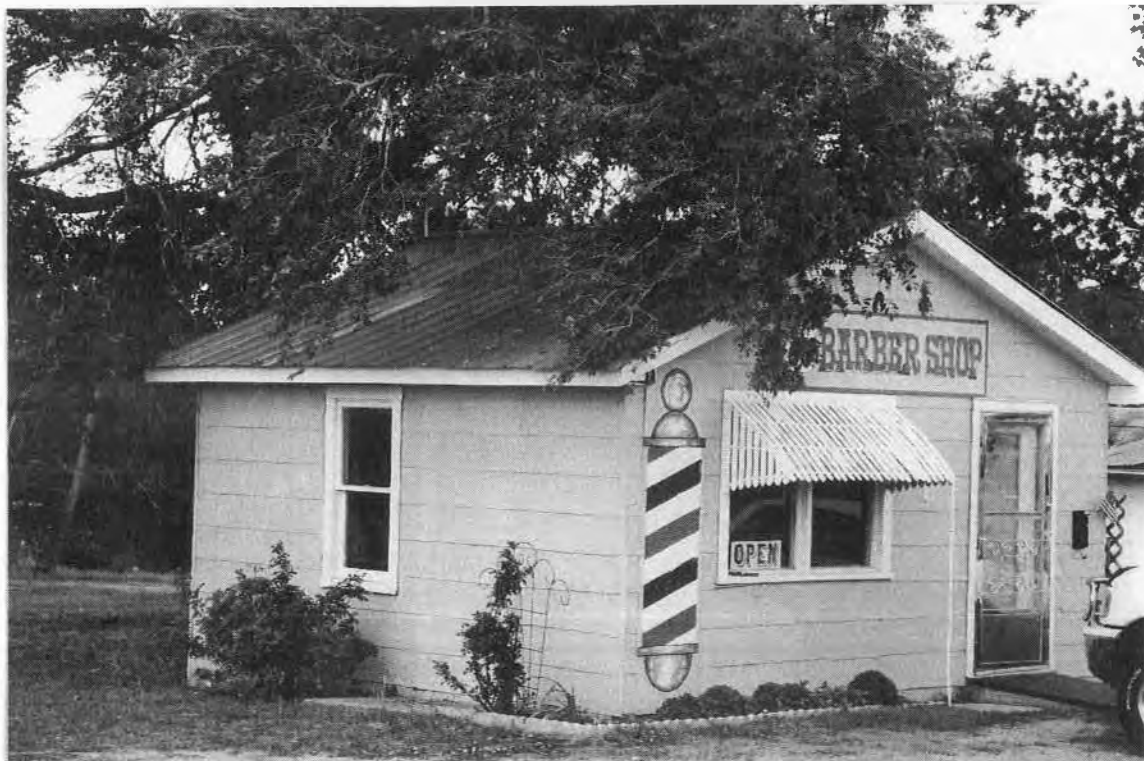
483-SH-35
PHOT 7(324) - 5
FACING NORTH EAST

General Architectural Description could possible have been domestic / tourist cabin.

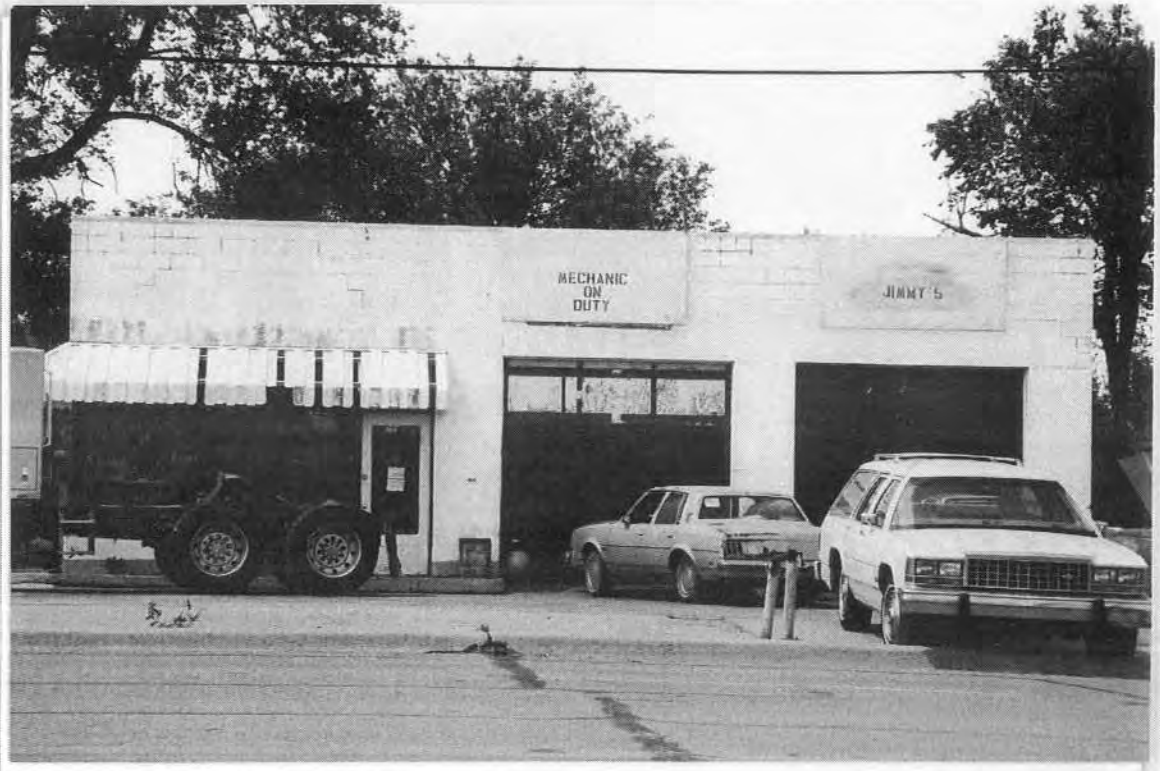
General Architectural Description typical 2-bay auto garage & gas station layout
Appears to be band of paint or other covering missing from top

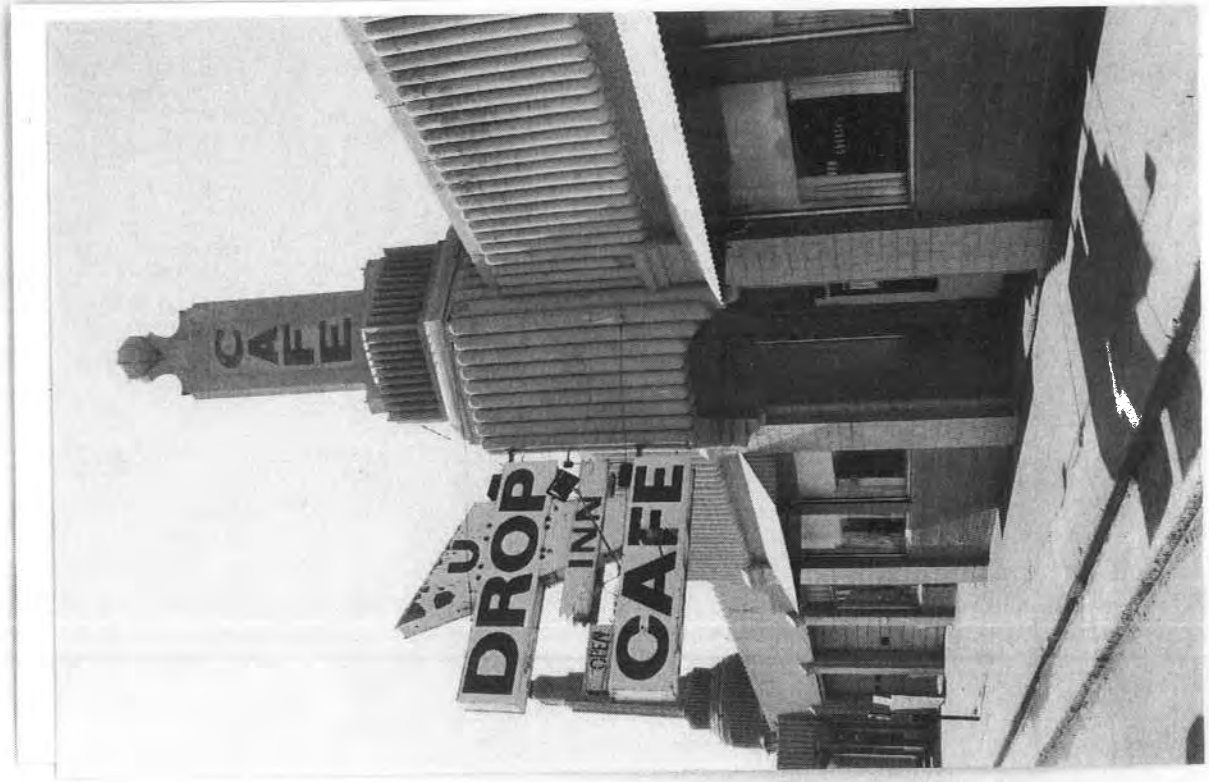
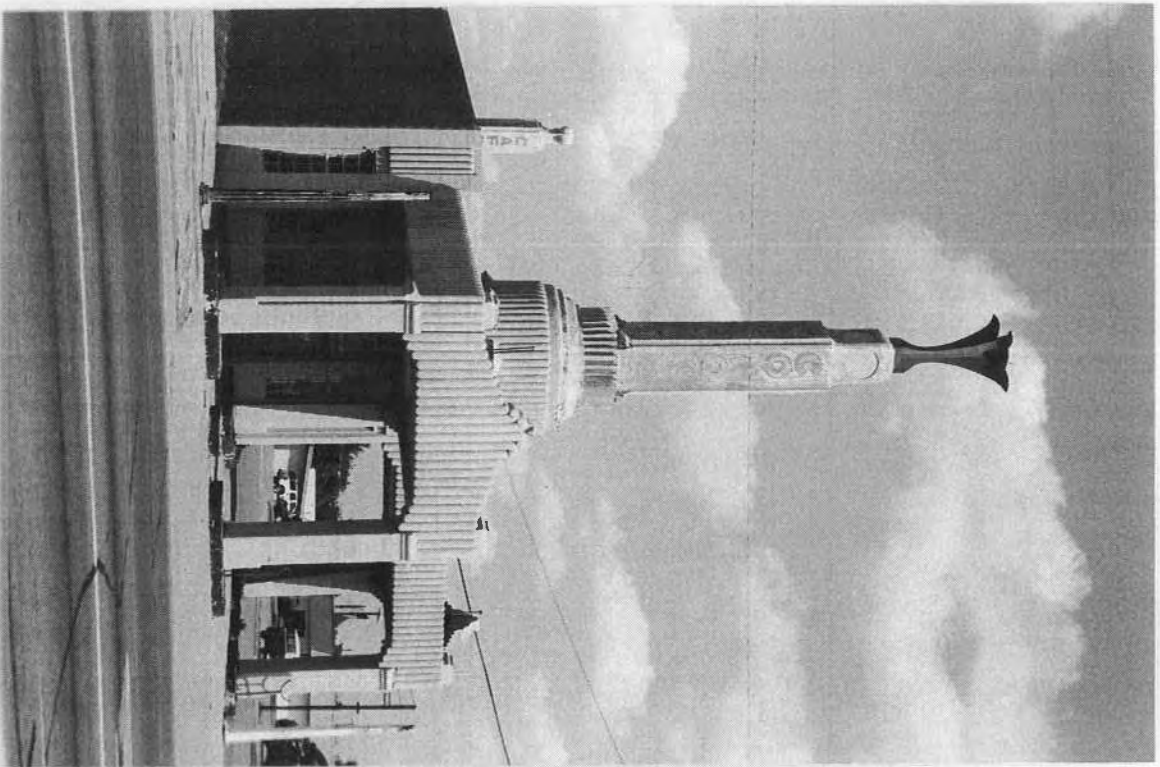
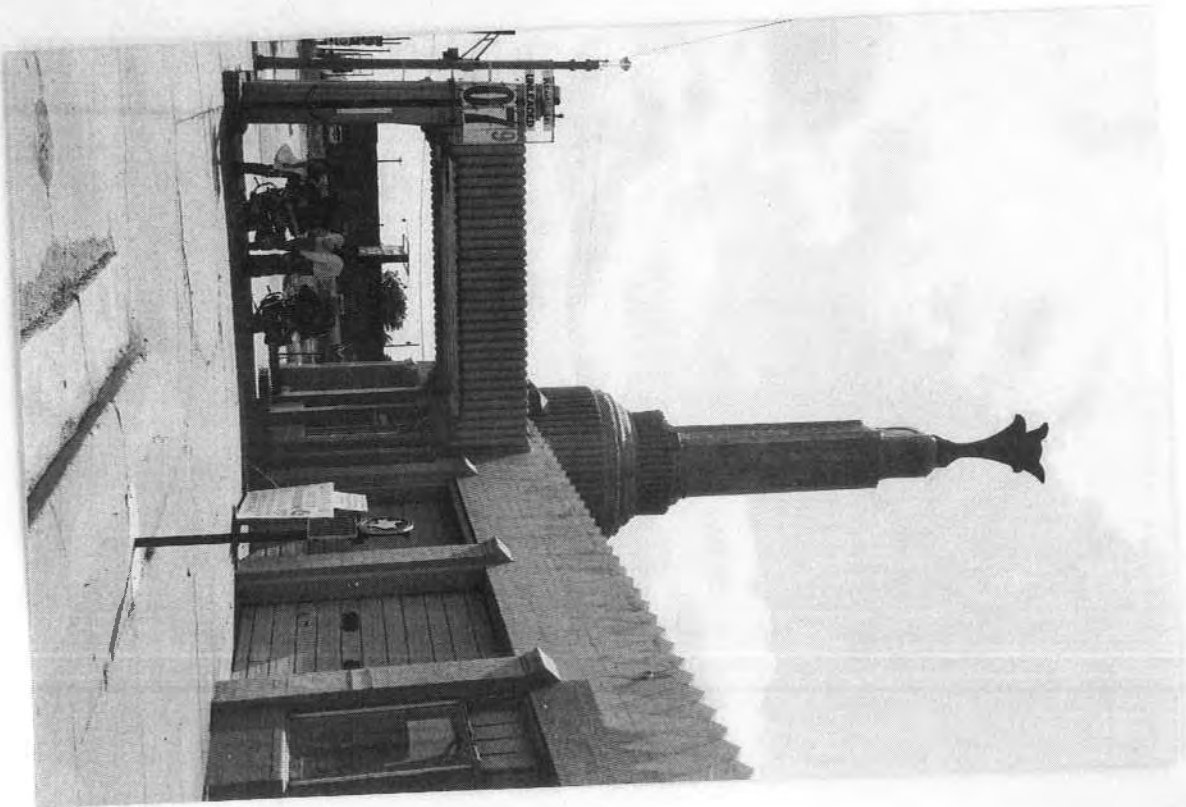
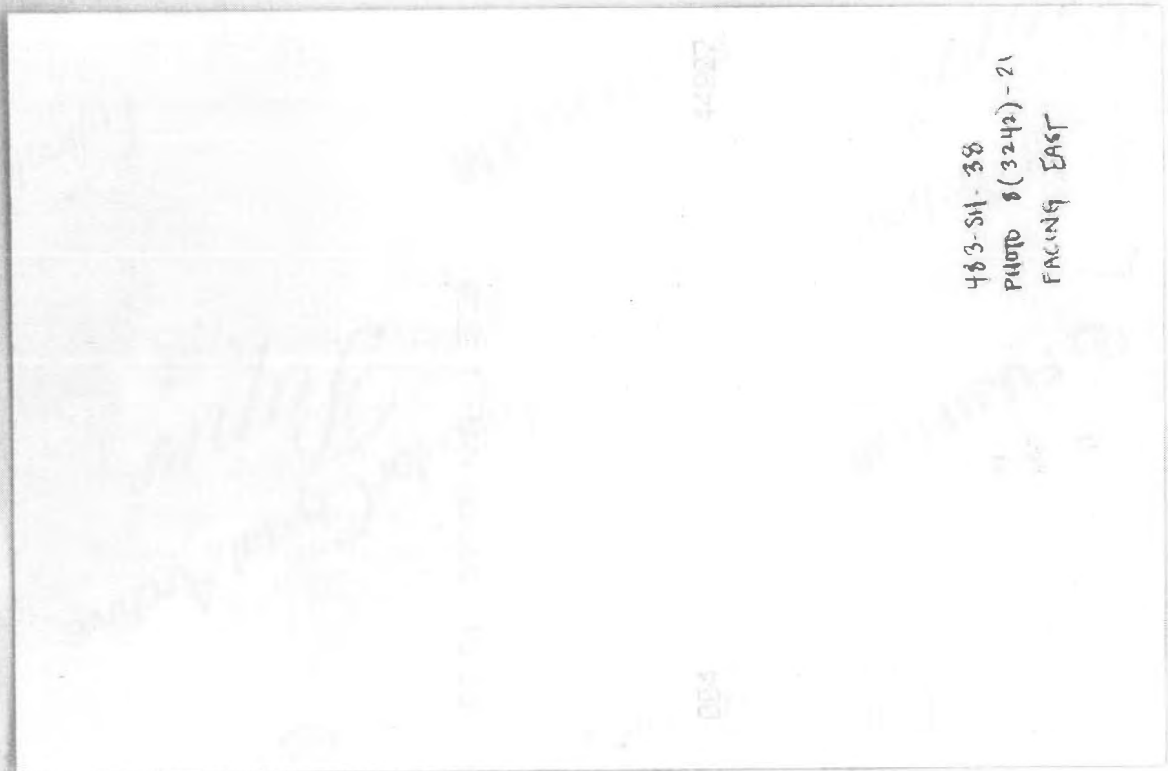
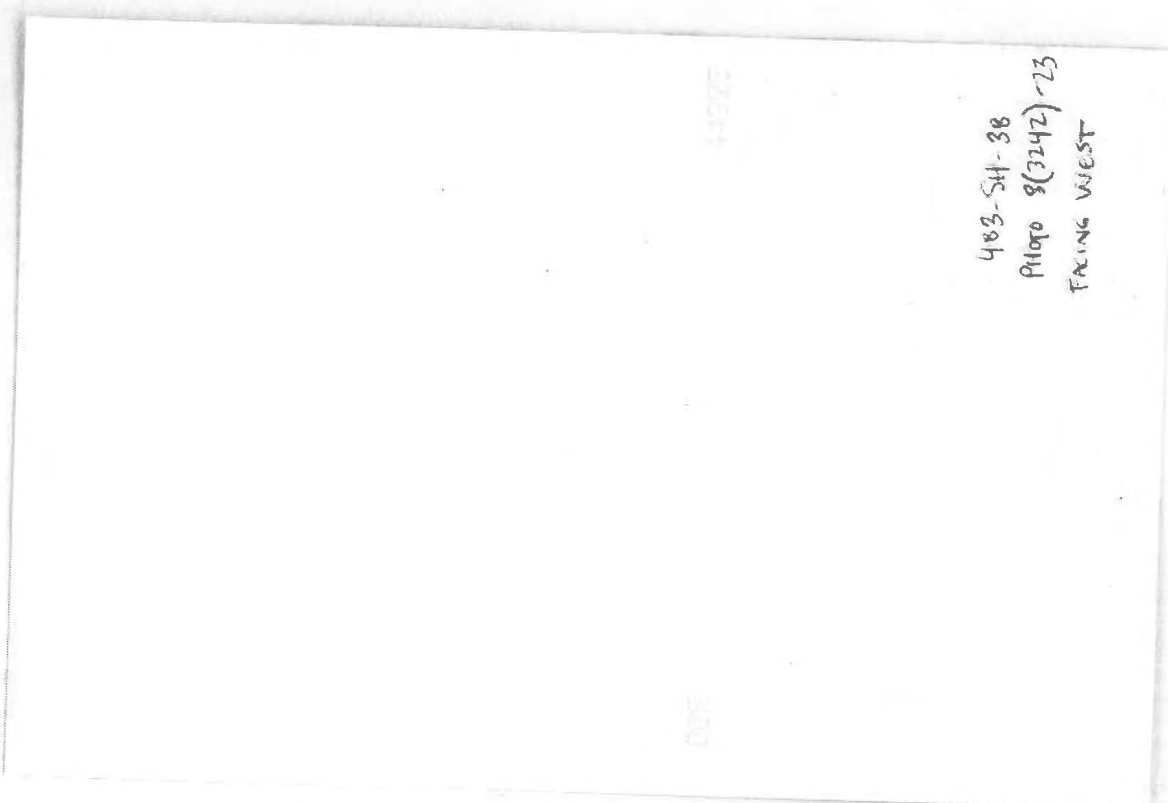
483-SH-38
PHOTO 8(3242)-21
FACING EAST

Stylistic Influence(s) Deco / Moderne

Roof type flat w/ scalloped parapet Materials _____

Wall façade clay tile (2 colors); brick on non-public facades Foundation STUCCO in main facade

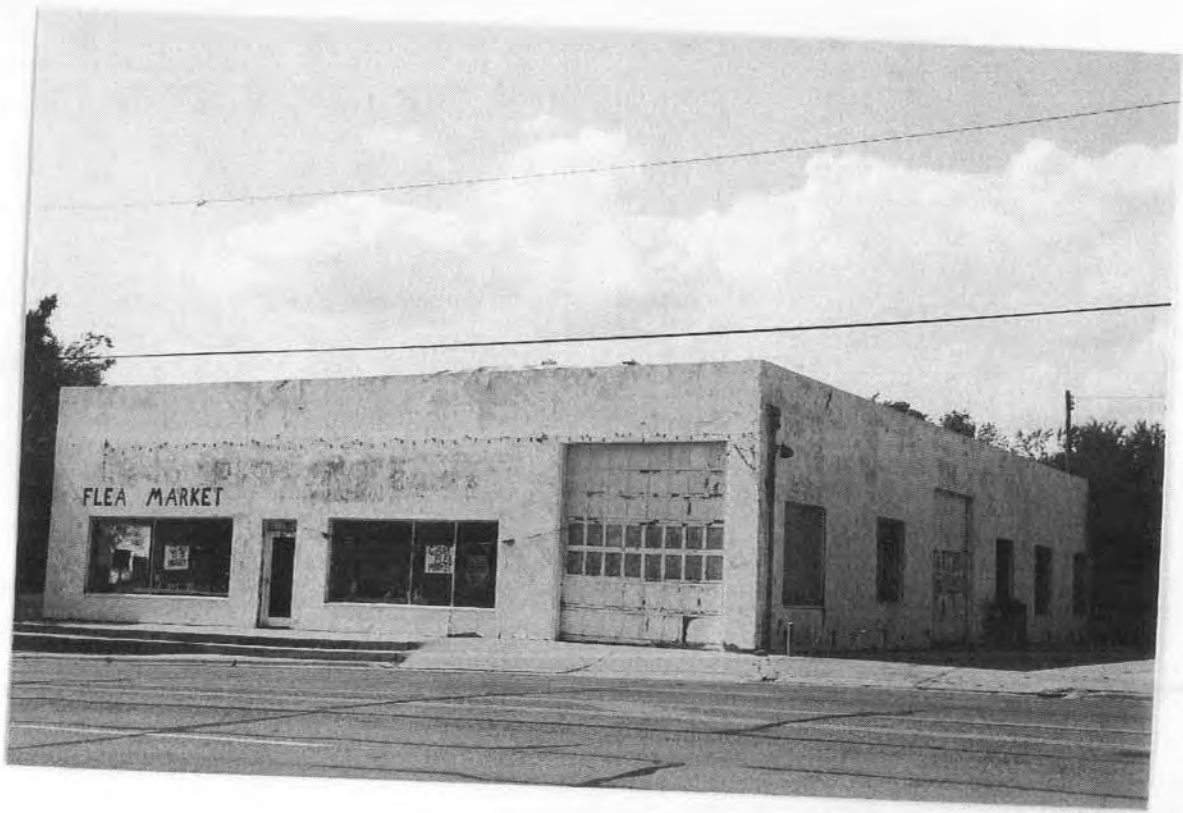
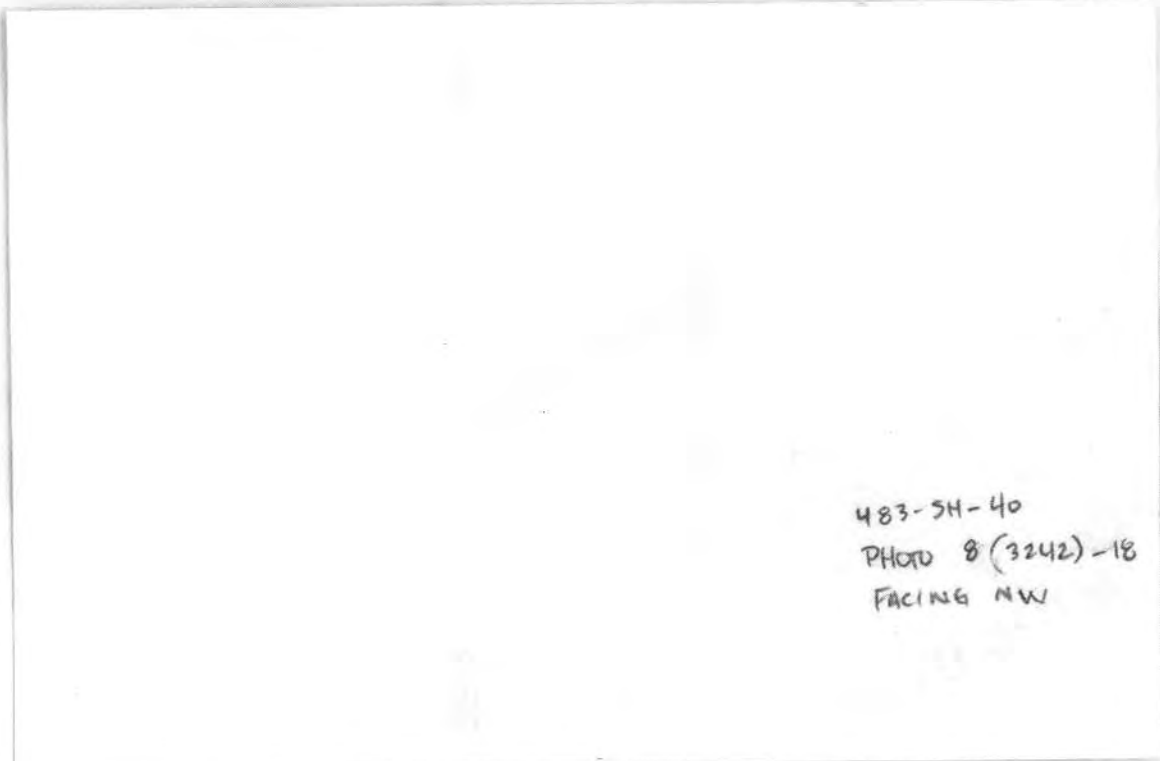
483-54-40
PHOTO 8 (3242)-18
FACING NW

General Architectural Description Large box-like bldg, perhaps combo show-room, & garage space

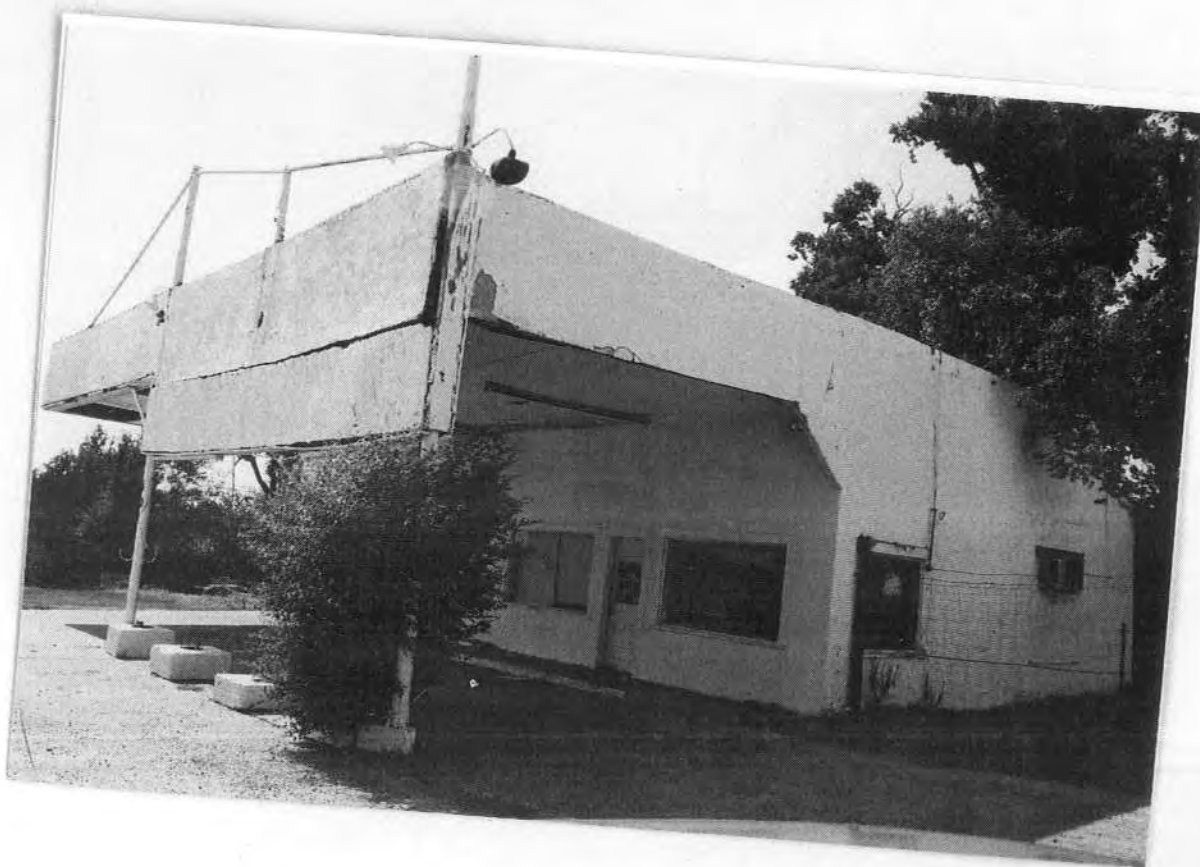
General Architectural Description typical gas station - unusual clipped end on underside of port cochere. Framing for roof signs remain.

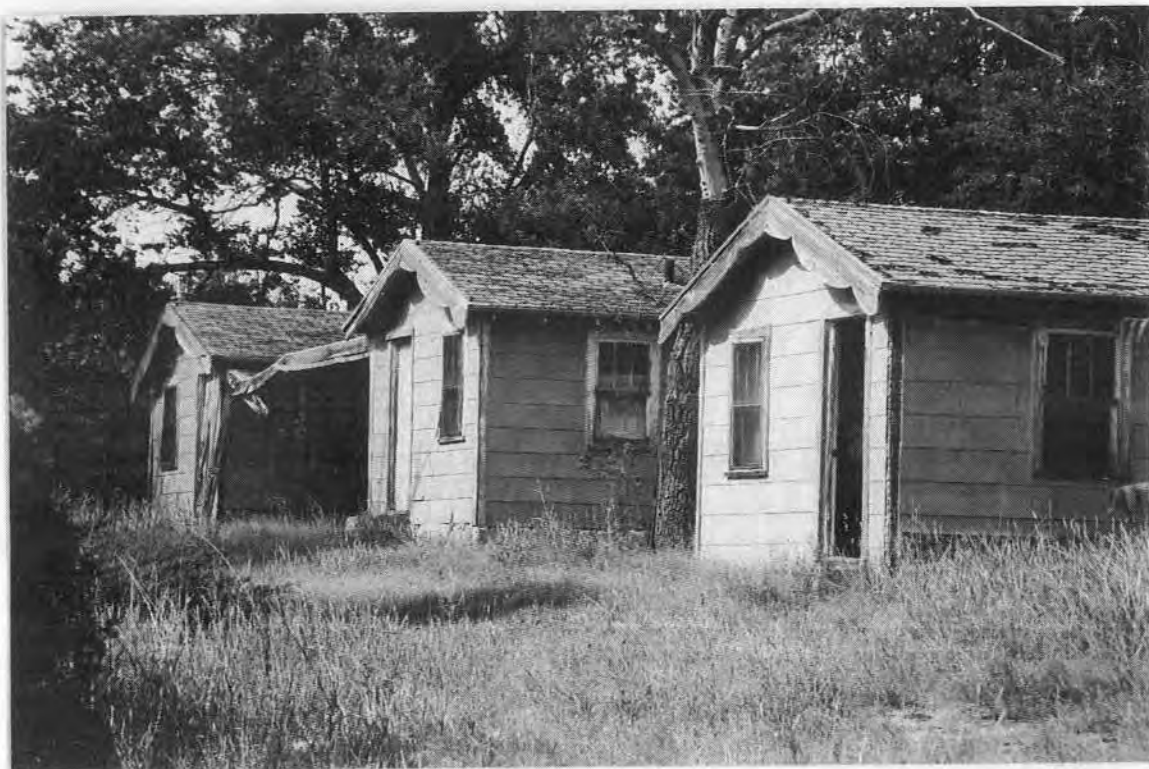
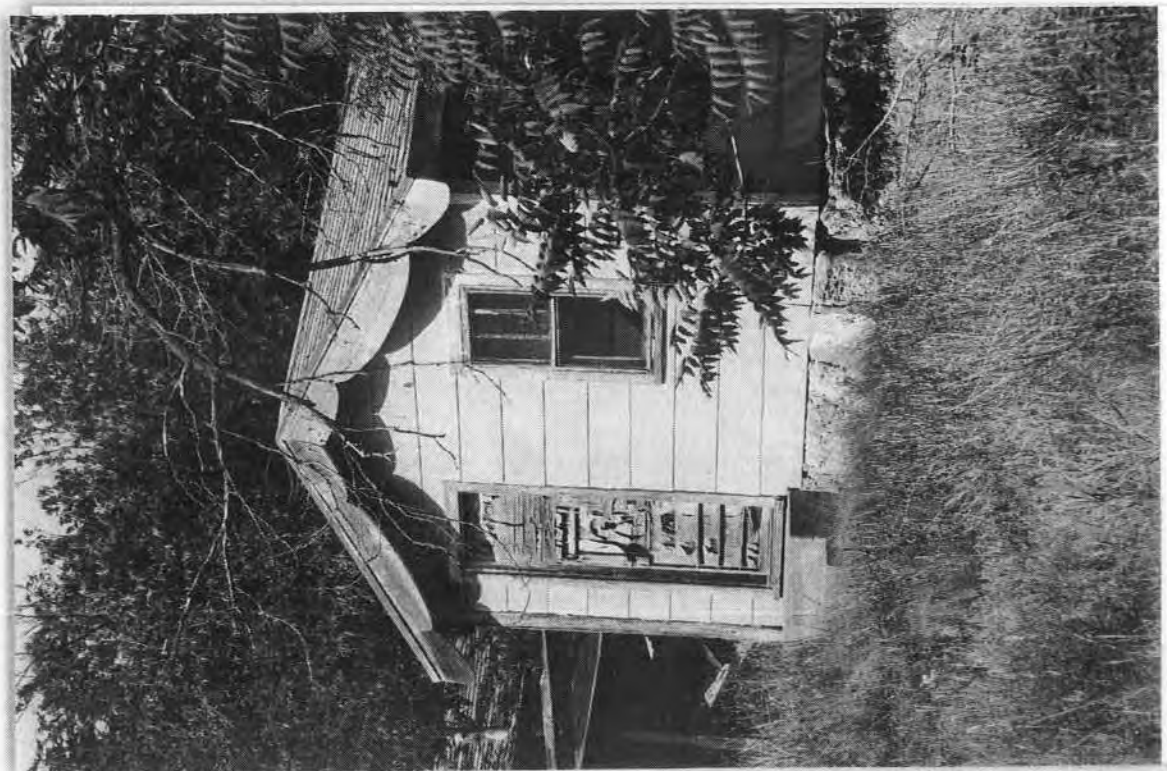
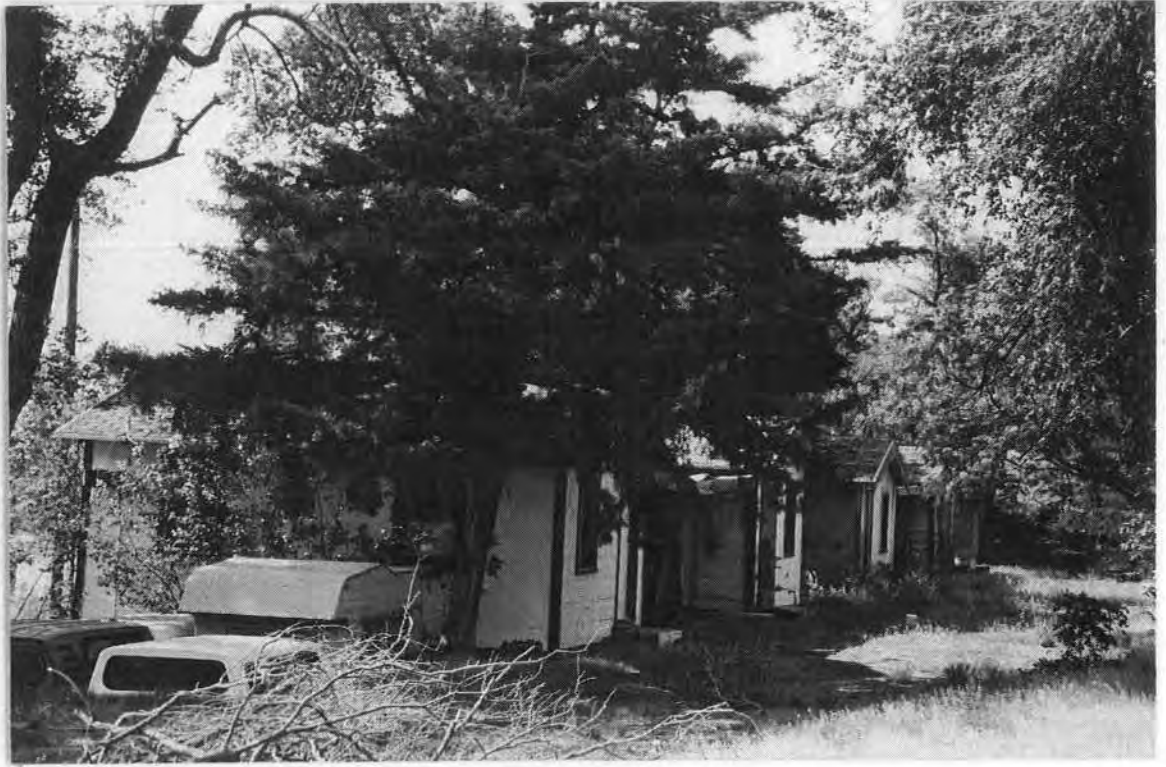
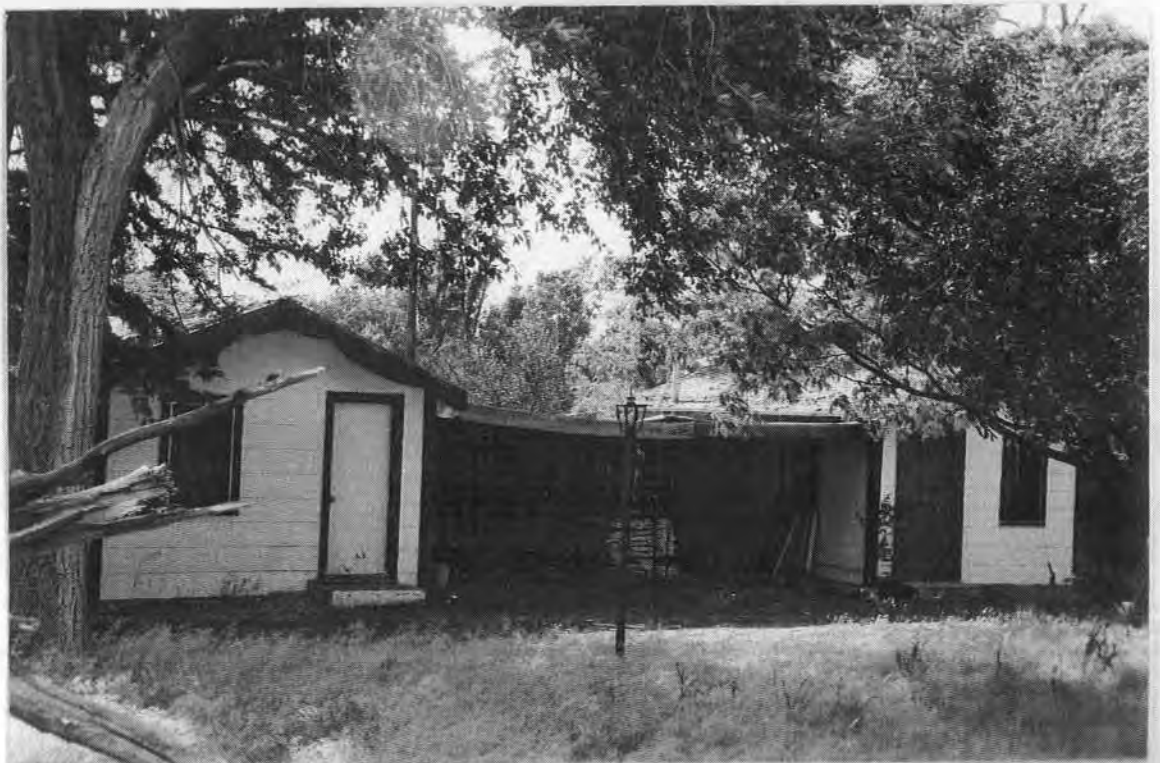
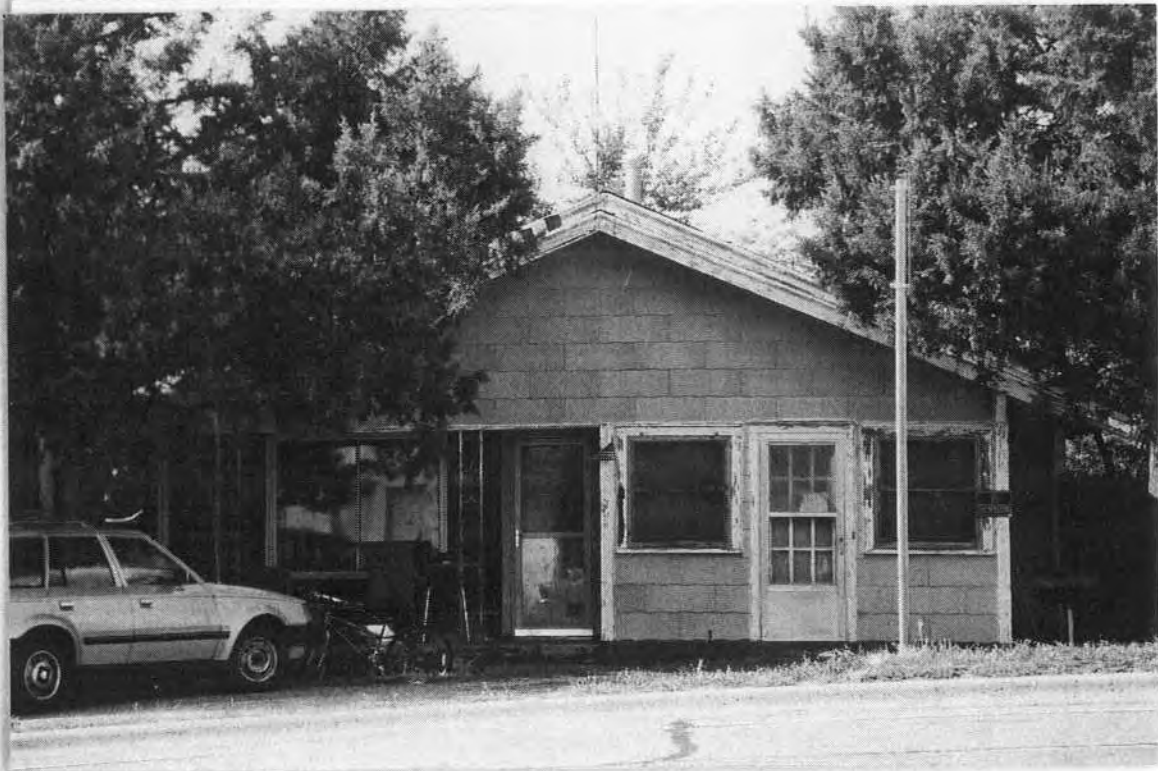
483-54-42
PHOTO 8(3242)-14
FACING NW

Chimney(s) _____
 General Architectural Description Tourist courts w/ 10 units. Two cabins are joined by double-car porch supported in center w/ metal pole. Most have scalloped fascia boards. Green Bungalow was office - front gabled w/ inset porch, 2 entrances (prob. 1 for business & one for res.) ? ← not all are visible at interior

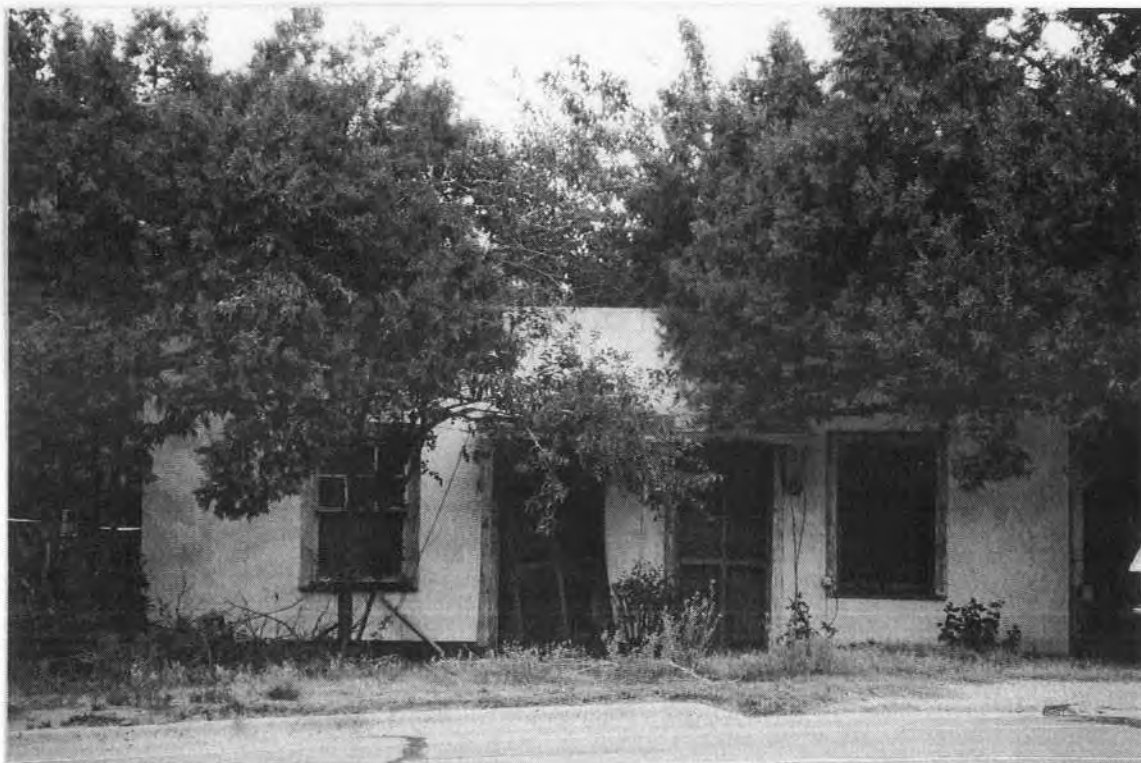
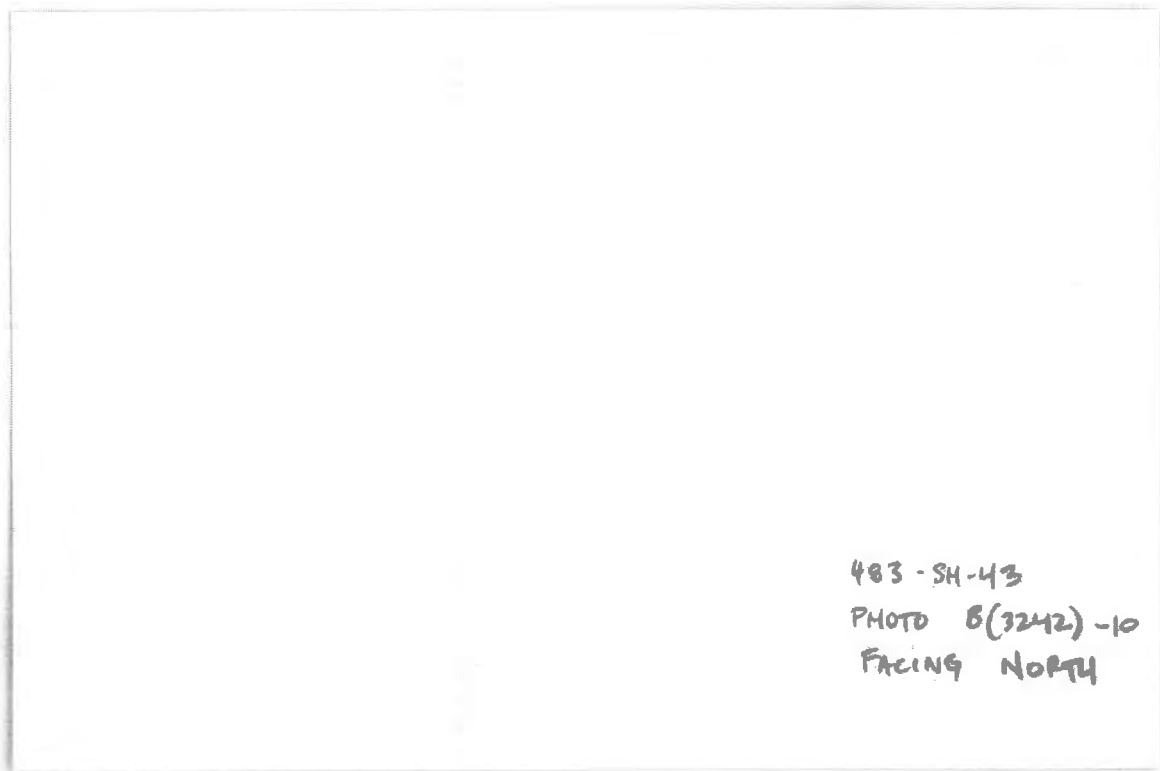
483-SH-43
PHOTO 8(3242)-10
FACING NORTH

Wall façade white stucco _____ Foundation _____

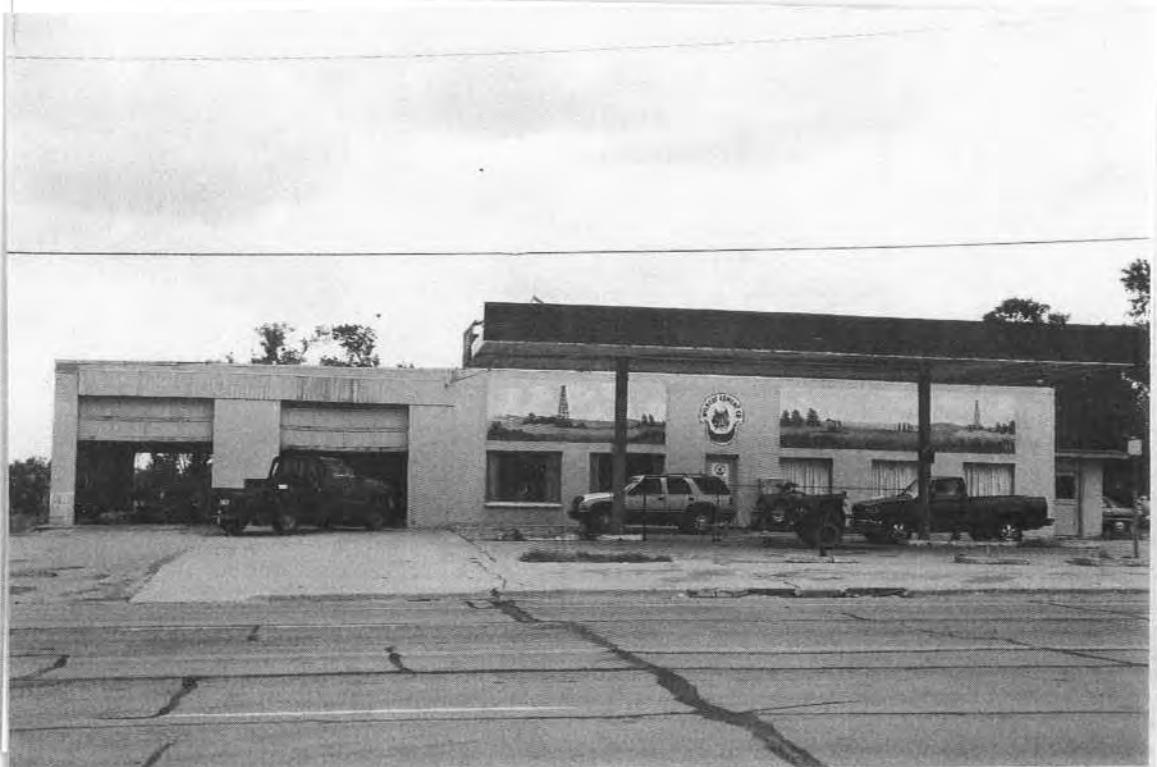
General Architectural Description garage bays are pull-thru (w/ symm. overhead doors @ rear) lg box-like bldg w/ small projection to E side. Large canopy intact. Original sign frame present.
