Historic Resources Survey

Route 66 through Texas

Survey Materials

Wheeler County

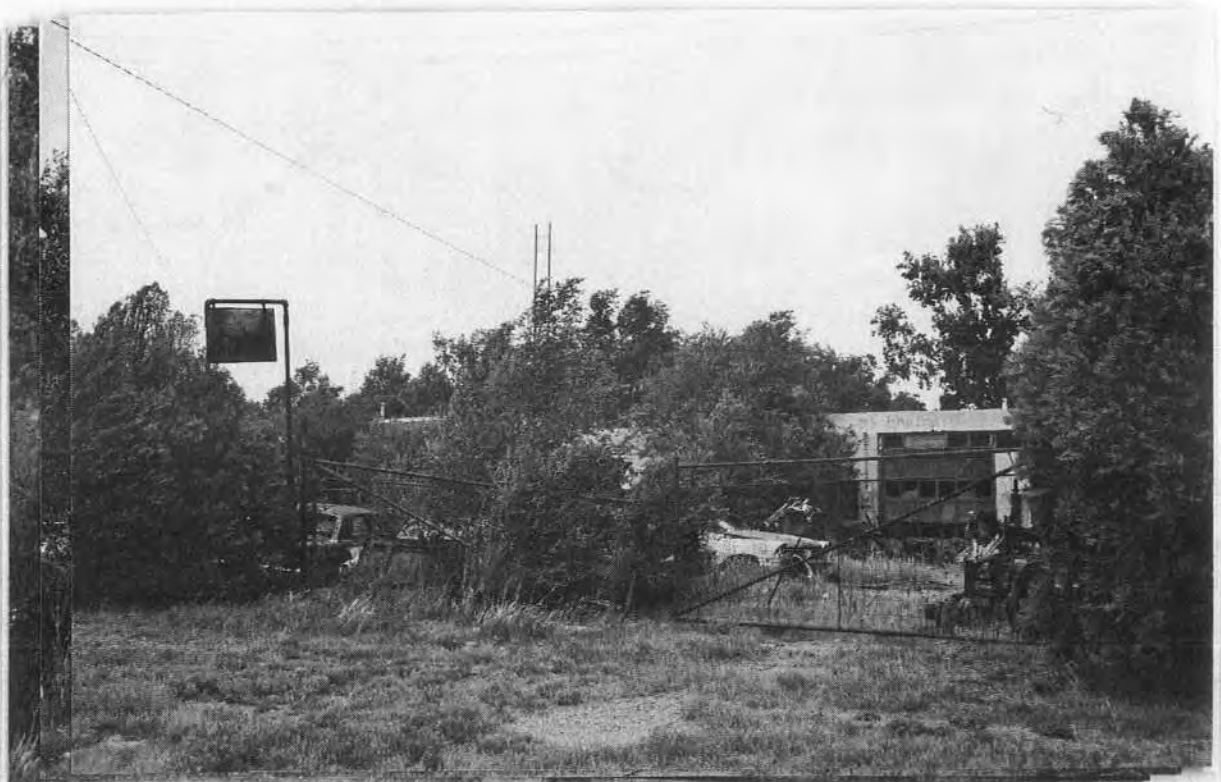
Wall façade Stucco Foundation _____

General Architectural Description Most of bldg is obstructed by trees & junk. Elements are not in full view. Old rusty sign out front, illegible. Jeep on top of bldg! Appears to be part of a complex of bldgs - rest are domestic.

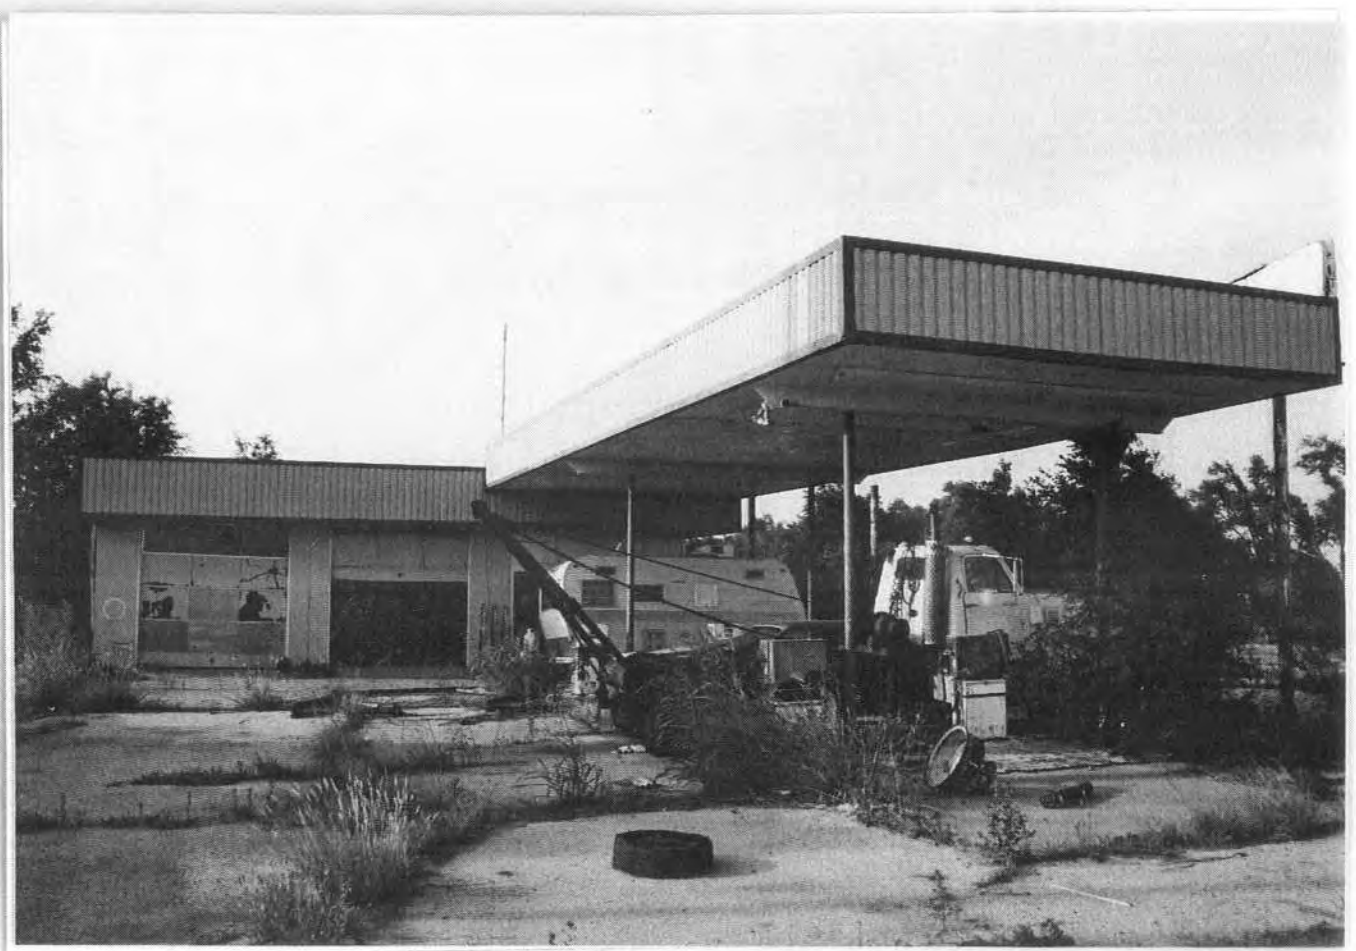
Roof type flat w/ corr metal parapet Materials _____

Wall façade stucco Foundation _____

certainly grand time of 1940s/1950s?

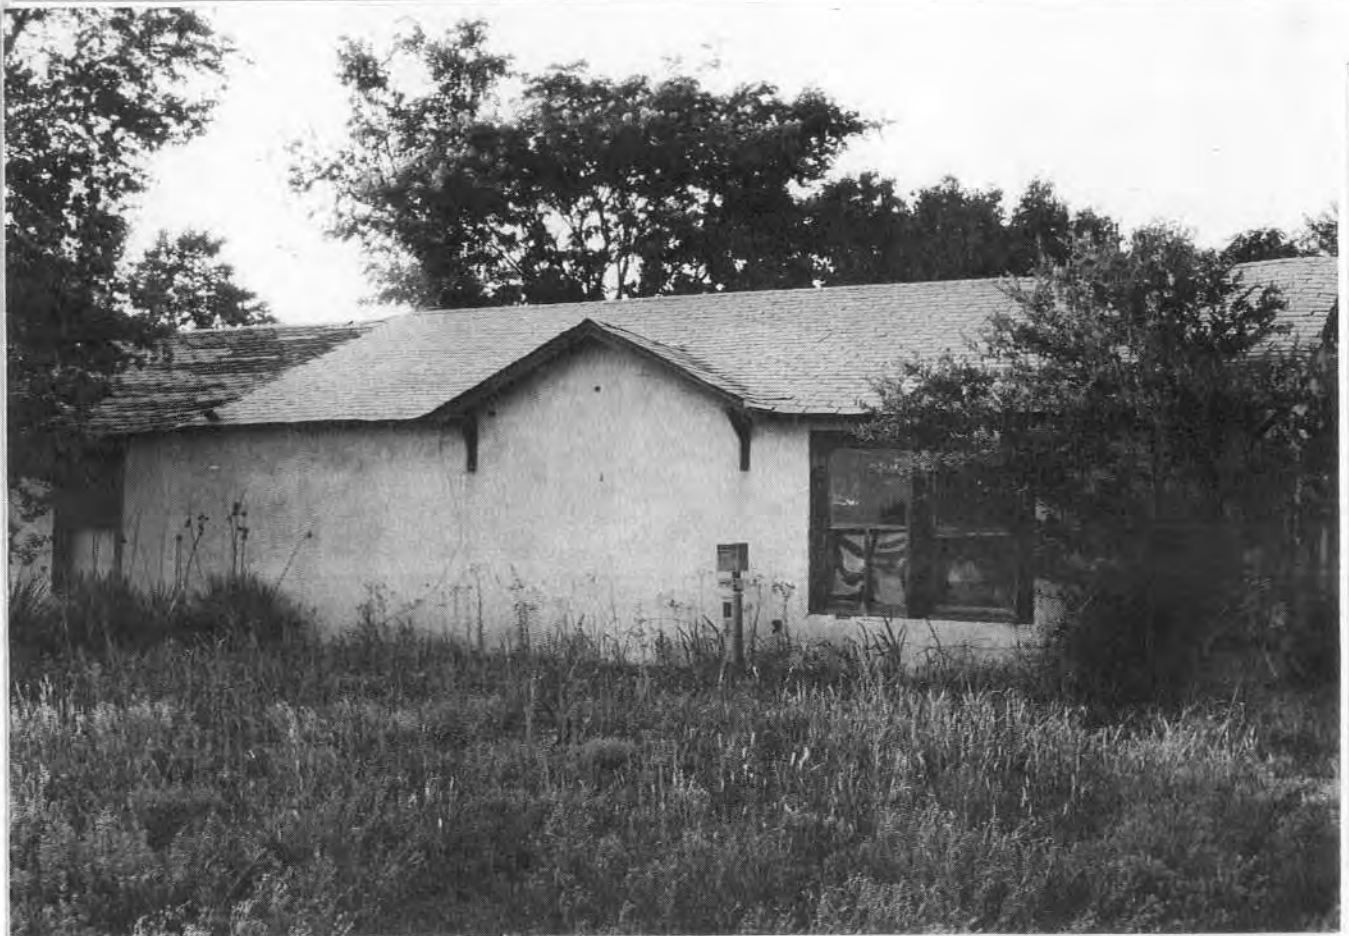
Stylistic Influence(s) _____
 Roof type s. do gable w/ project front gable Materials succ old entrance exposed rafters ends
 Wall façade Stucco Foundation _____
 Window type wood sash Materials _____
 Door type front entrance filled in. Main door on W end Materials _____
 Porch type n/a but has slight projecting gable supported in Materials in knee brackets
 Number of Stories 1 Plan linear
 Chimney(s) _____

General Architectural Description function unclear. Only unusual feature is
entrance treatment

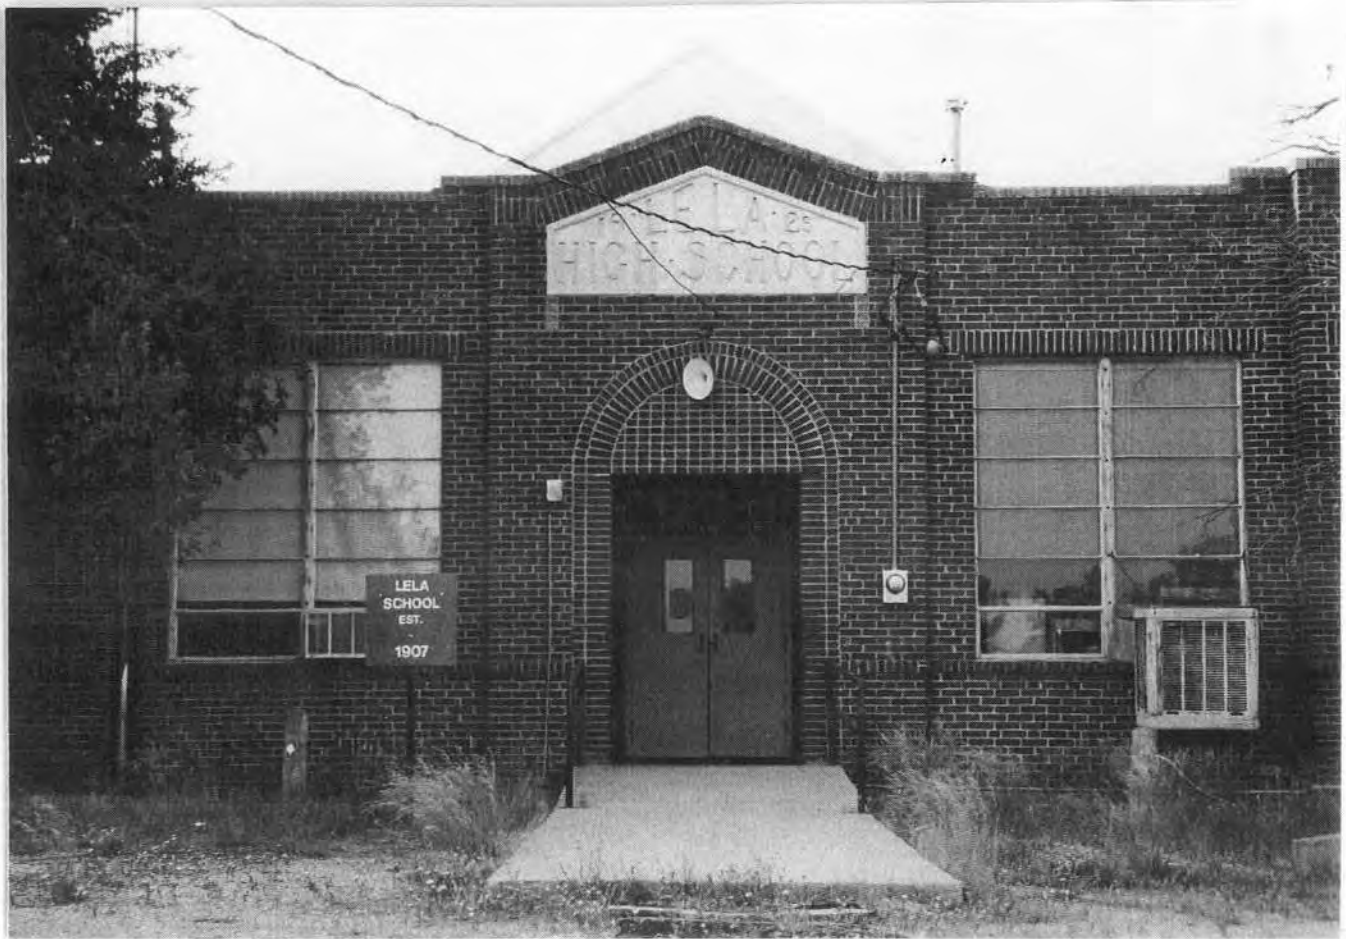
Stylistic Influence(s) _____
 Roof type pitched behind parapet Materials corr metal (new)
 Wall façade multicolored (red & darker) brick Foundation _____
 Window type hopper style under fixed multi lite Materials metal
 Door type inst. double metal doors w/ small Materials 6 in each door
 Porch type inset entry Materials _____
 Number of Stories 1 Plan _____ *roof line*
 Chimney(s) _____

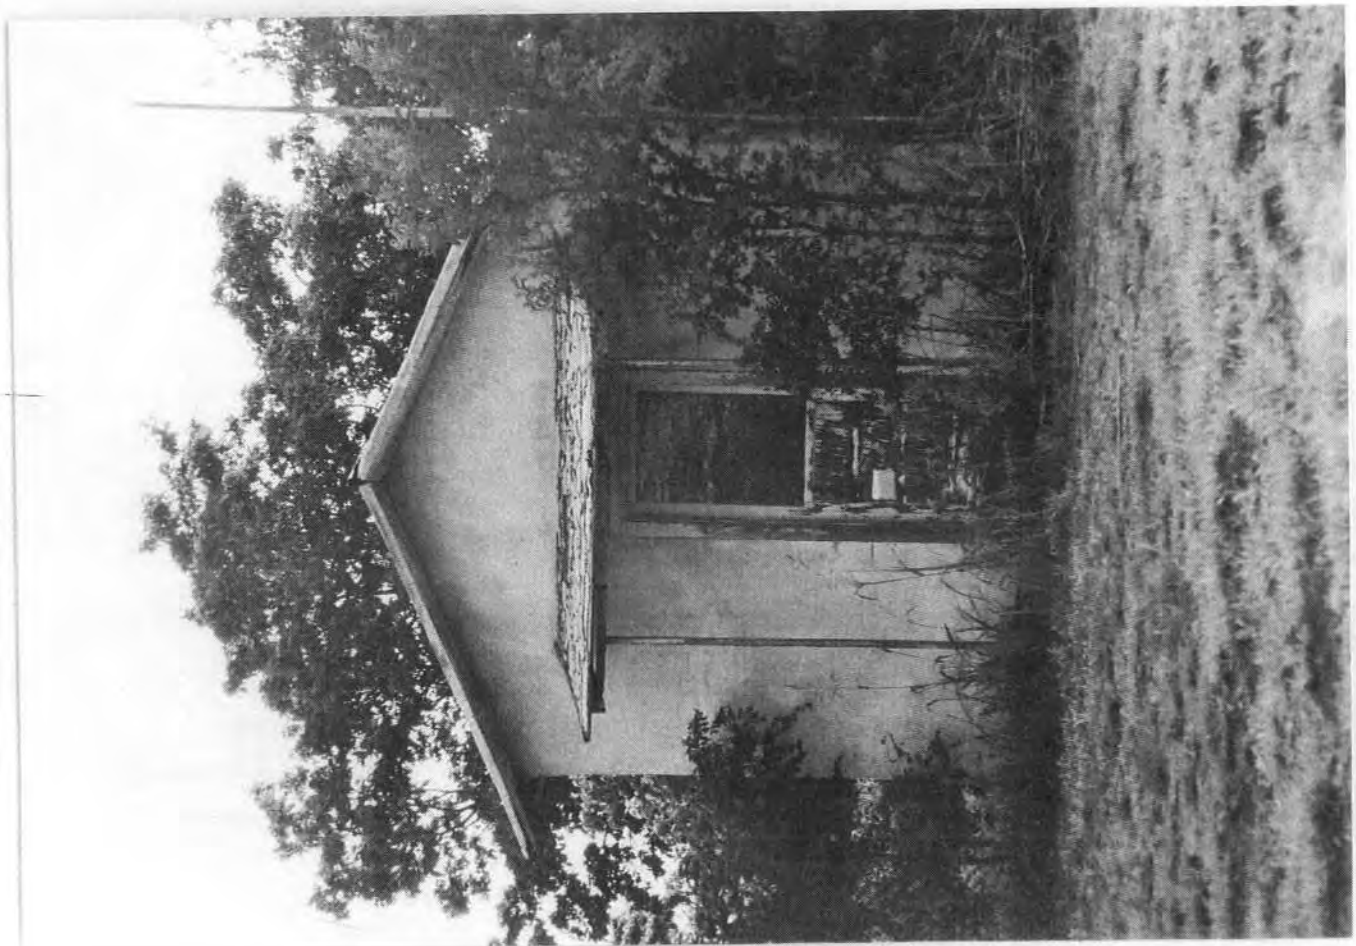
County Wheeler City Kila Inventory # 483-LE 4

Roof type front gable w/ exposed rafters

General Architectural Description tiny shack, but looks to have had corner
fracture. Sides obscured by brush.
