Historic Resources Survey Route 66 through Texas

Survey Materials

Glenrio

Prepared By: Monica Penick, Consulting Architectural Historian

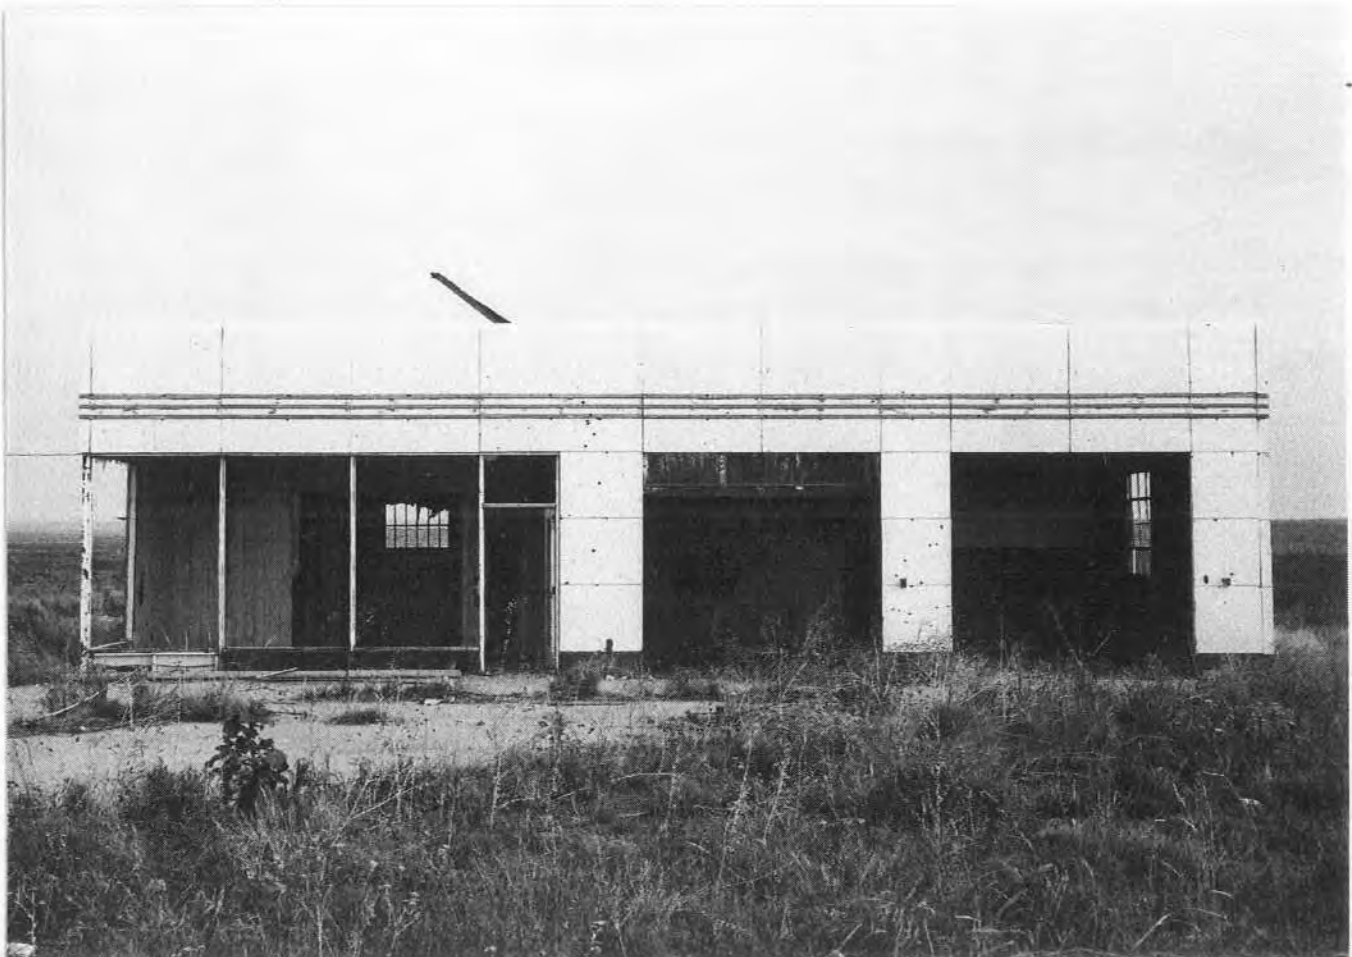
PHOTO 20-3754-17
FACING NORTH

Wall facade white porcelain w/ 3 horizontal green stripes Foundation _____

Window type metal frame - glass missing Materials _____

Door type metal frame - glass missing w/ transom; 2 overhead bays Materials _____

*bldg prop. moved from Glenridge to Ifo road

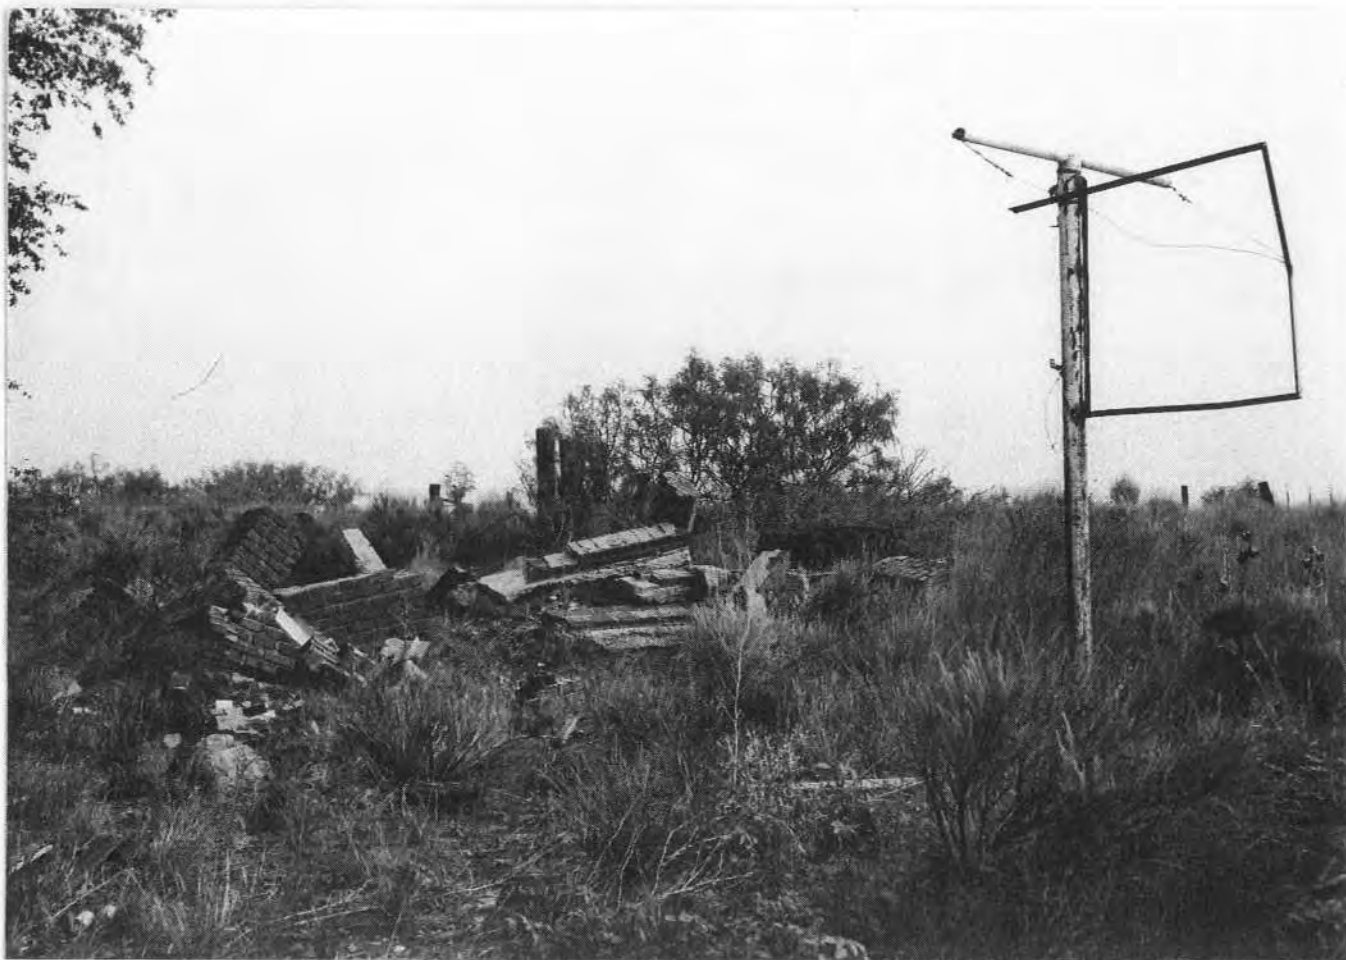
117 GL-3
PHOTO 20-3754-16
FACING NORTH

General Architectural Description brick rubble & sign frame

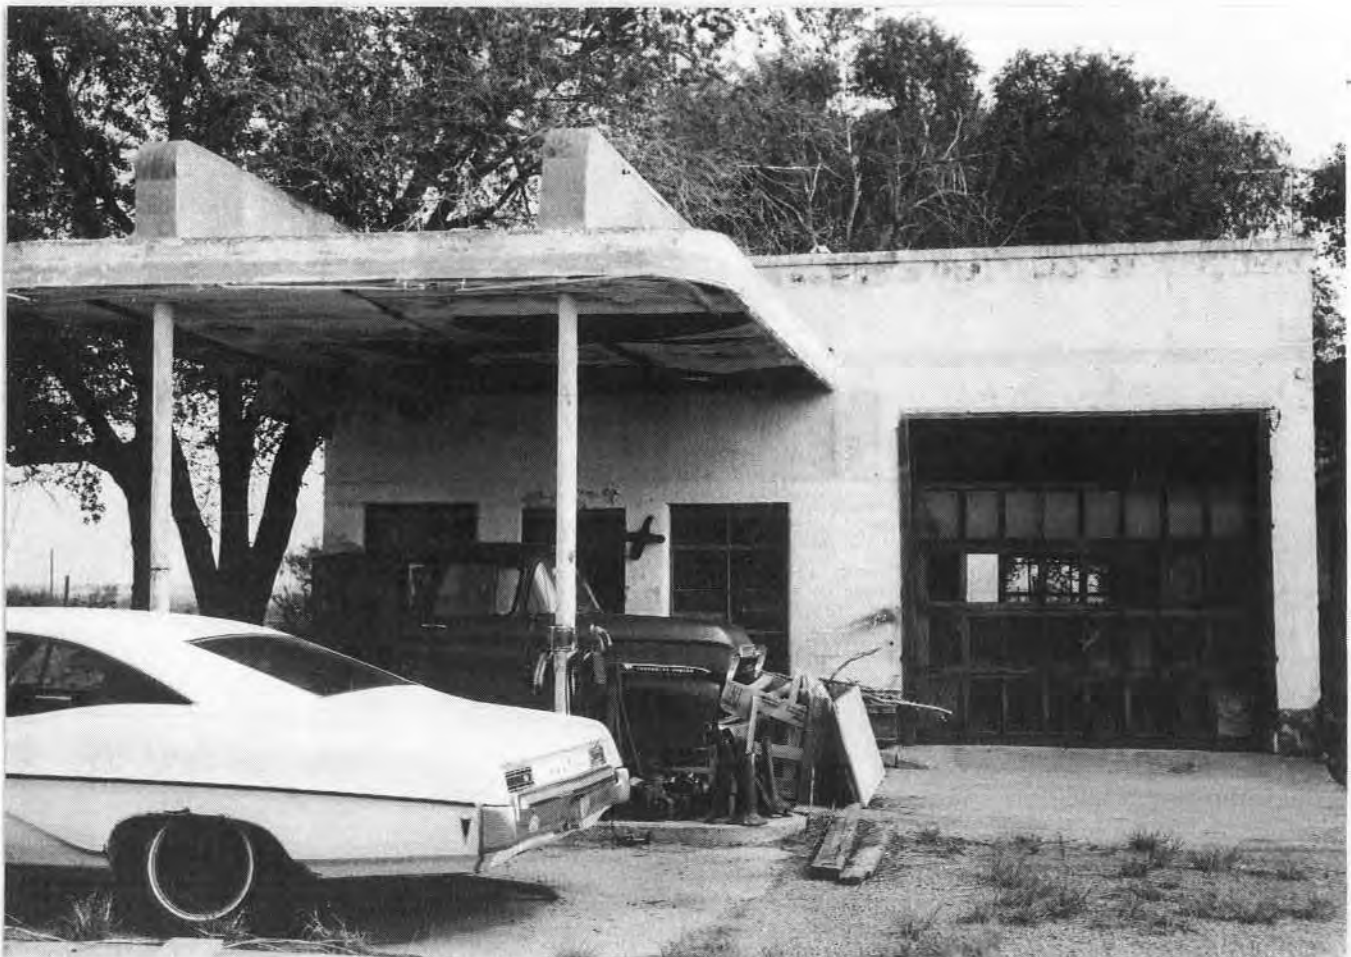
117-6L-4
PHOTO 20-3754-15
FACING NORTH

Roof type flat w/ parapet Materials _____

Wall facade stucco over conc block Foundation _____

Window type #8 light metal casement Materials _____

Door type 1 man door - frame glazed in wood Materials multipanel overhead door 2 rows glaz.

Porch type canopy on steel posts, rounded corners Materials Protruding ridge row

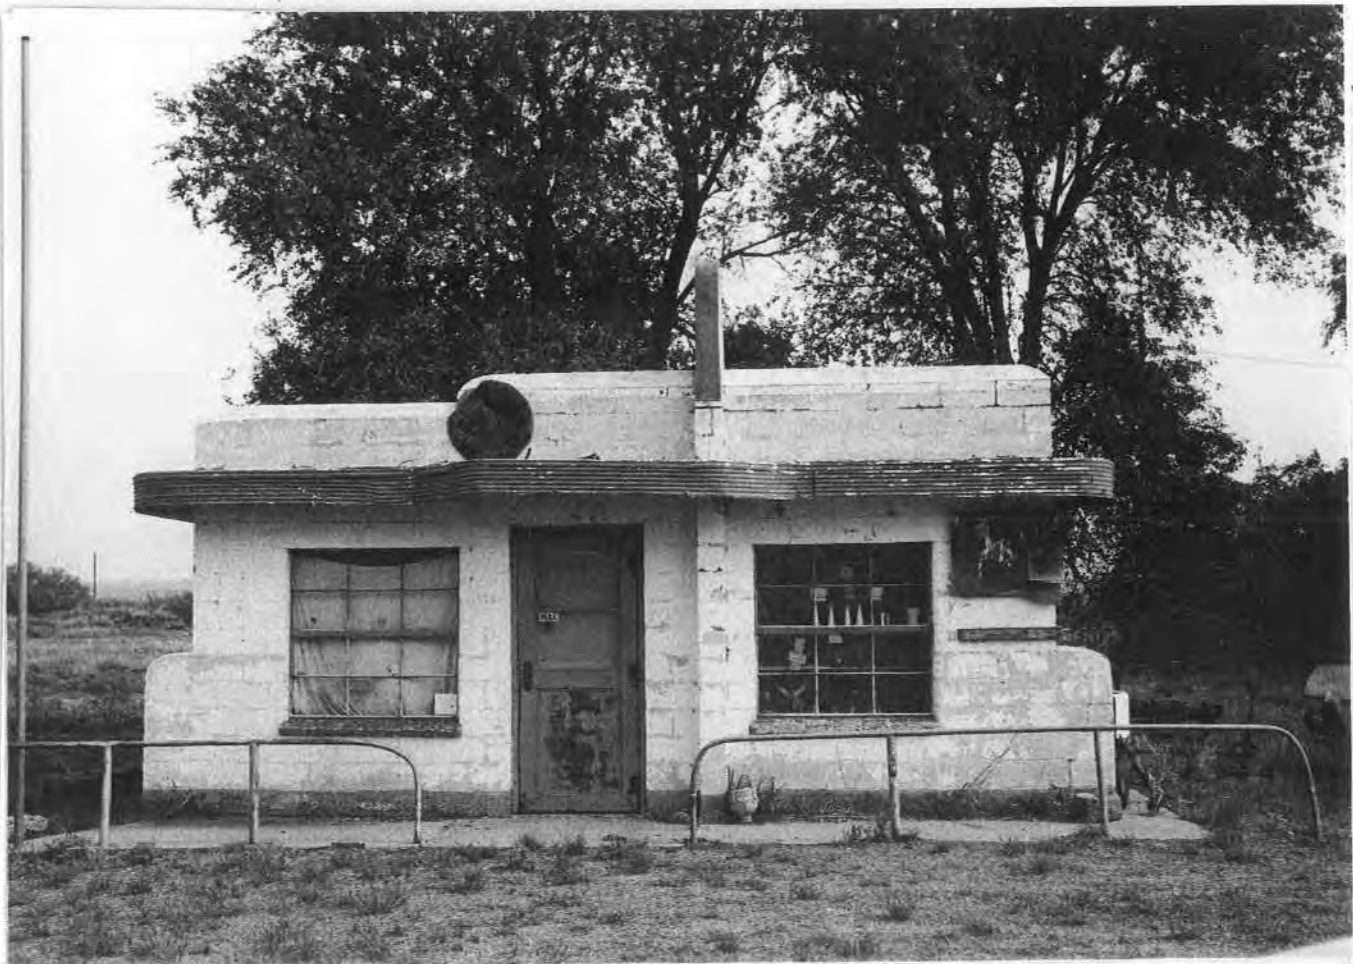
Roof type flat w/ parapet, curved toward rear of bldg Materials _____

Wall facade painted conc block Foundation _____

Window type metal casement Materials _____

Door type 1/2 pane 1/2 glass, wood Materials _____

General Architectural Description modern influences seen in protruding beltline
or cornice line (done in corr metal w/ curved rxs).

protruding - loc's crown? Door in rear of E ele,
prob restrooms

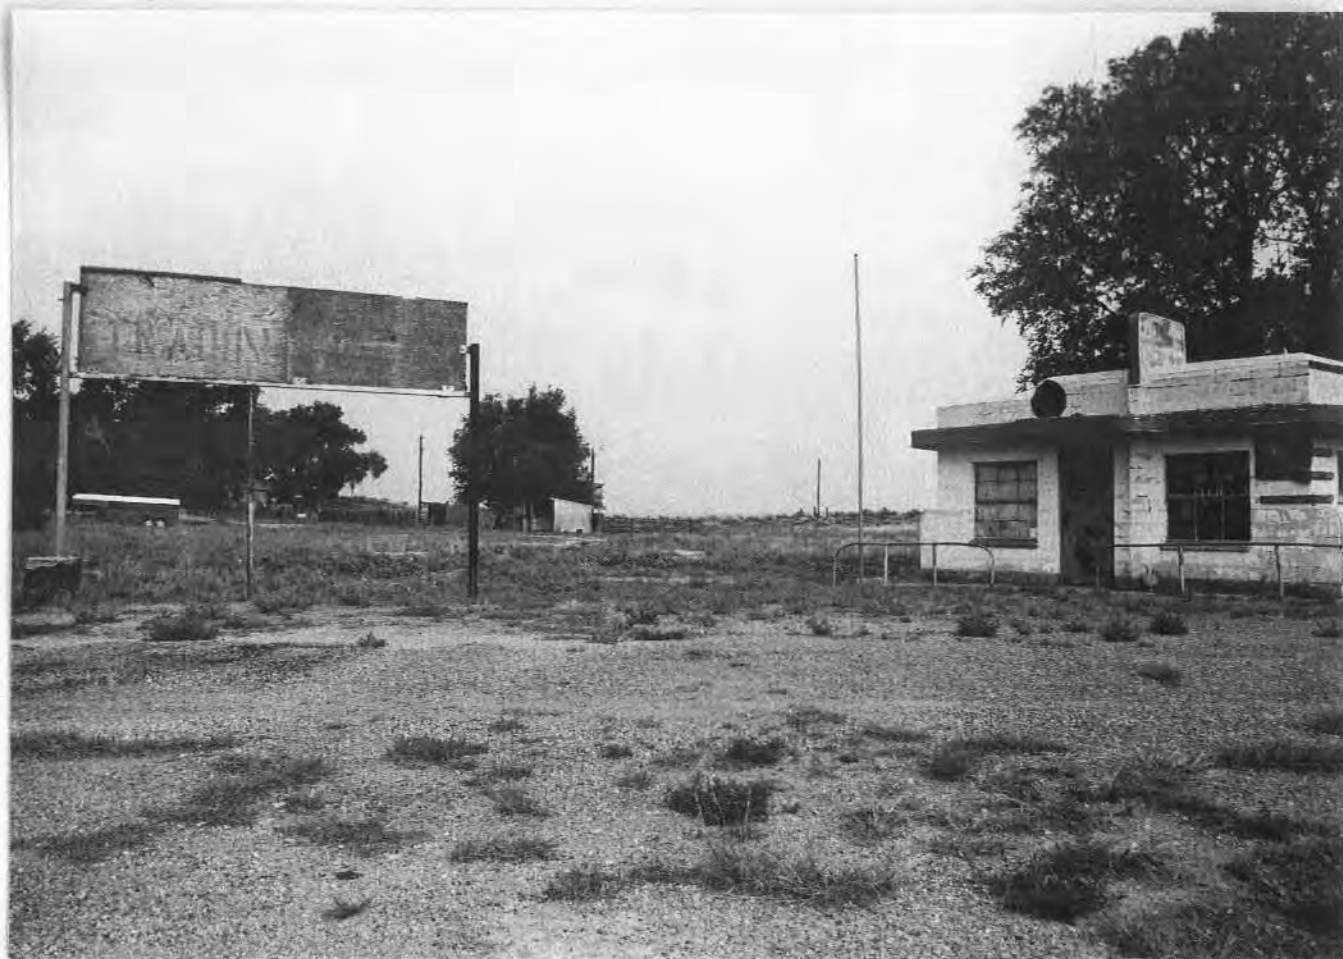
117-66-5
PHOTO 20-3754-12
FAC NO NW

12 overall w/ sign NW

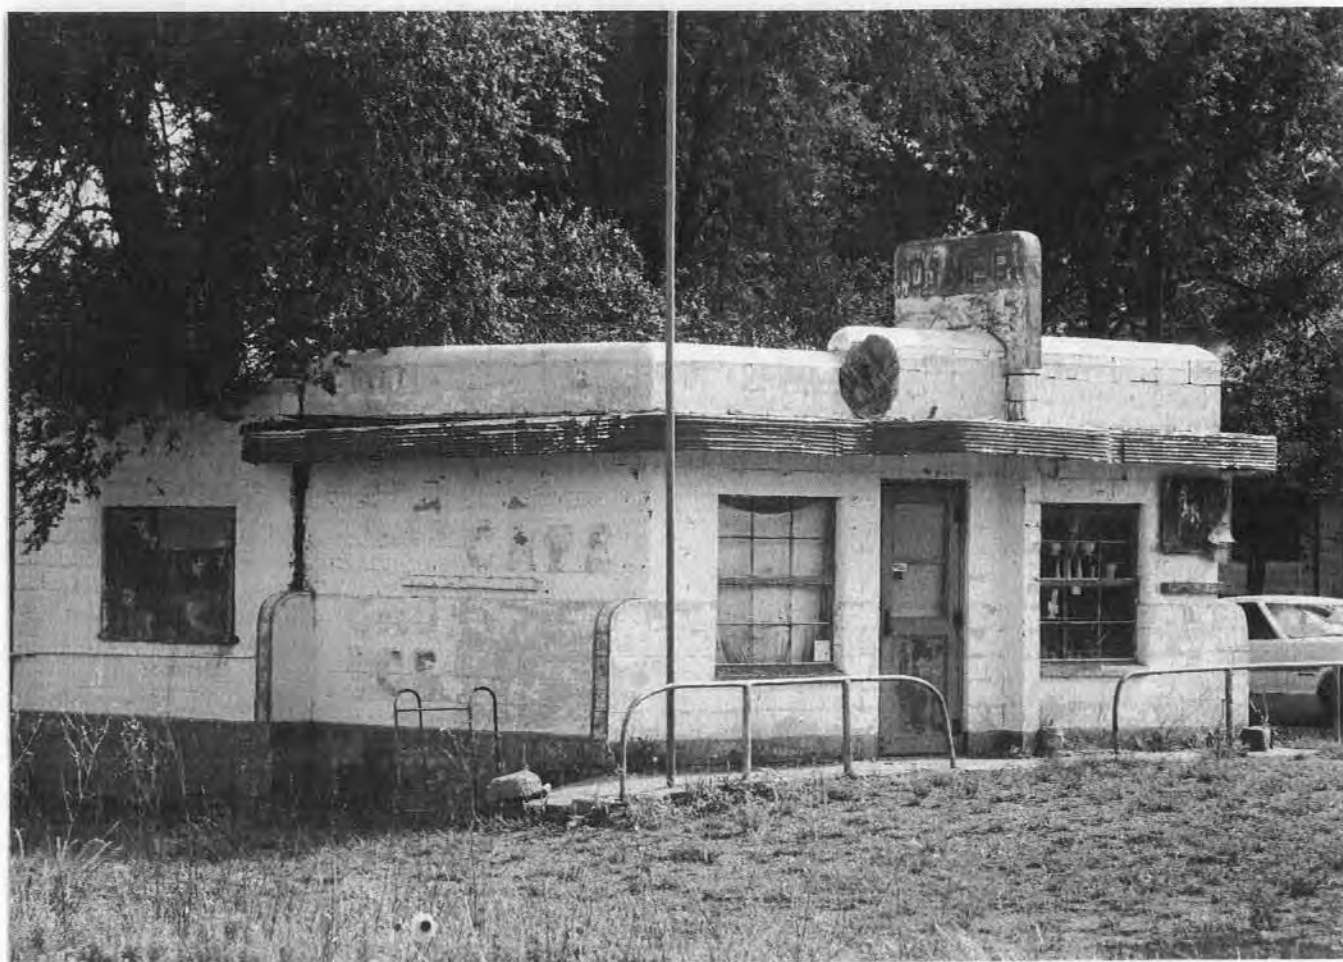
117-66-5
PHOTO 20-3754-11
FACING EAST

11 lock

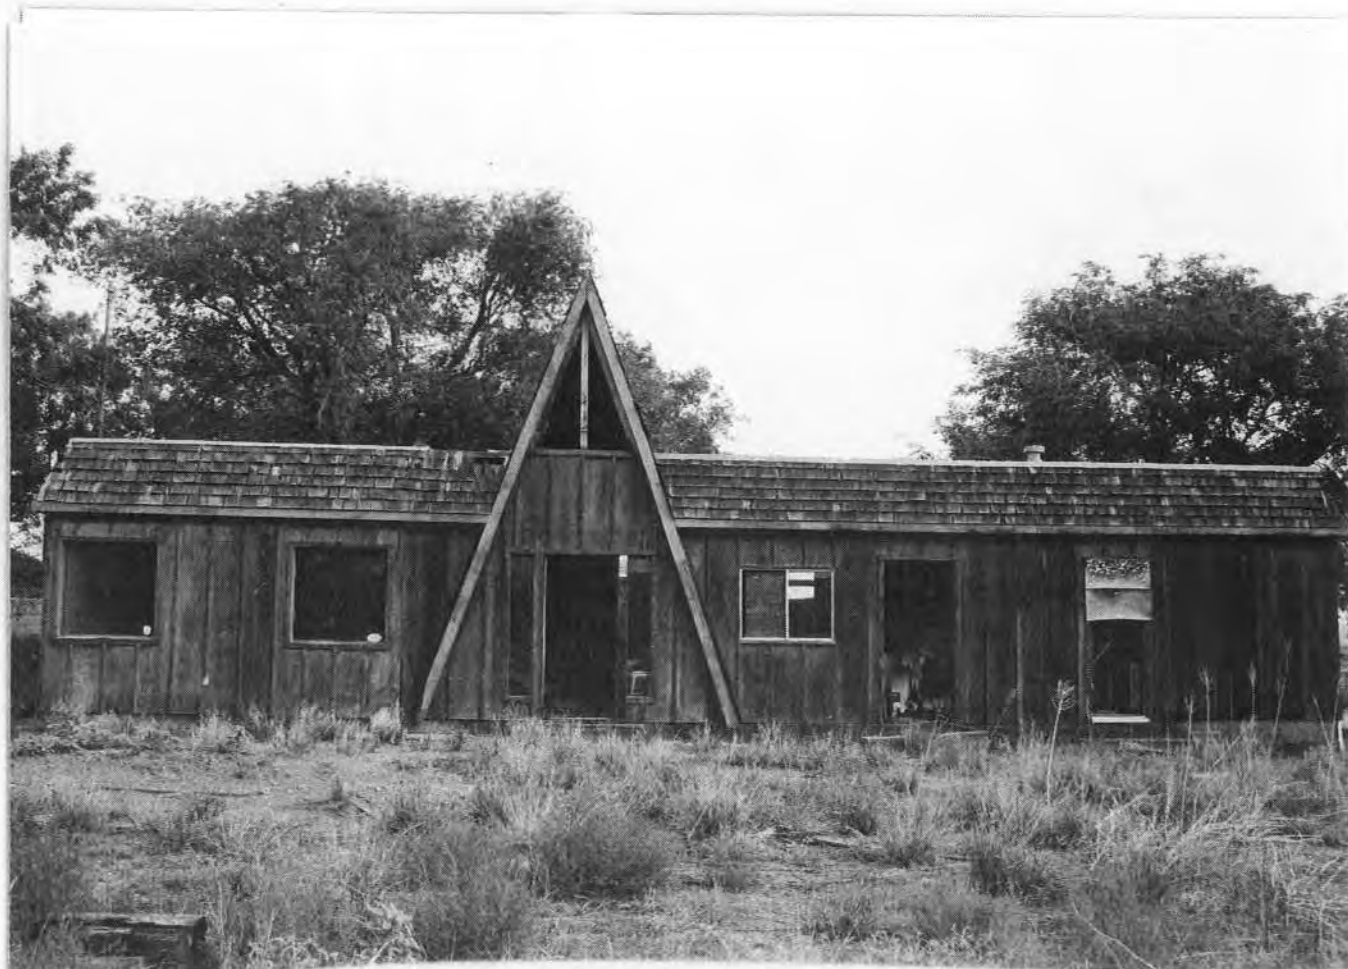
Stylistic Influence(s) _____
 Roof type mansard w/ A-frame ^{A-frame?} ~~- mansard~~ is wood shingle, rd is likely flat
 Wall facade board & batten
 Window type plate in wood
 Door type missing; central door had side light Materials 3 openings for doors
 Porch type N/A
 Number of Stories _____
 Chimney(s) _____

General Architectural Description unusual A-frame entry portal on this
 1 unit deep linear plan bldg. All used wood
 shingle. No signage

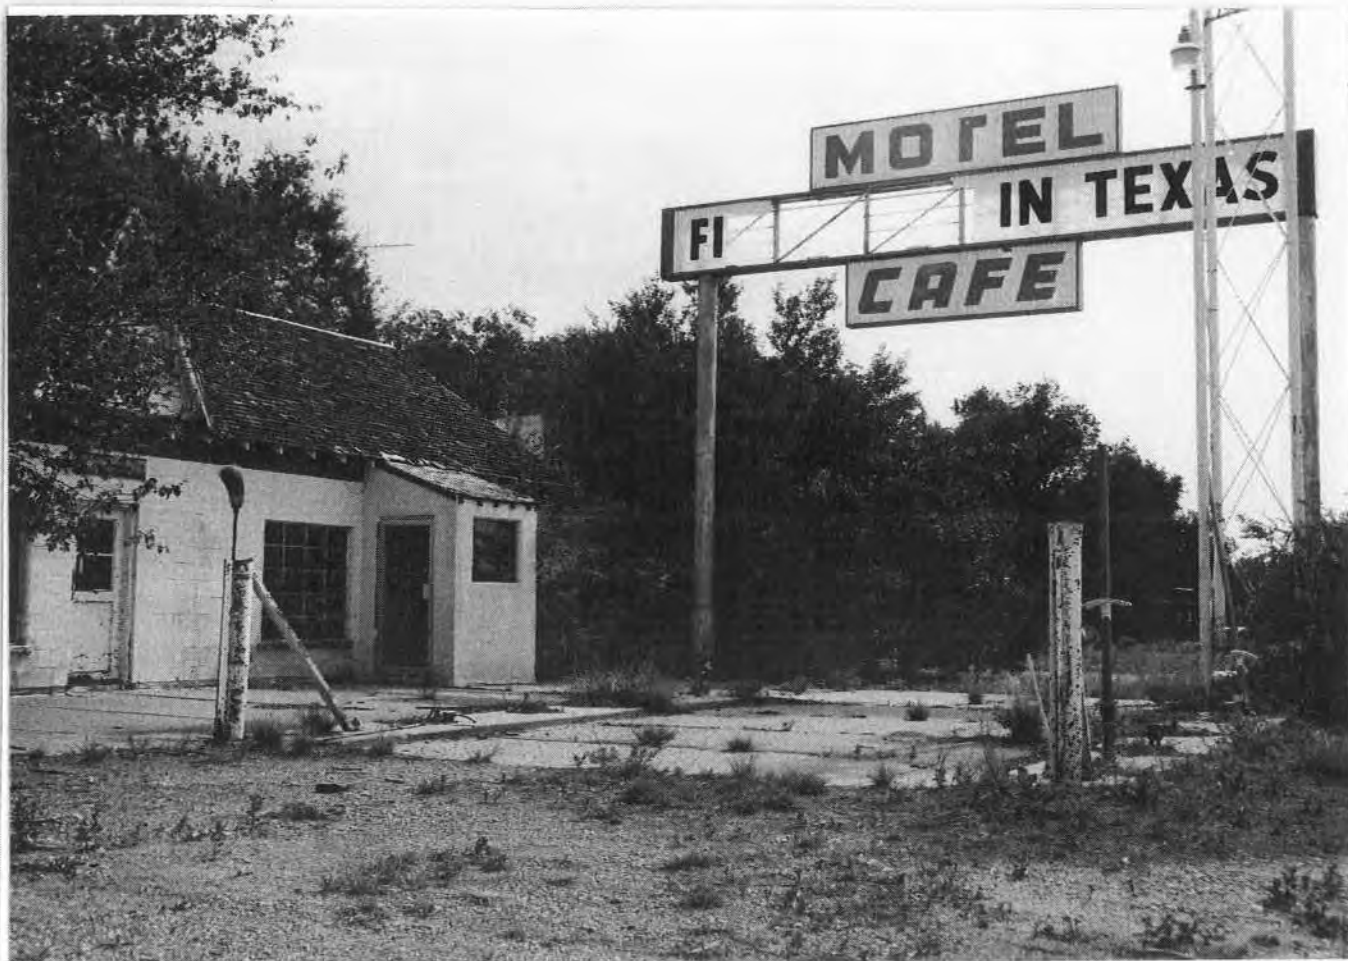
Roof type ^{① side gable w/ cross gable entry porch, covered shingle} ^{② side gable w/ ex raft ends, covered shingle} ^{③ exposed raft ends} Materials _____

Wall facade ^{① painted conc block} ^{② painted conc block} ^{③ W wing is stucco} Foundation _____

Window type ^{① metal casement} ^{② west wing has 4, wood sash} ^{③ metal sash} Materials _____

Door type ^{① 1/2 glass 1/2 panel, 1 derhaco bay, 1 bay glass in metal frame - this is at rear of entrance} ^{② west wing - wood paneled; N wing solid wood} Materials _____

Porch type ^{① covered} ^{② extending over porch in decorative iron rails} Materials _____

General Architectural Description ^{standing kids is not like long shing}
^{metal sign, no dots visible from street}

^{west wing appears oldest; E wing looks to have been residence}
^{office west combo gas / garage / office / maybe cafe}

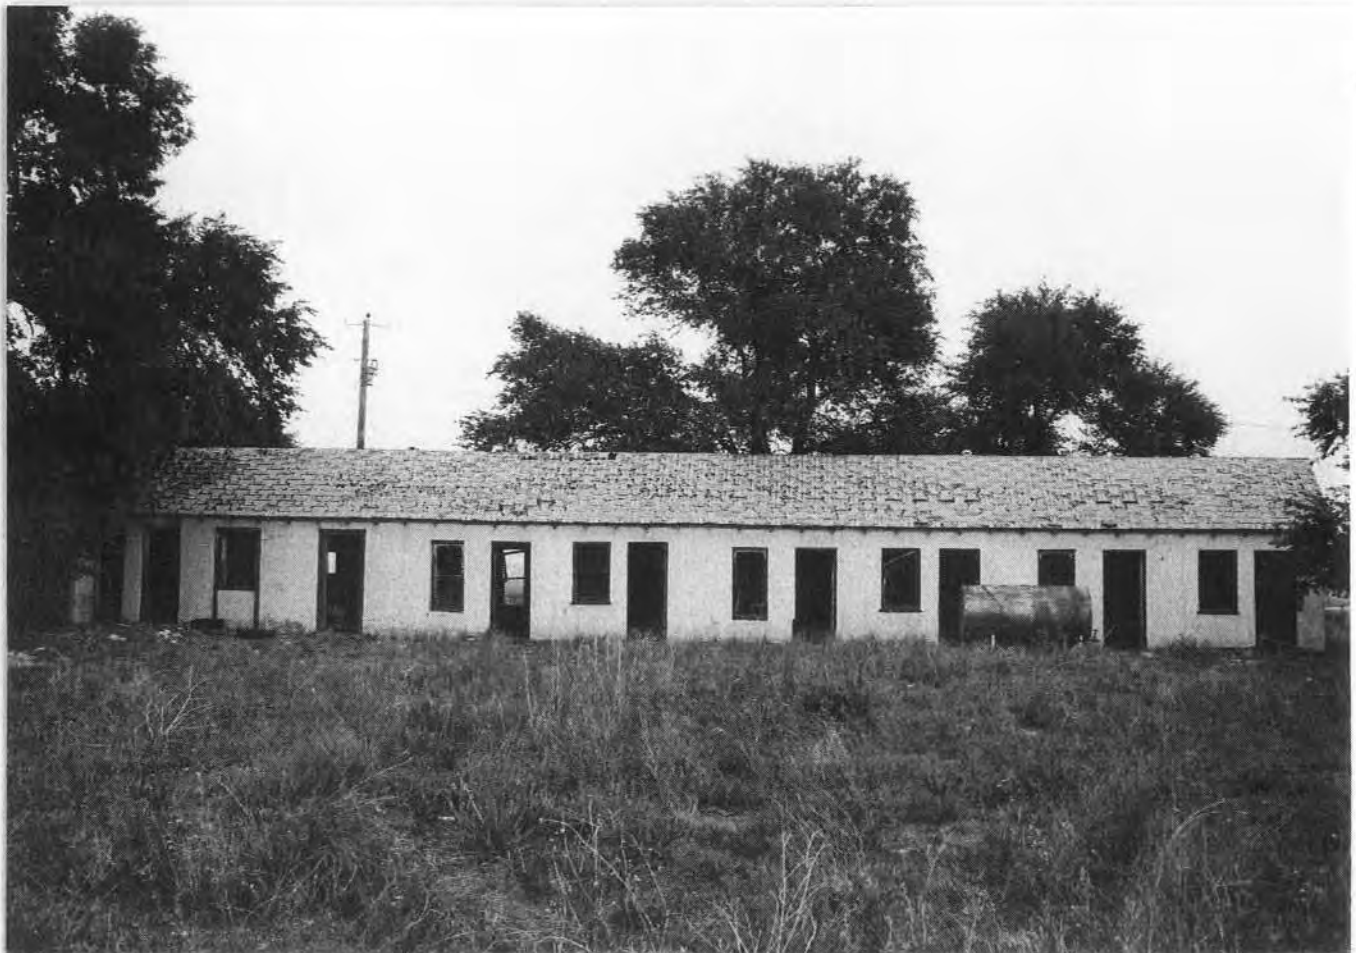
Roof type side gable w/ exposed rafters

Wall facade stucco

Window type 1" wood sash

Door type wood frame - [all doors missing]

General Architectural Description approx 7 units Bathrooms may have been
on W end,

19 may have been office for this motel

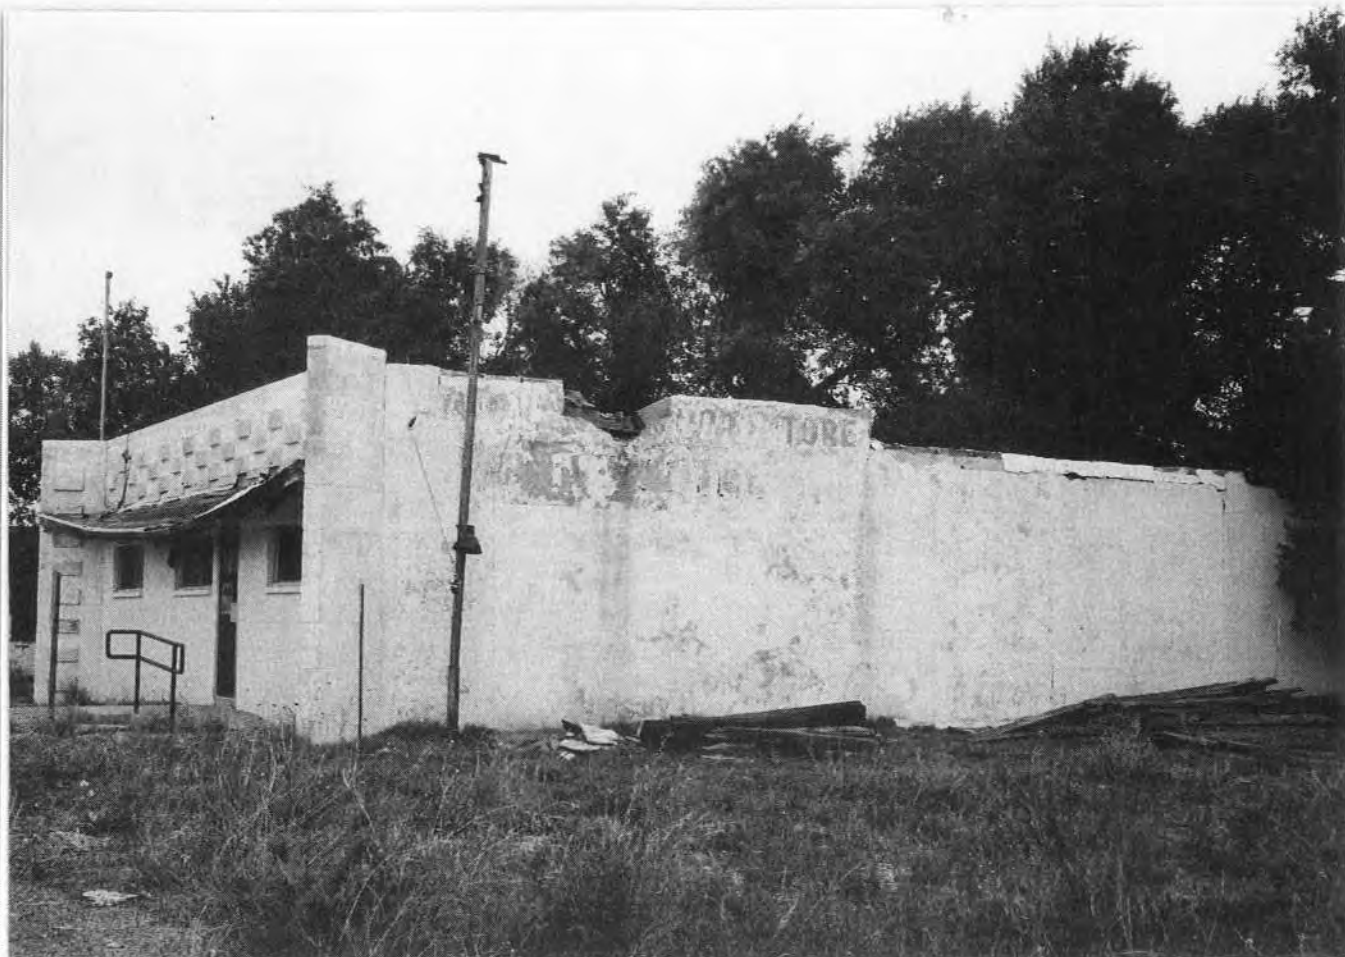
Roof type flat w/ parapet Materials _____

Wall facade Stucco / painted concrete block Foundation staked by walls

Window type front: horiz sliders in metal frame Materials _____

Door type fully glazed in metal frame Materials _____

Porch type wood frame awning no supports Materials _____

General Architectural Description facade has unusual protruding wings (1 cmu unit deep). facade also has decorative pattern comprised of alternating protruding blocks - painted yellow. Ghosting - N E etc.

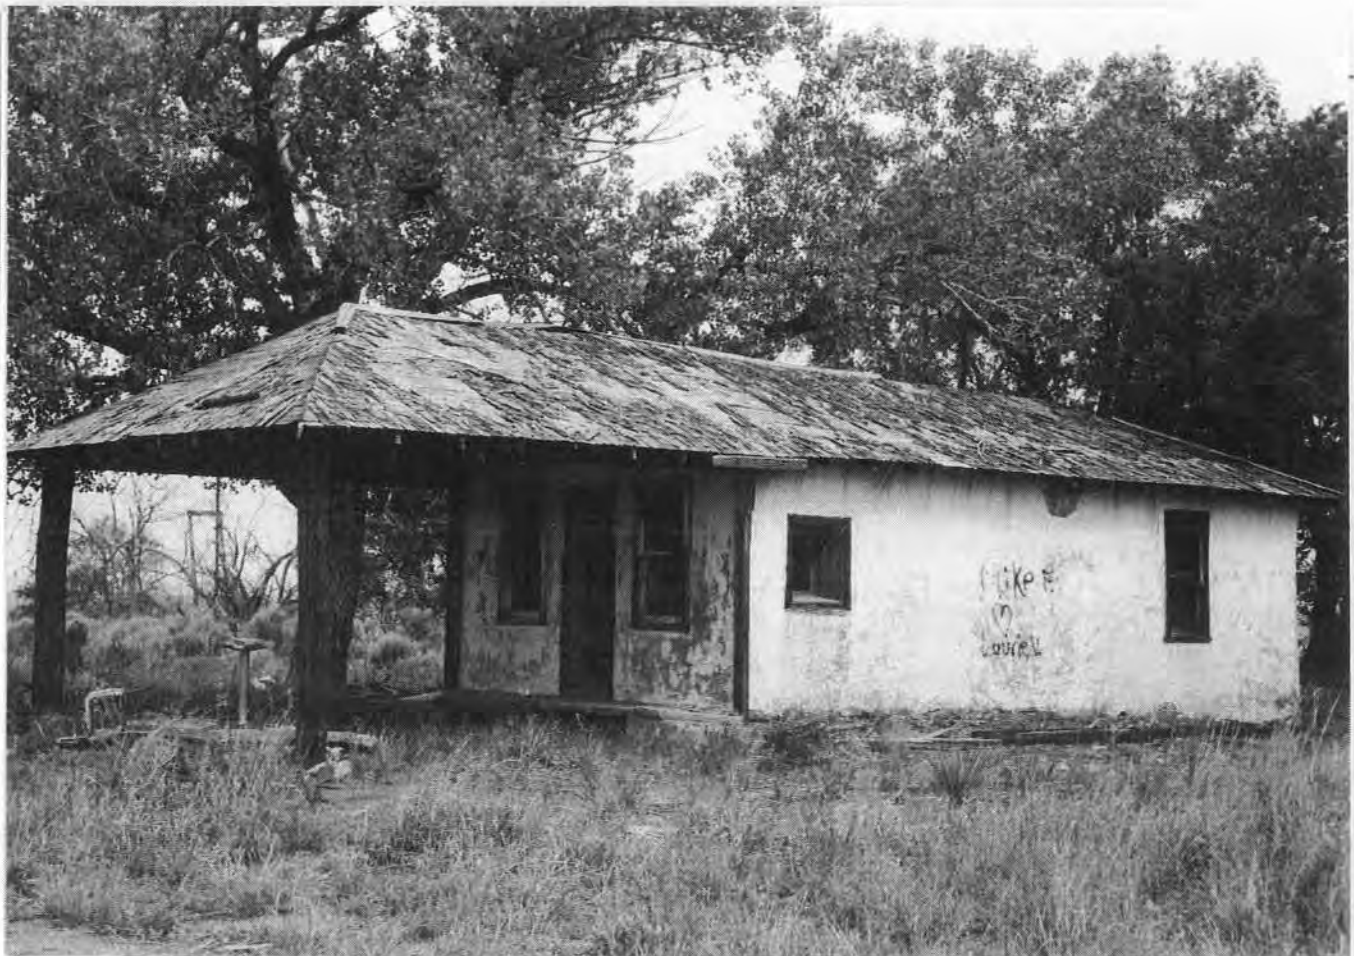
Roof type hipped w/ exposed rafters Materials wood shingle

Wall facade stucco Foundation _____

Window type 1/1 wood sash Materials _____

Door type central - 1/2 glazed 1/2 hollow pane Materials wood frame

Porch type canopy on wood posts Materials _____

General Architectural Description very conc old gas station w/ matching outbldg

another sm conc outbldg (no roof or windows left) is to W, but not
sure if it's part of this station)

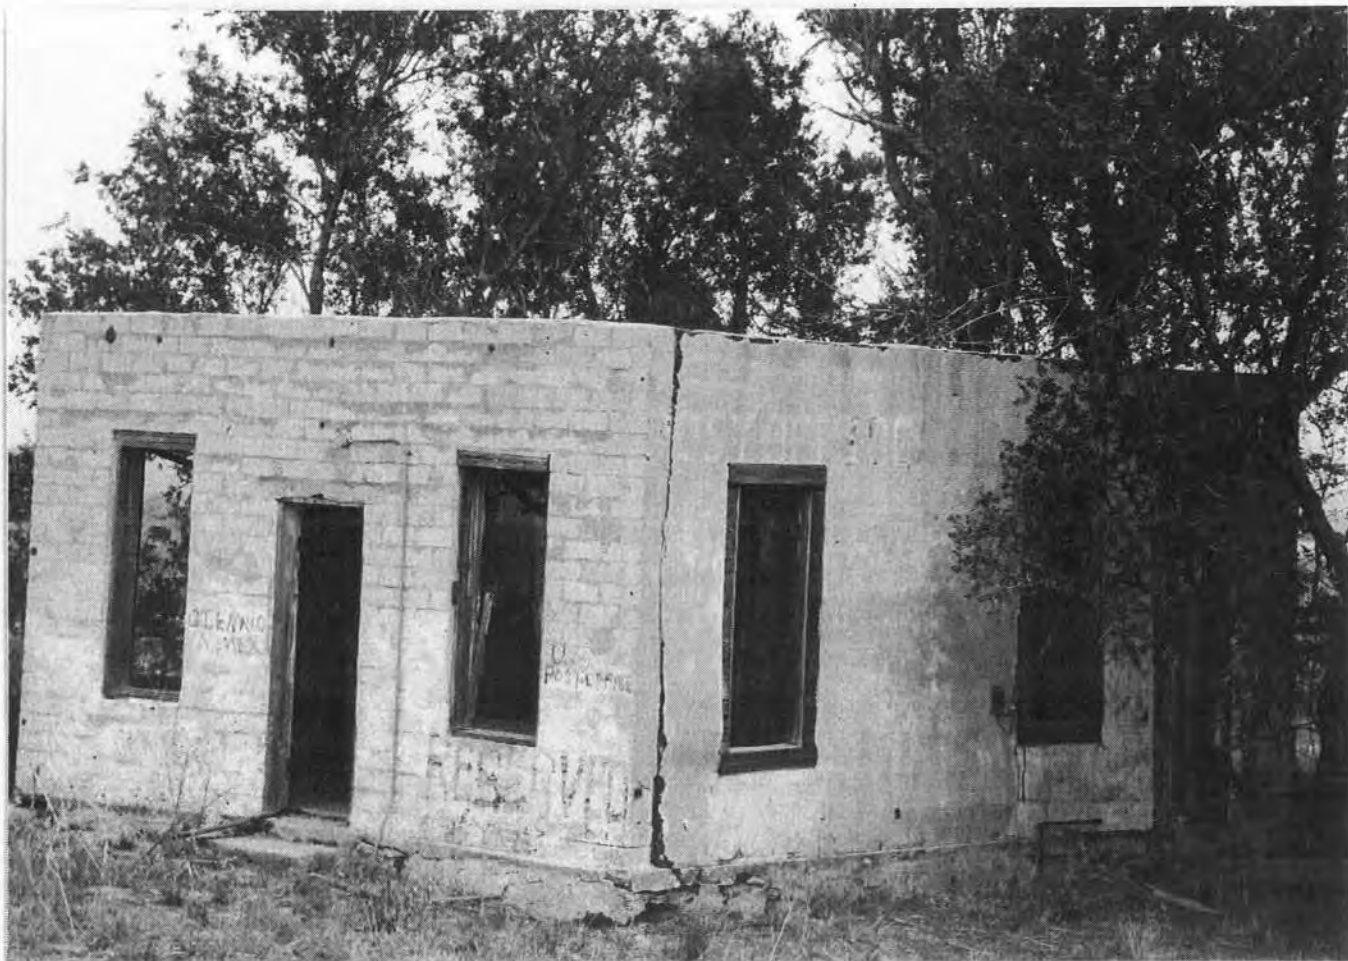
NM037-GL '11
PHOTO 21-3762-31
FACING NW

Roof type MISSING Materials _____

Wall facade conc block / stucco Foundation _____

Window type wood frame; [windows missing] Materials _____

Door type wood frame [door missing] Materials _____

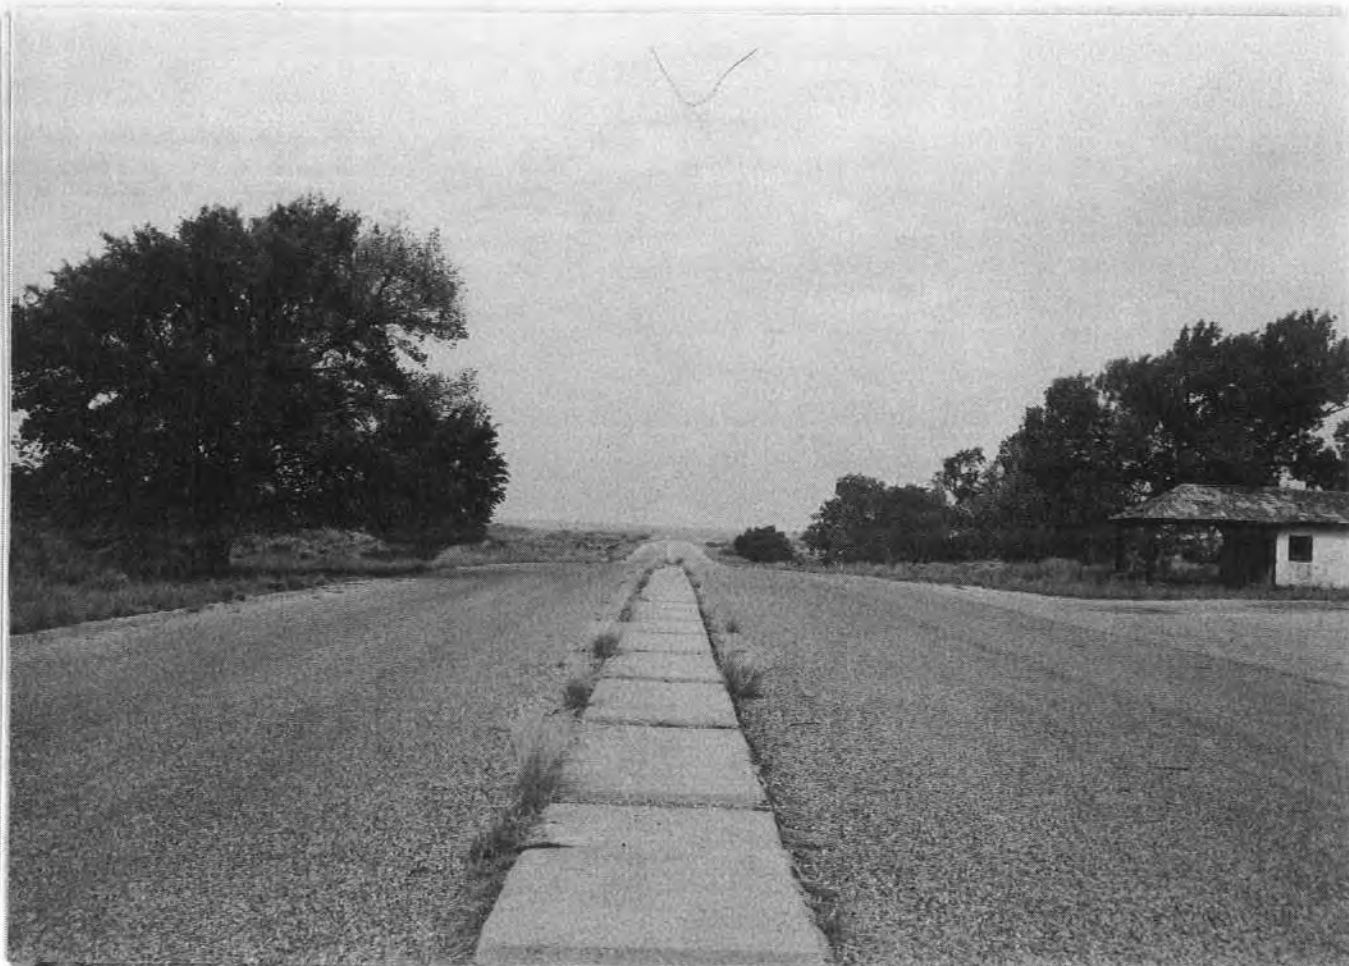
General Architectural Description 4 lanes divided by conc median (2 lanes each side)

Median strip on TX side is missing; on N.M. side is approx 2.5' wide w/ 8 ft sections (rectangular w/ chamfered edges).

Excellent intact strip of rd thru Giarro - distance from entry ramp to dot (N.M. side) is approx $\frac{9}{10}$ to 1 miles. Rd connects to San Jon, NM (via N.M. Jct). Rd contains 13/10 E of Giarro but pavement ends & DOT project is changing alignment here.
