COURTHOUSE IN DANGER

San Saba County Courthouse one of many needing emergency repairs

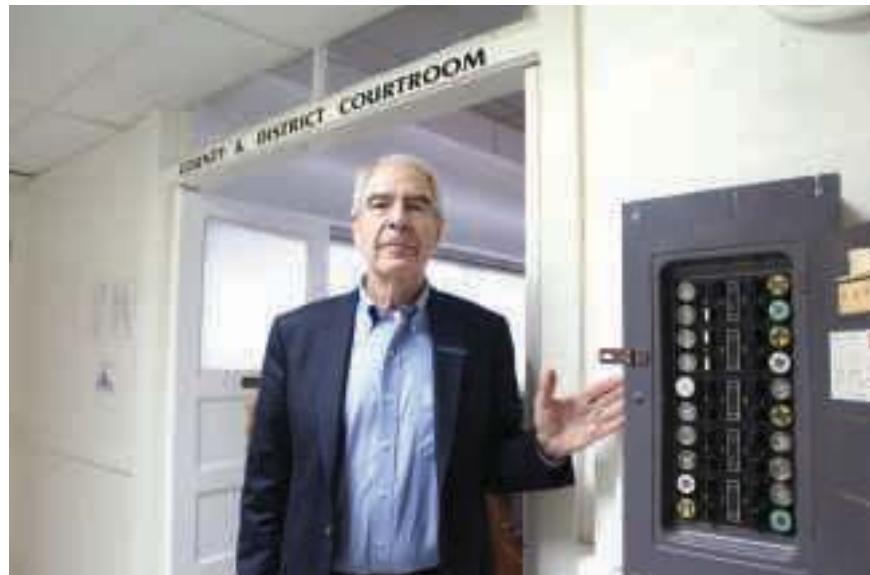
Judge Byron Theodosis with the obsolete plug fuse electrical panel outside San Saba County's County and District Courtroom. Workers must flip switches on this panel to control the lights in the courtroom. (Photo by Liz Carmack.)

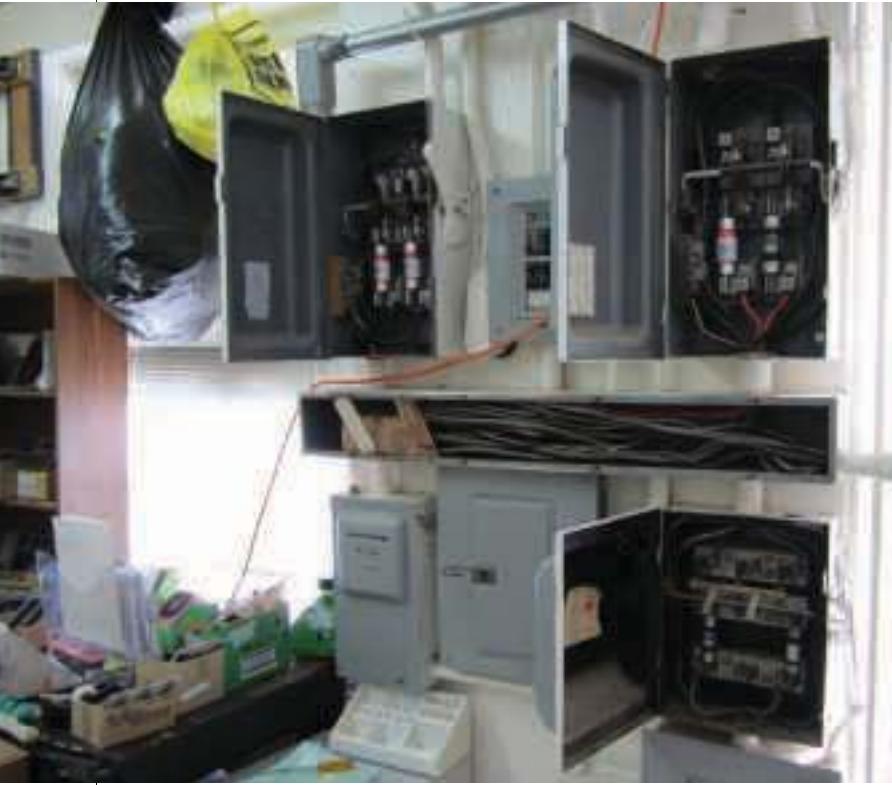
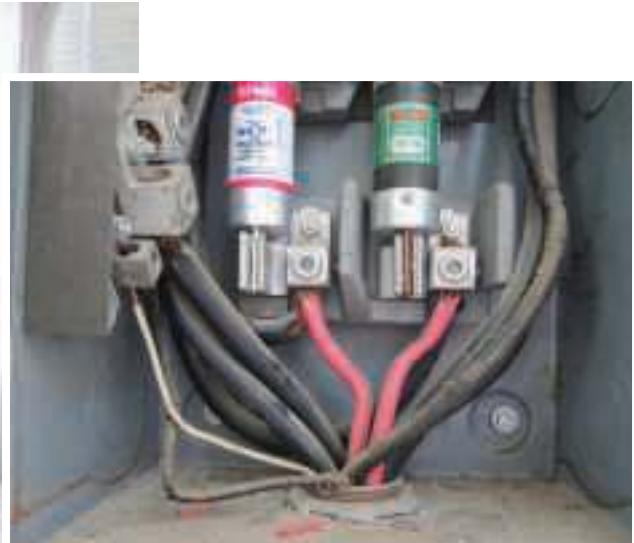
Electrical wiring, switches and panels shown in the courthouse's original service entrance that are considered a safety and fire hazard because of exposed live parts, cloth covered feeder conductors with deteriorating insulation, unlabeled equipment and other issues. (Photos courtesy Architexas.)

Six Christmases have passed, yet today that sub-standard electrical system remains in place. It's still not up to code and much of it dates to 1952. The hazardous situation is a safety concern for county officials and employees who work in the three-story courthouse, as well as the public engaging in a variety of business there. Every San Saba County official calls the courthouse home. "When a citizen needs something that has to do with county government, this is where they come," said County Judge Byron Theodosis.

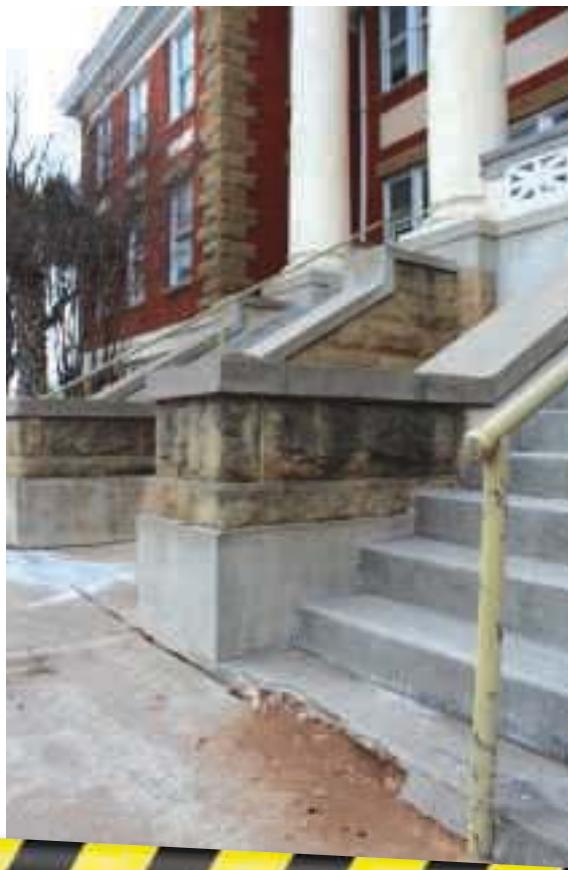
Crumbling and cracked concrete on the building's exterior stairs and sidewalks are on the list of immediate repairs needed to improve safety at the San Saba County Courthouse. (Photo by Liz Carmack.)

The county is seeking a \$449,750 emergency grant and has pledged the same toward the project. The grant application states the courthouse is "a true time bomb with a fast-burning fuse." In addition to addressing the much-needed electrical upgrades, the money will help San Saba County remove trip hazards and repair damaged stairways, reconstitute severely deteriorated sidewalks and upgrade handrails on stairs to make them ADA compliant.
