United States Department of the Interior
National Park Service
National Register of Historic Places Registration Form

Historic Name: Cotulla Downtown Historic District
Other name/site number: NA
Name of related multiple property listing: NA

Cotulla Downtown Historic District, Cotulla, La Salle County, Texas

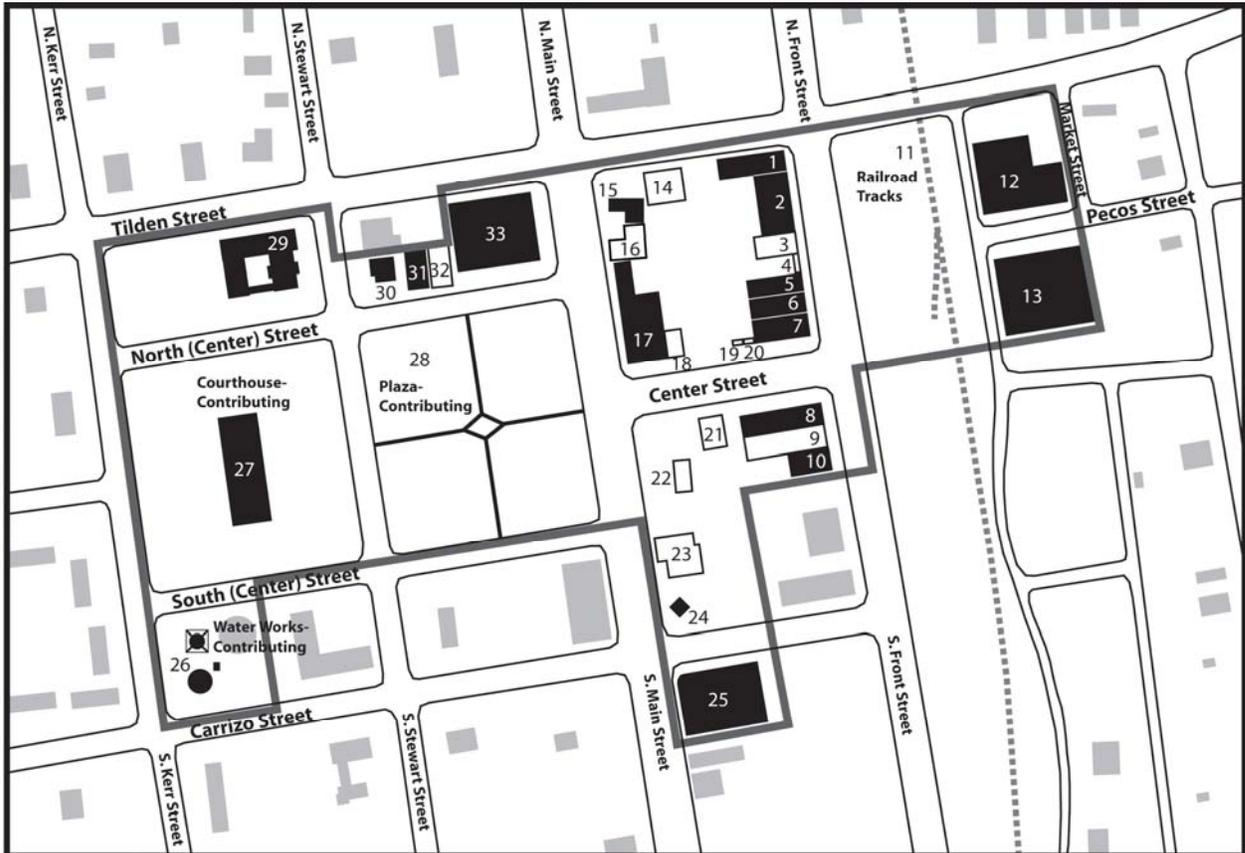
Cotulla Historic District

- = District Boundary
- = Contributing Resource
- = Noncontributing Resource
